Inspection Report (Bulldozer)

Year	2013
Make	CAT
Model	D6T
Serial Number	ZJB01163
Hour Meter Reading	12,207 Hrs.
Previous Application (e.g., earth moving, mining, demolition, etc)	General Construction

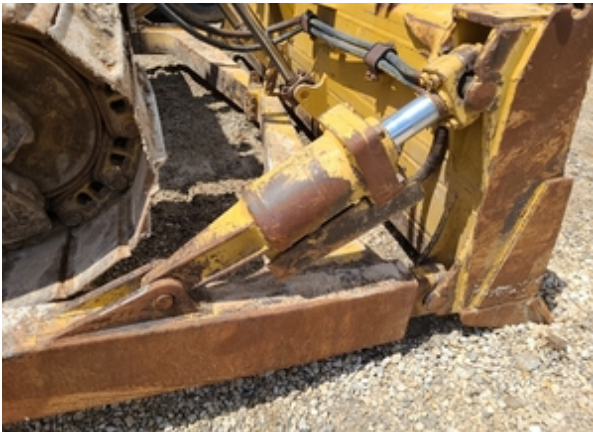
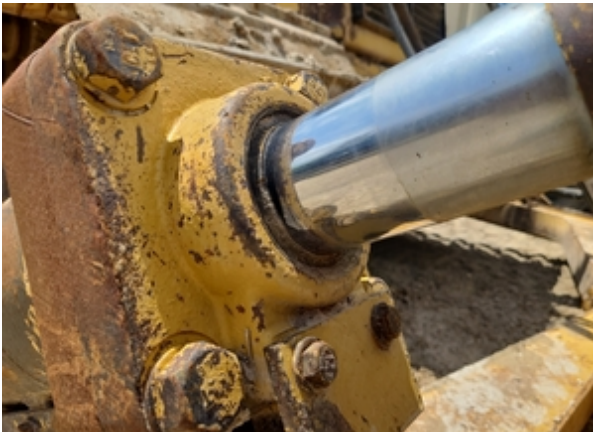
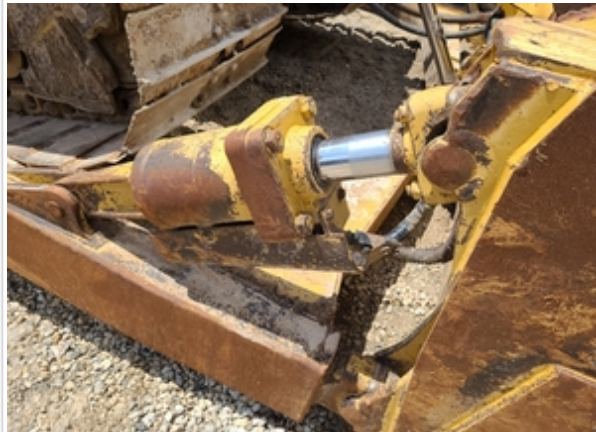
Tilt Cylinder	Check the tilt cylinder. Note any wear, pitting, discoloration, etc. Take photos.
Tilt Cylinder: Mounting Pin	3
Tilt Cylinder: Oil Leaks	No
Tilt Cylinder Photos

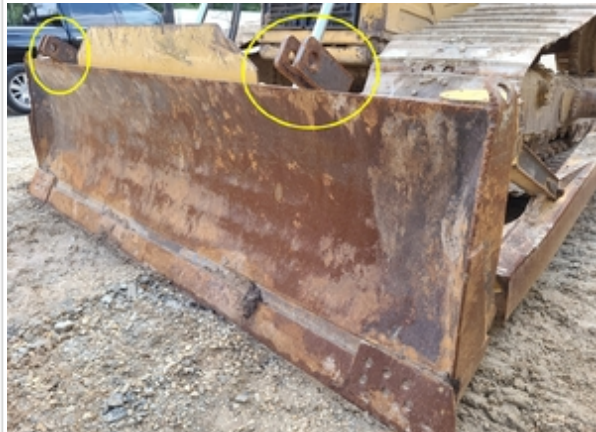
<p data-bbox="531 1653 893 1682">Front Rake Attachment Brackets</p>

Blade Condition	3 - Normal Wear & Tear
Comments	Front of blade okay. Rear frame trunnion to cylinders and c frame worn
Blade Photos

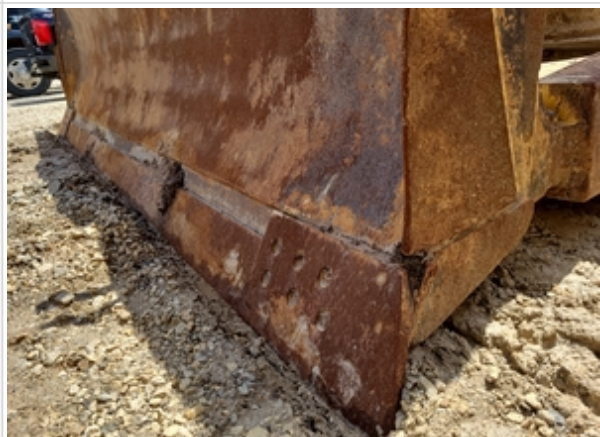
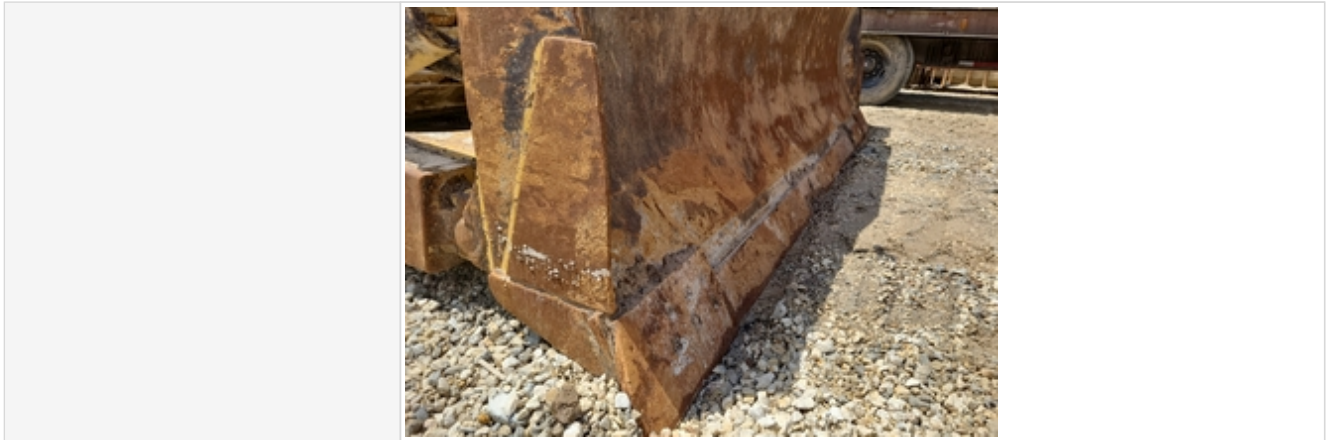
<p>Blade Edge</p>	<p>3 - Normal Wear & Tear</p>	
<p>Blade Edge Photos</p>
