General Info

Year	2014
Make	CAT
Model	450F
Serial Number	HJR00248
Hour Meter Reading	2,040
Previous Application (e.g., earth moving, mining, demolition, etc)	Demolition General Construction

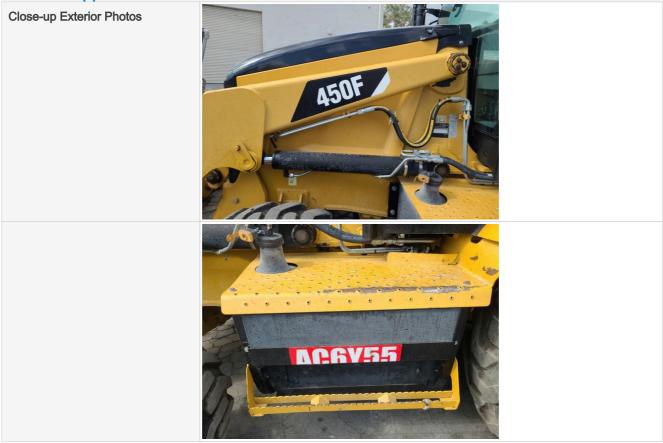
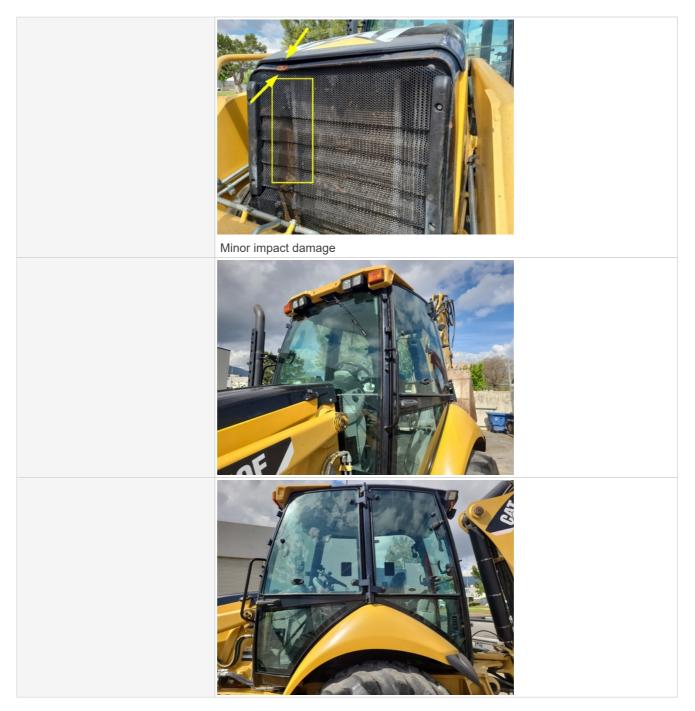
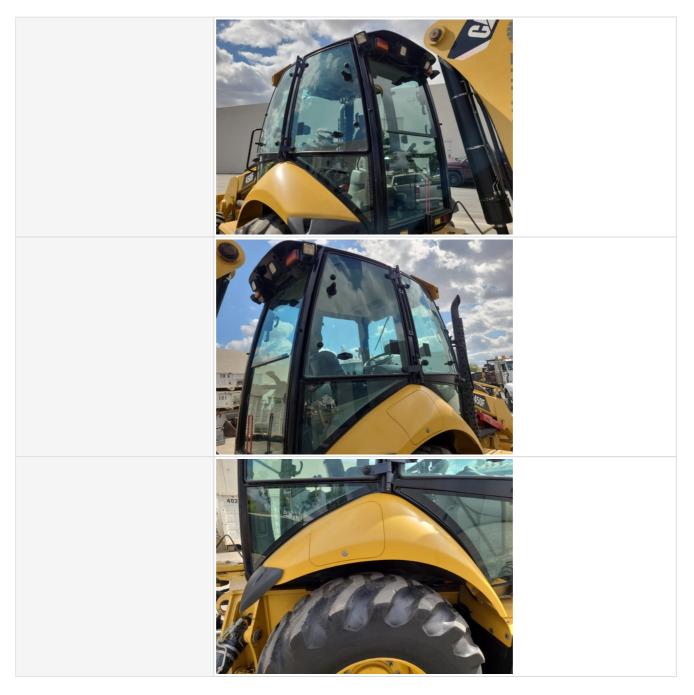
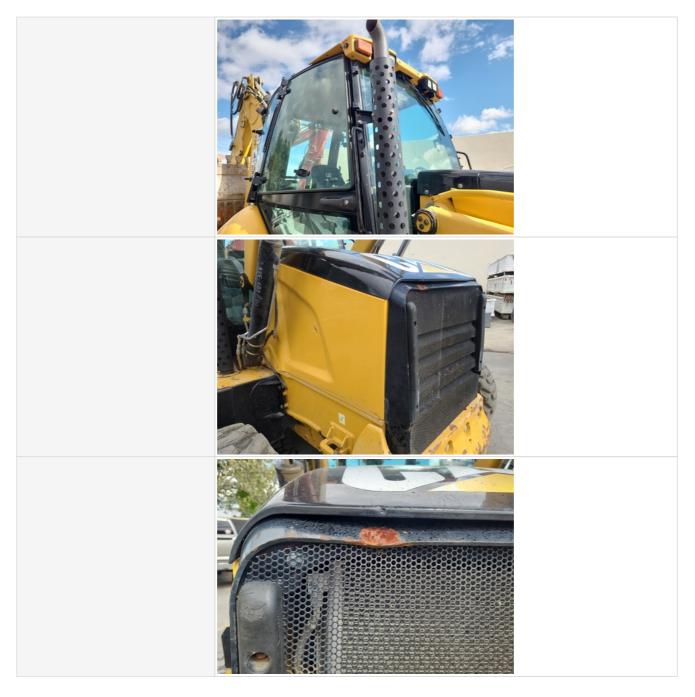
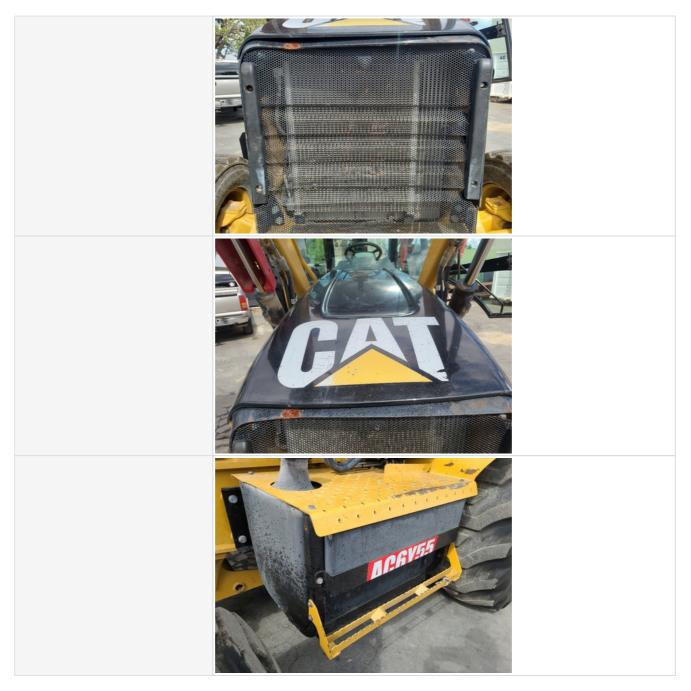
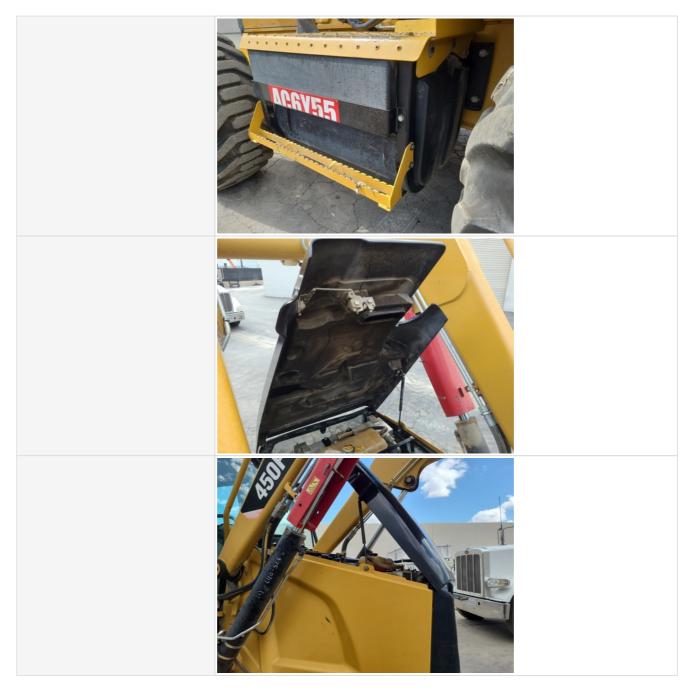
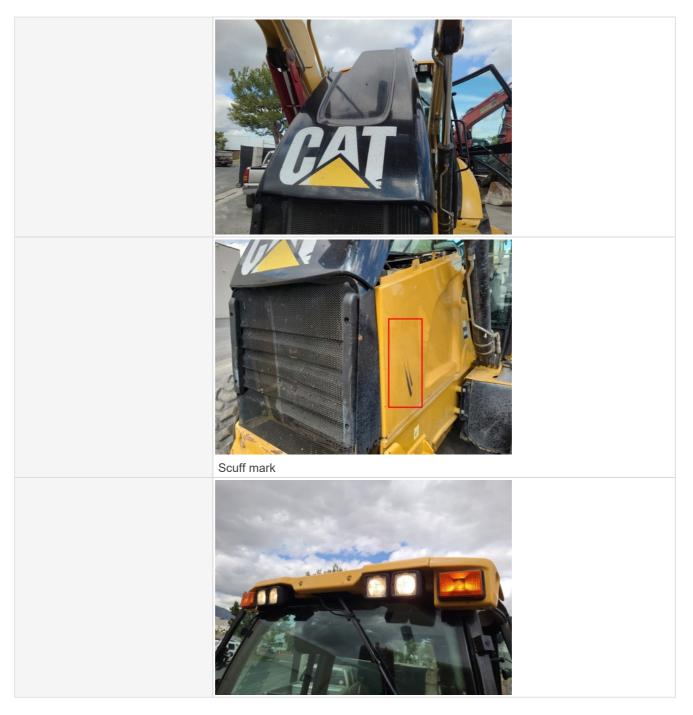
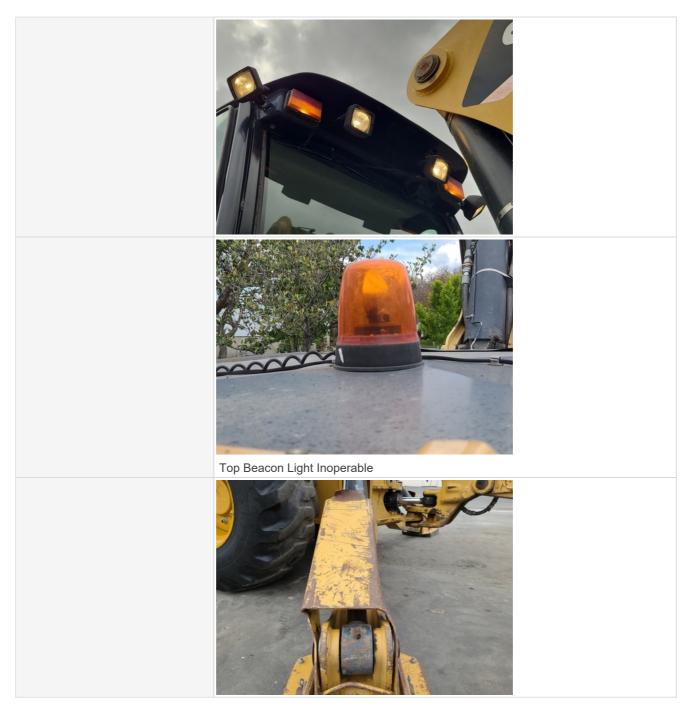
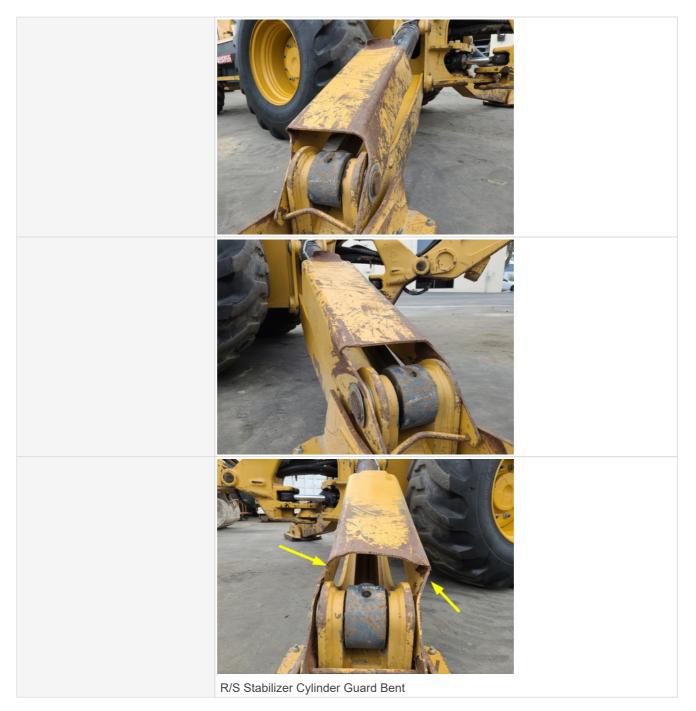
General Appearance

R/S Stabilizer Cylinder Shield bent
Body Panels	3 - Normal Wear & Tear
Body Panel Condition	No visible damage, good paint condition and panel fitment, Other (see comments)
Comments	Minor scuff marks observed
Doors / Canopy Latches	3 - Normal Wear & Tear
Doors / Canopy Latches Condition	No visible damage
Steps / Ladders	3 - Normal Wear & Tear
Steps / Ladders Condition	Steps/ladders are fully intact and appear structurally sound
Handrails	3 - Normal Wear & Tear
Handrails Condition	Handrails are fully intact and appear structurally sound
Glass	3 - Normal Wear & Tear
Glass Condition	Glass intact, no visible damage
Mirrors	3 - Normal Wear & Tear
Mirror Condition	Mirrors present and intact, no visible damage
Exterior Lights	3 - Normal Wear & Tear
Exterior Lights Condition	No visible damage, lighting system is operational, Other (see comments)
Comments	All main lights work well. Top beacon light inoperable

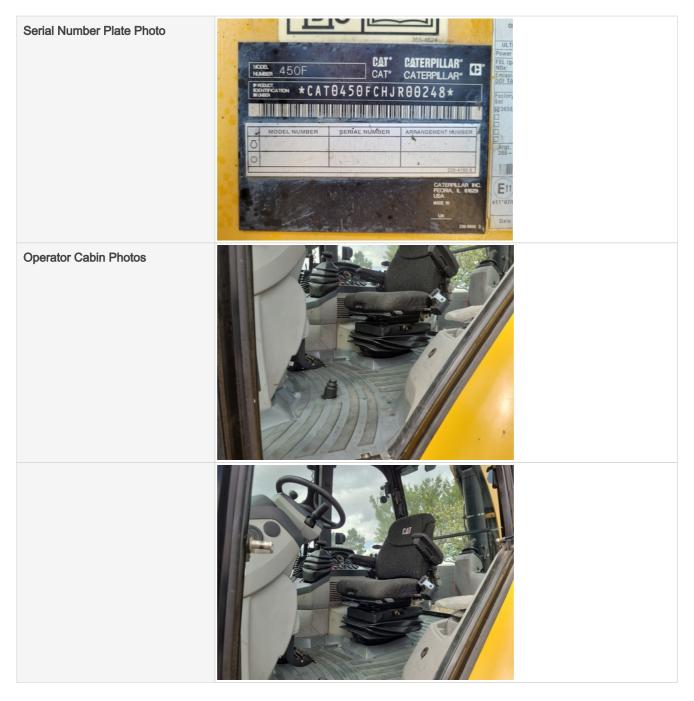
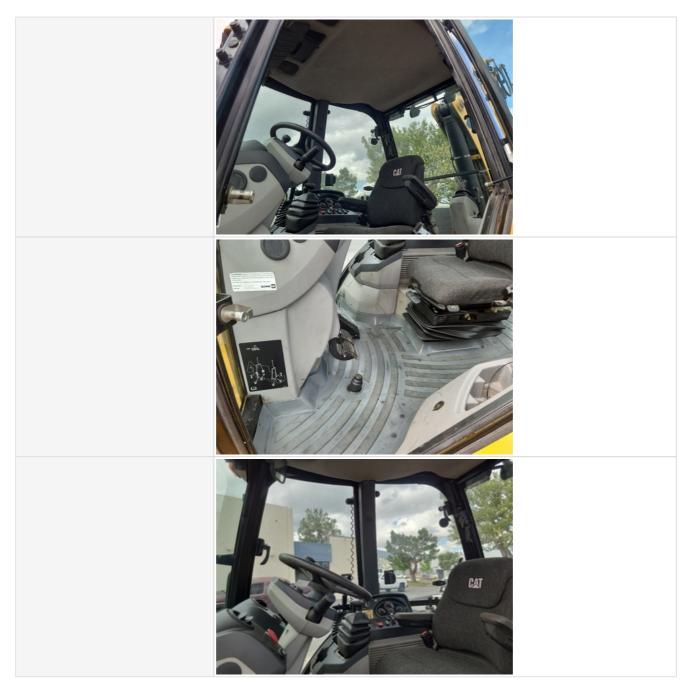
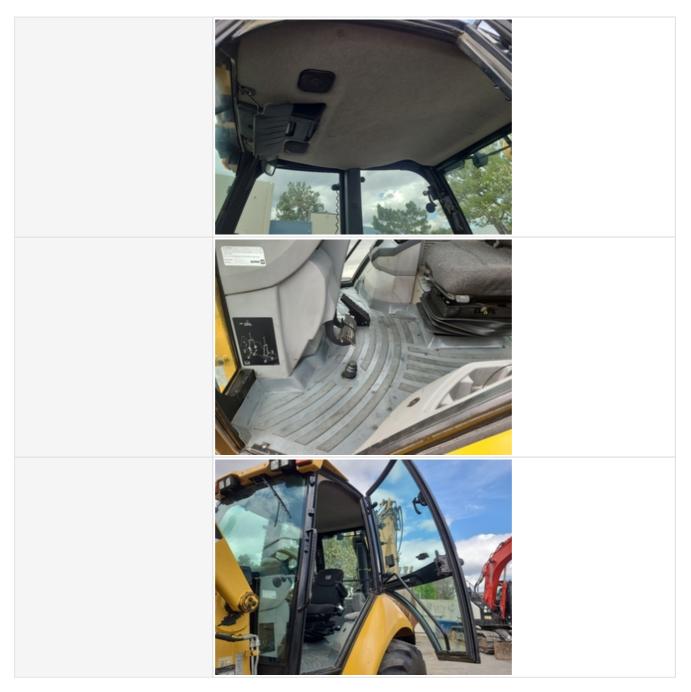
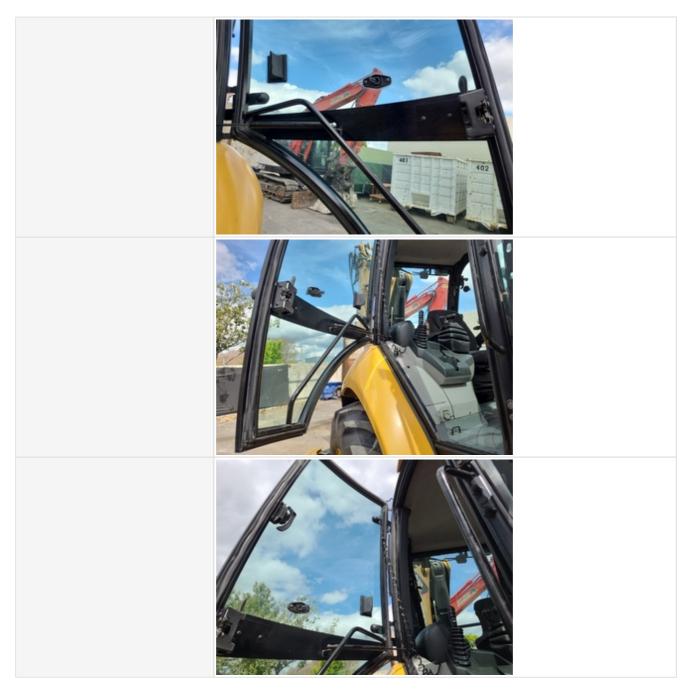
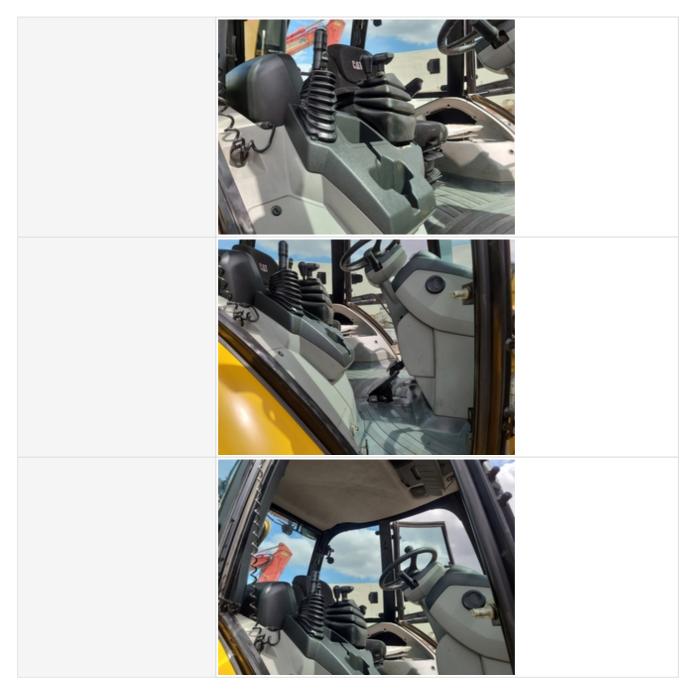
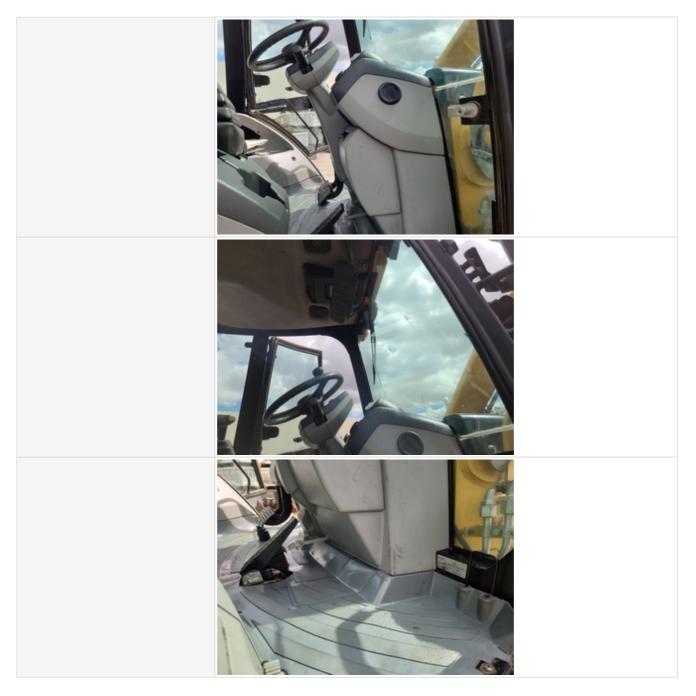
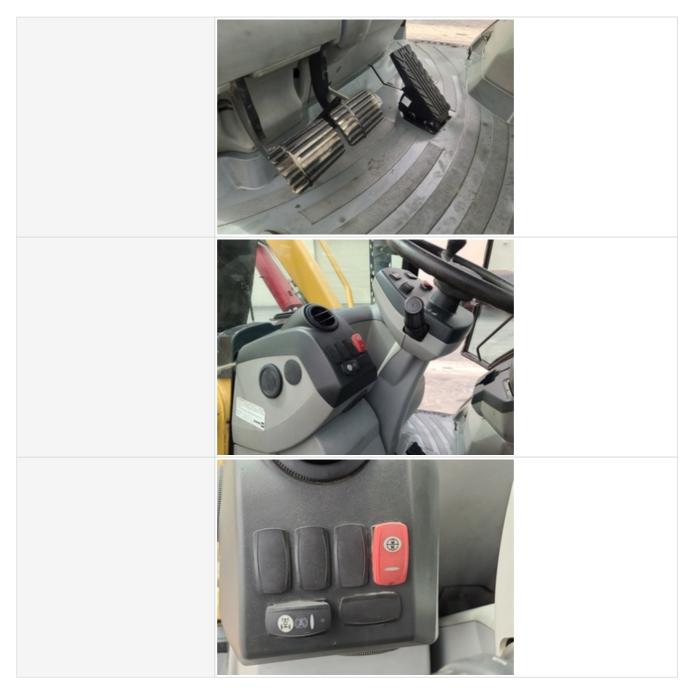
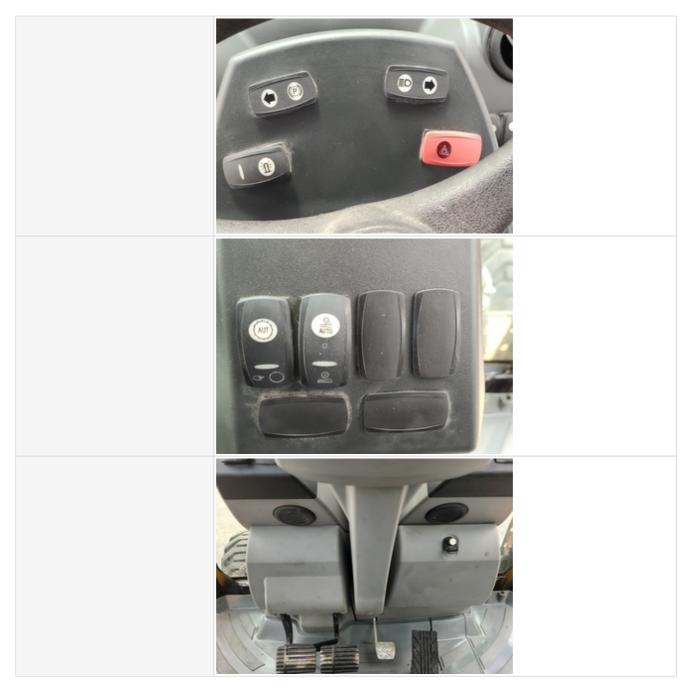
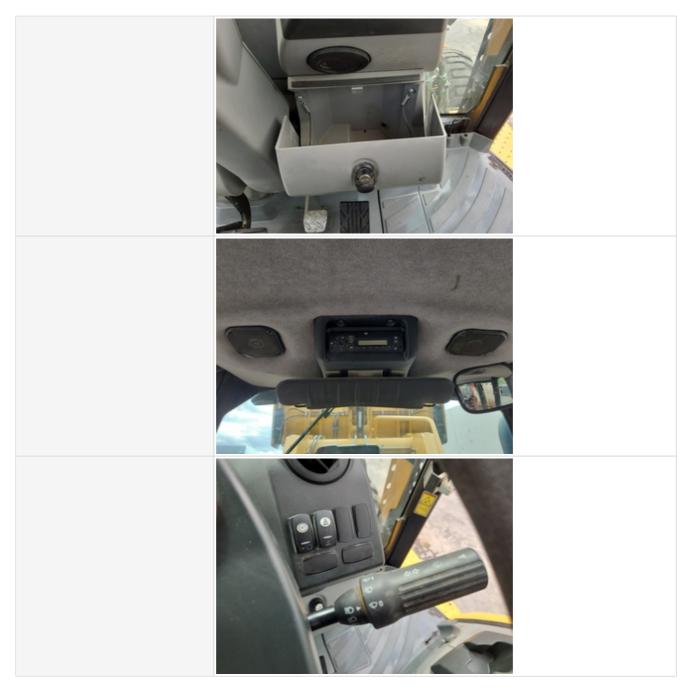
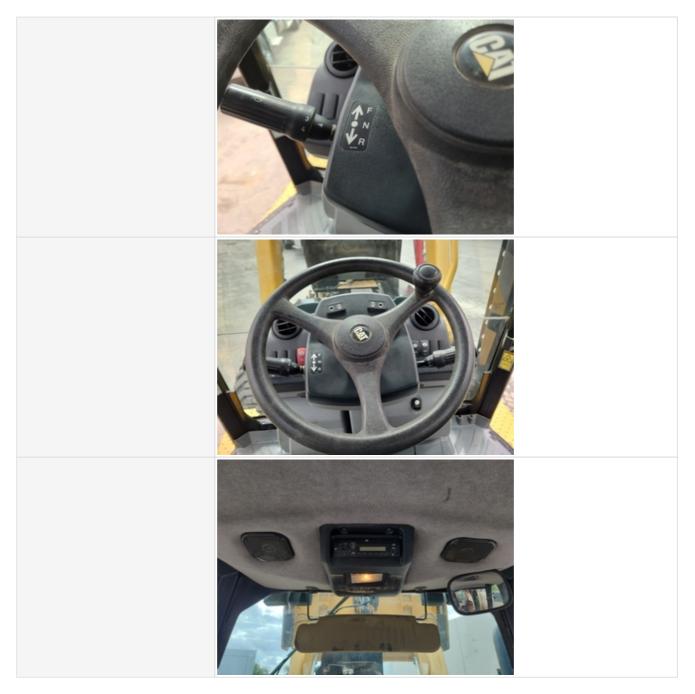
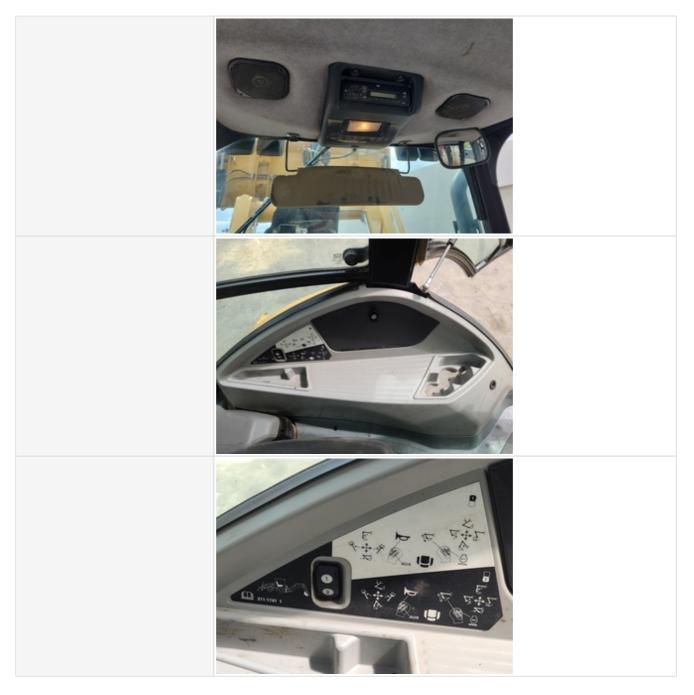
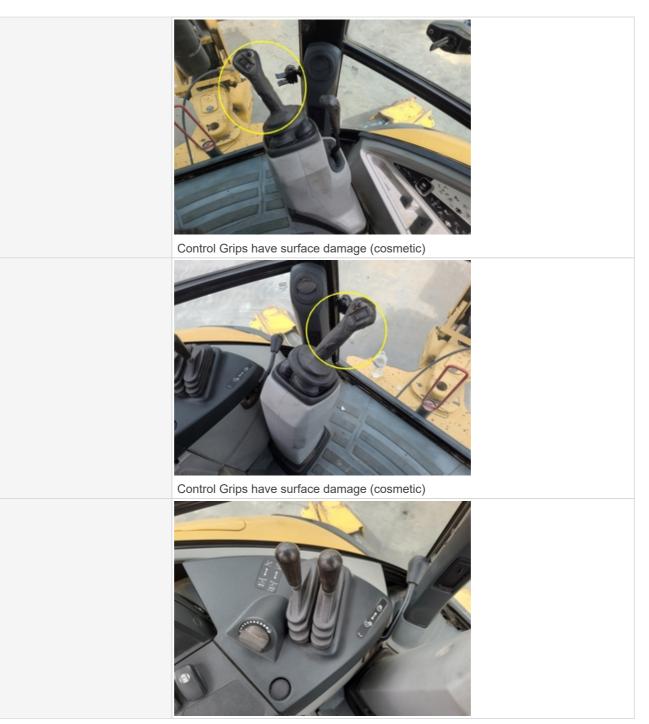
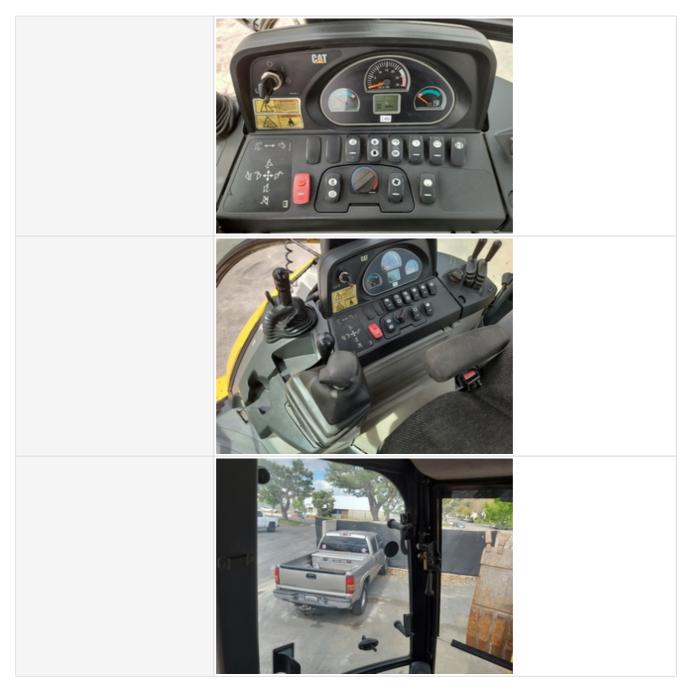
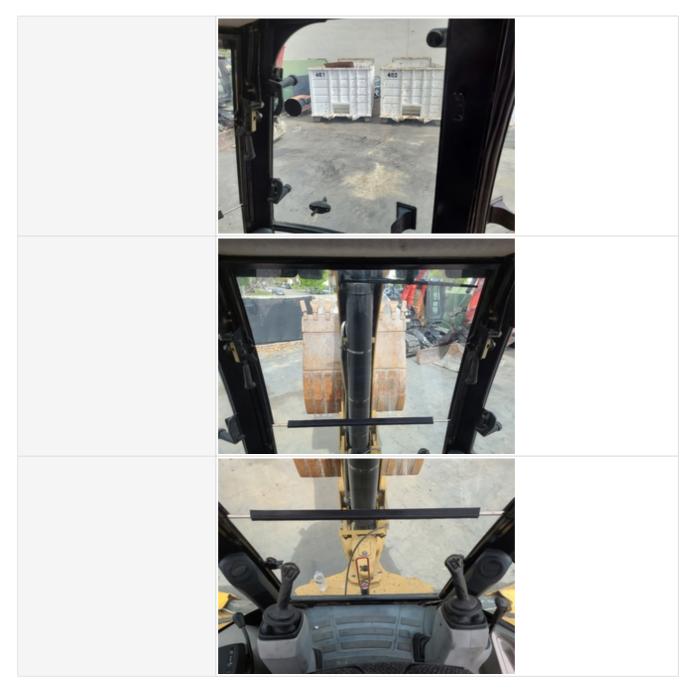
Control Station

Front Wiper Worn
Operator Cabin Overall	3 - Normal Wear & Tear
Operator Cabin Overall Condition	Good cabin appearance, solid floors, panels, and ceiling
Operator Seat	3 - Normal Wear & Tear
Operator Seat Condition	Seat(s) in good condition, no stains or tears in upholstery
Cabin Lights	3 - Normal Wear & Tear
Cabin Lights Condition	Cabin lights are installed with all light covers in place, bulbs are installed and working properly
Safety Lock Out / Stop	2 - Above Average Wear

Safety Lock Out / Stop Condition	Safety lock out device is present, in good condition, and functional
Controls & Switches	3 - Normal Wear & Tear
Controls & Switches Condition	All switches are installed and functional
Hour Meter Activity	3 - Normal Wear & Tear
Hour Meter Condition	Hour meter is functional and in good condition
Hour Meter Activity Photos	
Other Gauge Activity	3 - Normal Wear & Tear
Other Gauge Condition	All cockpit gauges are functional and in good condition
Heater & A/C	3 - Normal Wear & Tear
Heater & A/C Condition	Heater and A/C work as expected
Travel Alarm	3 - Normal Wear & Tear
Travel Alarm Condition	Travel alarm is installed and functioning as expected
Horn	3 - Normal Wear & Tear
Horn Condition	Horn is installed and functioning as expected
Backup Camera	0

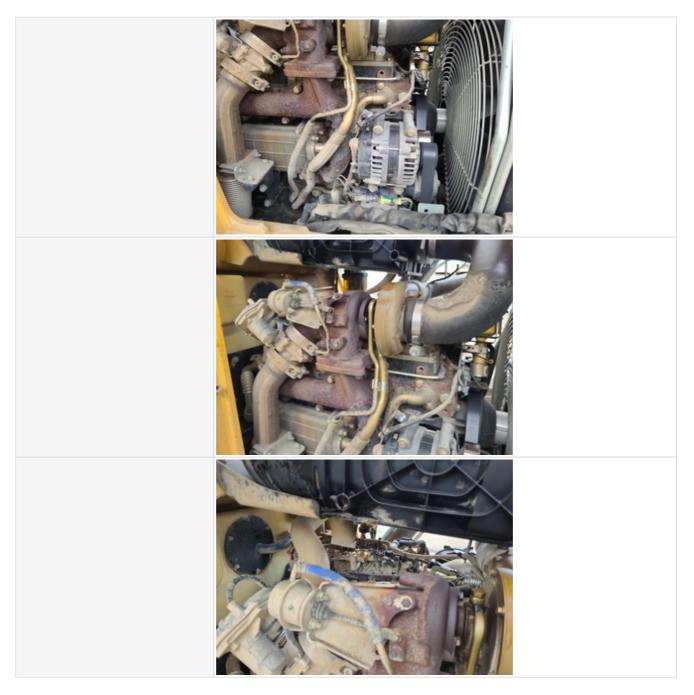
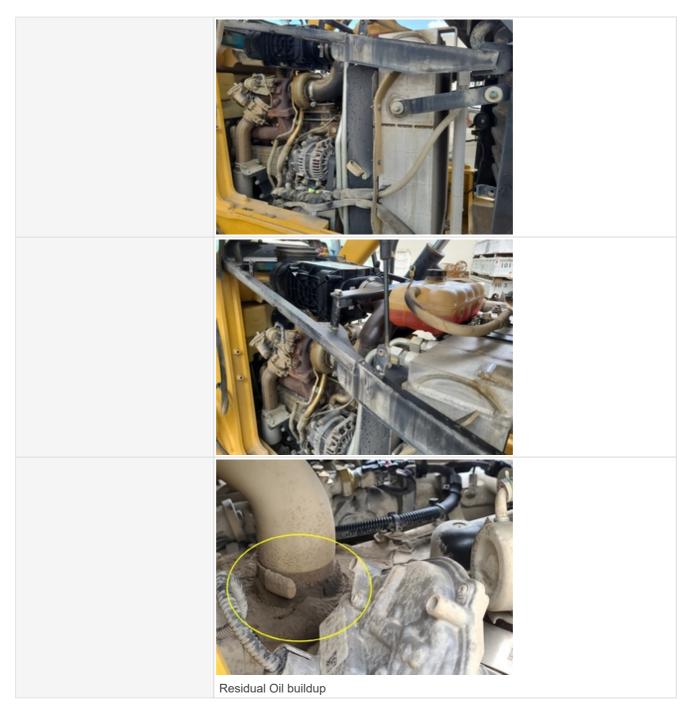
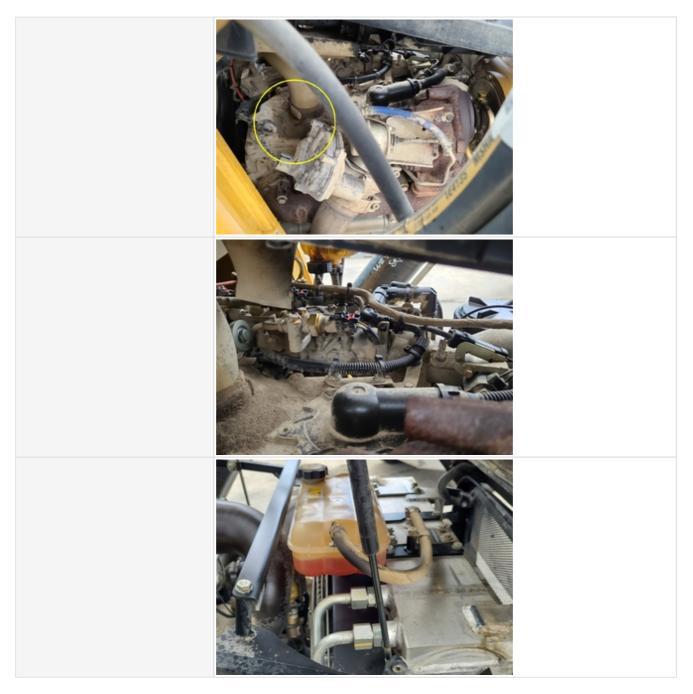
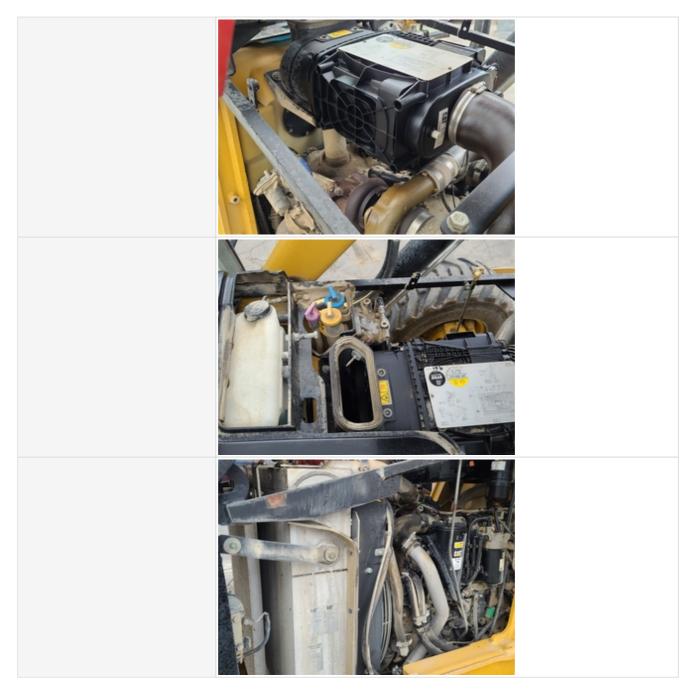
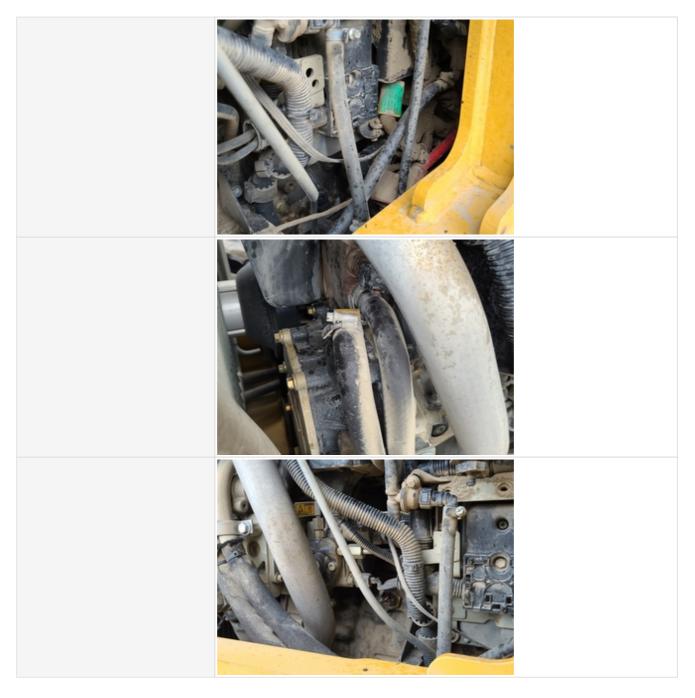
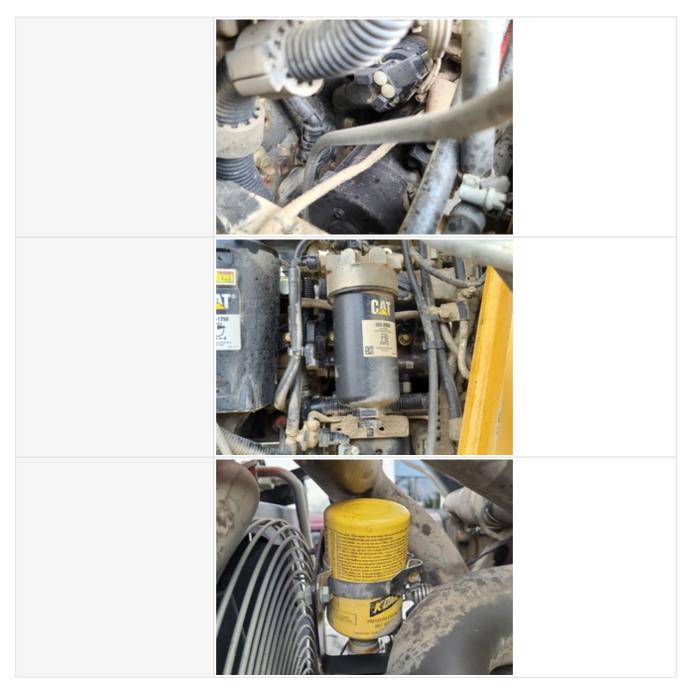
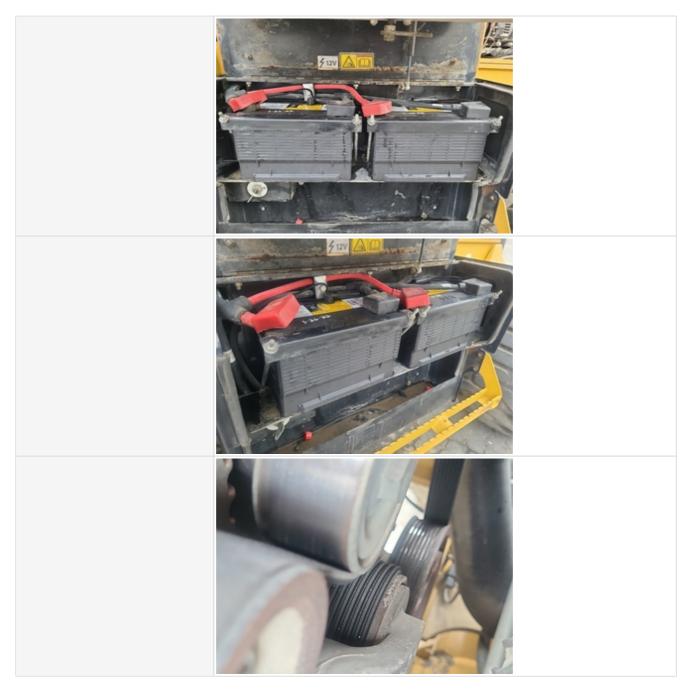
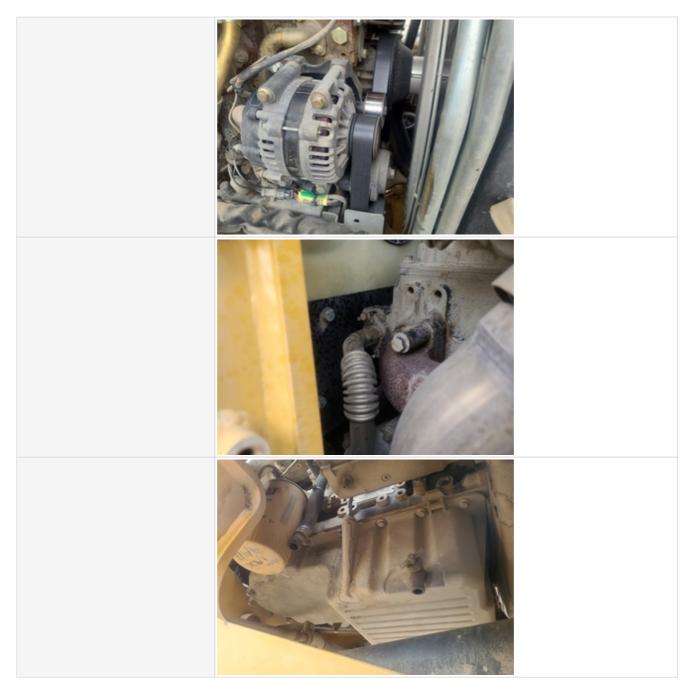
Engine Photos

CONTRACTOR OF CO
Blow-by (Visual Observation Check)	No
Unusual Noises (Upon Start-up, Idle, Shutdown)	No
Unusual Noise Notes	No unusual noises heard
Engine Smoke (Upon Start-up, Idle, Shutdown)	No
Engine Smoke Notes	No engine smoke issues observed
Engine Exhaust Color	Clear
Battery	3 - Normal Wear & Tear
Battery Condition	Clean & dry appearance, tight connections
Radiator	3 - Normal Wear & Tear
Radiator Condition	Radiator fins & components appear to be in good working order, no signs of damage or leaks
Belts	3 - Normal Wear & Tear
Belt Condition	Belts appear in good condition & alignment with proper tension
Hoses	3 - Normal Wear & Tear
Hose Condition	Firm, pliant hoses with no signs of wear or leaks
Water Pump	3 - Normal Wear & Tear

Water Pump Condition	No unusual pump noises heard
Cooling System Leaks	No
Coolant Color / Appearance	3 - Normal Wear & Tear
Coolant Color/Appearance Notes	Normal Translucent appearance, no visual signs of contamination
Oil Leaks	No
Oil Color / Appearance	3 - Normal Wear & Tear
Oil Color / Appearance Notes	Clean oil appearance, no signs of cross contamination, Appropriate oil level
Fuel Leaks	No
Requires DEF (Diesel Exhaust Fluid)	No
Overall Engine Appearance	Areas of dried seepage seen on engine hoses & components, Dusty & dry
Overall Engine Comments	Minor residual oil buildup at top of valve cover area. Engine has well maintained and healthy appearance with no active leaks.

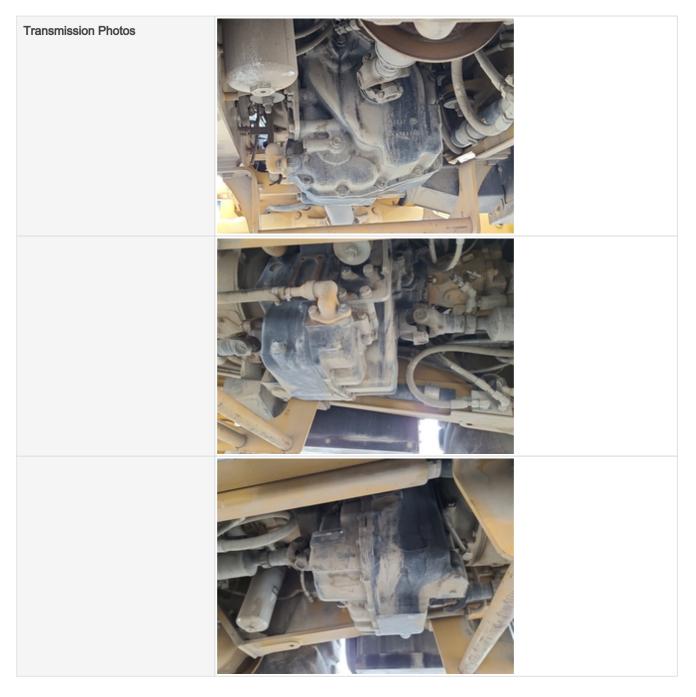
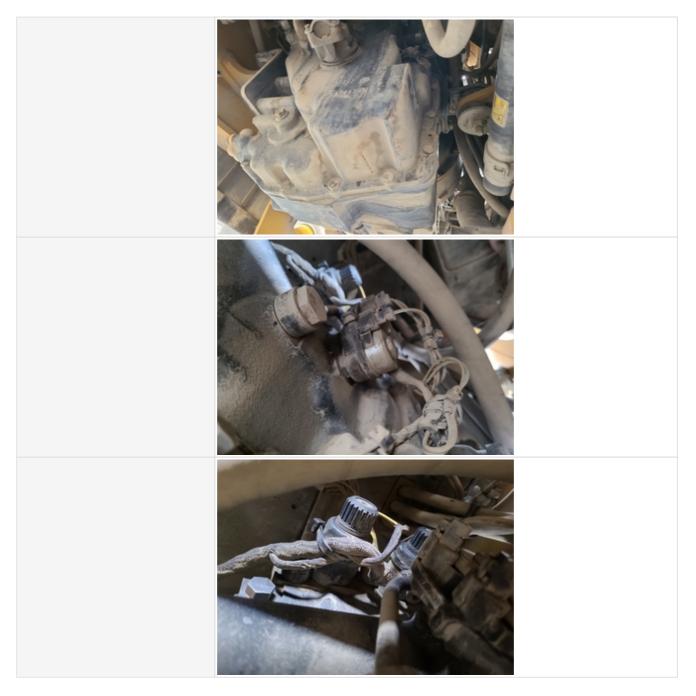
<image/>
Clutch	0
Shift Lever	3 - Normal Wear & Tear
Shift Lever Condition	Good forward and reverse function
Shift Level Photos	
Foot Brake	3 - Normal Wear & Tear
Foot Brake Condition	Good brake function
Inching Brake	0
Parking Brake	2 - Above Average Wear
Parking Brake Condition	Other (see comments)

Comments	Parking brake electronic sensor works properly. Mechanical brake cable needs adjustment (Parking brake not working properly)
Parking Brake Photos	
Overall Drivetrain Comments	Overall Drivetrain visually in excellent condition and operating well during inspection.
