General Info

Year	2014
Make	CAT
Model	450F
Serial Number	HJR00248
Hour Meter Reading	2,040
Previous Application (e.g., earth moving, mining, demolition, etc)	Demolition General Construction

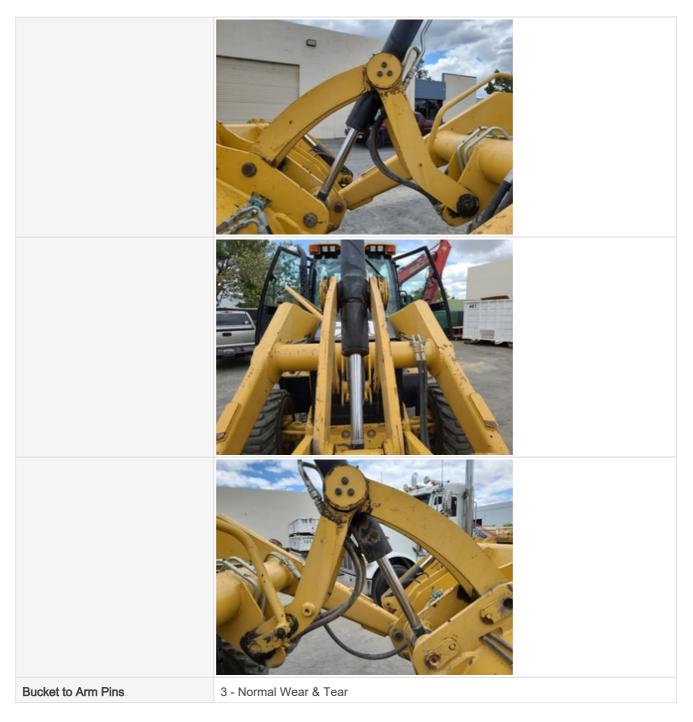
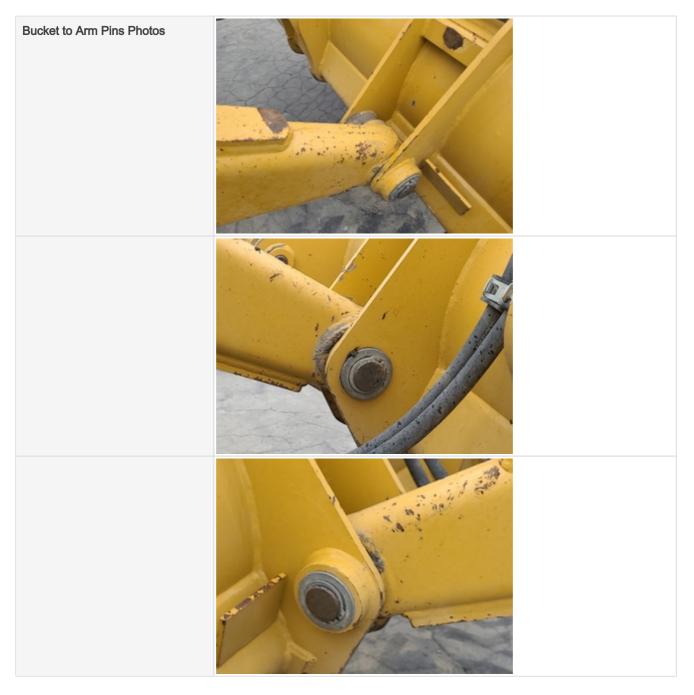
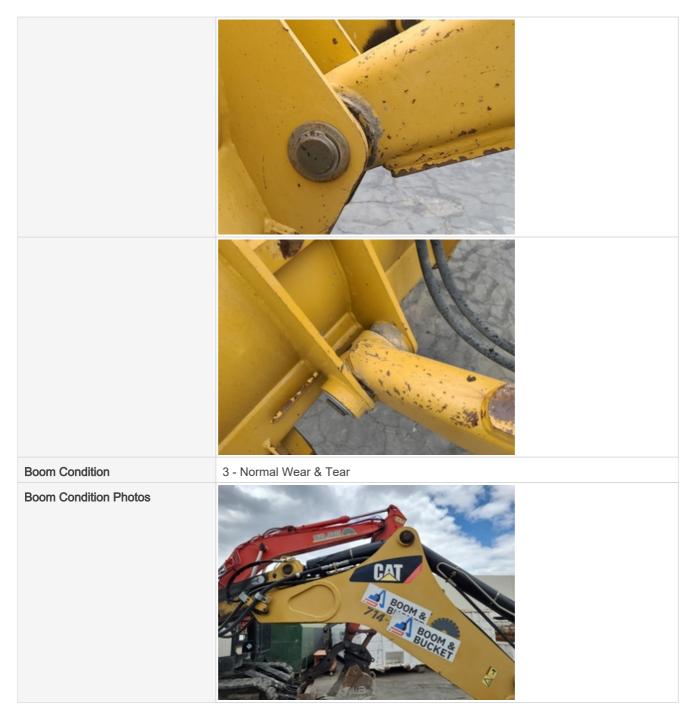
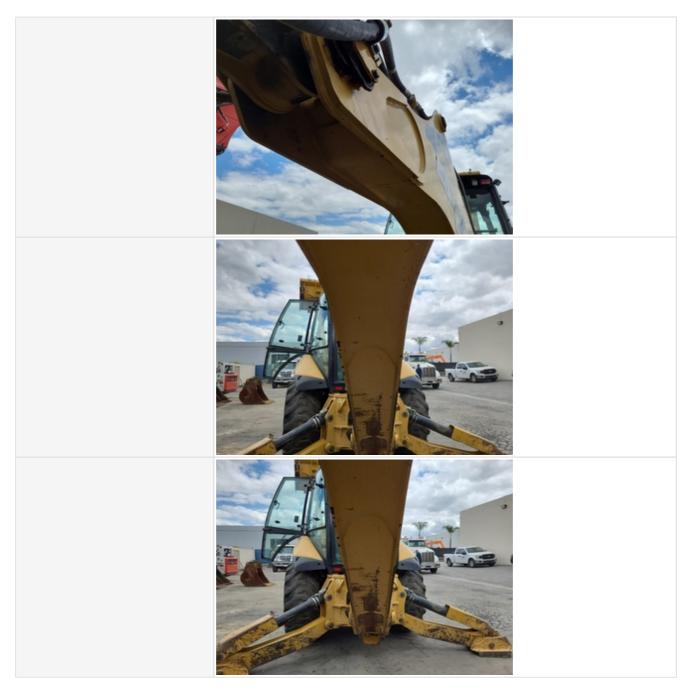
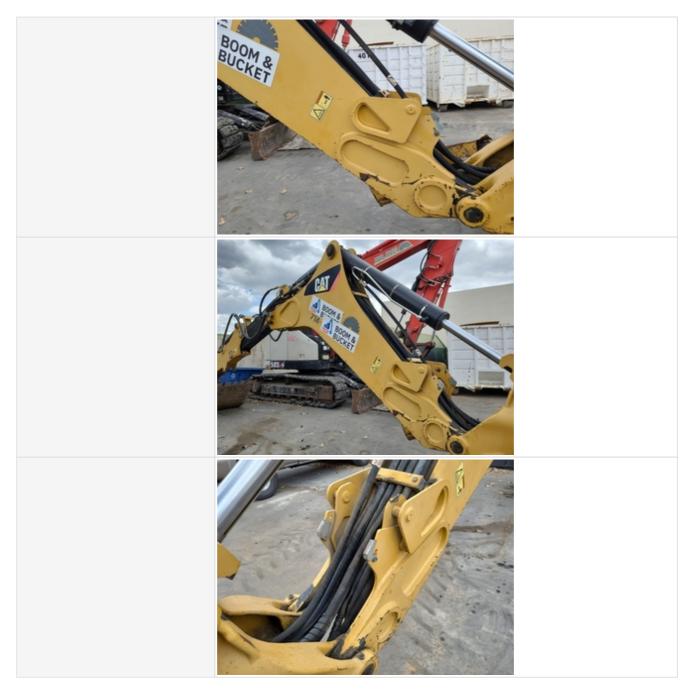
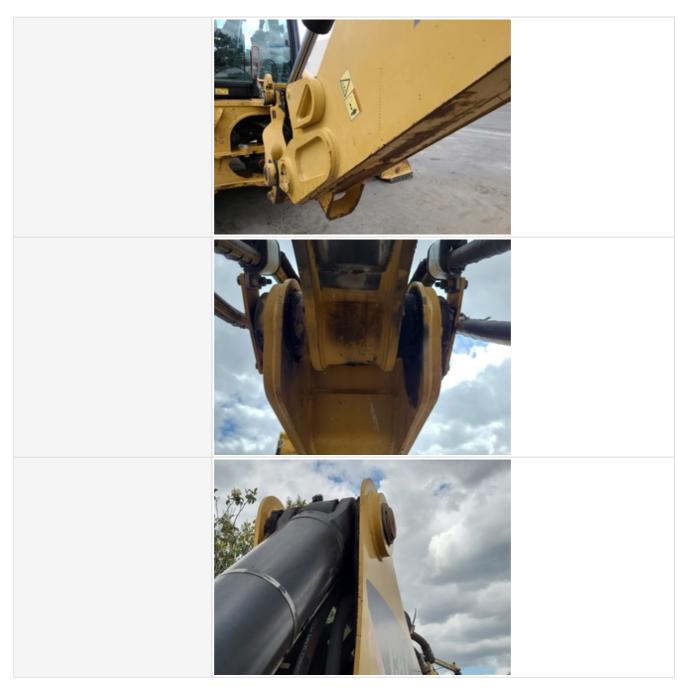
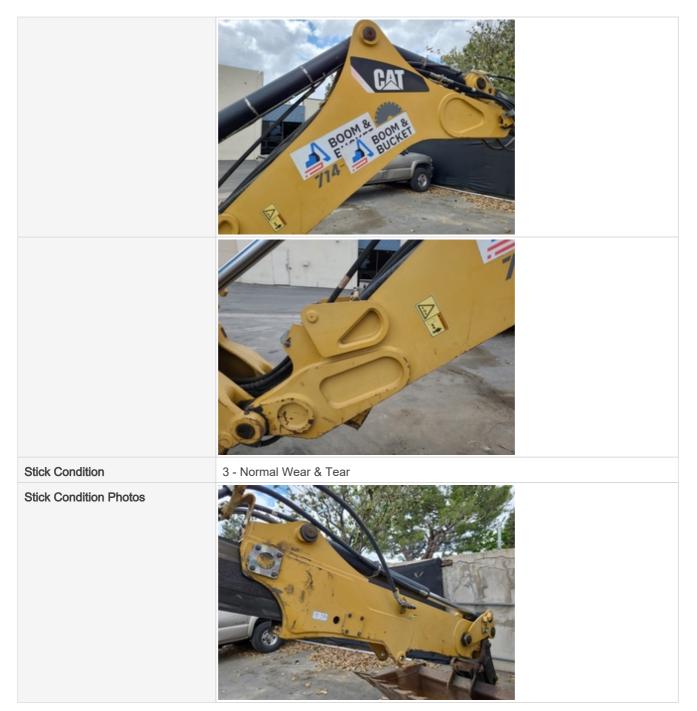
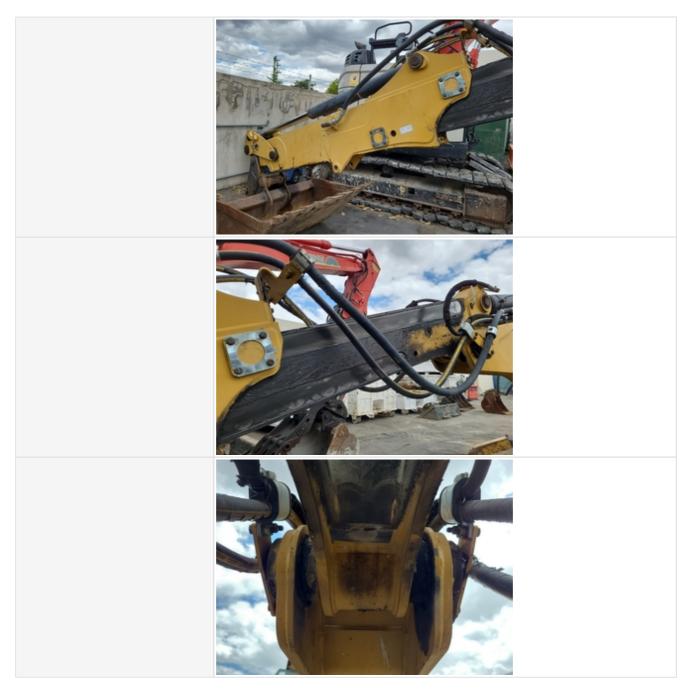
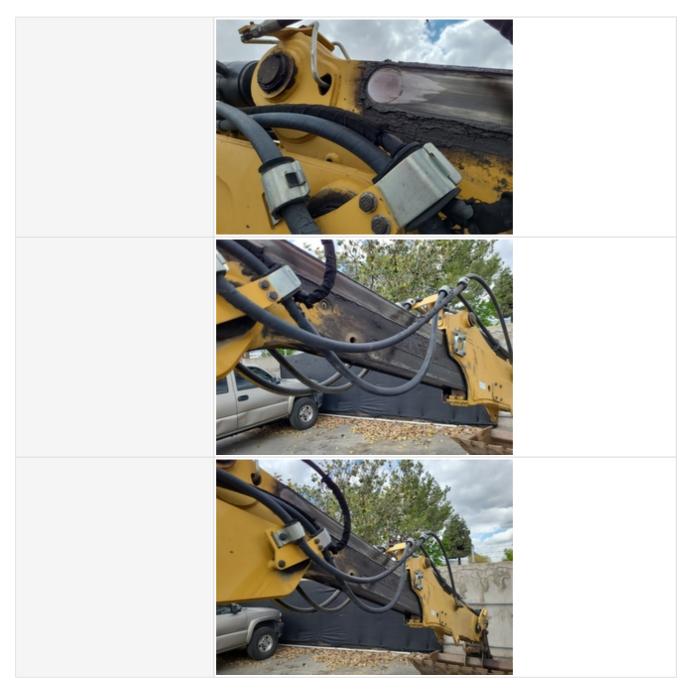
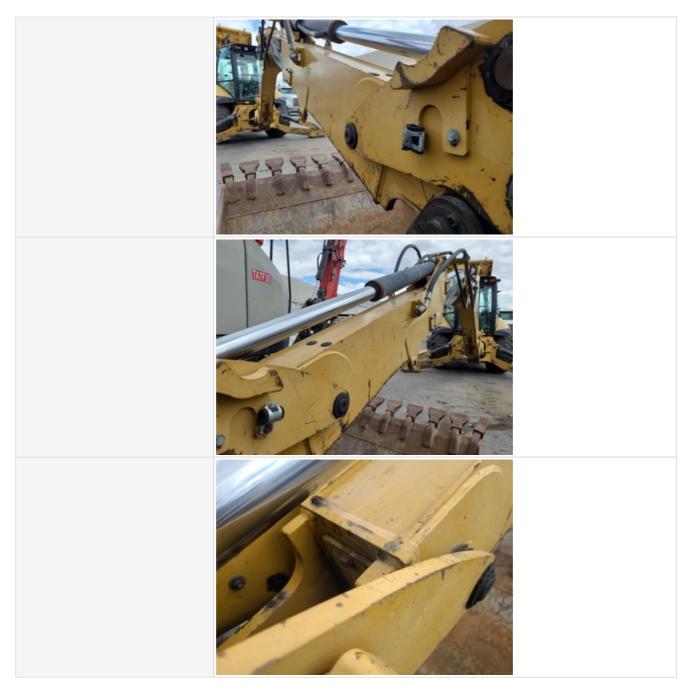
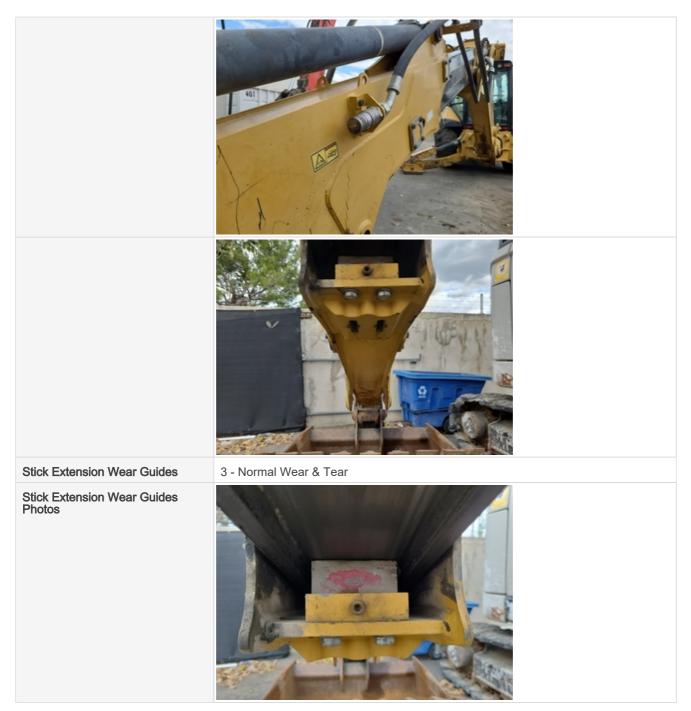
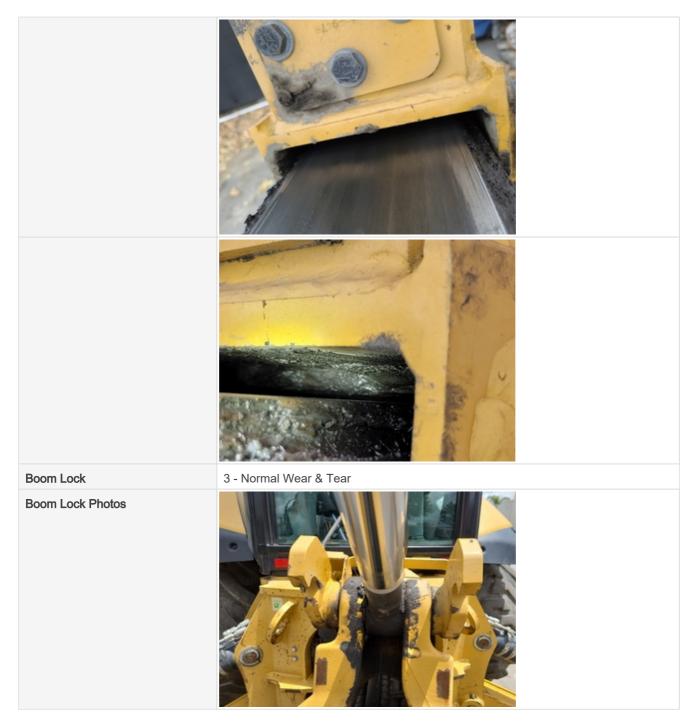
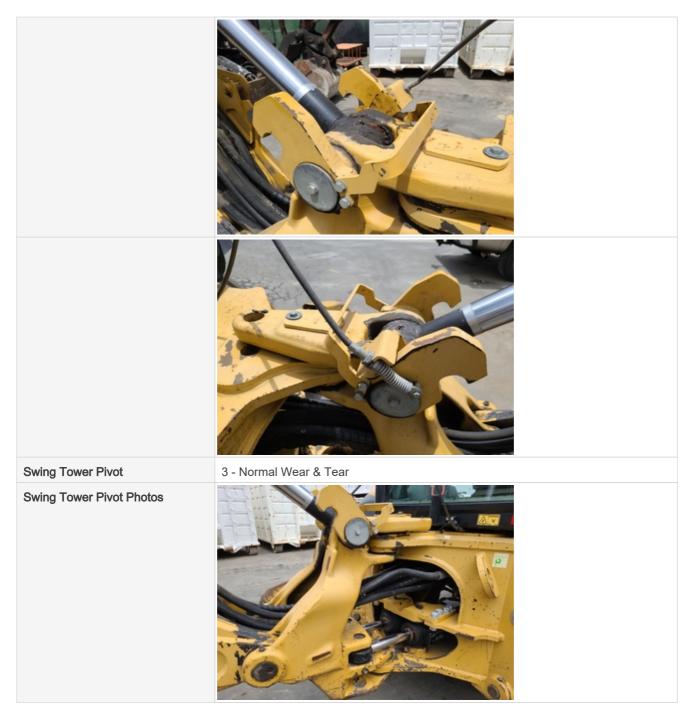
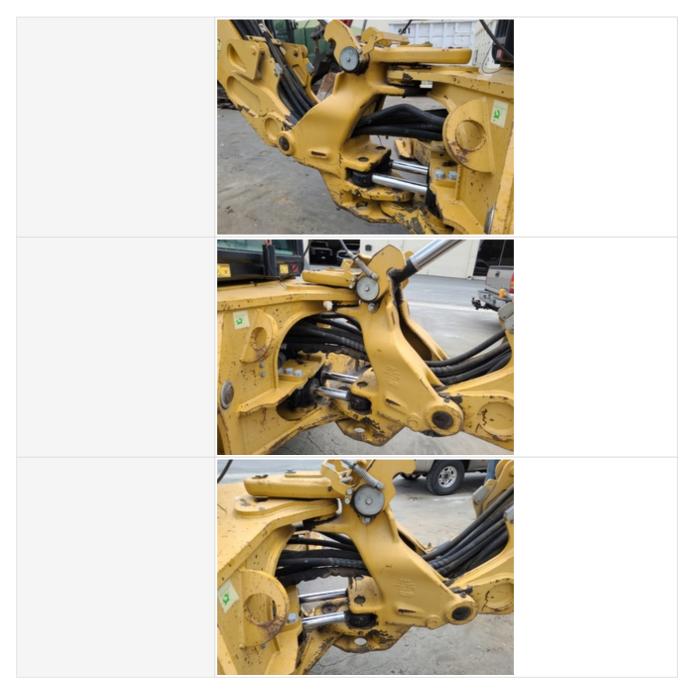
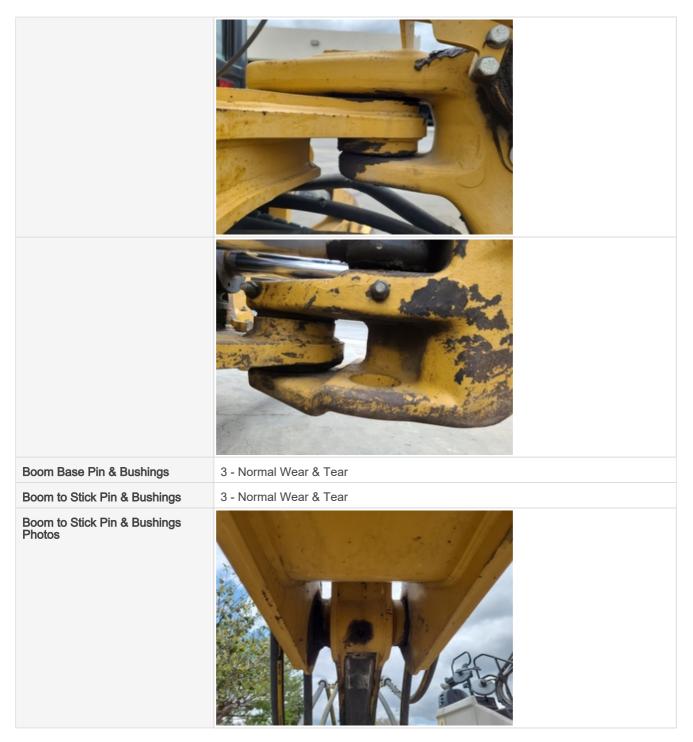
Tilt Linkage Pins & Bushings	3 - Normal Wear & Tear
Tilt Linkage Pins & Bushings Photos

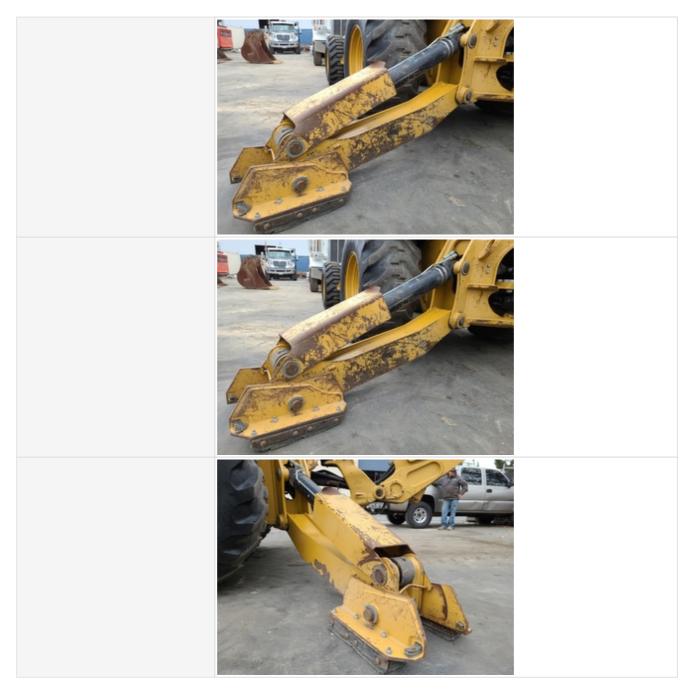
Outriggers	3 - Normal Wear & Tear
Outriggers Photos

Overall Chassis	3 - Normal Wear & Tear
Overall Chassis Comments	Overall Chassis in solid shape with no issues observed with implements.

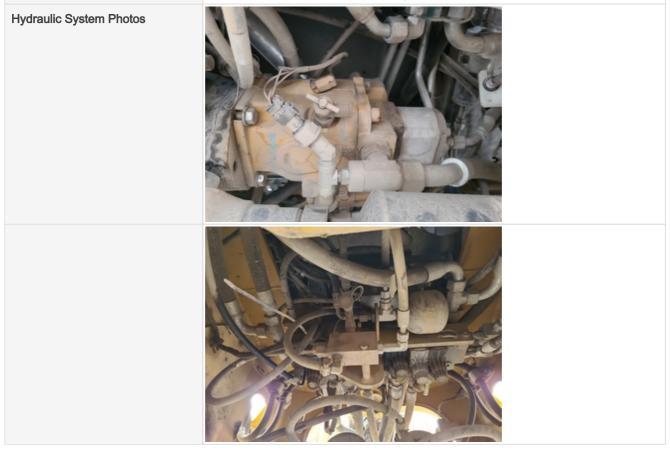
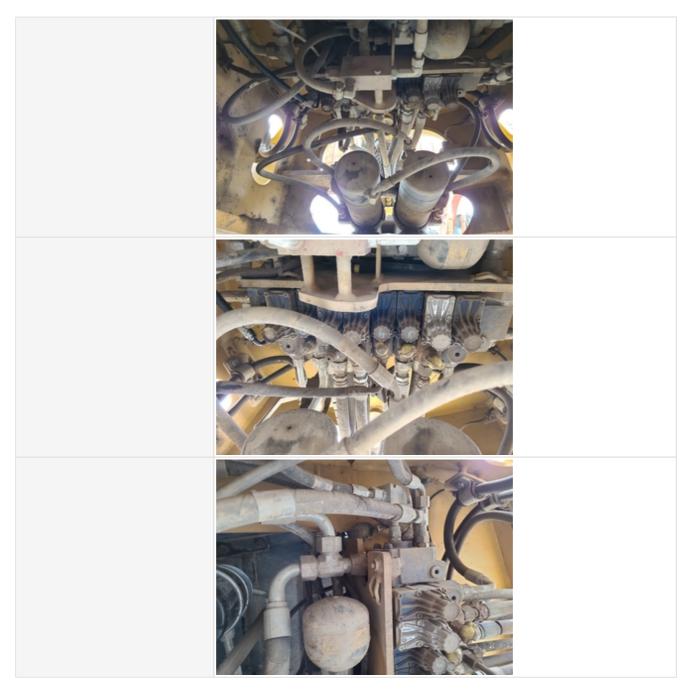
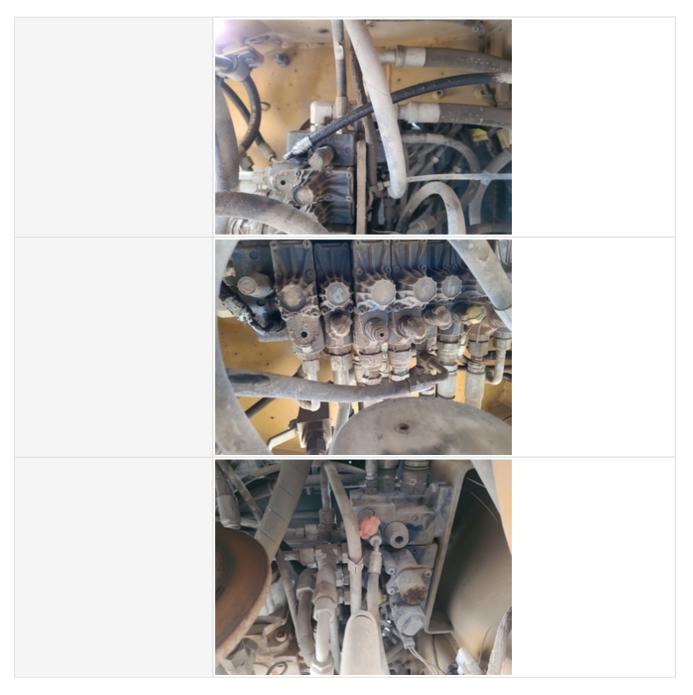
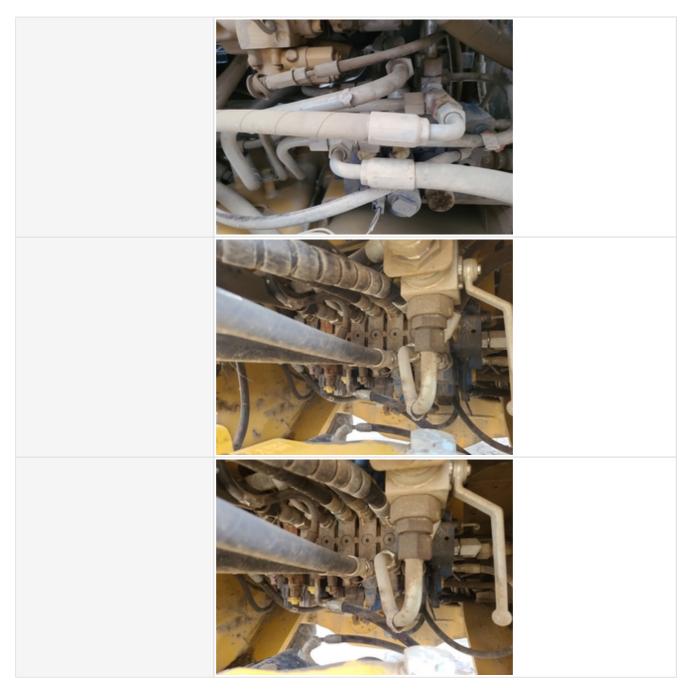
Hydraulic System

Take close-up photos of the hydraulic components including the pump, lines, fittings, controls, and levers. Note any damage, wear, or leaks.

Wet or Damp Hydraulic Lines / Fittings	No
Appearance of Hydraulic Lines / Fittings	3 - Normal Wear & Tear
Hydraulic Lines / Fittings Condition	Hydraulic lines & fittings are clean and in good condition
Unusual Noises (Hydraulic Pump)	No
Hydraulic Pump Notes	No unusual noises heard during operation
Comments	Hydraulics work well and have healthy appearance with. o active leaks observed.
Hydraulics Cylinders Inspection Points

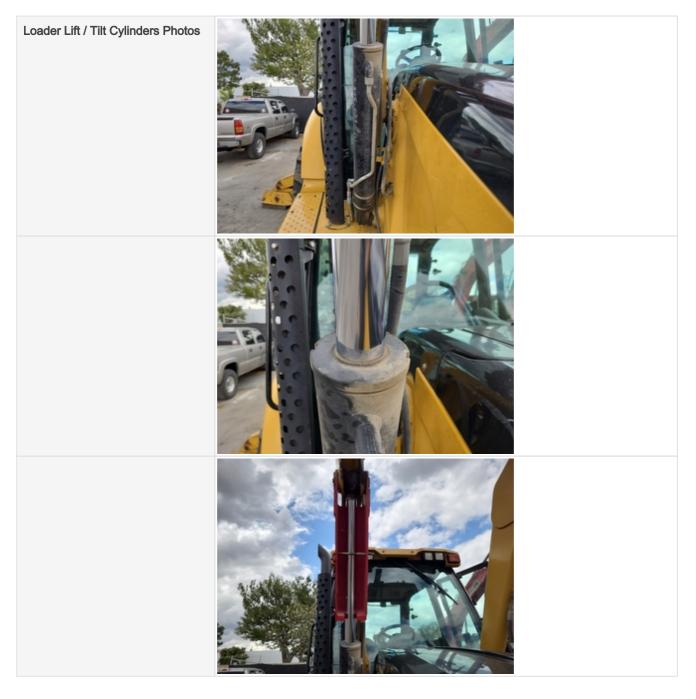
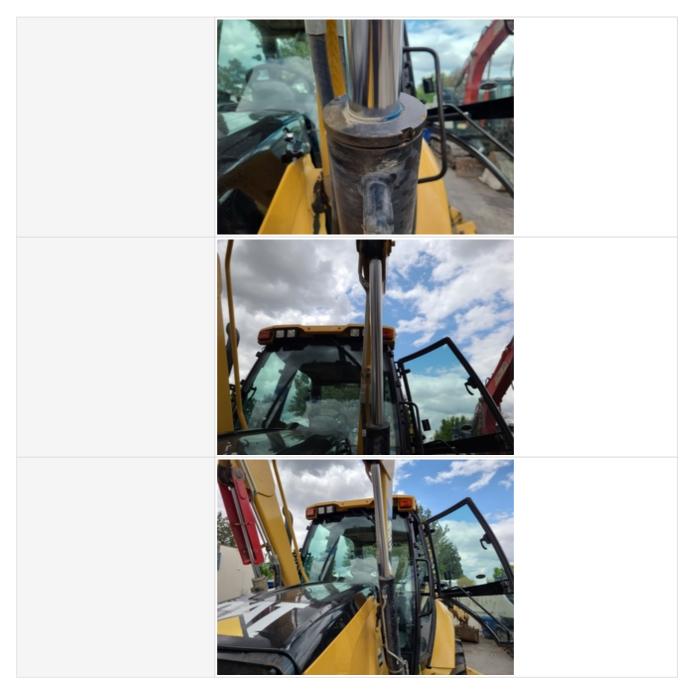
Loader Lift / Tilt Cylinders	Check the lift and tilt cylinders. Note any wear, pitting, discoloration, etc. Take photos.
Loader Lift / Tilt Cylinders: Mounting Pin	3
Loader Lift / Tilt Cylinders: Oil Leaks	No

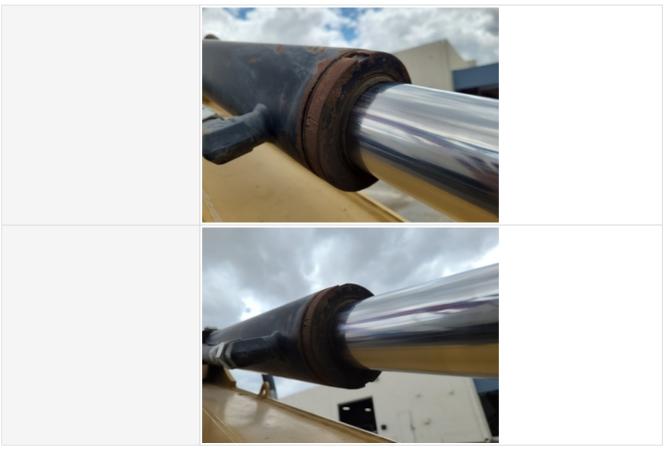
Bucket Cylinder	Check the bucket cylinder. Note any wear, pitting, discoloration, etc. Take photos.
Bucket Cylinder: Mounting Pin	3
Bucket Cylinder: Oil Leaks	No
Bucket Cylinder Photos

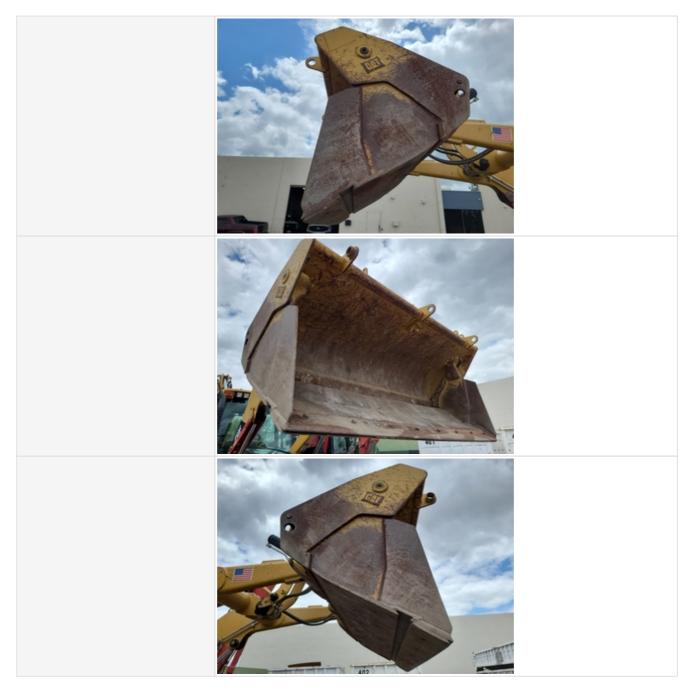
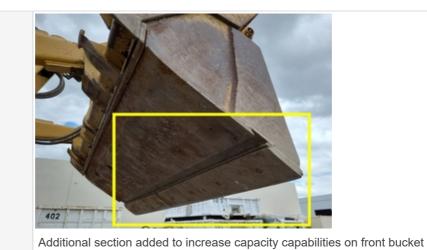
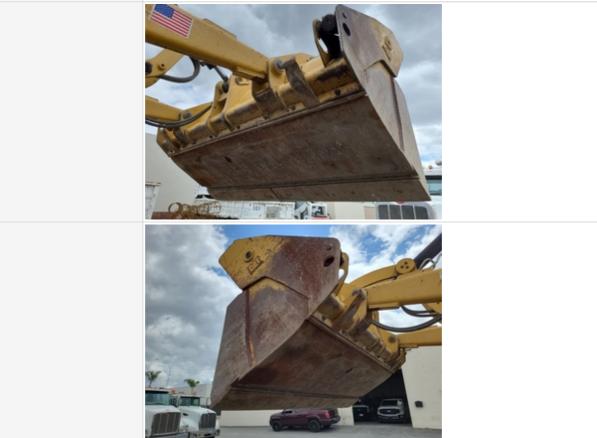
Loader Bucket	3 - Normal Wear & Tear
Comments	Loader Bucket custom fabricated for being able to have the ability to carry more load/capacity
Loader Bucket Photos
