Inspection Report (On-Highway Service Truck)

Year	2015
Make	Ford
Model	F 550
Serial Number	1FDUF5GT1FED32839
Truck Odometer Reading	156787
Current Inspection / State Cert / DOT	06/22 TX D6545930
Previous Application (e.g., earth moving, mining, demolition, etc)	service truck

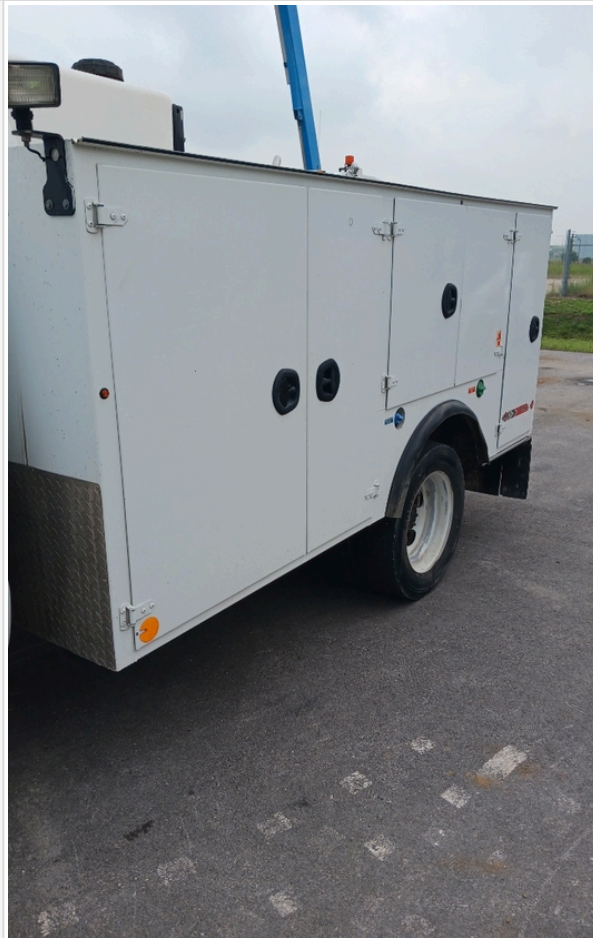
on the left-hand side of the box, there is some paint missing. 9inches long and 3 1/2 inches wide

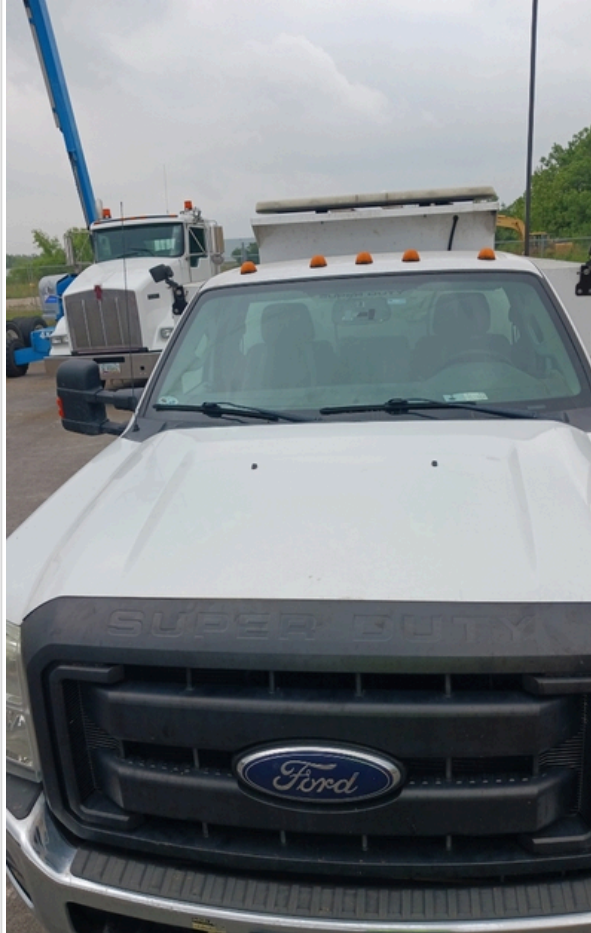
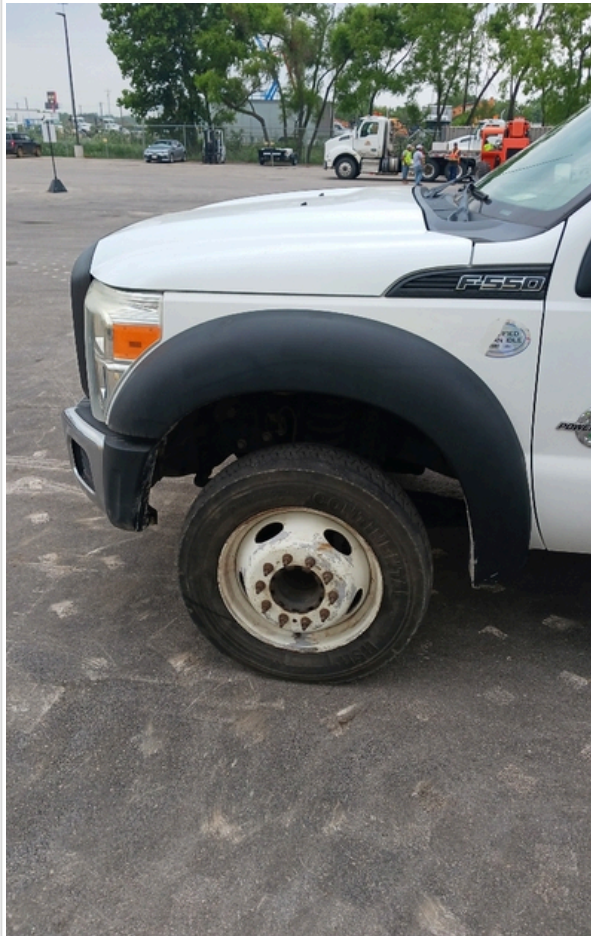
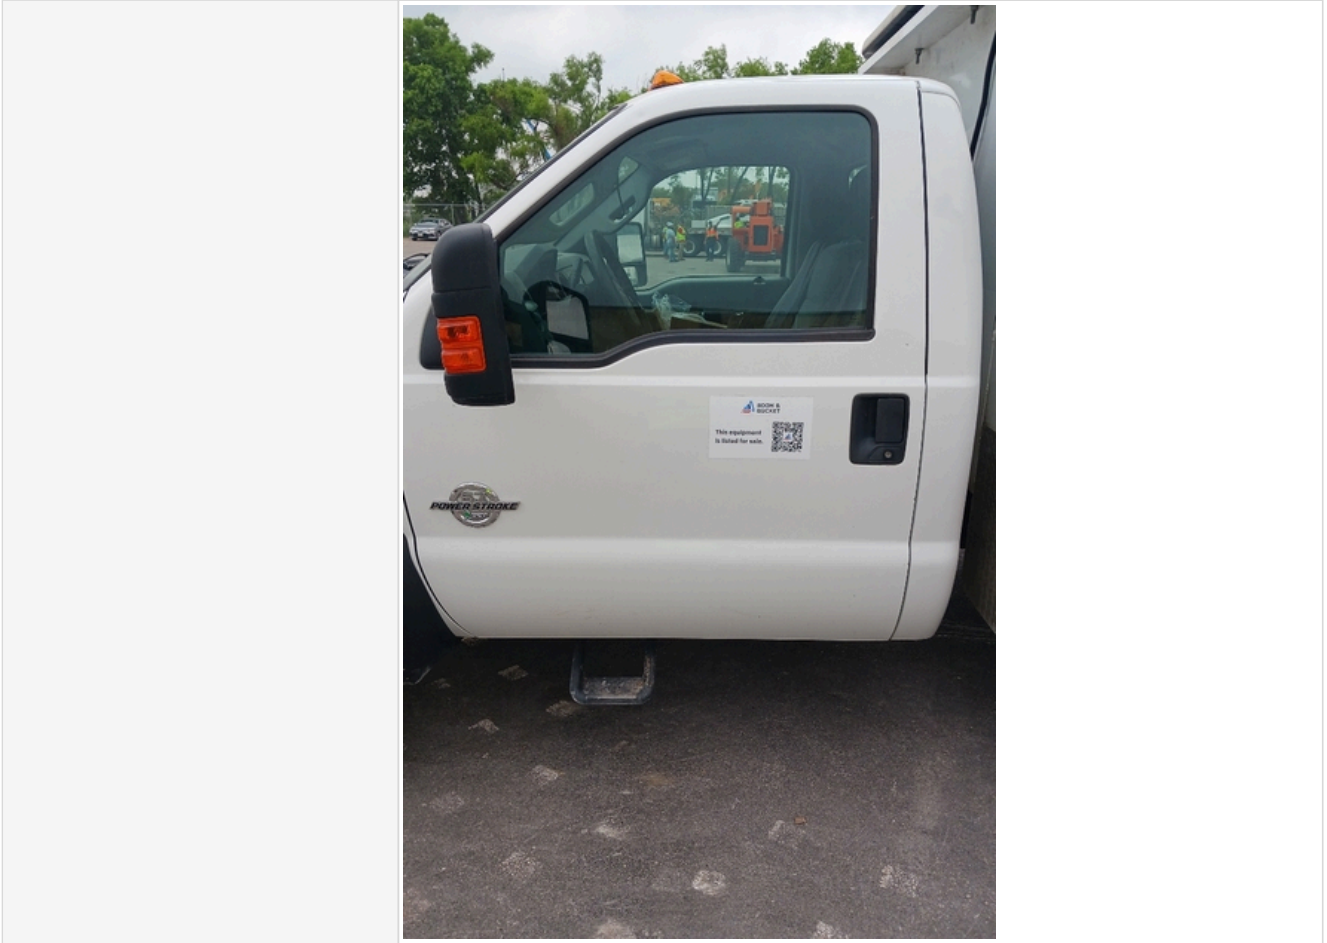
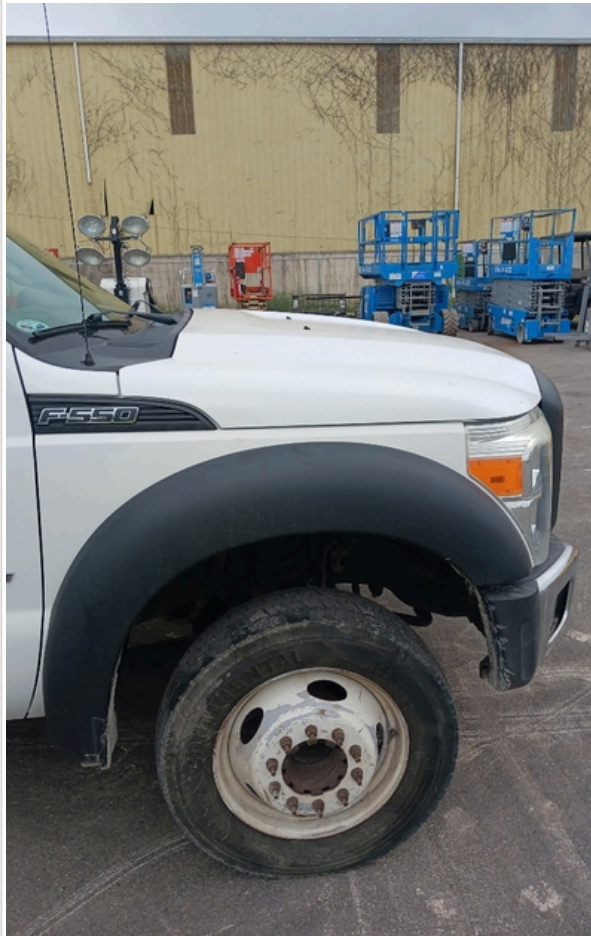
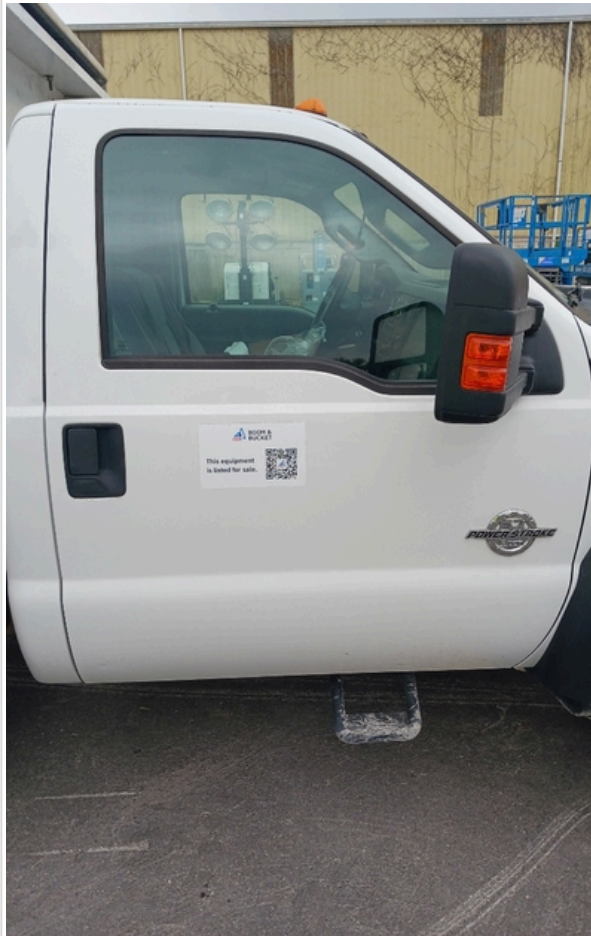
Body Panels Photos

Body Panels	3 - Normal Wear & Tear
Body Panel Condition	Visible chipped paint or dents
Comments	panels are in good condition and only have some small cosmetic issues

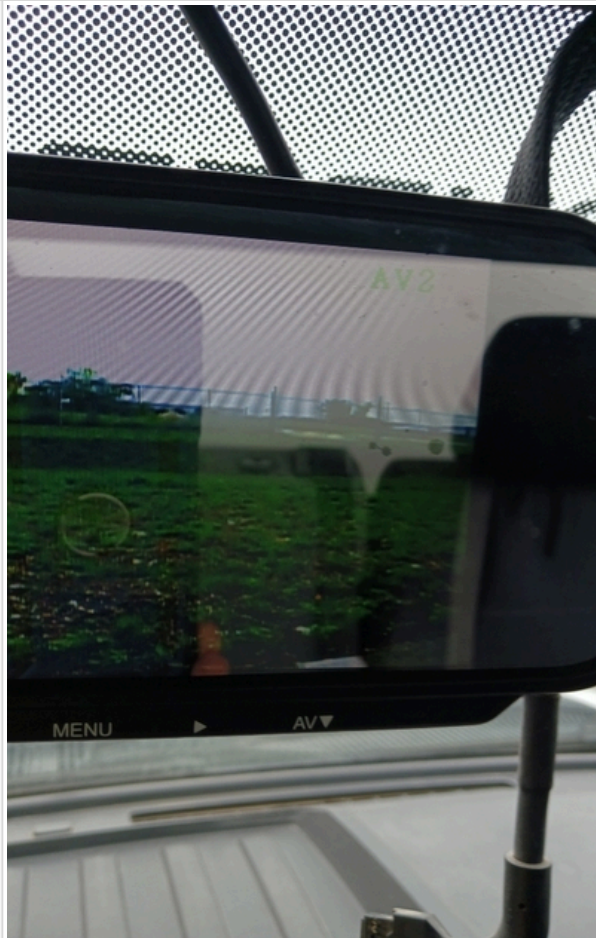
Backup Camera Photos

Odometer Activity	3 - Normal Wear & Tear
Odometer Condition	Odometer is working and in good condition
Controls/Switches/Gauges	3 - Normal Wear & Tear
Controls/Switches/Gauges Condition	All switches/gauges are in good condition and functioning
Brake System Type	Other (Please Specify)
Specify Brake System Type	super duty disc breaking system
Clutch	0
Horn	3 - Normal Wear & Tear
Horn Condition	Horn is functioning as expected
Reverse Alarm / Backup Camera	3 - Normal Wear & Tear
Reverse Alarm / Backup Camera Condition	Backup camera has clear display and is working as expected, Other (see comments)
Comments	This vehicle does not have a back up alarm

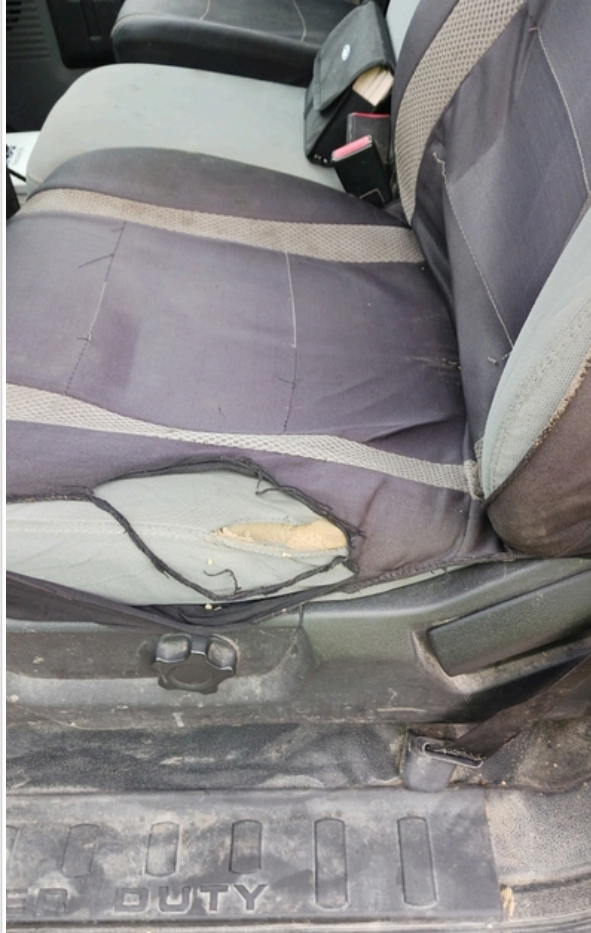
Seats/ Seat Belt Photos

Heater & A/C	3 - Normal Wear & Tear
Heat & A/C Condition	Heater and A/C work as expected
Interior Lights	3 - Normal Wear & Tear
Interior Lights Condition	All interior lights are installed and functioning
Seats/Seat Belts	3 - Normal Wear & Tear
Seats/Seat Belt Condition	Seat(s) have minor surface staining or small tears, Seat belt secures properly
Comments	there are some small tears on the driver side seat

Cab Interior Overall Rating	3 - Normal Wear & Tear
Comments	cab has a minor tear on the driver side seat and the interior has some minor staining, but it is in good condition.

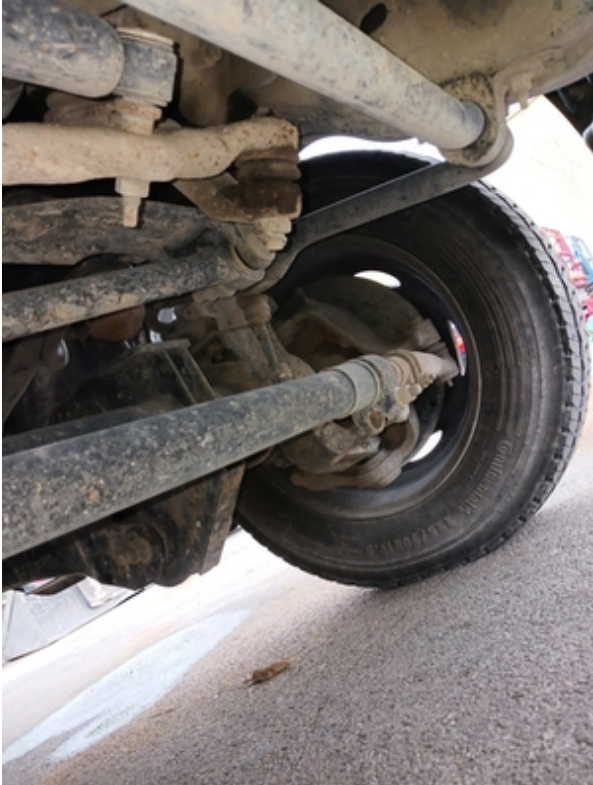
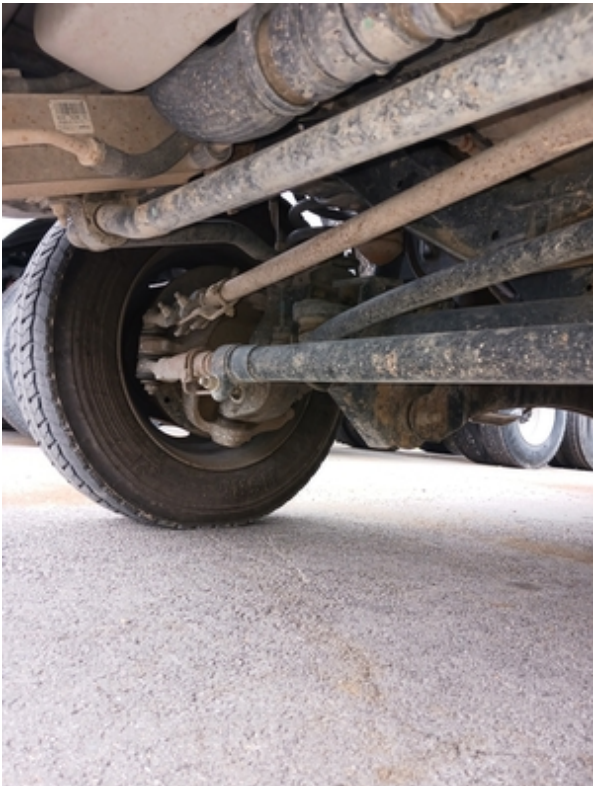
Steering Components	3 - Normal Wear & Tear
Steering Component Photos

Frame	3 - Normal Wear & Tear
Suspension	3 - Normal Wear & Tear
Steer Axle Condition	3 - Normal Wear & Tear

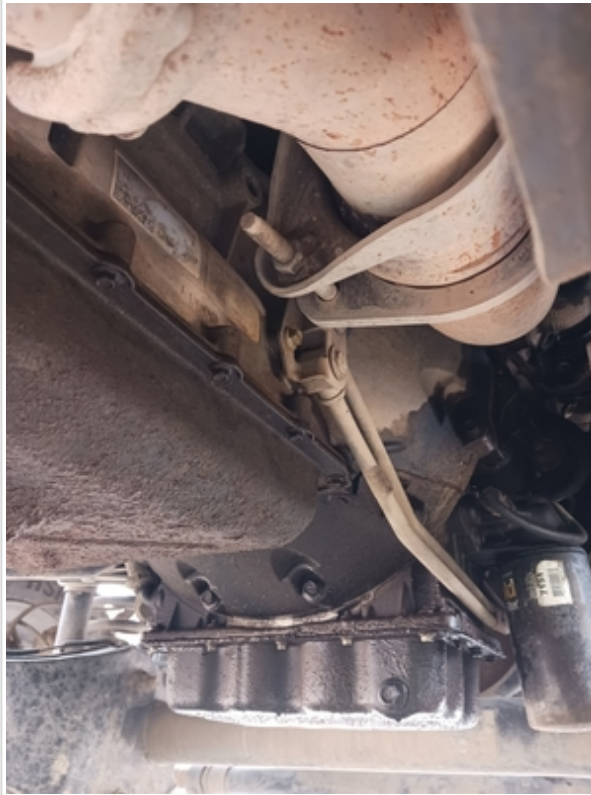
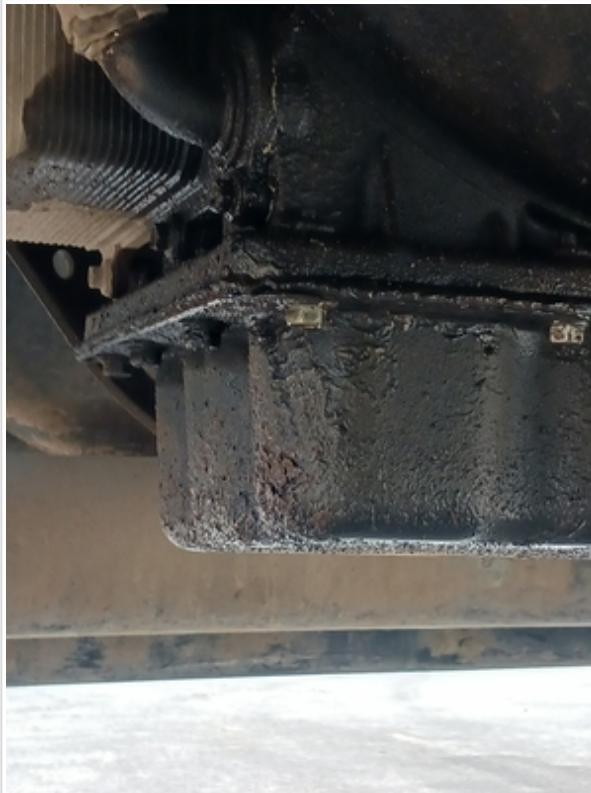
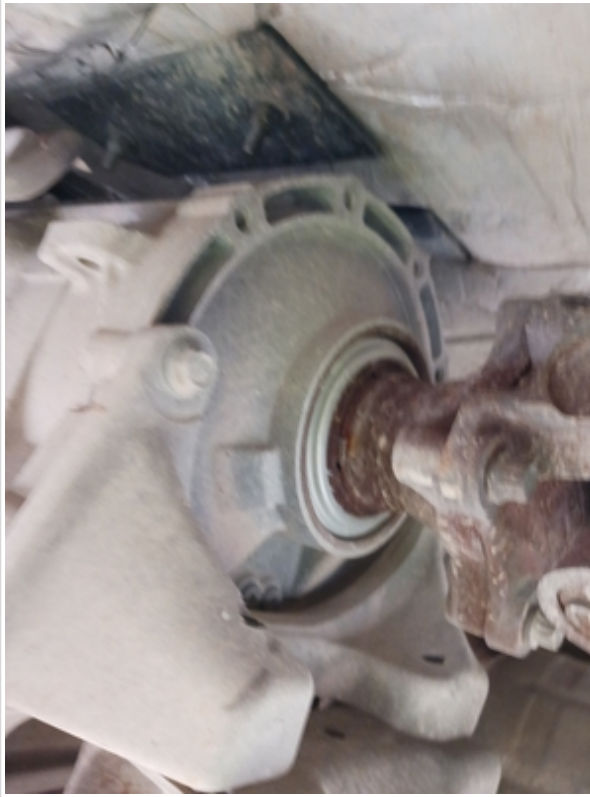
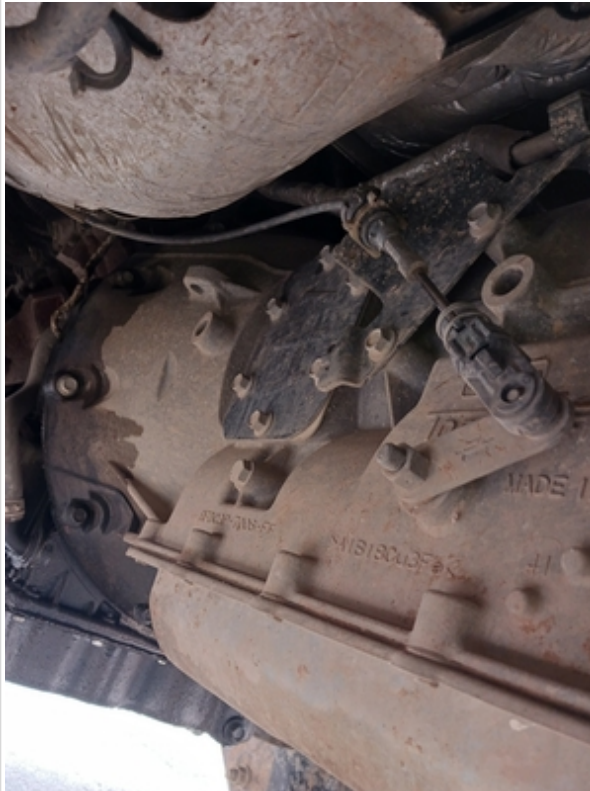
Transmission Condition Photos

Transmission Info (Make/Model)	Ford super duty automatic 6 speed
Transmission	3 - Normal Wear & Tear
Transmission Condition	No unusual noises or vibrations

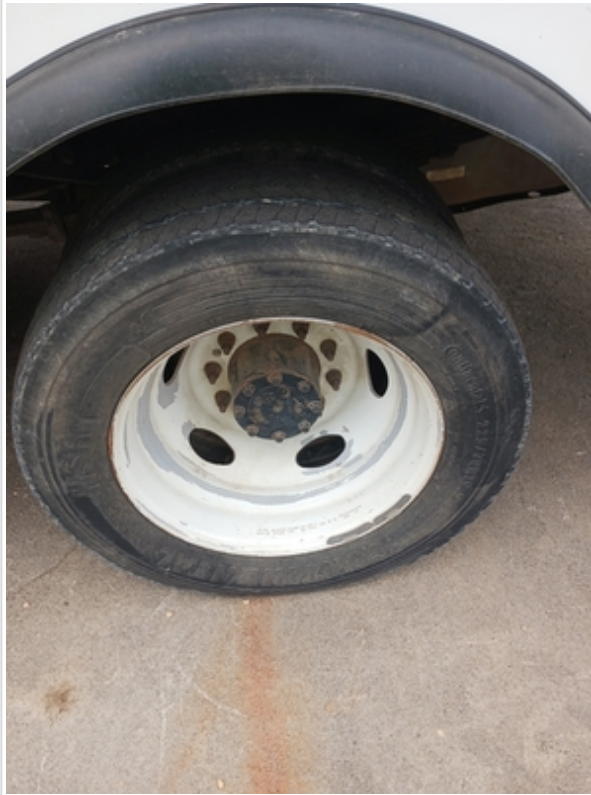
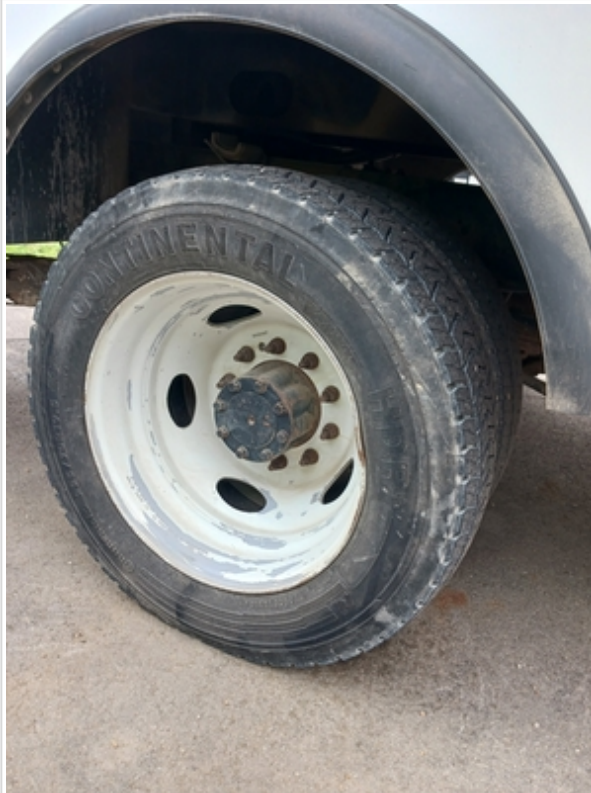
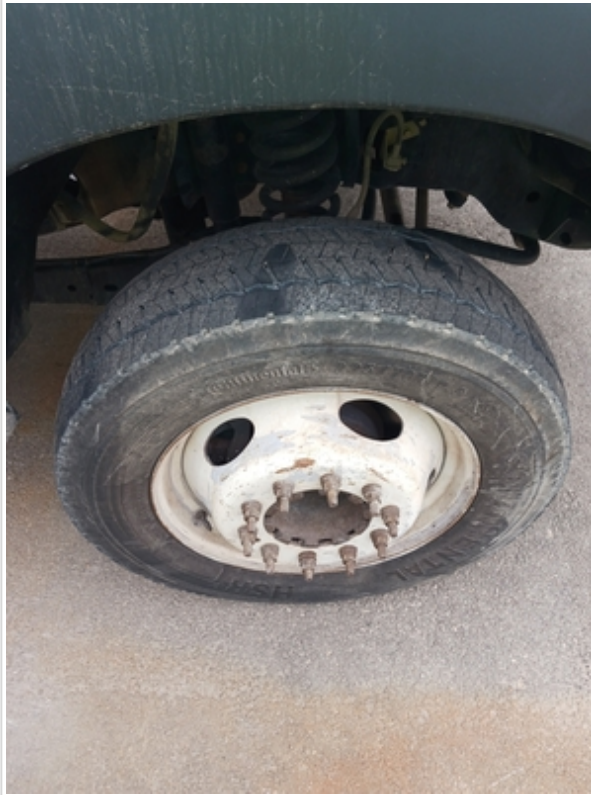
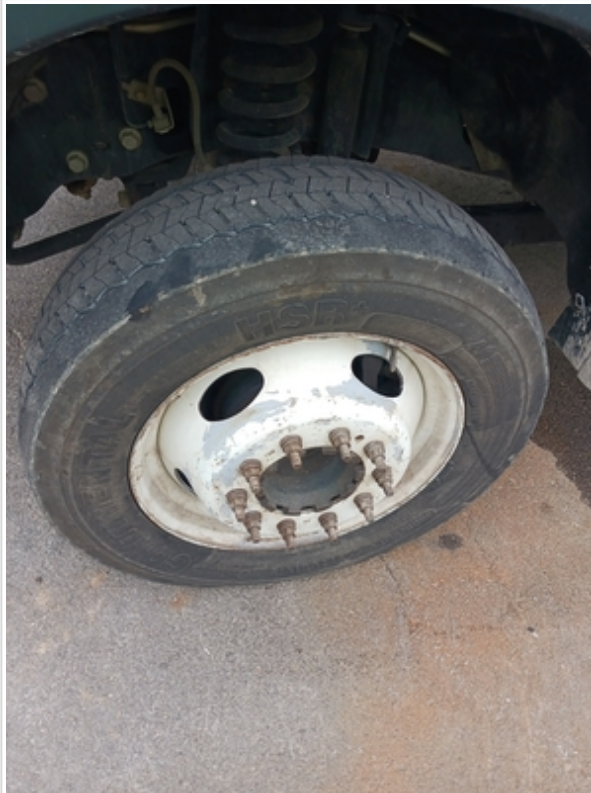
Wheels & Hub Photos

Wheels & Hub Condition	3
Comments	wheels and hubs are in good condition

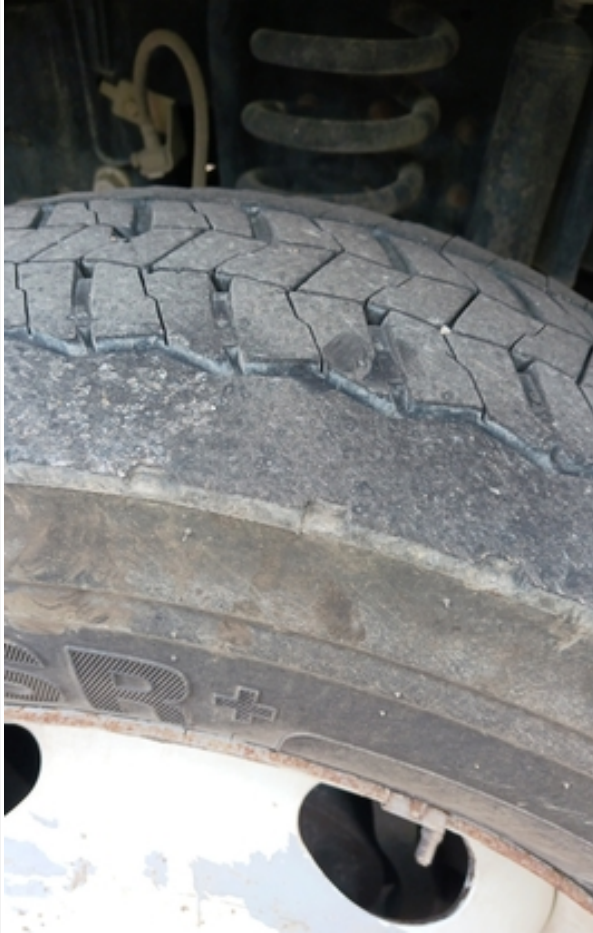
Front Left Tire - Ratio Remaining	50%
Front Left Tire Photos

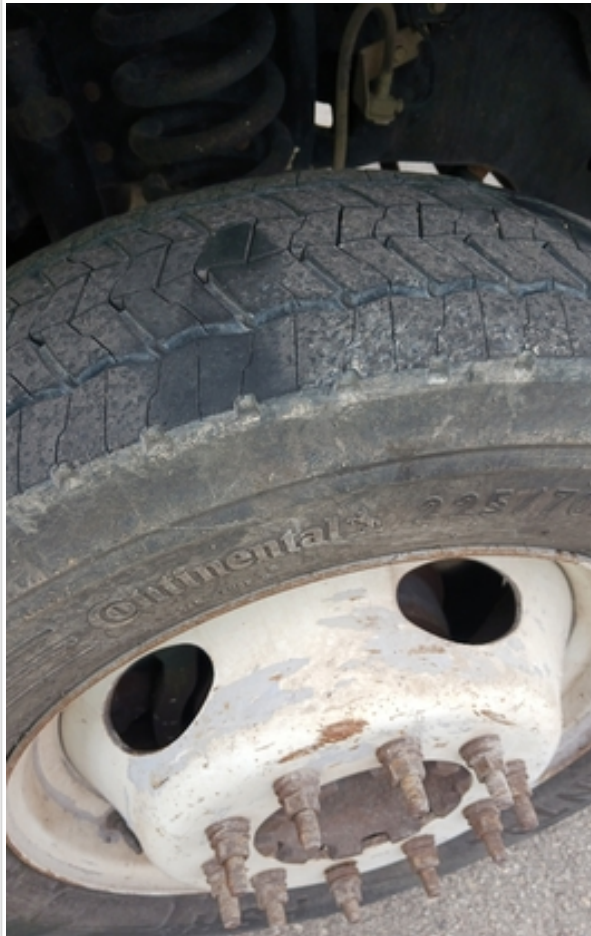
Front Right Tire Photos

Front Right Tire - Ratio Remaining	50%

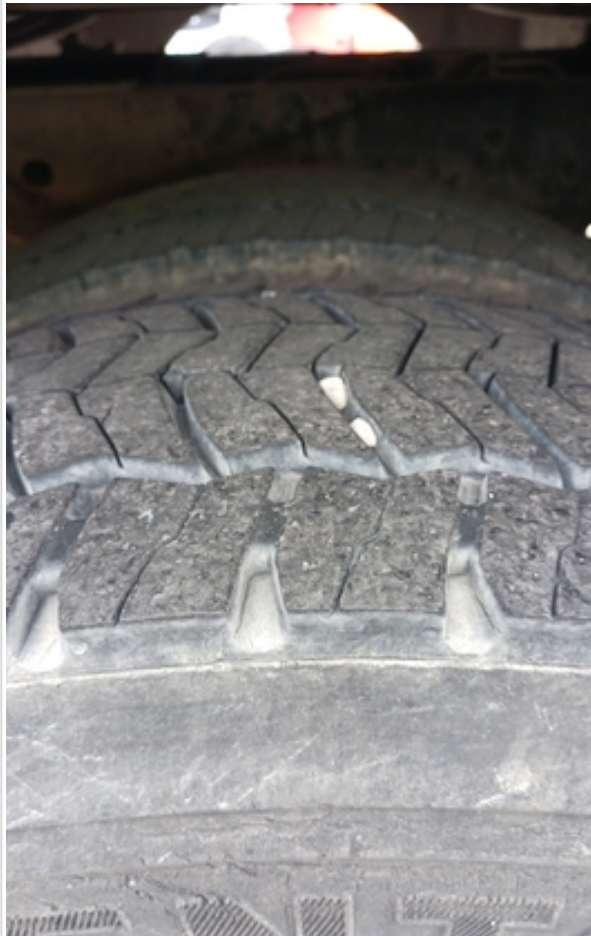
Rear Right Tire Photos

Rear Right Tire - Ratio Remaining

70%

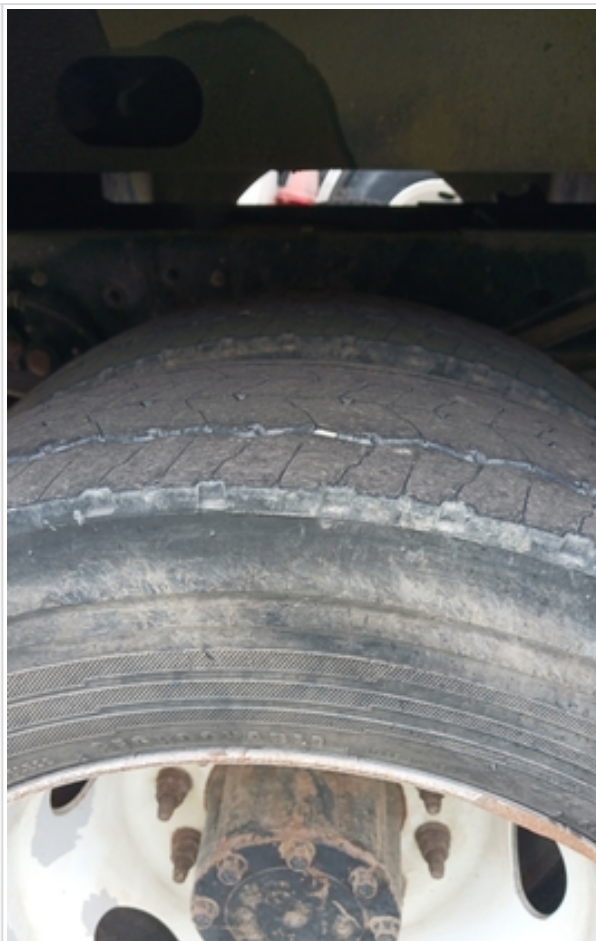
Rear Left Tire Photos

Rear Left Tire - Ratio Remaining

70%

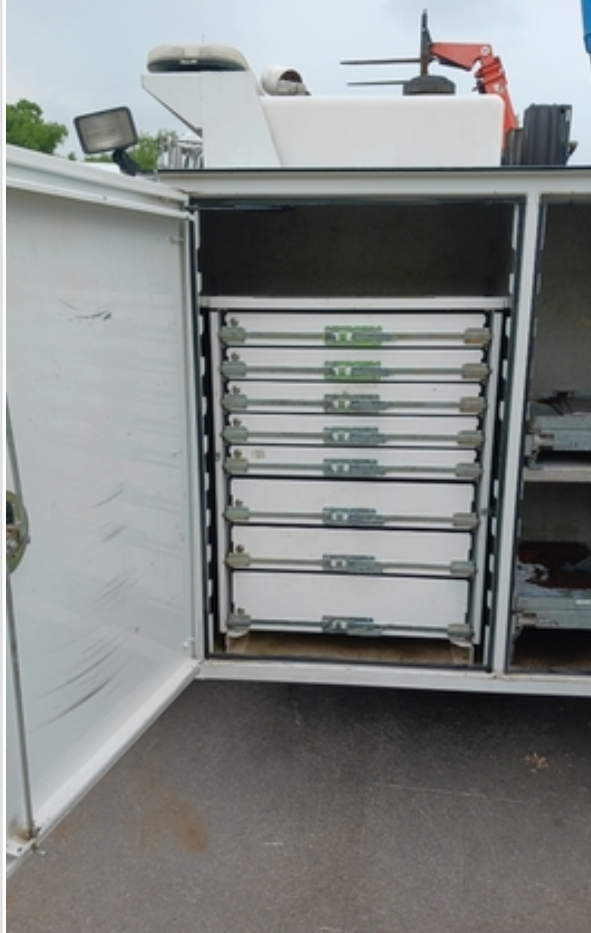
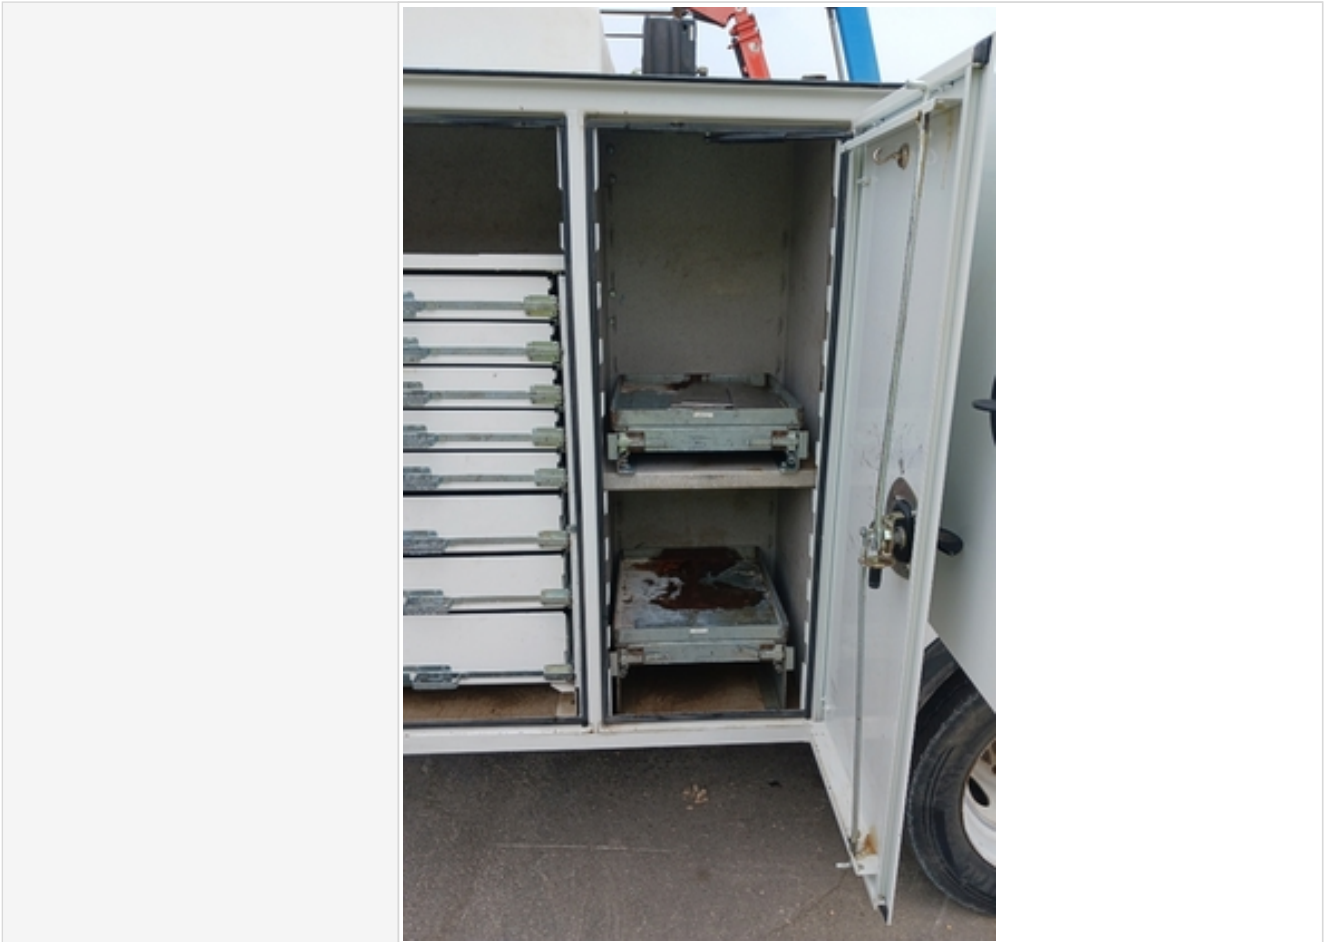
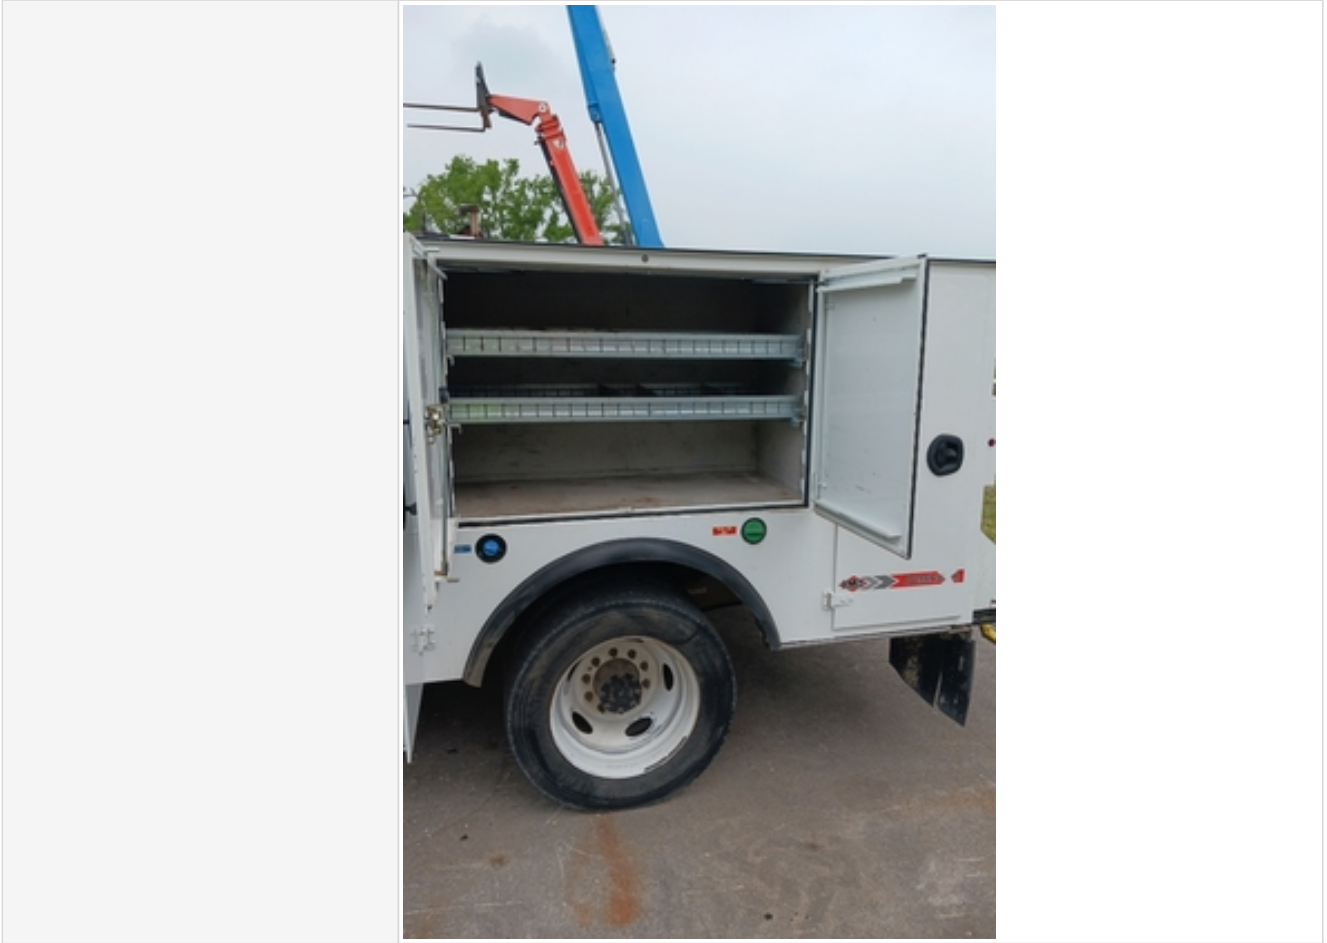
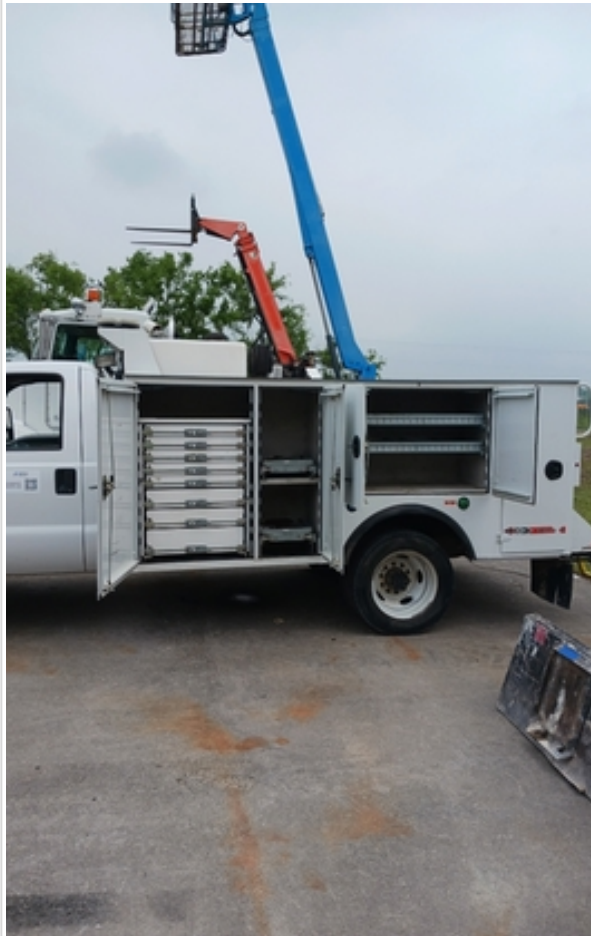
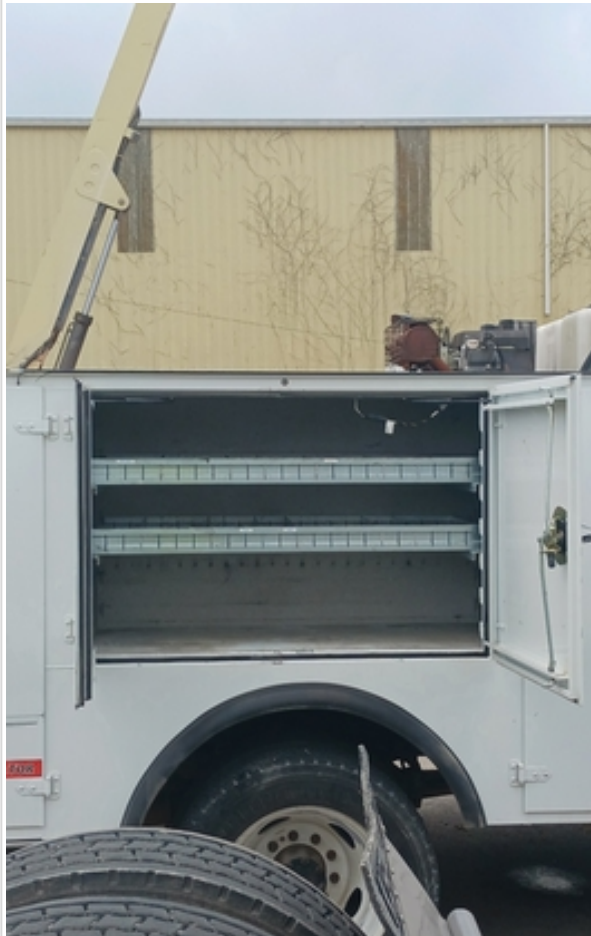
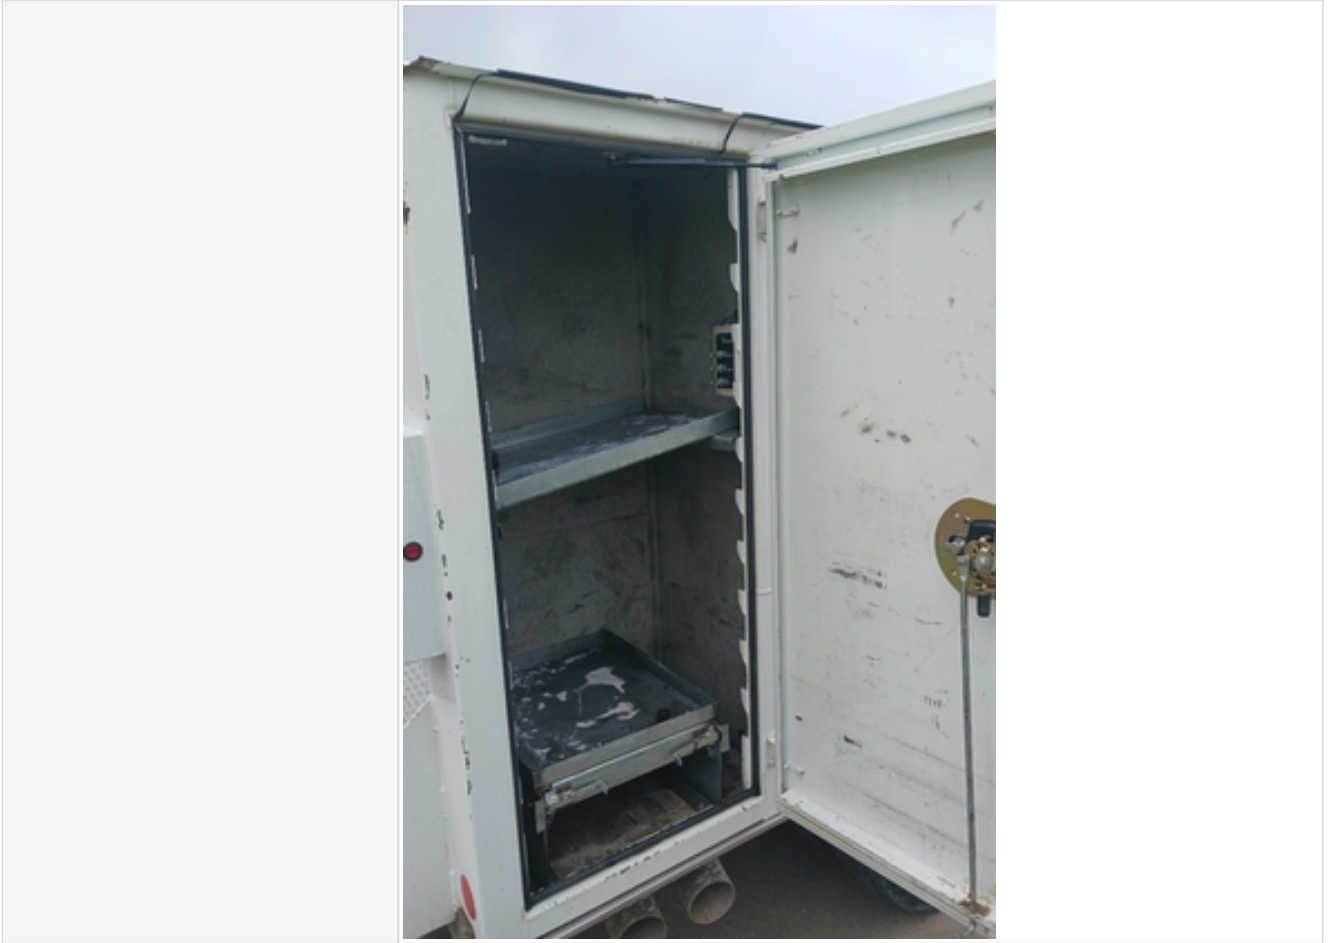
Toolbox Photos

Tool Truck Body	Check the condition of the tool truck bed body, tool boxes (interior and exterior), and lift gate (if equipped).
Bed Body	3
Comments	has rust but is still in good condition
