## Inspection Report (On-Highway Truck Cab + Chassis)

Year	2013
Make	kenworth
Model	T 800
Serial Number	1XKDDP9X6EJ387089
Truck Odometer Reading	267372
Current Inspection / State Cert / DOT	12/21 TX DOT D6993293
Previous Application (e.g., earth moving, mining, demolition, etc)	transport

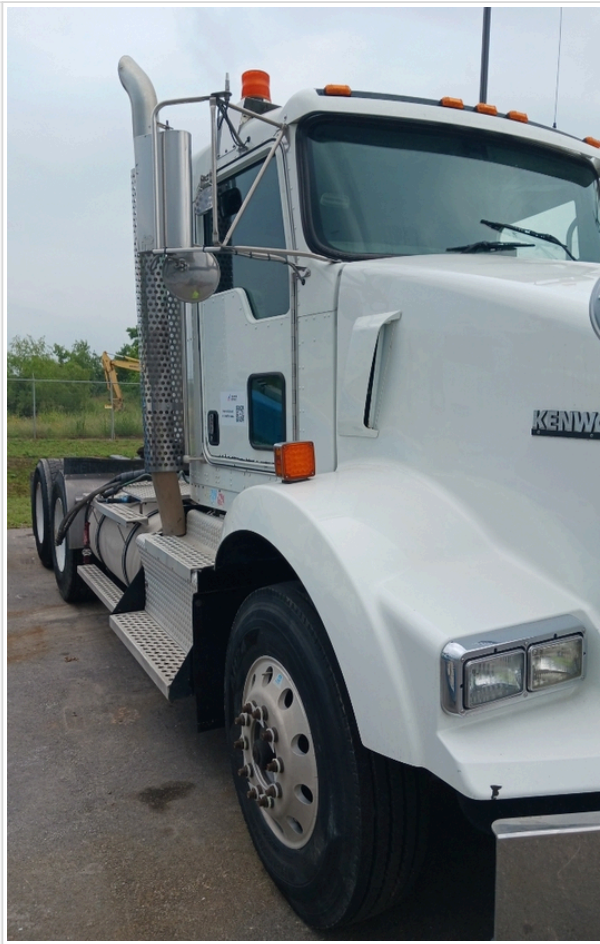
<b>Body Panels</b>	3 - Normal Wear & Tear
<b>Body Panel Condition</b>	Visible chipped paint or dents

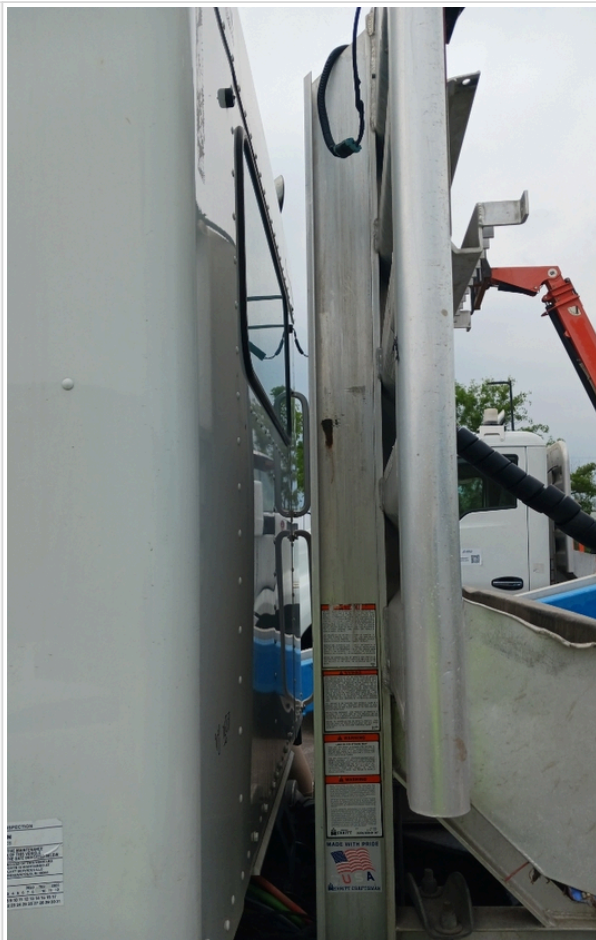
<b>Doors / Canopy Latches</b>	3 - Normal Wear & Tear
<b>Doors / Canopy Latches Condition</b>	Other (see comments)
<b>Comments</b>	doors gave small chips and cracks on the paint, but are still in good condition and operational

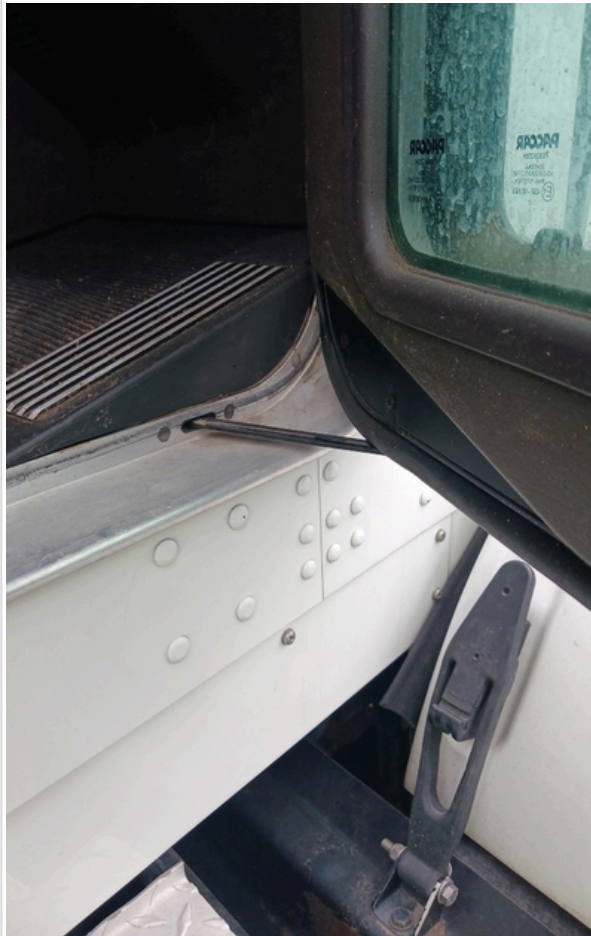
<b>Steps / Ladders</b>	3 - Normal Wear & Tear
<b>Steps / Ladders Condition</b>	Steps/ladders are fully intact and appear structurally sound
<b>Handrails</b>	3 - Normal Wear & Tear
<b>Handrails Condition</b>	Handrails are fully intact and appear structurally sound
<b>Glass</b>	3 - Normal Wear & Tear
<b>Glass Condition</b>	Glass intact, no visible damage
<b>Mirrors</b>	3 - Normal Wear & Tear
<b>Mirror Condition</b>	Mirrors present and intact, no visible damage
<b>Exterior Lights</b>	3 - Normal Wear & Tear
<b>Exterior Lights Condition</b>	No visible damage, lighting system is operational, Other (see comments)
<b>Comments</b>	lights are in good condition, there is some minor lifting or the chrome casing surrounding the head lights

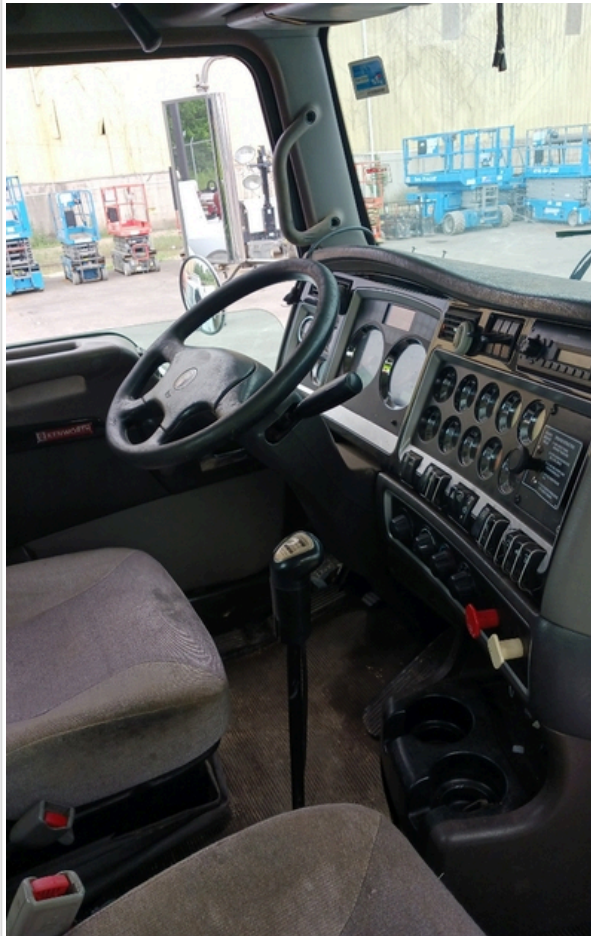
<b>Odometer Activity</b>	3 - Normal Wear & Tear
<b>Odometer Condition</b>	Odometer is working and in good condition
<b>Controls/Switches/Gauges</b>	3 - Normal Wear & Tear
<b>Controls/Switches/Gauges Condition</b>	Minor cosmetic wear to switches/gauges, good functionality, Other (see comments)
<b>Comments</b>	2 switches near parking breaks are missing a small cover.

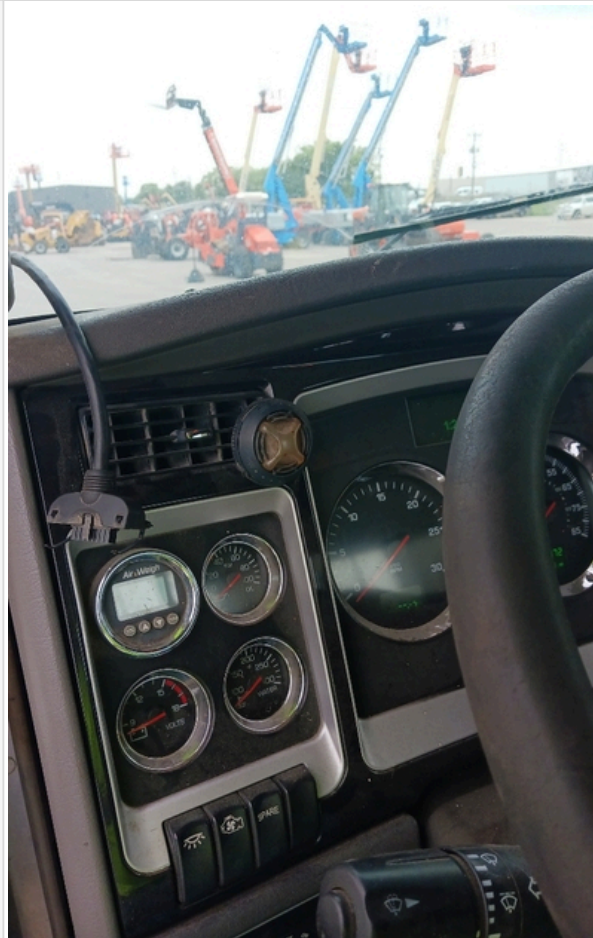
<b>Brake System Type</b>	Air Brakes
<b>Air Brakes Build Correct Pressure</b>	Yes
<b>Clutch</b>	3 - Normal Wear & Tear
<b>Clutch Function</b>	Clutch is functioning as expected
<b>Horn</b>	3 - Normal Wear & Tear
<b>Horn Condition</b>	Horn is functioning as expected
<b>Reverse Alarm / Backup Camera</b>	3 - Normal Wear & Tear
<b>Reverse Alarm / Backup Camera Condition</b>	Reverse alarm working as expected, Other (see comments)
<b>Comments</b>	vehicle has a back up alarm, but no back up camera
<b>Heater &amp; A/C</b>	3 - Normal Wear & Tear
<b>Heat &amp; A/C Condition</b>	Heater and A/C work as expected
<b>Interior Lights</b>	3 - Normal Wear & Tear
<b>Interior Lights Condition</b>	All interior lights are installed and functioning
<b>Seats/Seat Belts</b>	3 - Normal Wear & Tear
<b>Seats/Seat Belt Condition</b>	Seat(s) have minor surface staining or small tears, Seat belt has nicks, cuts, holes, or fraying

<b>Comments</b>	driver side seat belt has a little fraying on seat belt. seats have some stains on them but are in good working condition
<b>Seats/ Seat Belt Photos</b>

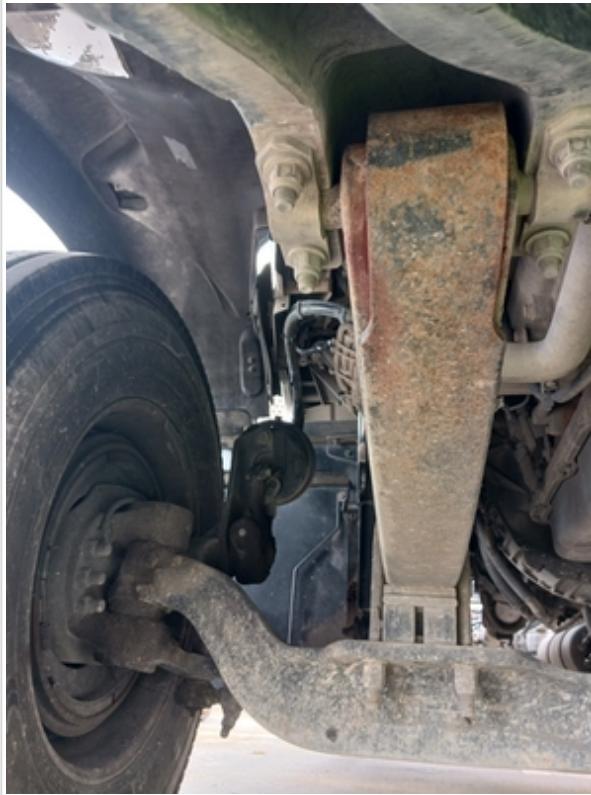
<b>Frame</b>	3 - Normal Wear & Tear
<b>Suspension</b>	3 - Normal Wear & Tear
<b>Steer Axle Condition</b>	3 - Normal Wear & Tear
<b>Steering Components</b>	3 - Normal Wear & Tear

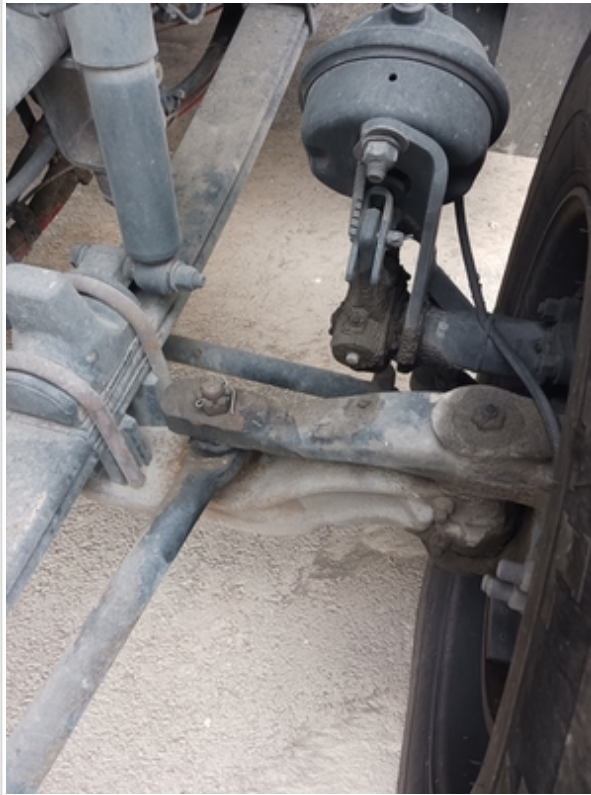
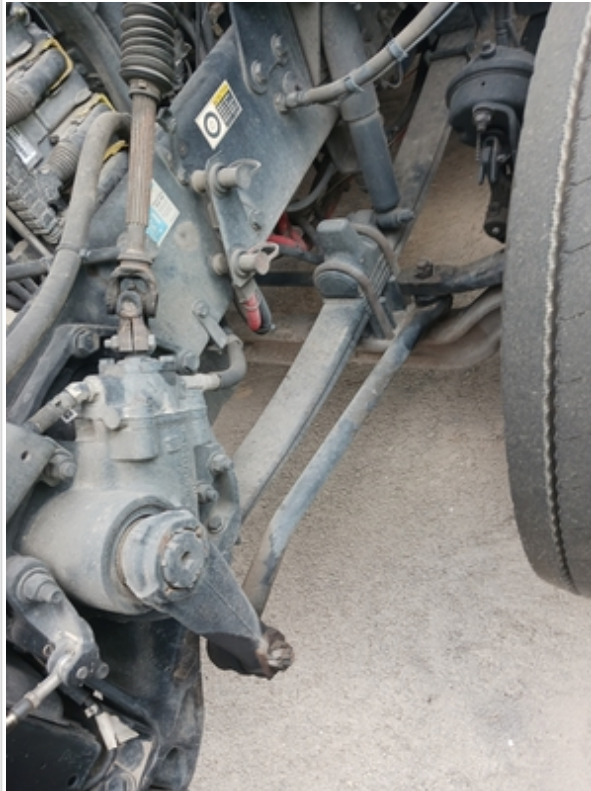
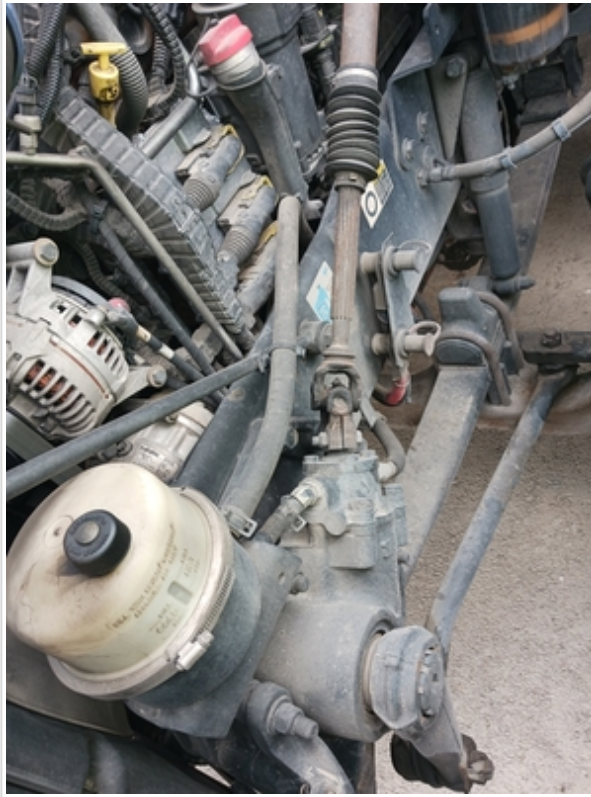
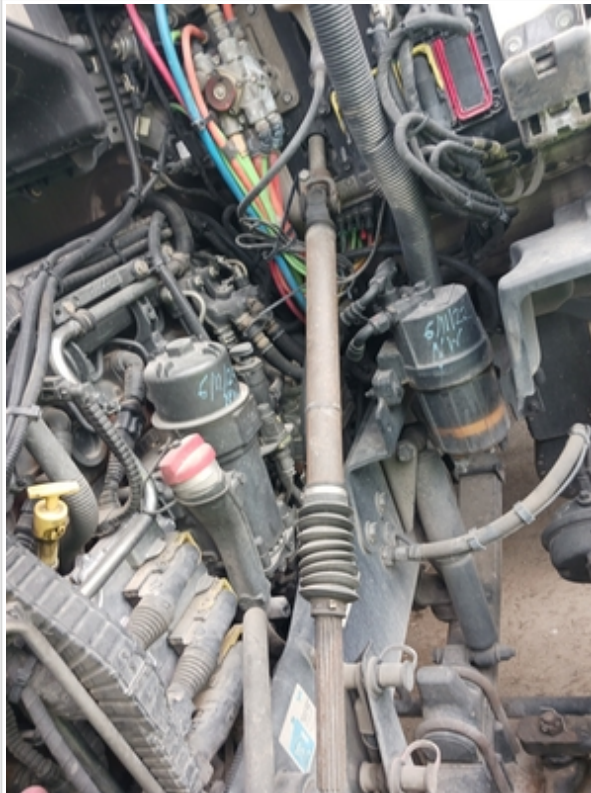
Steering Component Photos

Overall Chassis Condition	3 - Normal Wear & Tear
Overall Chassis Comments	Chassis is in good condition

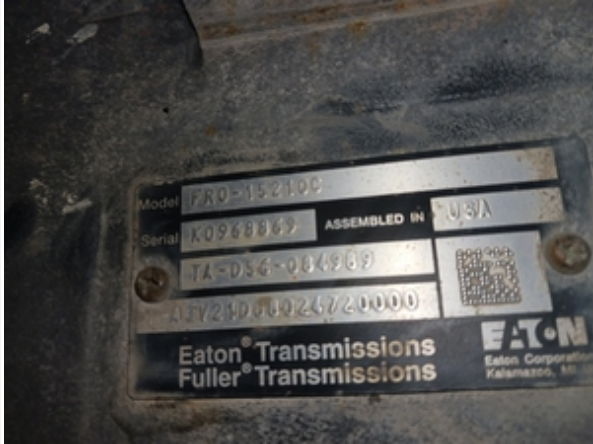
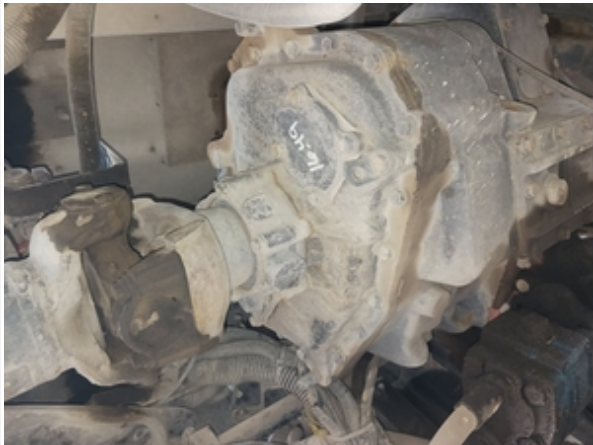
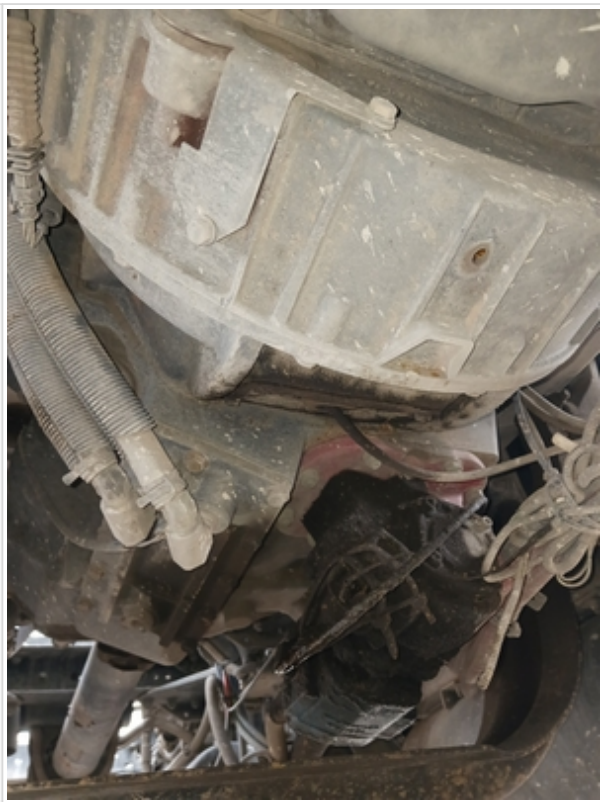
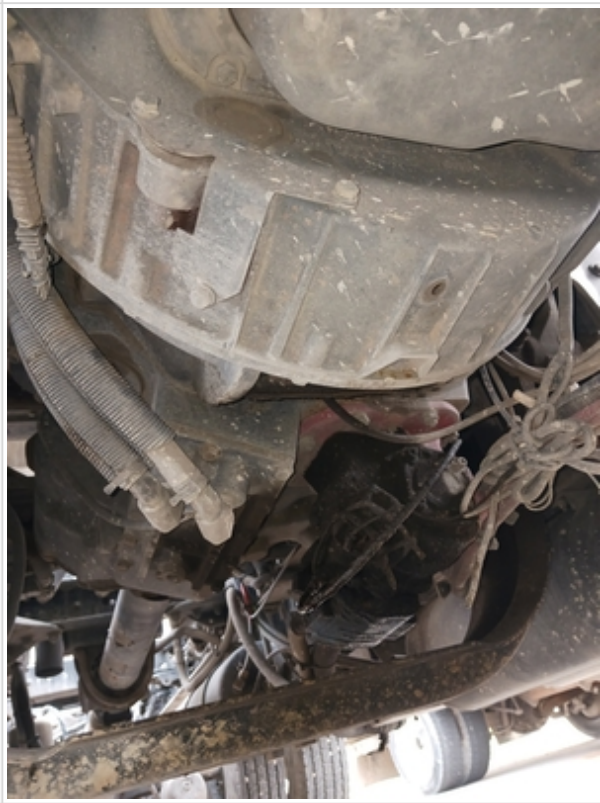
Transmission Info (Make/Model)	Eaton Fuller FRO15210C
Transmission	3 - Normal Wear & Tear
Transmission Condition	No unusual noises or vibrations
Transmission Condition Photos

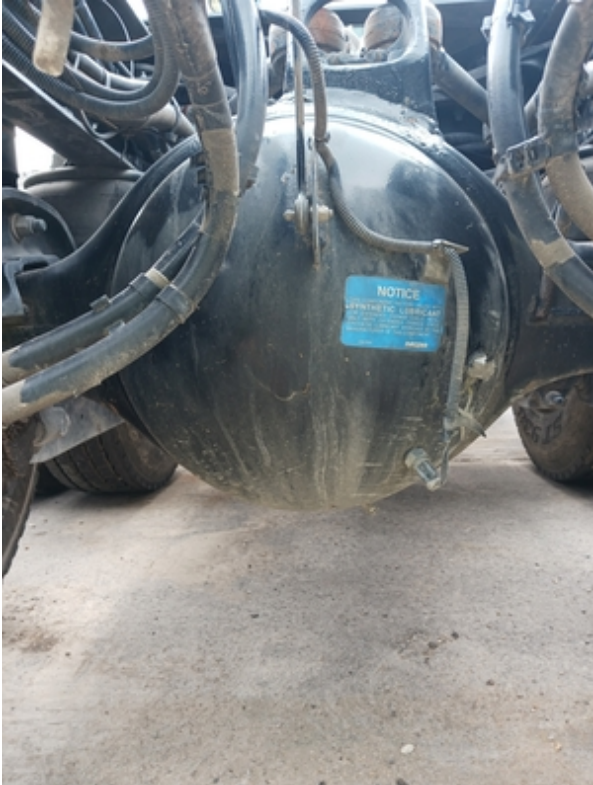
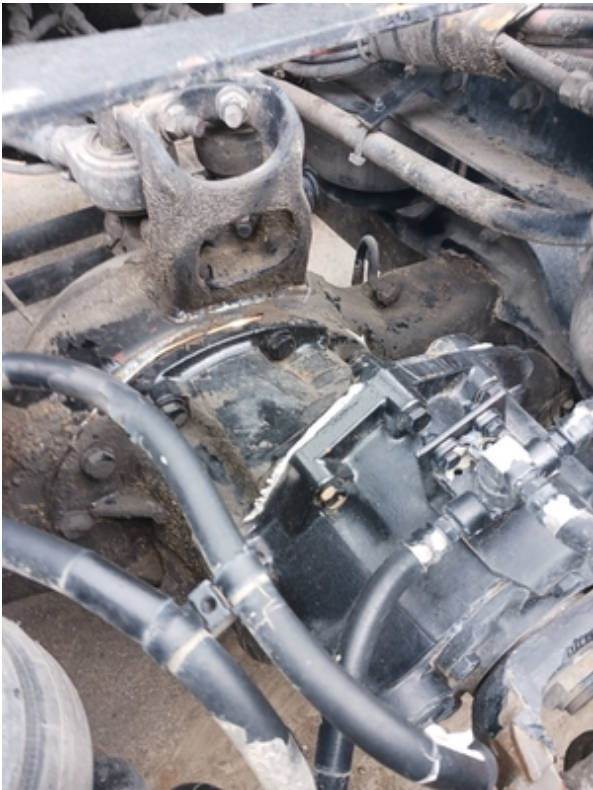
Rear Differential Condition	Dry housing appearance, no unusual noises heard during operation
Rear Differential Photos

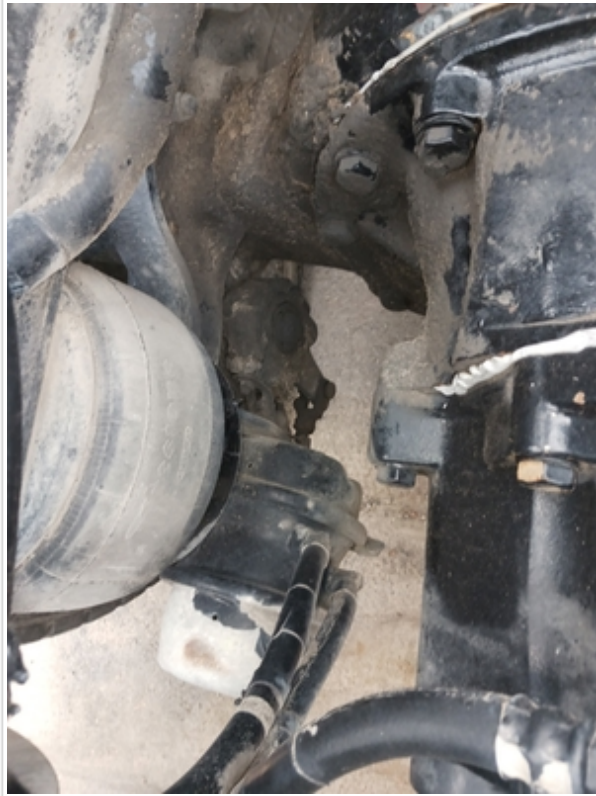
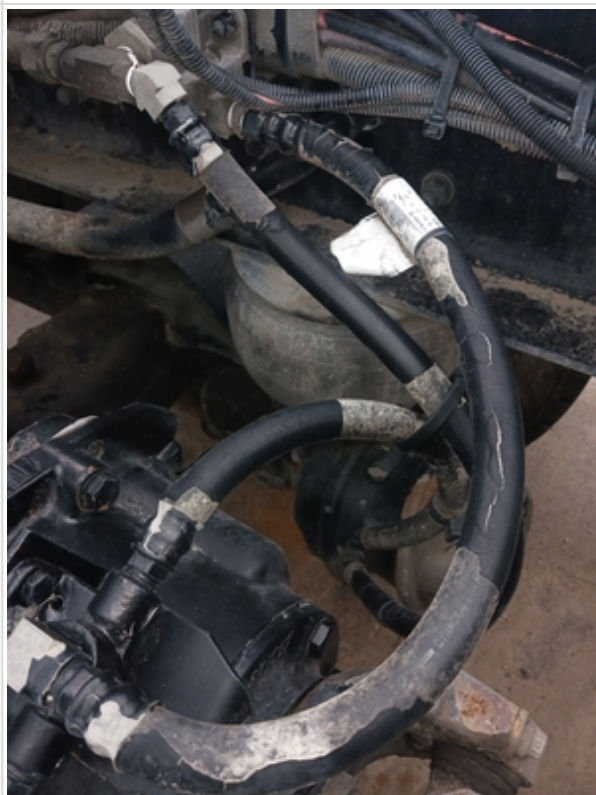
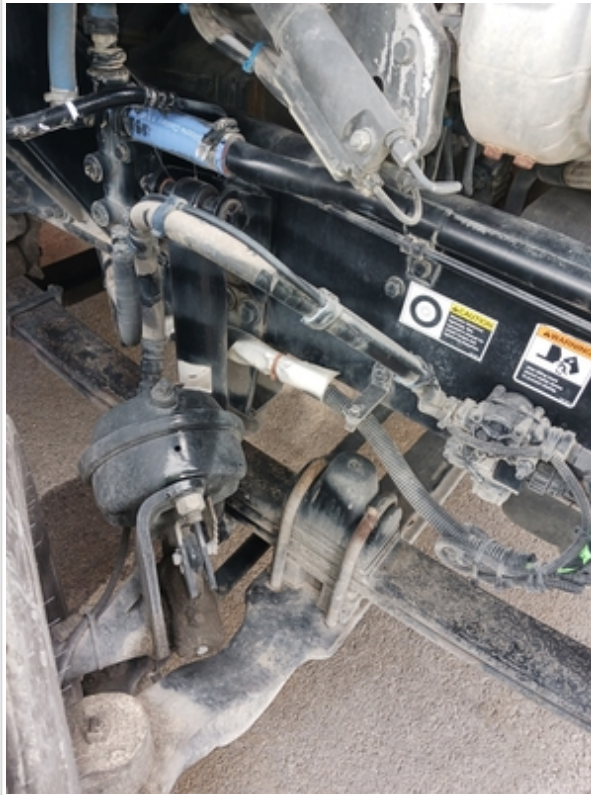
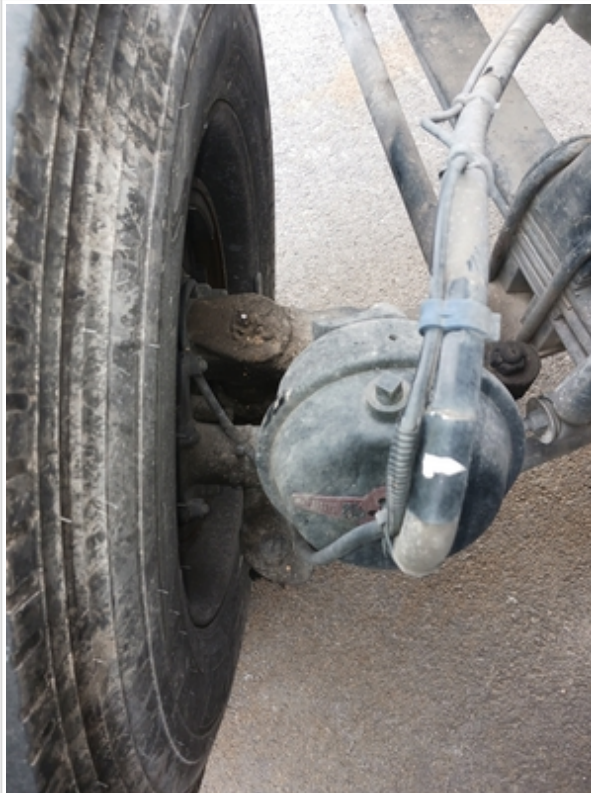
Air Brake System Leaks	No
Air Brake Hose Condition	3 - Normal Wear & Tear
Air Brake System Photos

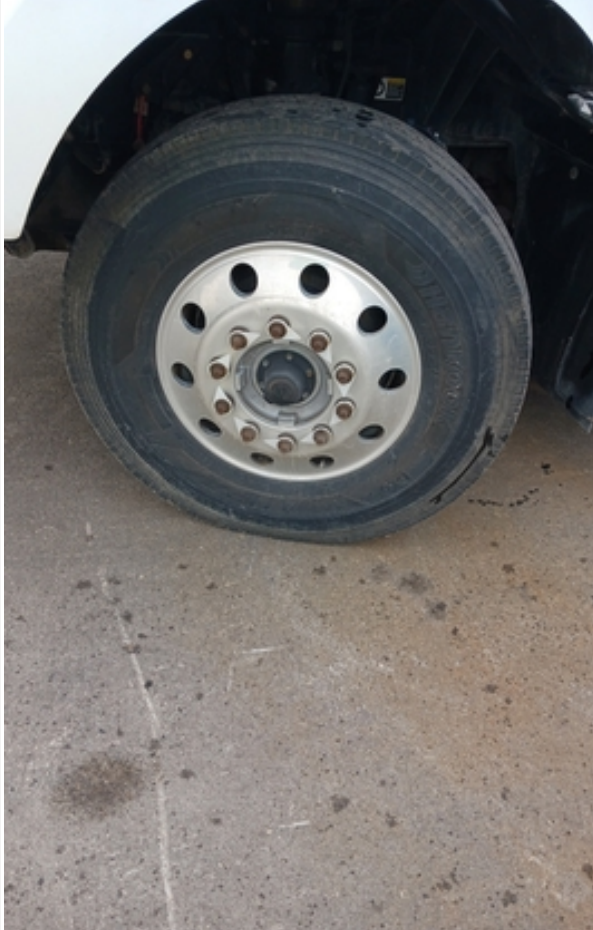
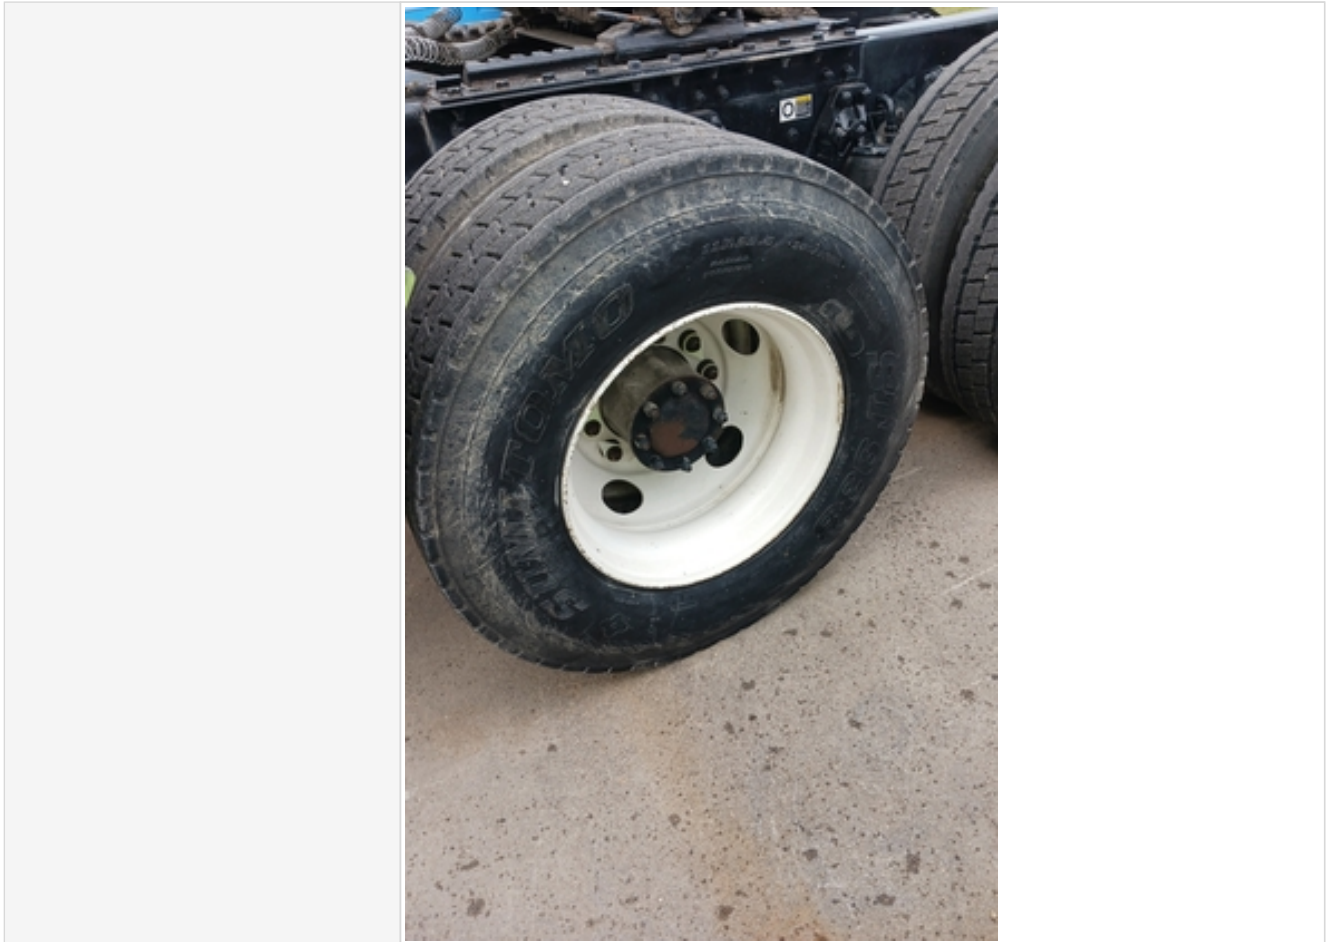
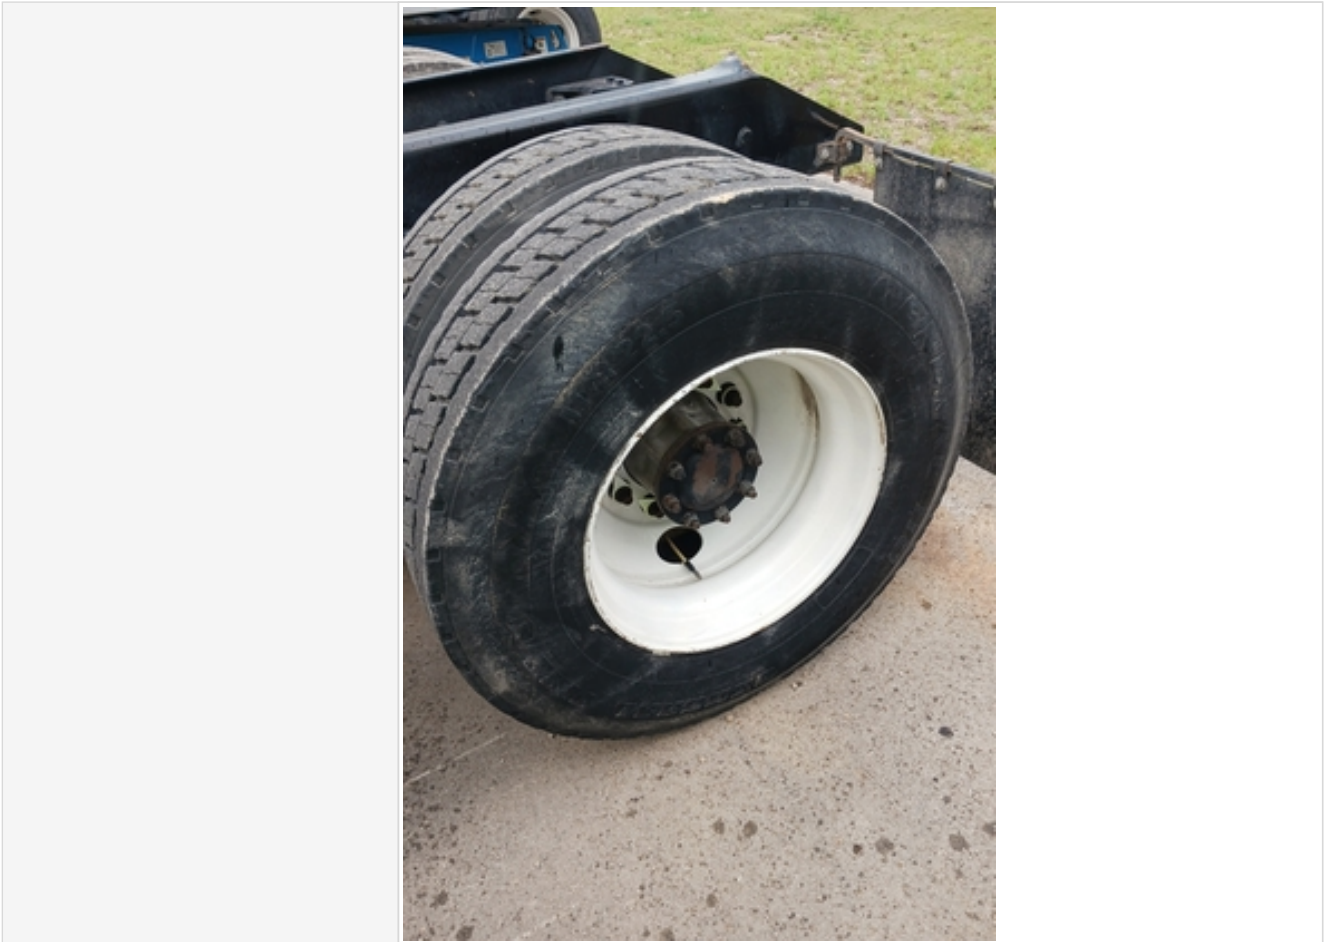
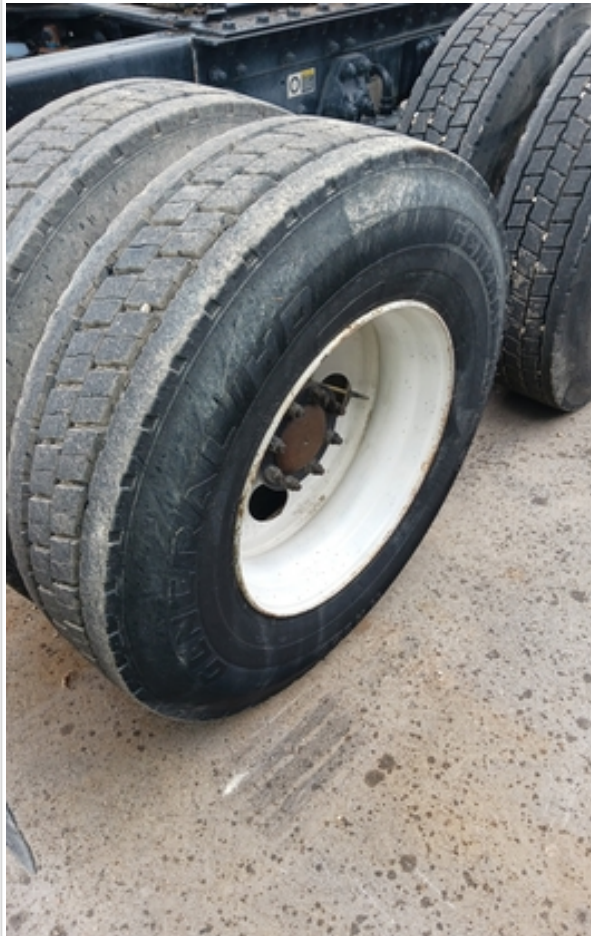
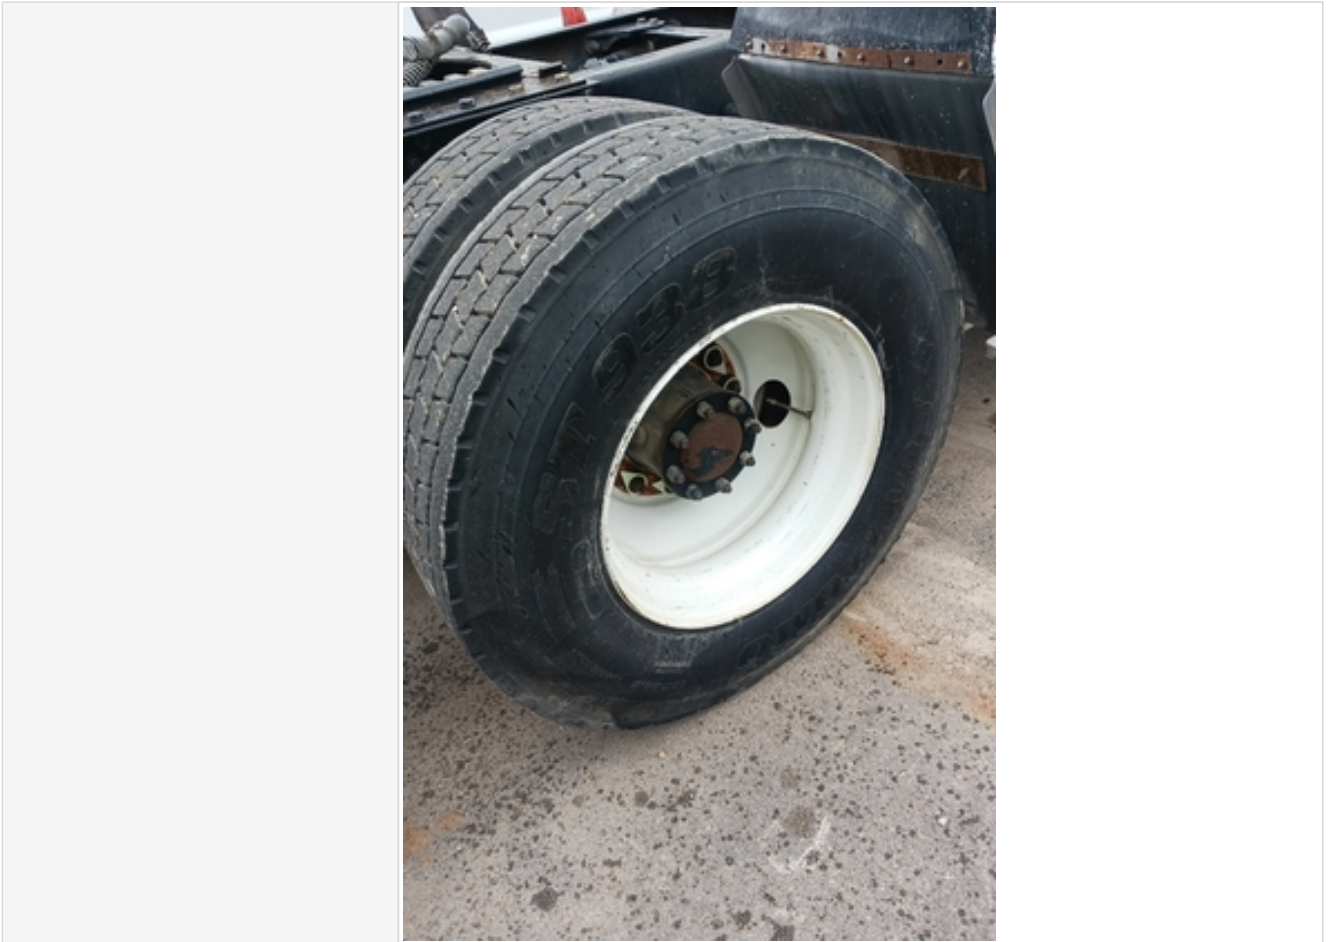
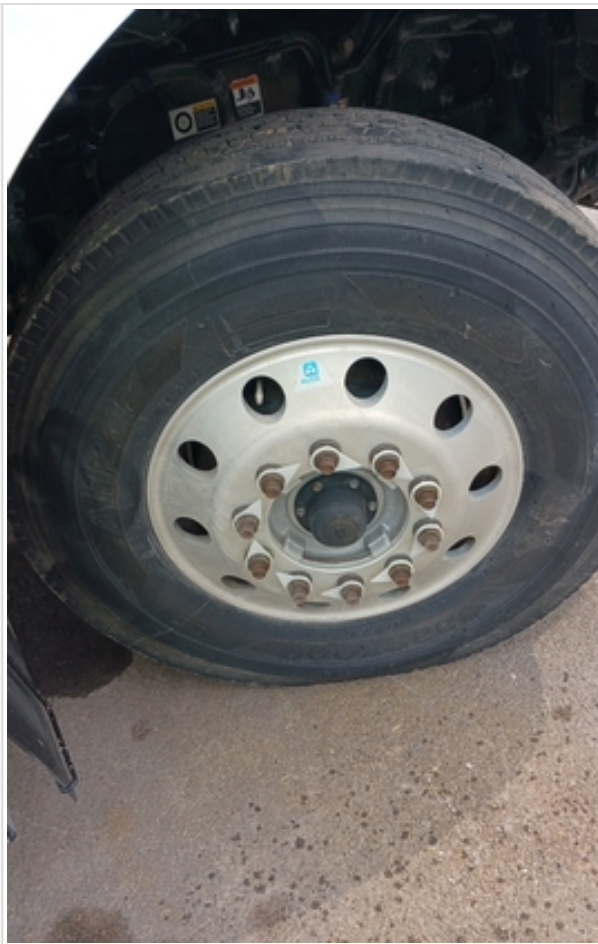
Wheels & Hub Condition	3
Wheels & Hub Photos
