Inspection Report (Telehandler)

Year	2012
Make	skytrack
Model	8042
Serial Number	0160044925
Hour Meter Reading	4523
Previous Application (e.g., earth moving, mining, demolition, etc)	Rental Equipment

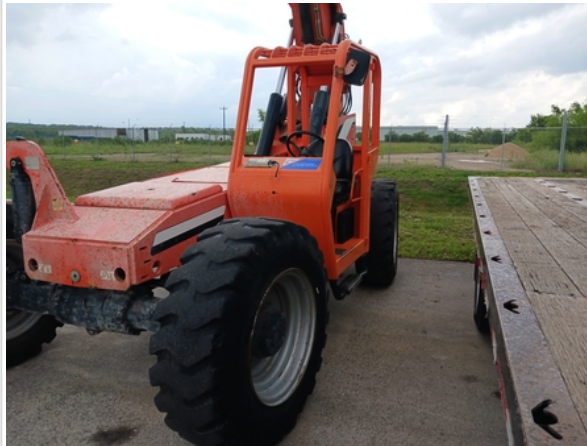
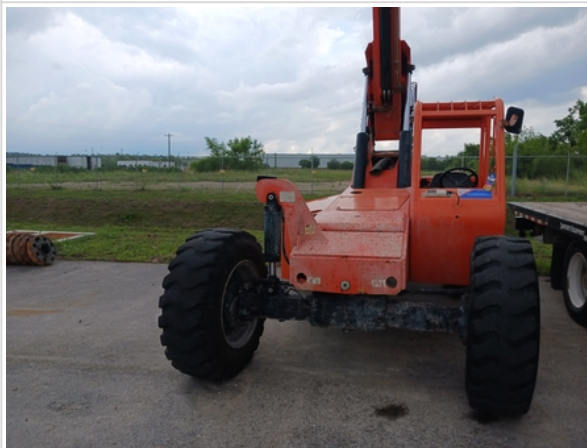
area of rust and missing paint

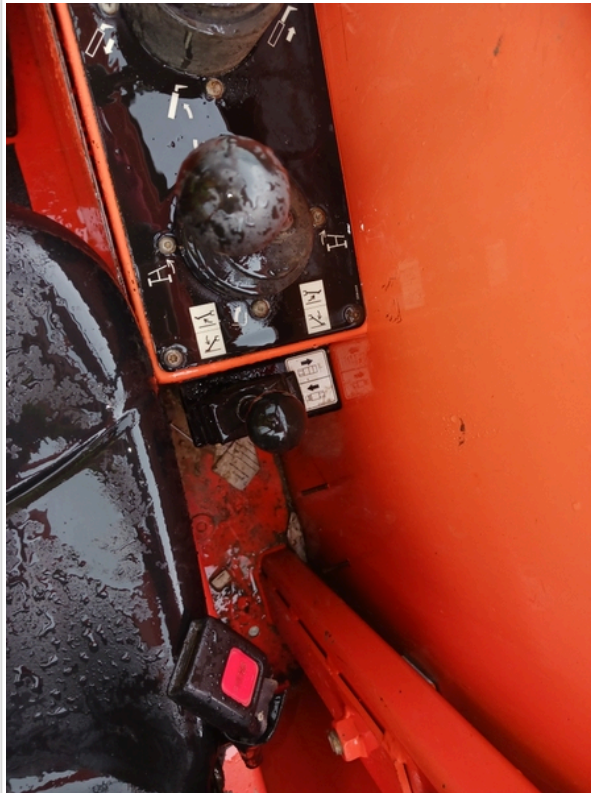
controls appear wet due to light drizzle

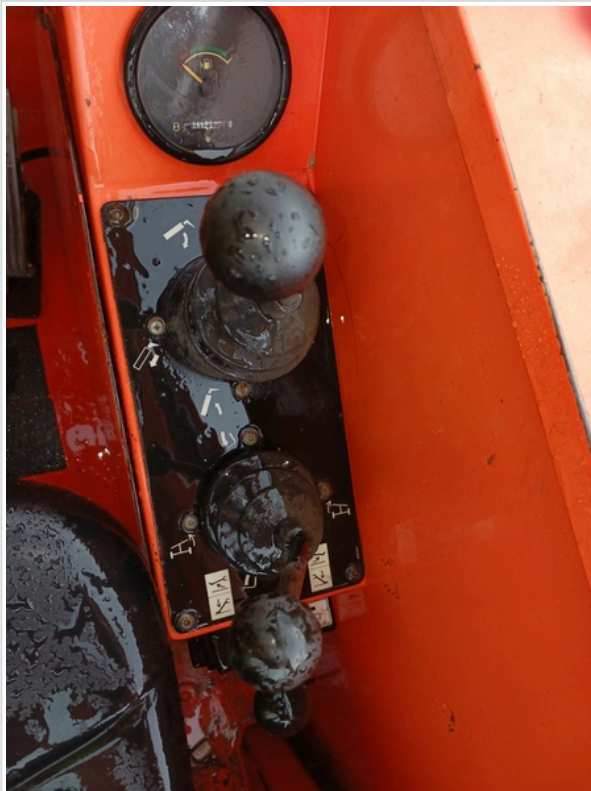
controls are wet due to minor rain

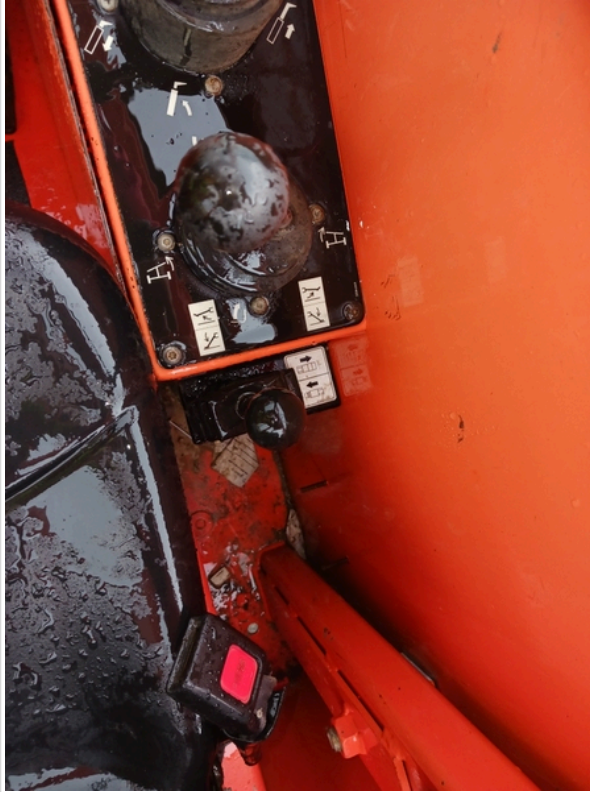
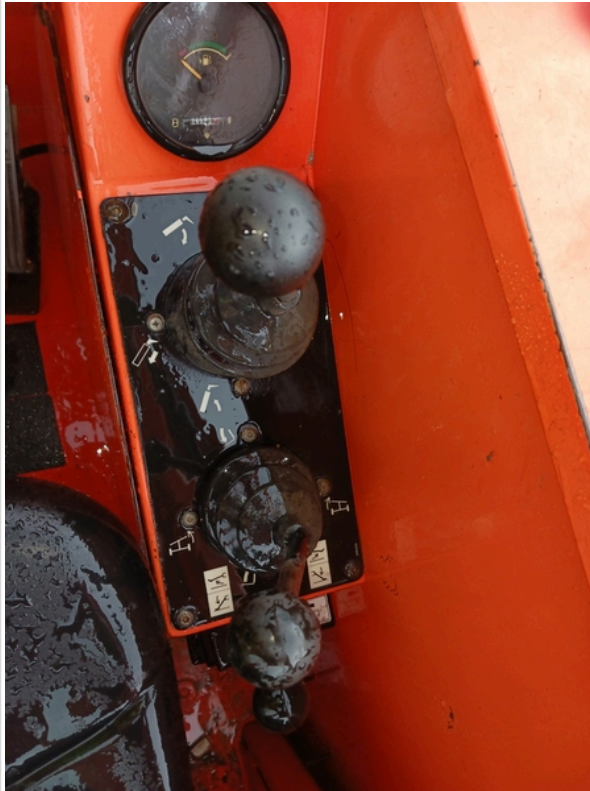
Controls & Switches Photos

Cabin Lights	0
Safety Lock Out / Stop	0
Controls & Switches	3 - Normal Wear & Tear
Controls & Switches Condition	Switches have good functionality, minor cosmetic damage observed

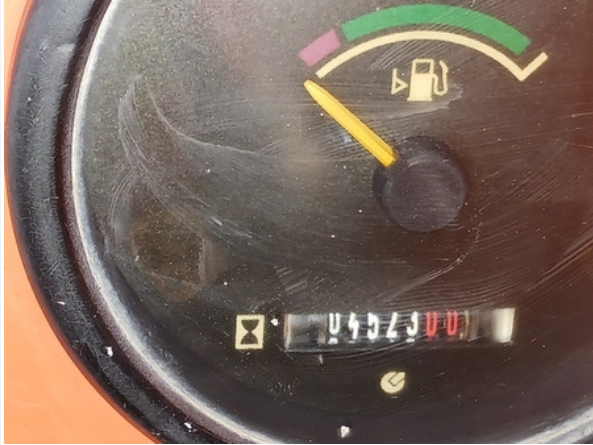
Hour Meter Activity Photos

Hour Meter Activity	3 - Normal Wear & Tear
Hour Meter Condition	Hour meter is functional and in good condition

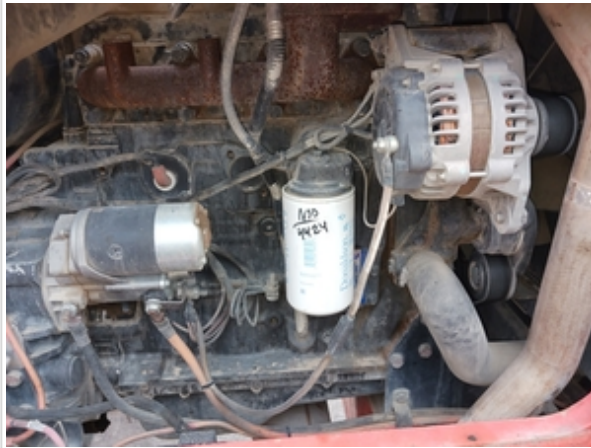
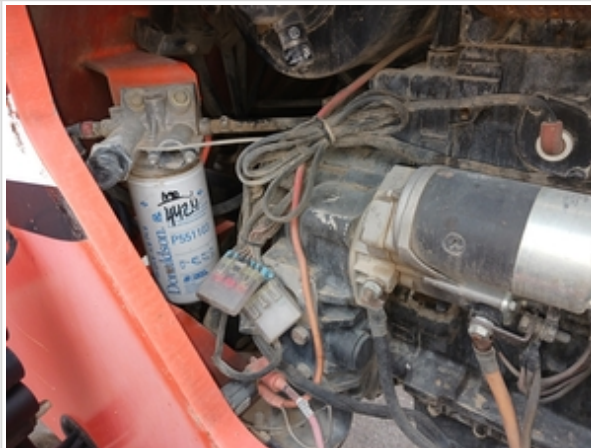
some rust on surface area

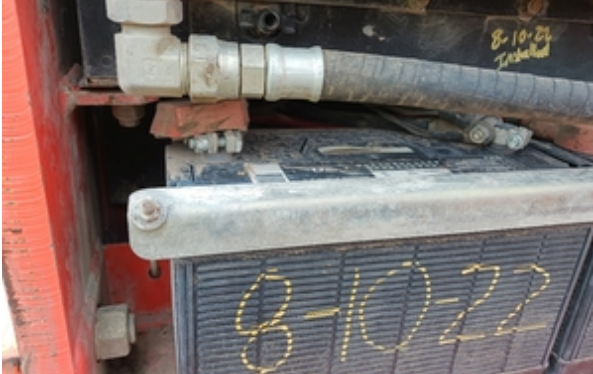
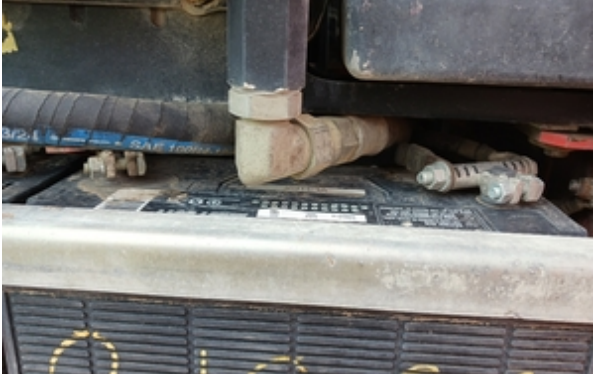
<p>Warning: improper use may result and warranty is voided. Always use proper operation.</p> <p>Engine Serial No. 6013-7166</p> <p>Remanufactured by: Engine Components Technology Limited Cummins No. 200 Epi 122 Industrial Code: 72309 Serial Unit Prefix: 4018419</p> <p>DR6348-RX 4018419</p> <p>Timing Valve L Fitted LOW M E 03</p>
Blow-by (Visual Observation Check)	N/A
Unusual Noises (Upon Start-up, Idle, Shutdown)	No
Unusual Noise Notes	No unusual noises heard
Engine Smoke (Upon Start-up, Idle, Shutdown)	No
Engine Smoke Notes	No engine smoke issues observed
Engine Exhaust Color	Clear
Battery	3 - Normal Wear & Tear
Battery Condition	Dusty & dirty appearance
Battery Condition Photos

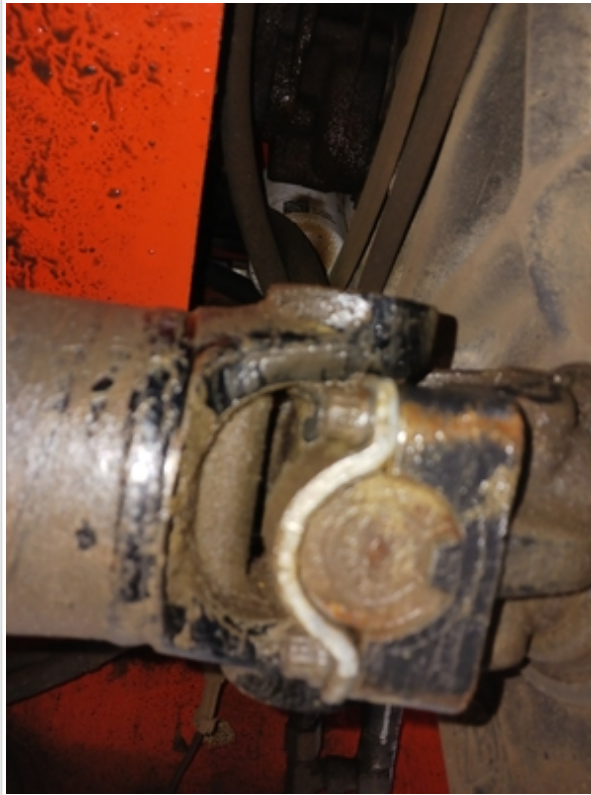
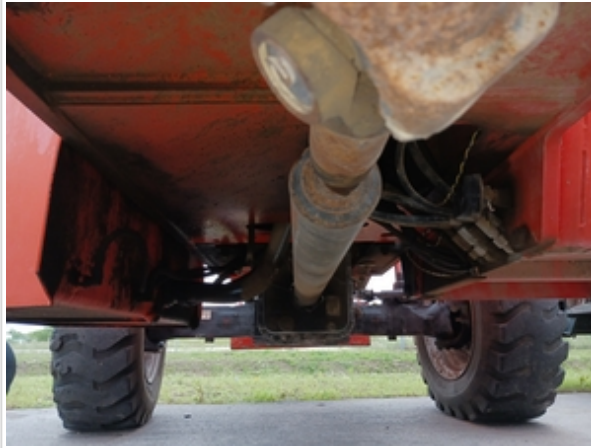
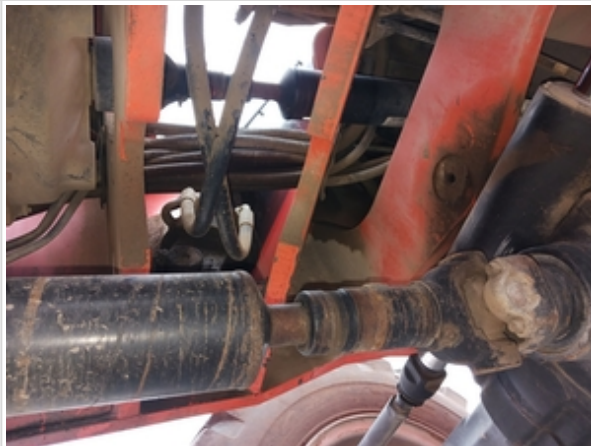
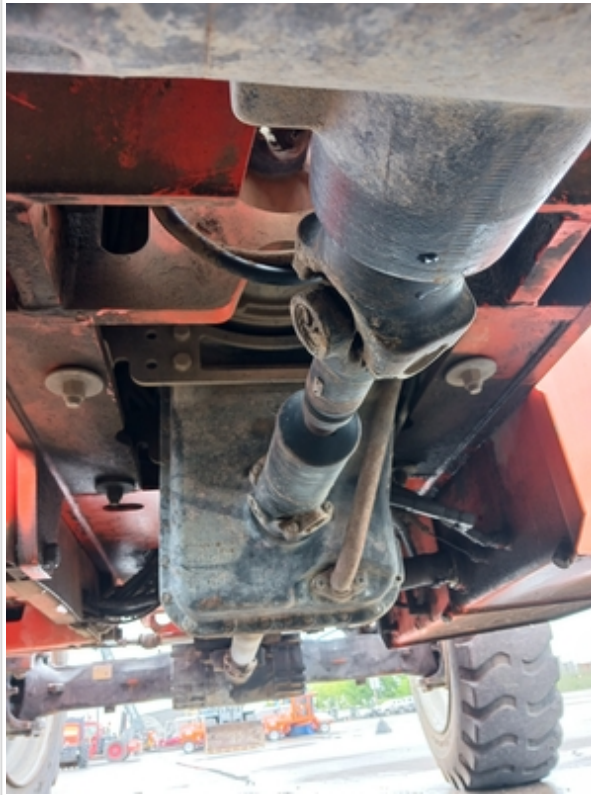
Hydrostatic Transmission?	No
2 Speed?	No
Hydrostatic Drive Configuration	Other (see comments)
Transmission Info (Make/Model/Speeds)	ZF, 4660013001, 4speed
Transmission Components	3 - Normal Wear & Tear
Transmission Condition	Good forward and reverse function, No unusual noises or vibrations
Drive Motors	3 - Normal, Operating as Expected
Parking Brake	3 - Normal, Operating as Expected
Parking Brake Function	Good brake function

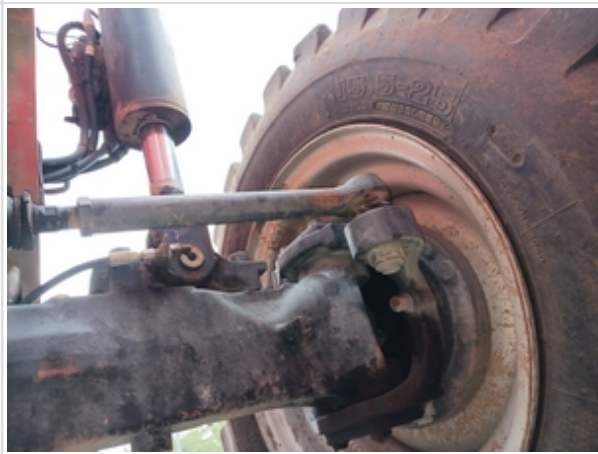
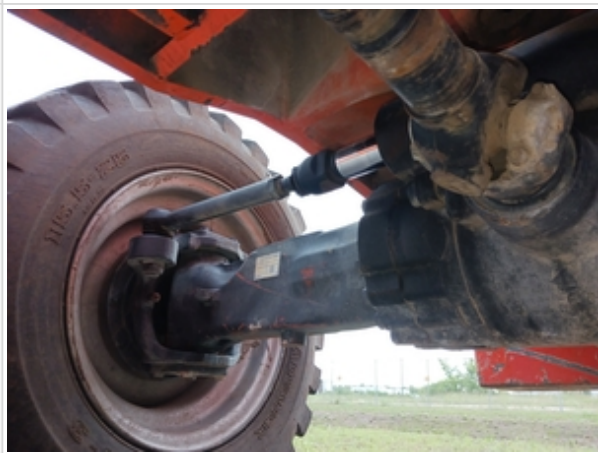
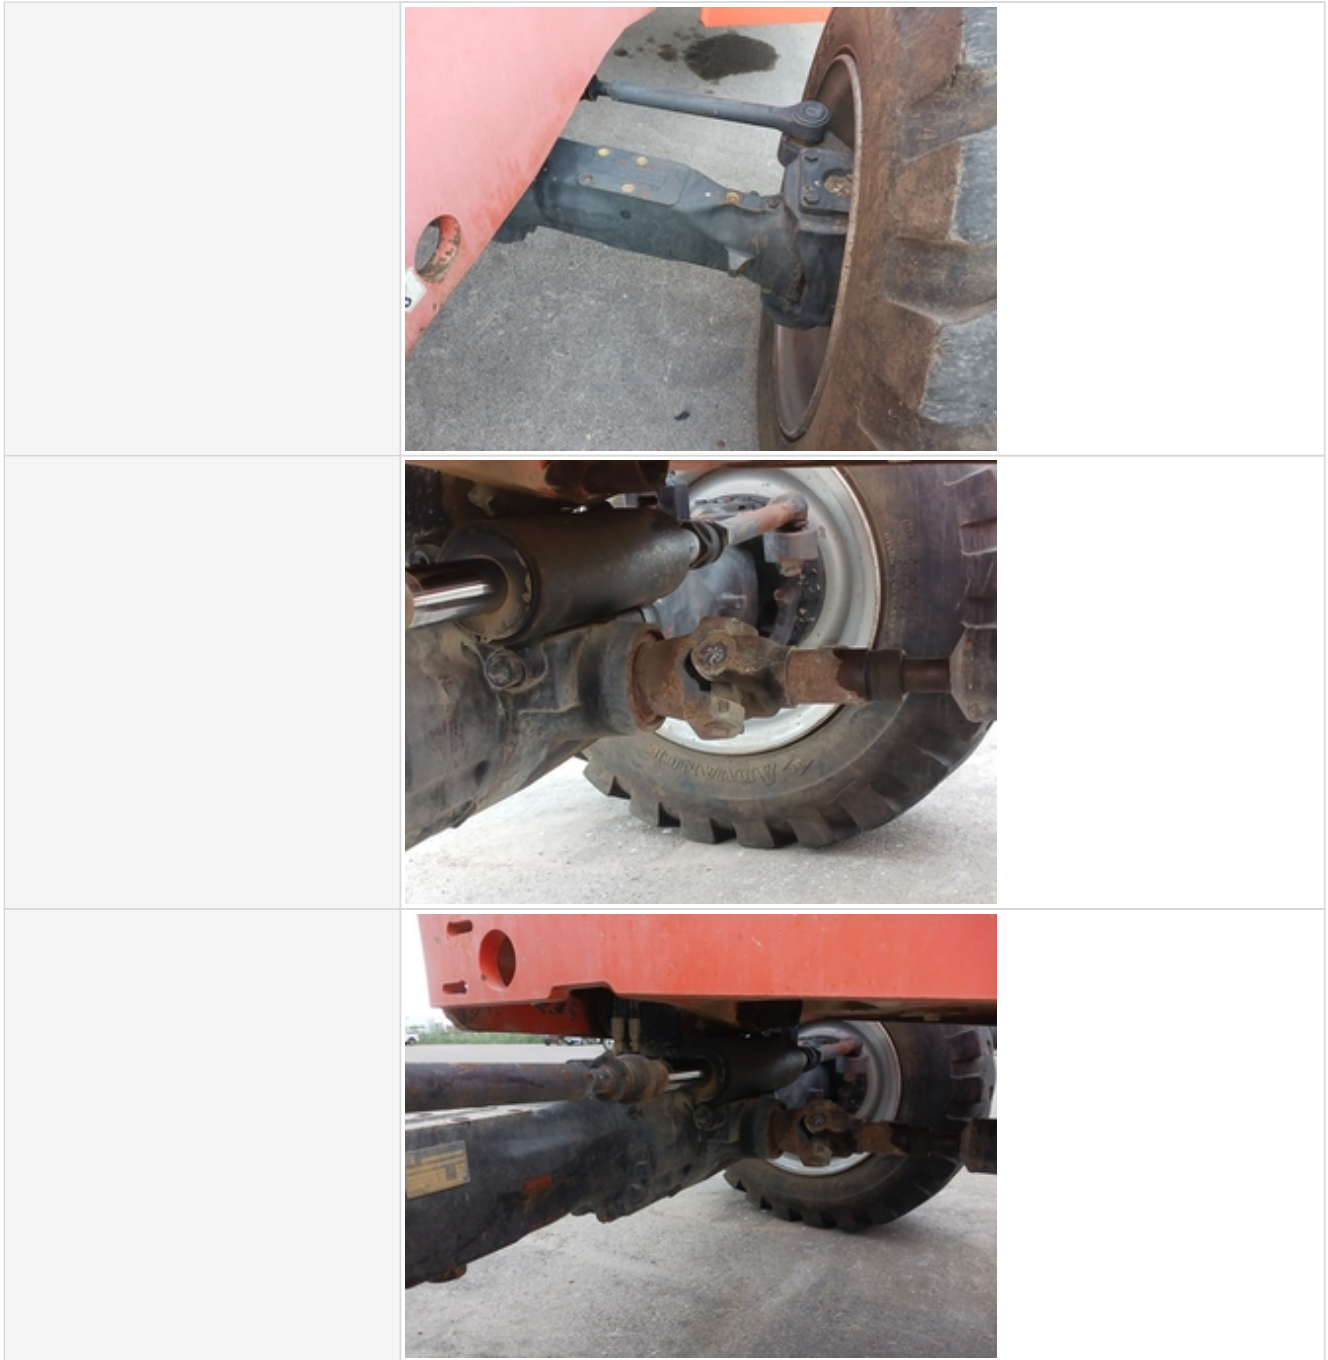
<p>Stance</p>	<p>3 - Normal Wear & Tear</p>	
<p>Stance Photos</p>

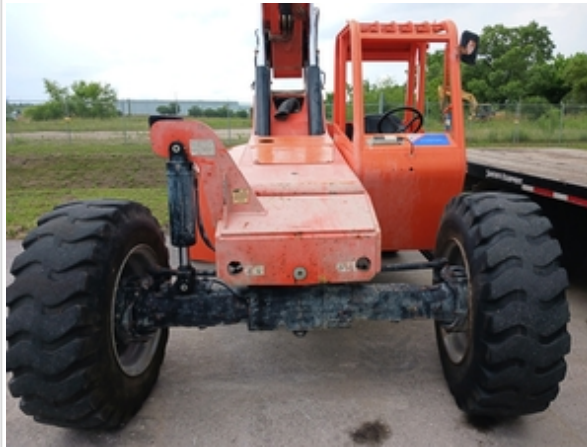
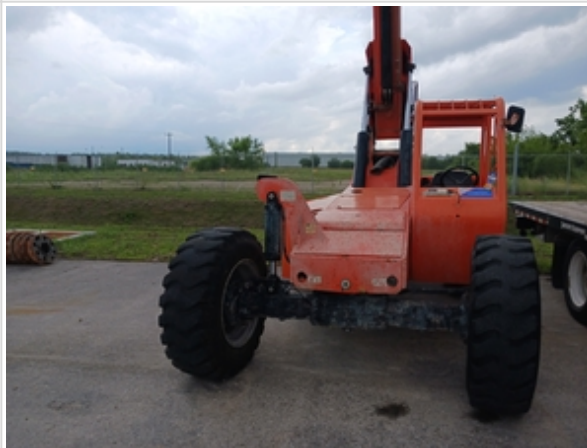
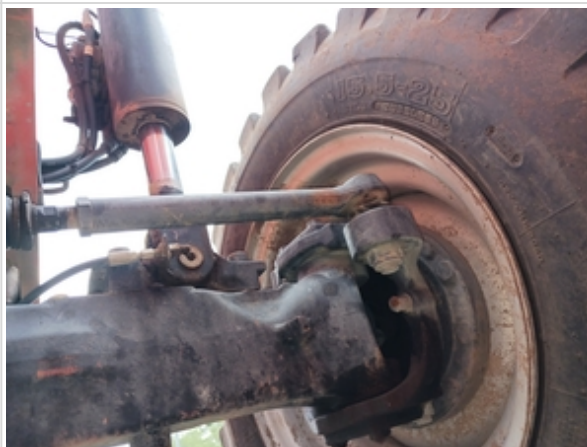
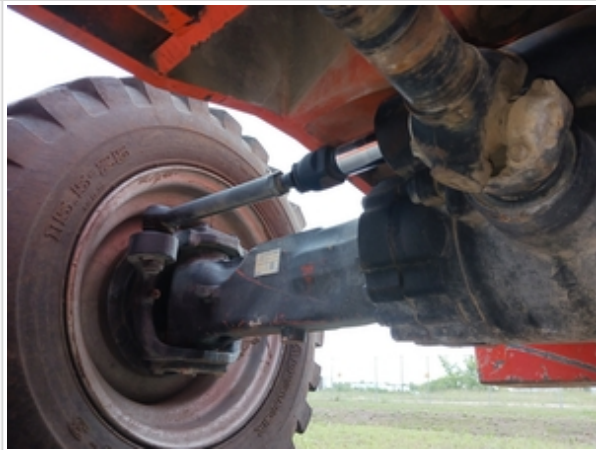
Front Axle Appearance Photos

<p>Front Axle Appearance</p>	<p>3 - Normal Wear & Tear</p>

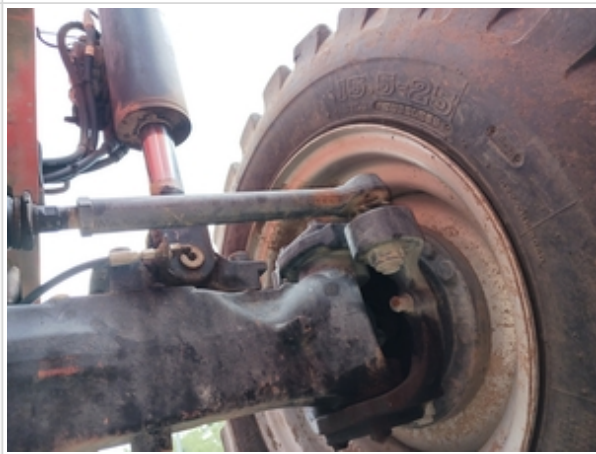
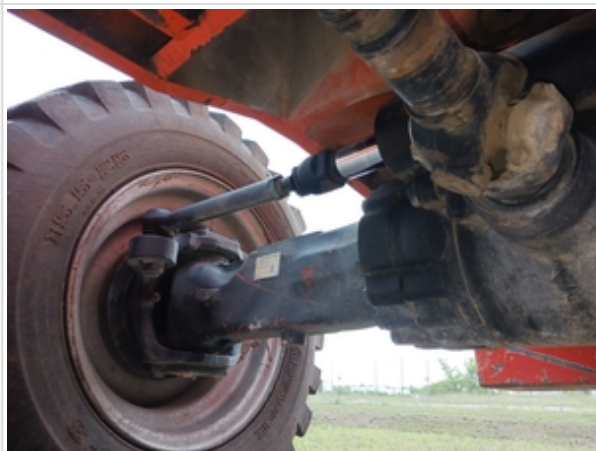
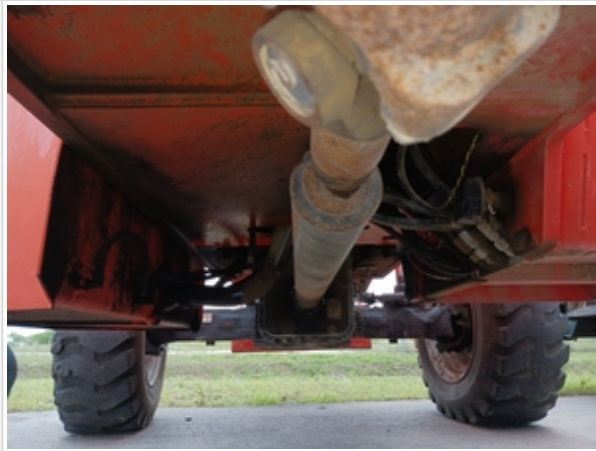
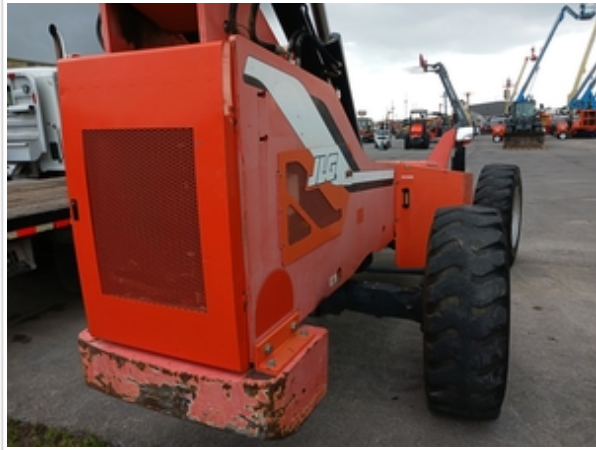
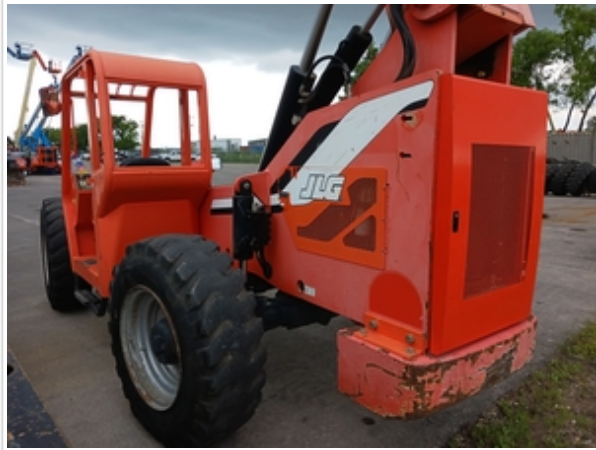
<p>Rear Axle Appearance</p>	<p>3 - Normal Wear & Tear</p>	
<p>Rear Axle Appearance Photos</p>

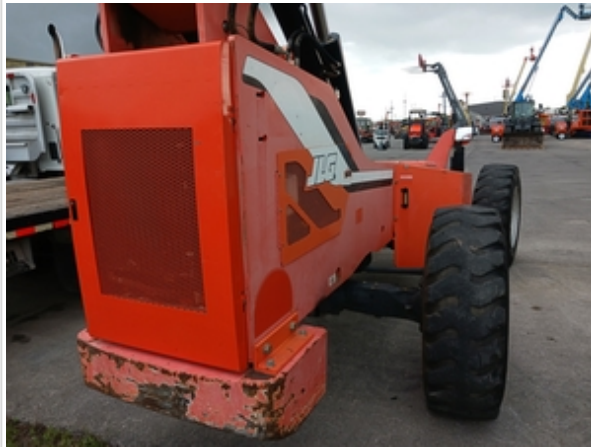
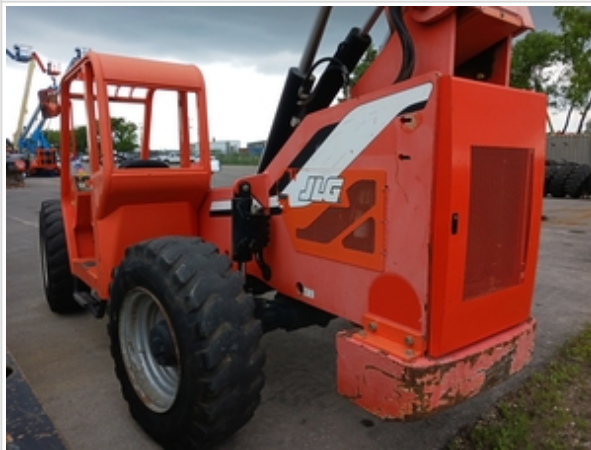
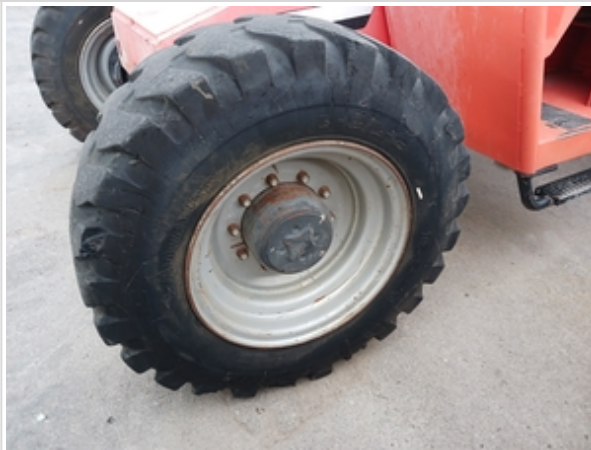
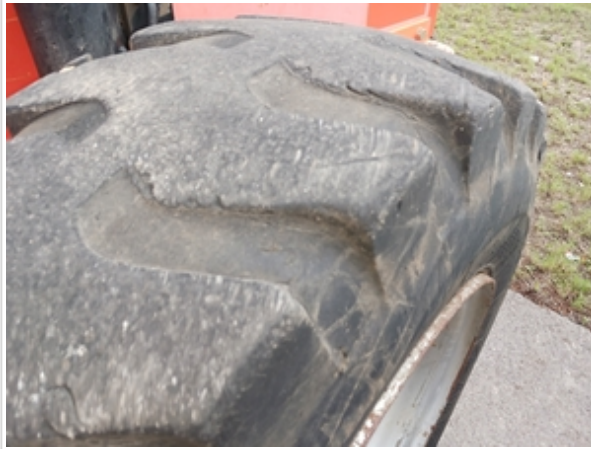
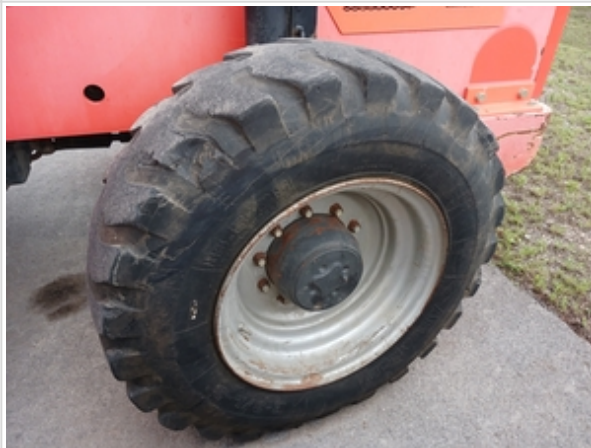
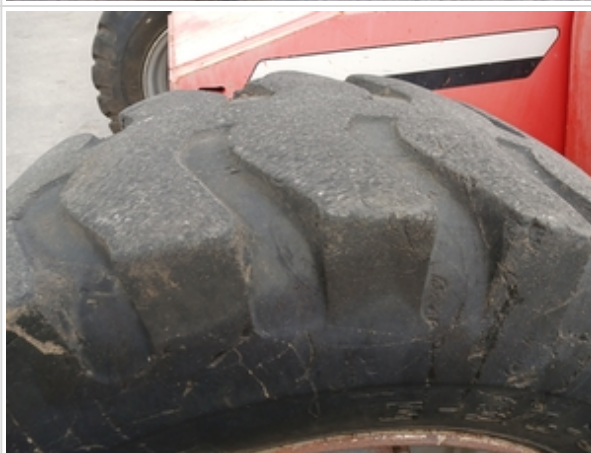
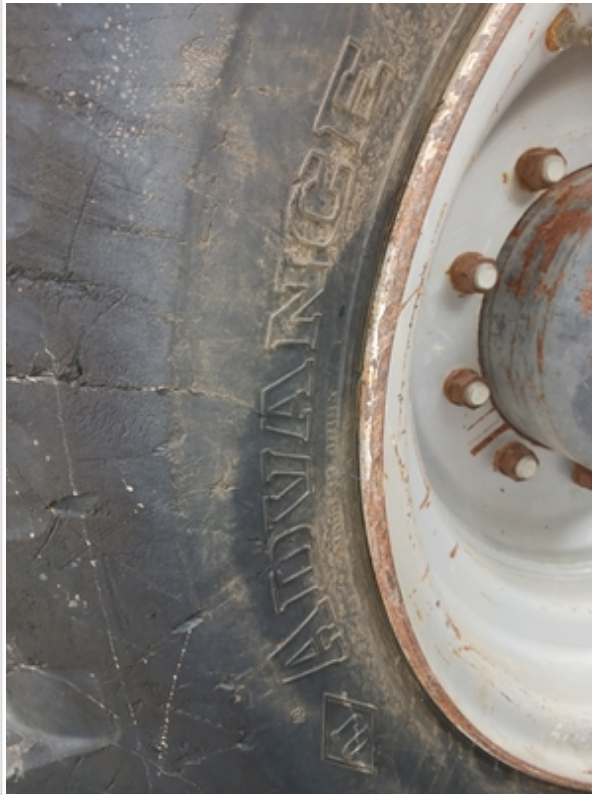
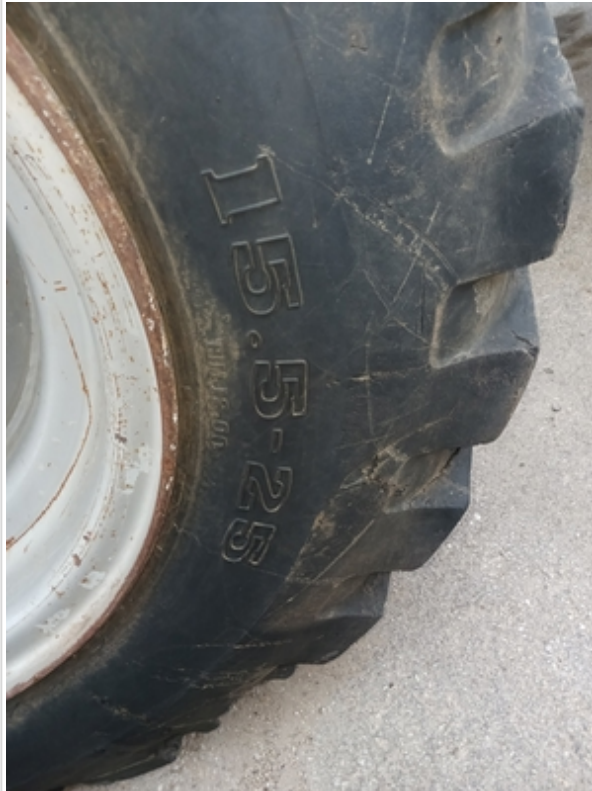
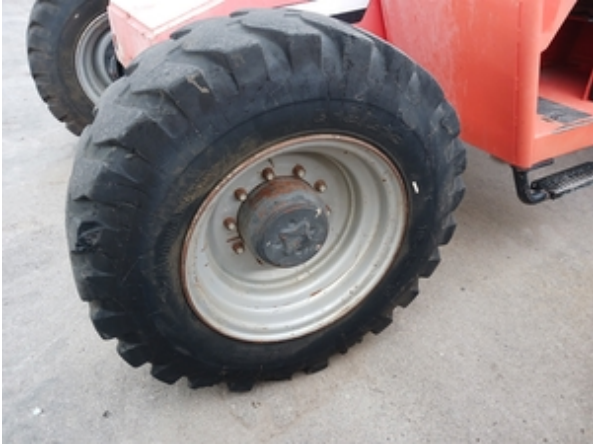
Wheels & Tires Photos

Oscillating Pin Appearance	0
Wheels & Tires	3 - Normal Wear & Tear

Tire Brand	Advance	
Tire Size	15.5 - 25	
Front Left Tire - Ratio Remaining	50%	
Rear Left Tire - Ratio Remaining	30%	
Front Right Tire - Ratio Remaining	30%	
Rear Right Tire - Ratio Remaining	30%	
Boom Condition	3 - Normal Wear & Tear	
Boom Condition Photos

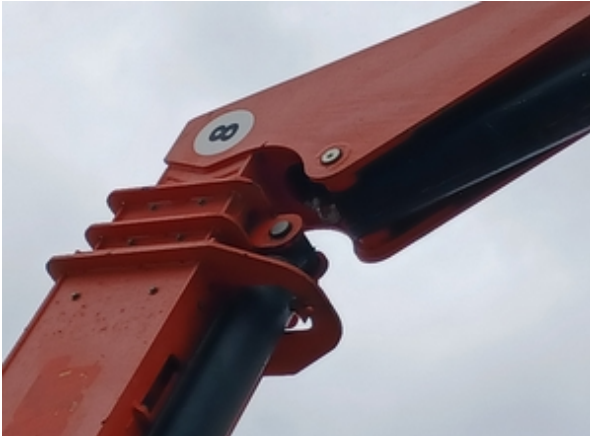
Chain / Tensioners	3 - Normal Wear & Tear	
Rollers & Guides	3 - Normal Wear & Tear	
Boom Wear Guides	3 - Normal Wear & Tear	
Boom Wear Guides Photos

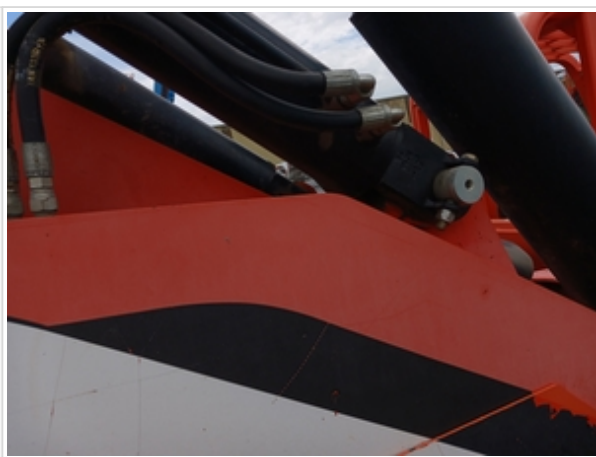
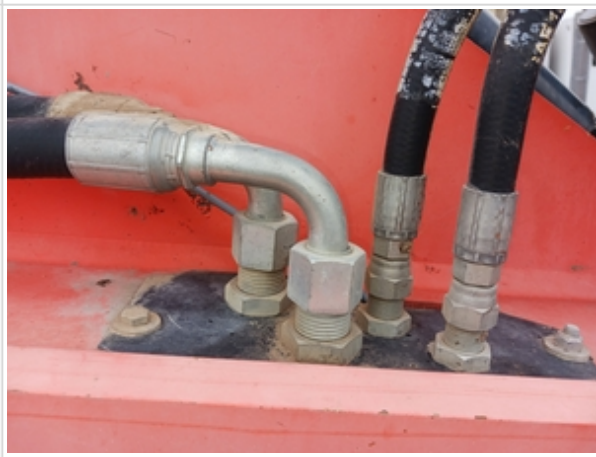
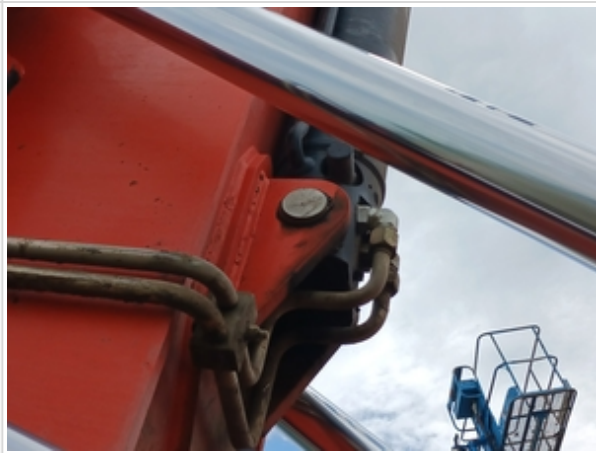
<p>Hydraulic System Photos</p>

Overall Chassis	3 - Normal Wear & Tear
Overall Chassis Comments	Chassis is in good condition
Hydraulics Overall Inspection Points	
Hydraulics Overall	
Hydraulic System	Take close-up photos of the hydraulic components including the pump, lines, fittings, controls, and levers. Note any damage, wear, or leaks.

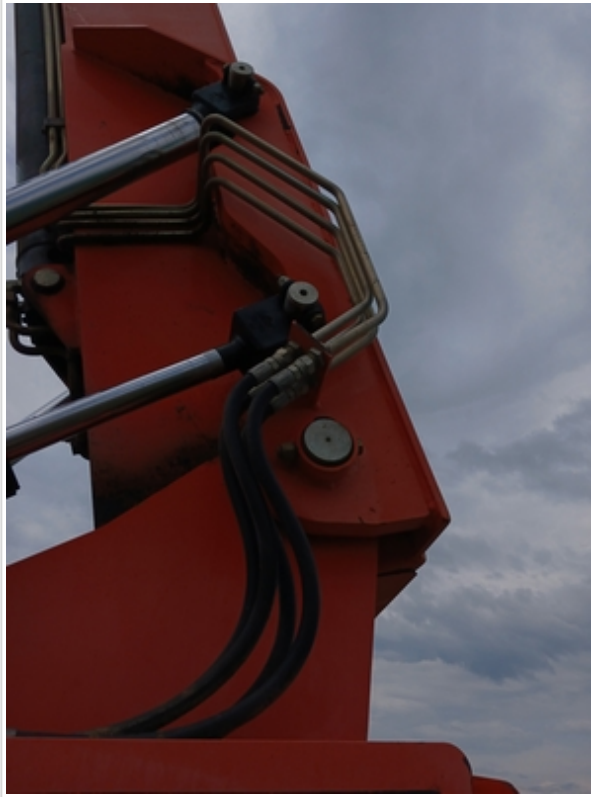
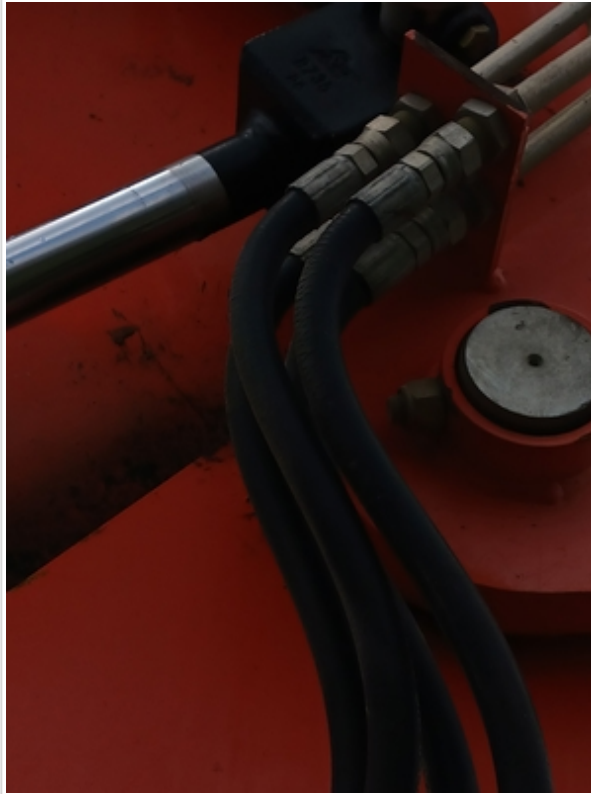
Wet or Damp Hydraulic Lines / Fittings	No
Appearance of Hydraulic Lines / Fittings	3 - Normal Wear & Tear
Hydraulic Lines / Fittings Condition	Hydraulic lines & fittings are clean and in good condition, Cracking, stiff, or charred hydraulic hoses
Appearance of Hydraulic Lines / Fittings Photos

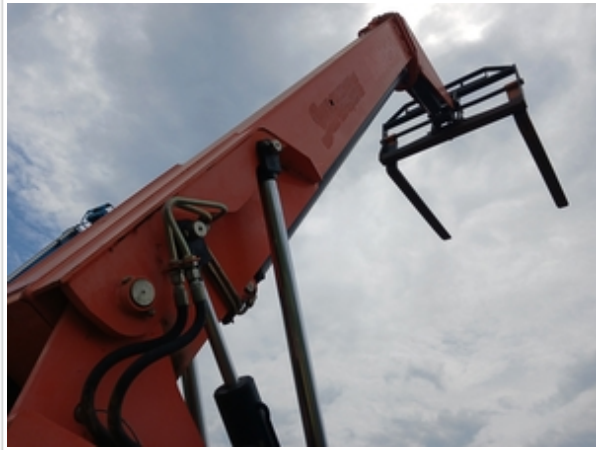
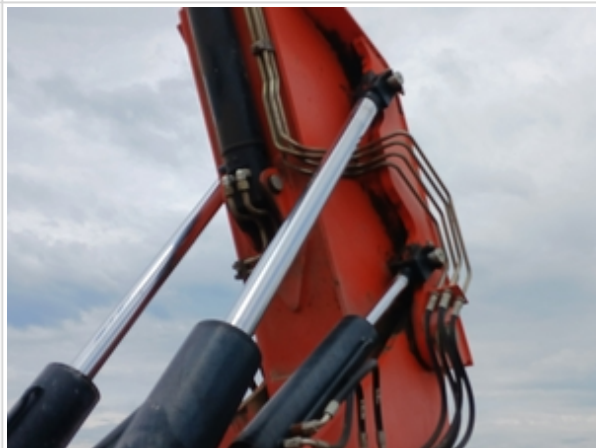
Boom Lift Cylinders	Check the boom lift cylinders. Note any wear, pitting, discoloration, etc. Take photos.	
Boom Lift Cylinders: Mounting Pin	3 - Normal Wear & Tear	
Boom Lift Cylinders: Oil Leaks	No	
Boom Lift Cylinders Photos

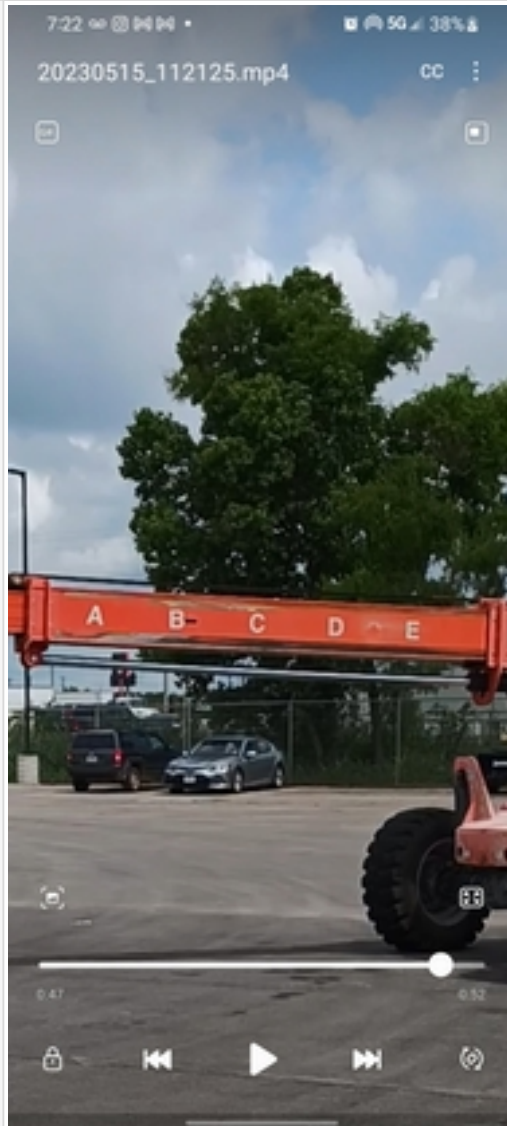
Telescopic Boom Cylinders
Photos

Telescopic Boom Cylinders	Check the telescopic boom cylinders. Note any wear, pitting, discoloration, etc. Take photos.
Telescopic Boom Cylinders: Mounting Pin	3 - Normal Wear & Tear
Telescopic Boom Cylinders: Oil Leaks	No

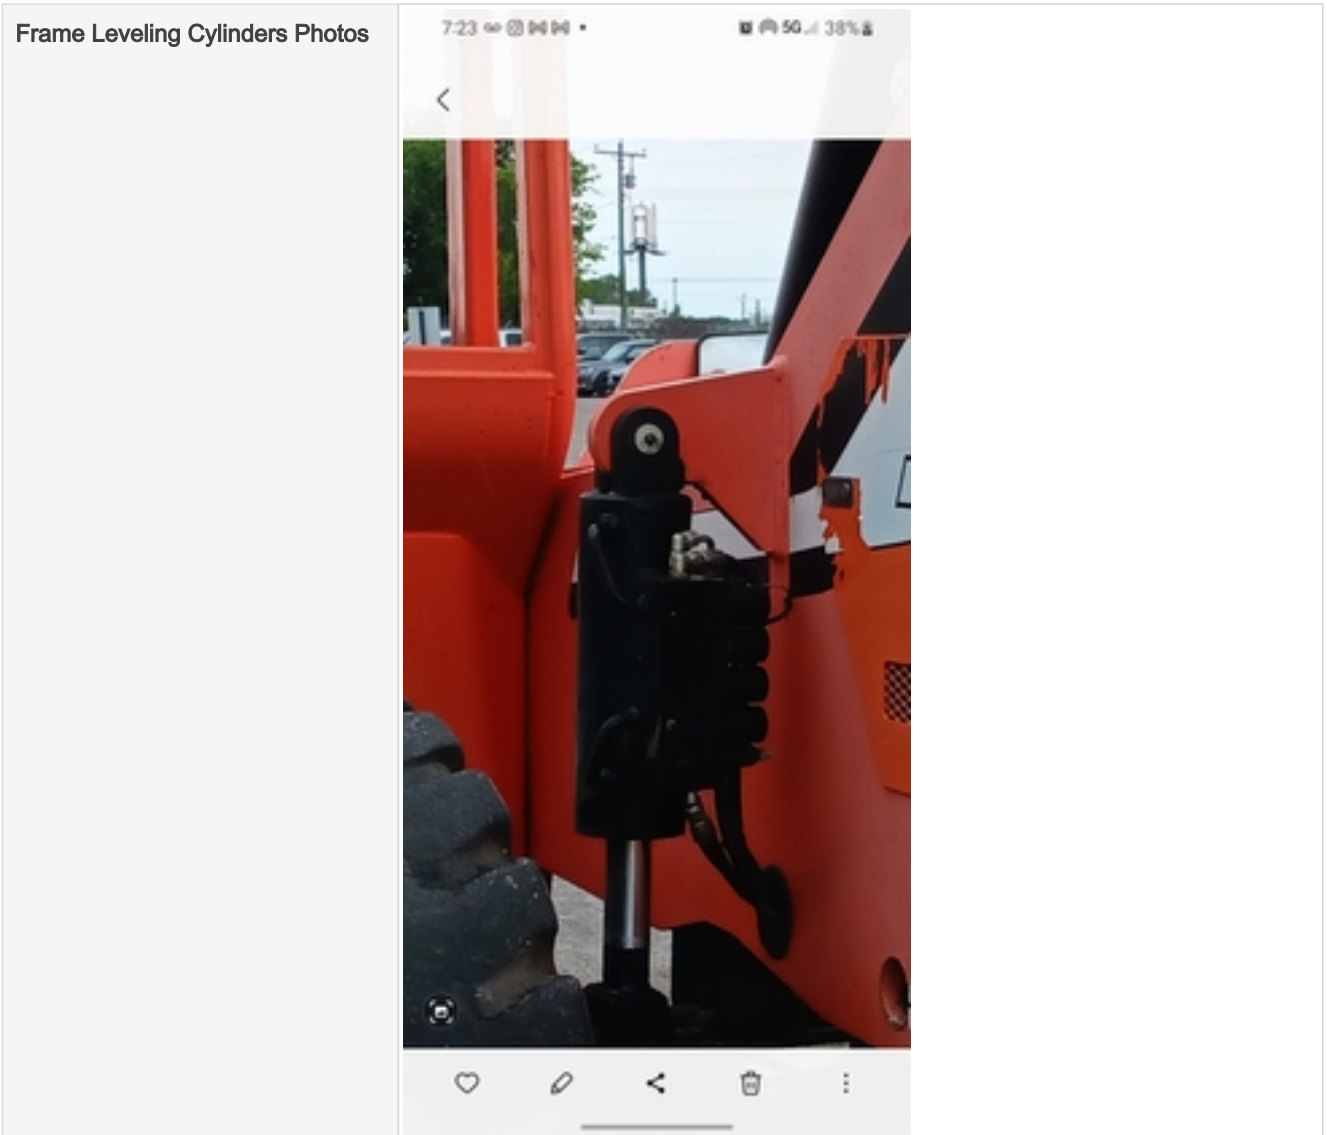
Frame Leveling Cylinders	Check the frame leveling cylinders. Note any wear, pitting, discoloration, etc. Take photos.
Frame Leveling Cylinders: Mounting Pin	3 - Normal Wear & Tear
Frame Leveling Cylinders: Oil Leaks	No

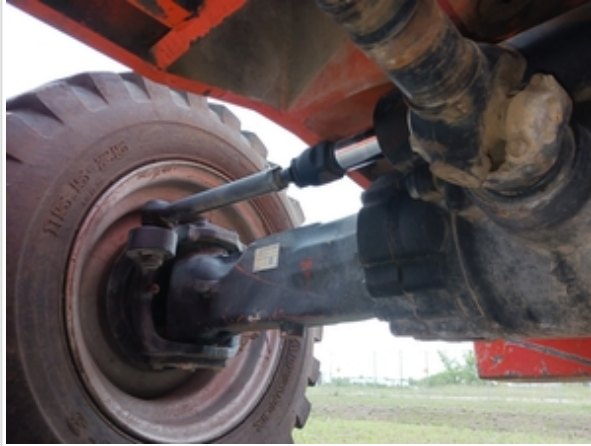
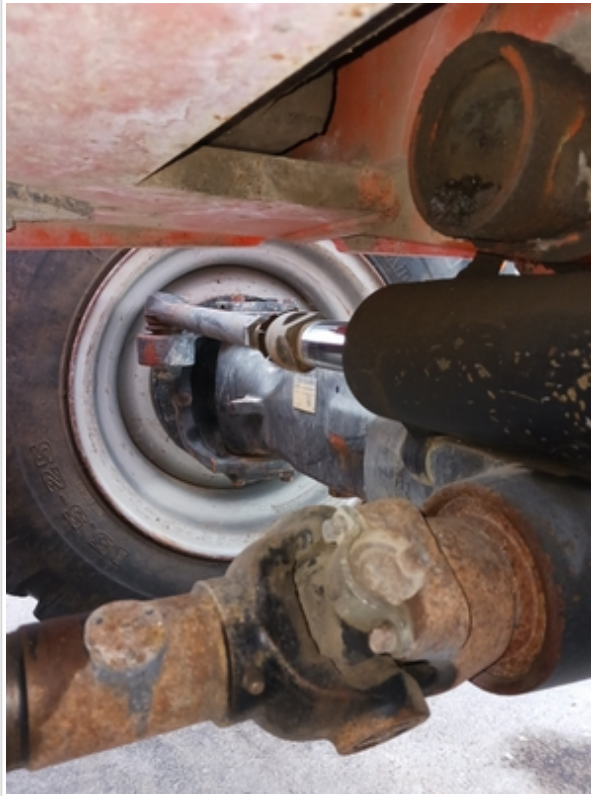
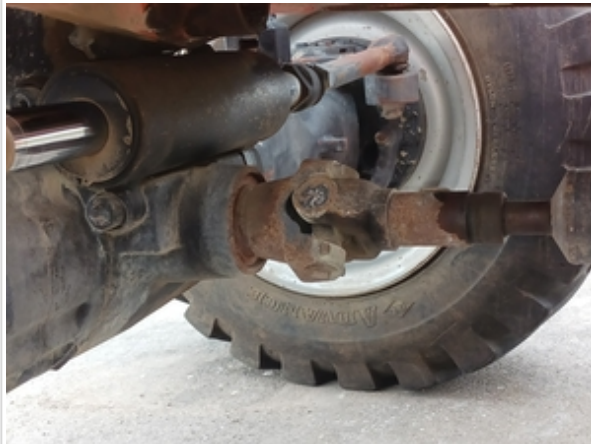
Steering Cylinders Photos

Carriage Tilt Cylinder	Check the carriage tilt cylinders. Note any wear, pitting, discoloration, etc. Take photos.
Carriage Tilt Cylinder: Mounting Pin	3 - Normal Wear & Tear
Carriage Tilt Cylinder: Oil Leaks	No
Side Shift Cylinder	Check the side shift cylinder. Note any wear, pitting, discoloration, etc. Take photos.
Outrigger Cylinders	Check the outrigger cylinders. Note any wear, pitting, discoloration, etc. Take photos.
Steering Cylinders	Check the steering cylinders. Note any wear, pitting, discoloration, etc. Take photos.
Steering Cylinders: Mounting Pin	3 - Normal Wear & Tear
Steering Cylinders: Oil Leaks	No

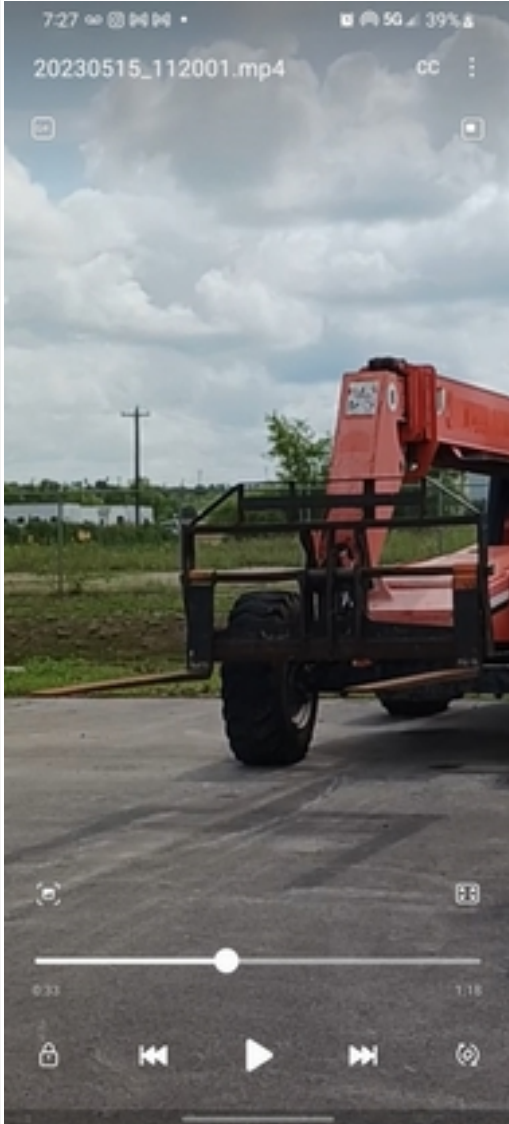
Forks / Work Tool Condition	3 - Normal Wear & Tear
Forks / Work Tool Photos
