Enterprise Equipment Inspection

Category	Excavator
Travel System	Track Undercarriage
Comments	
Year	2016
Make	Kobelco
Model	SK140SRLC-3
Serial Number	YH07-10093
Serial Number Plate

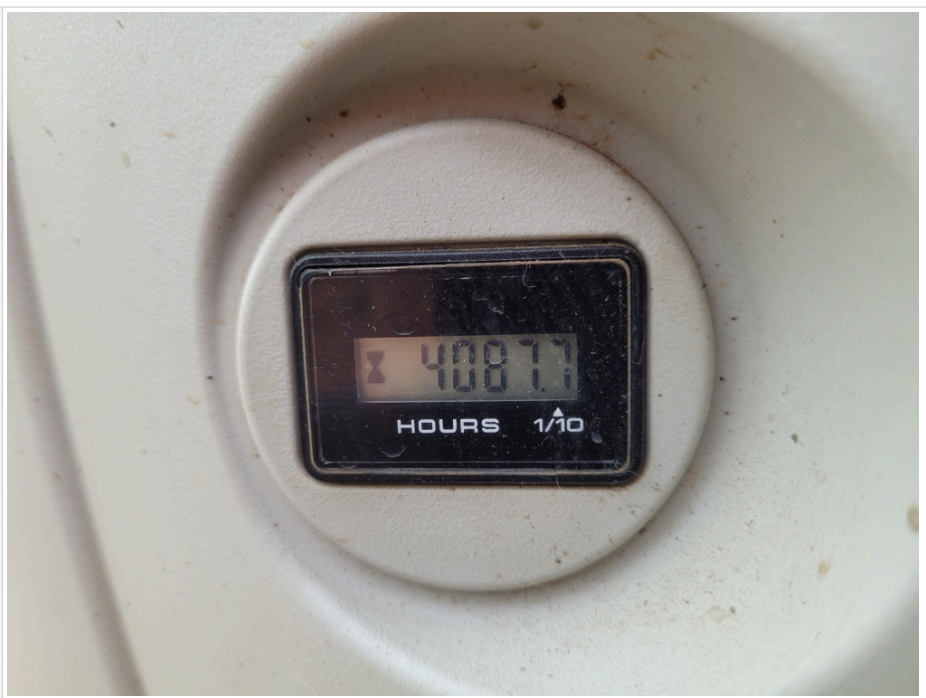
Hour Meter Photo

Hour Meter Reading	4,087

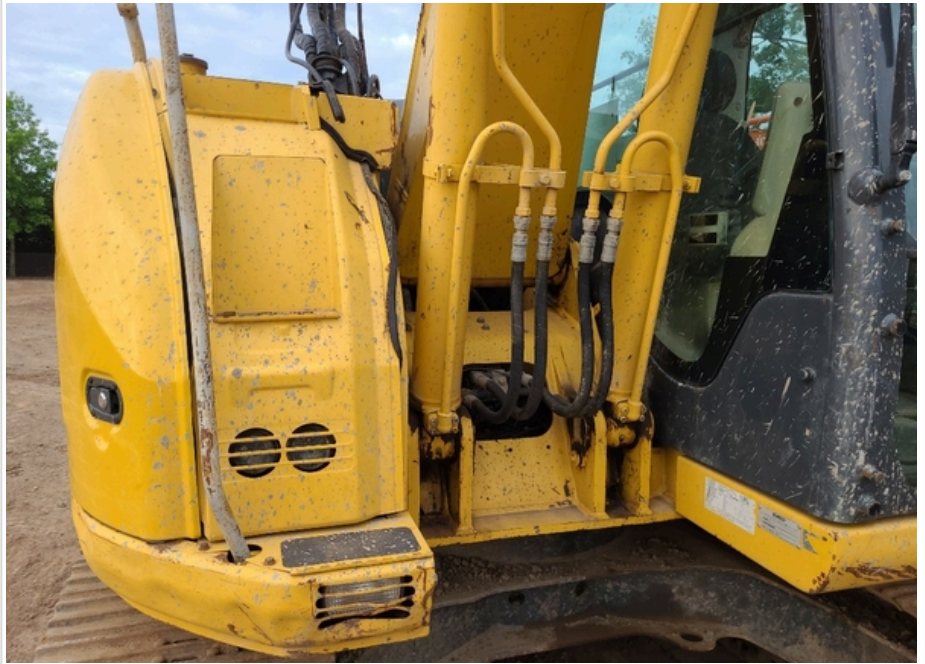
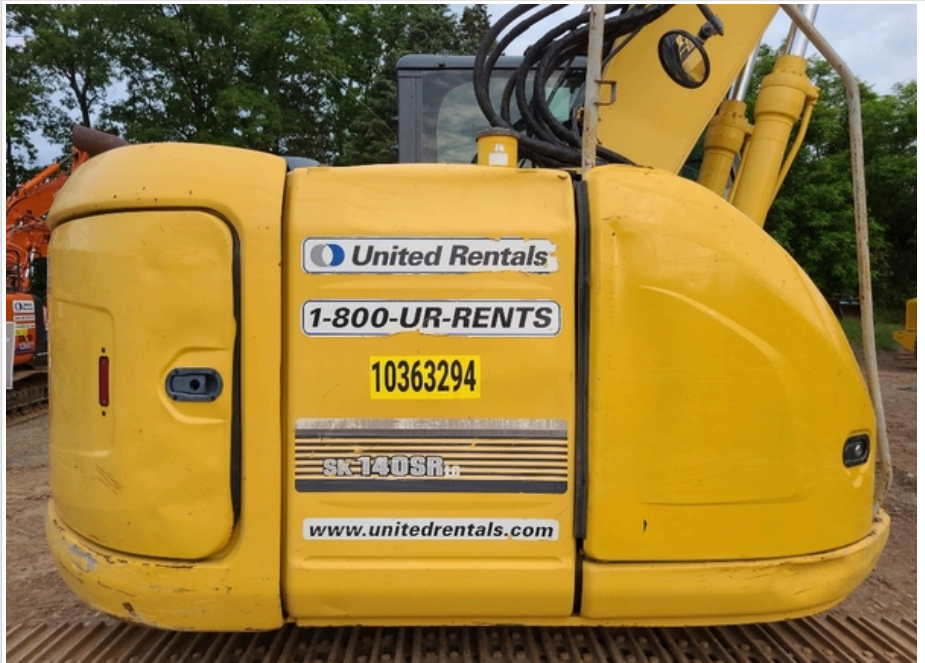
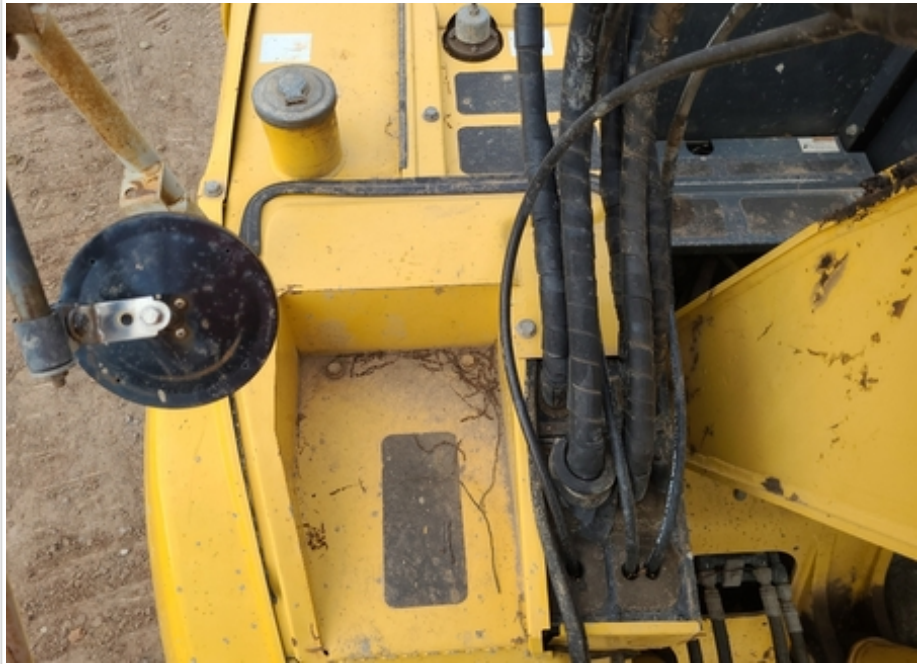
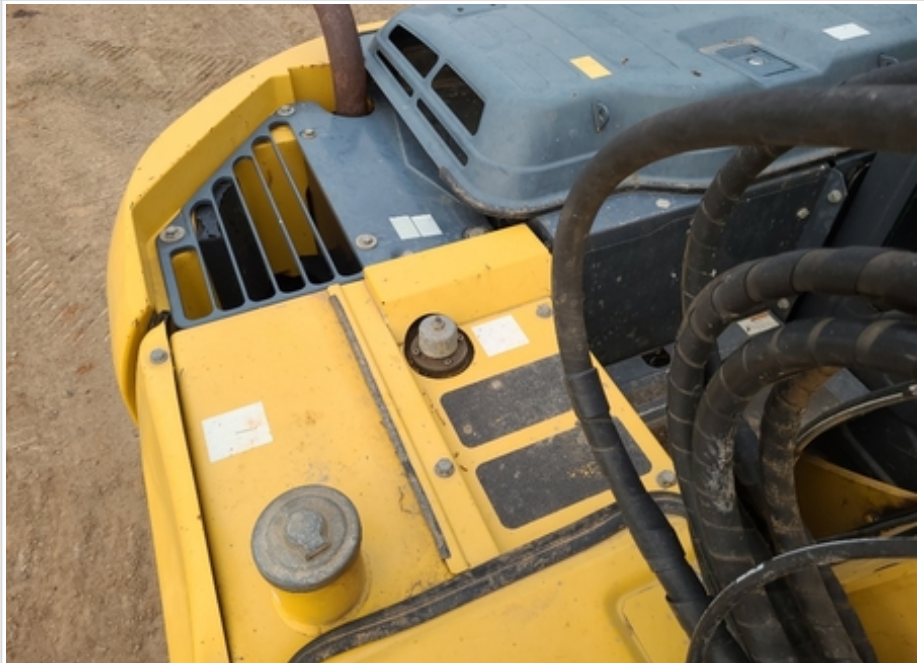
Close-Up Exterior Photos

Exterior Rating	3 - Normal Wear & Tear
Exterior Comments	Exterior in good shape, minor dent in front right work light panel.

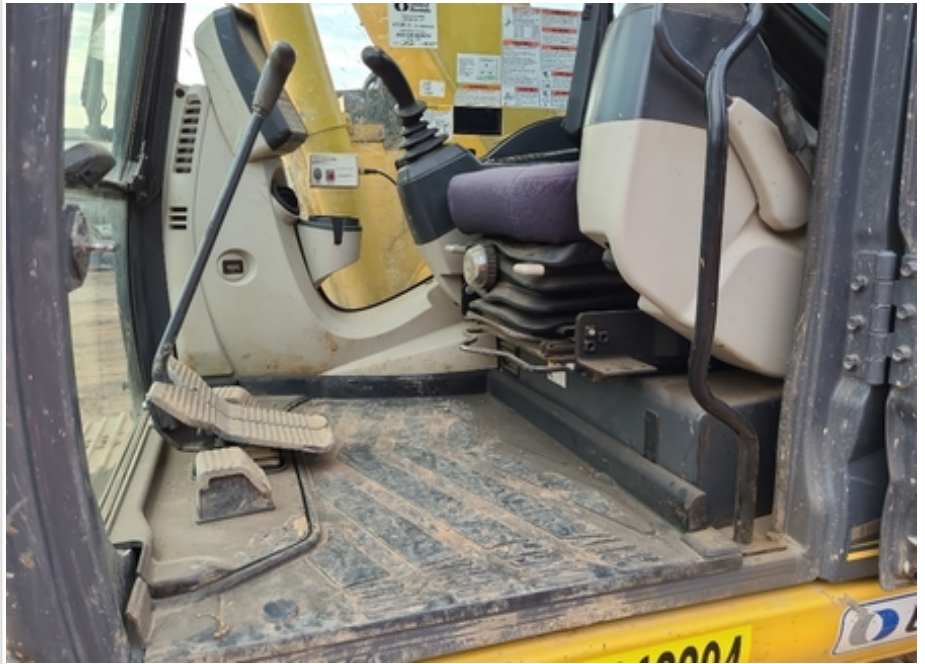
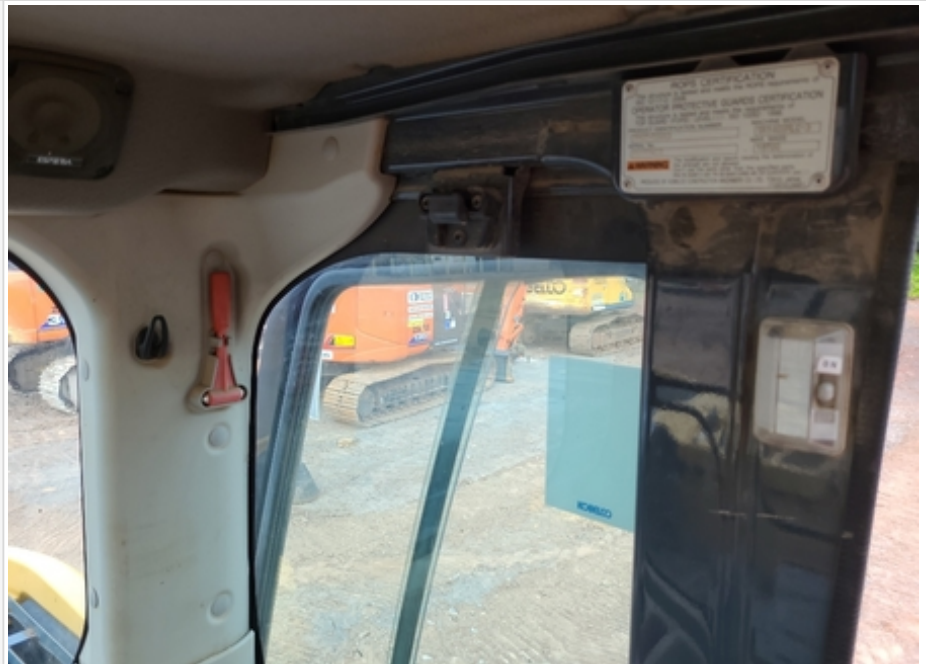
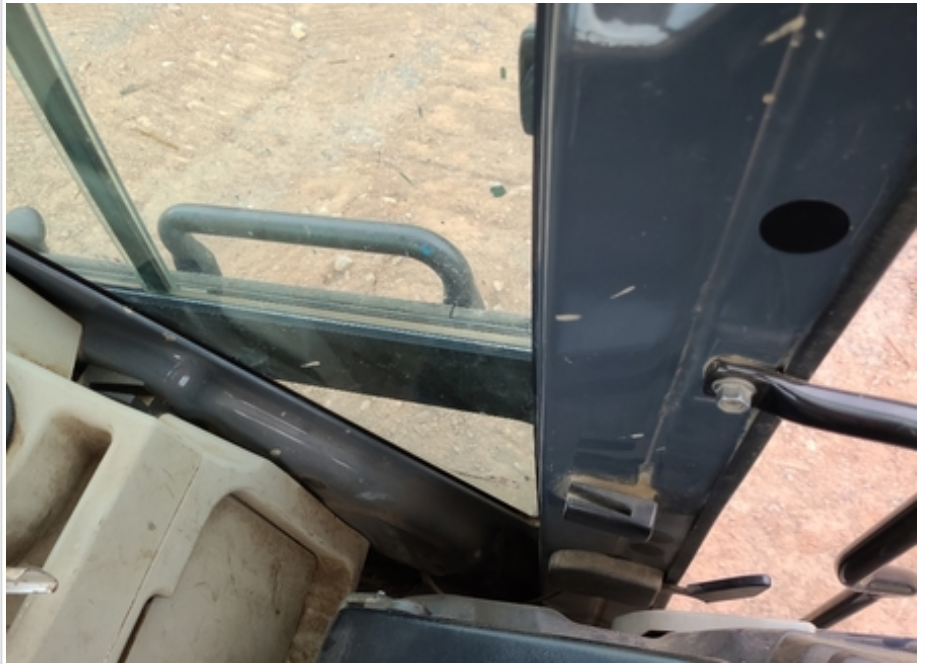
Control Station Rating	3 - Normal Wear & Tear
Control Station Overall Comments	Seat a bit torn, could use a detail. Structurally in good shape.

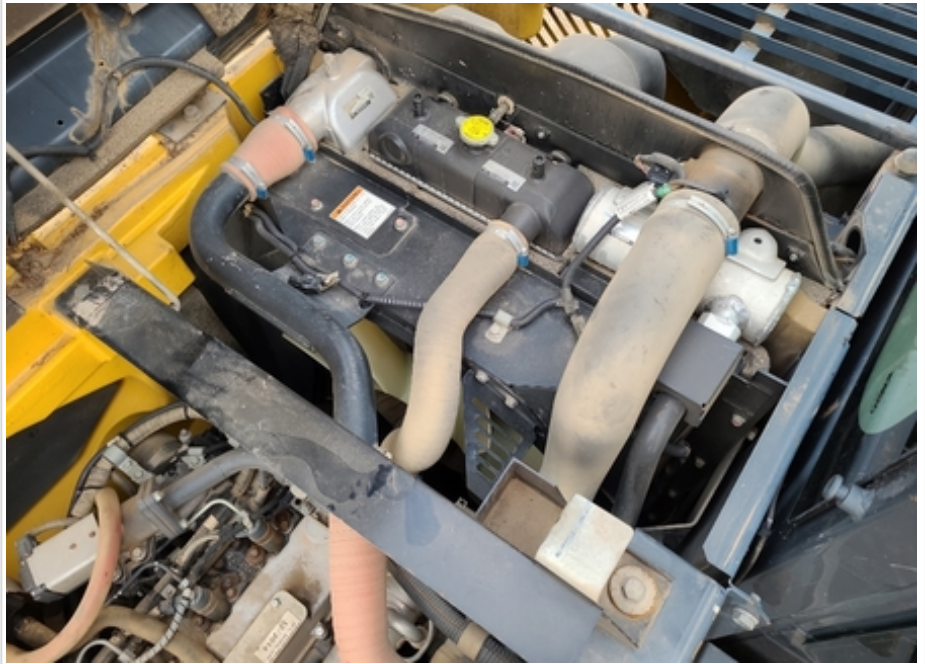
Engine Compartment

Engine Rating	3 - Normal Wear & Tear
Engine Overall Comments	Engine has well maintained healthy appearance.

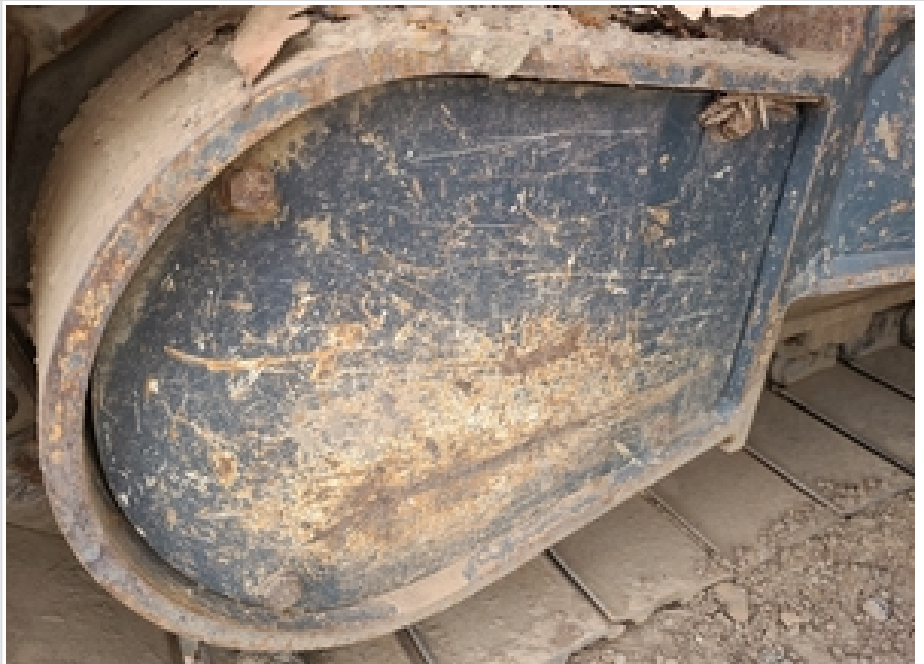
Drivetrain Photos	 
-------------------	--

Drivetrain operating well and final drives look to have been recently serviced.

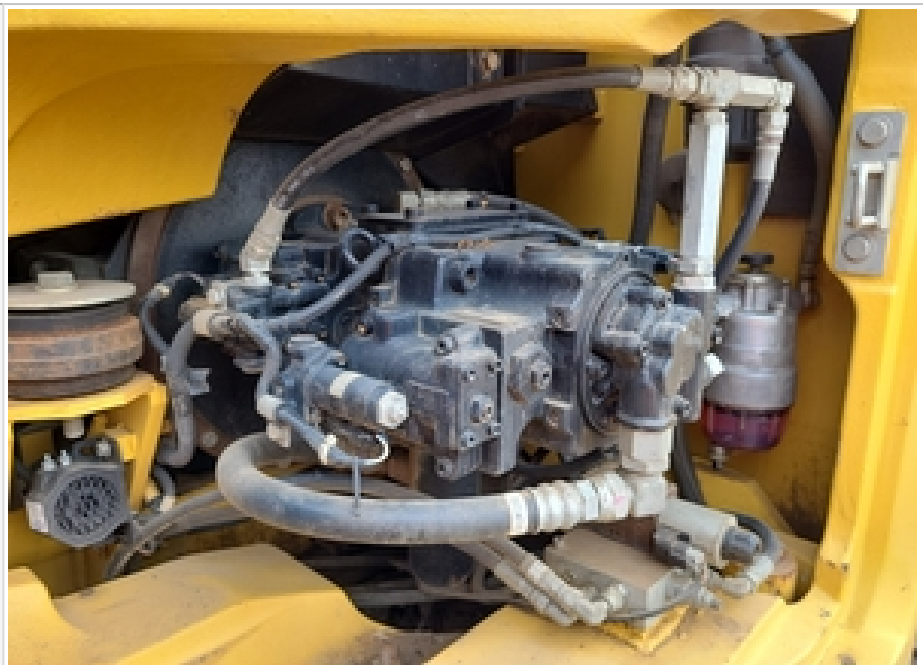
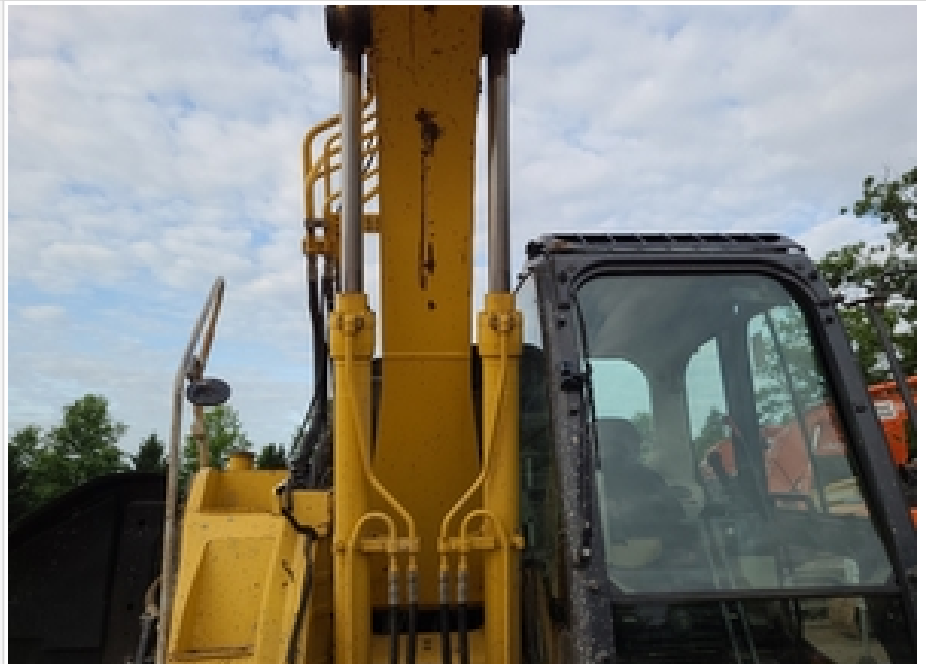
Hydraulic Pump/Fittings/Hoses

Hydraulic System Rating	3 - Normal Wear & Tear
Hydraulic System Comments	No active leaks observed and system running well.

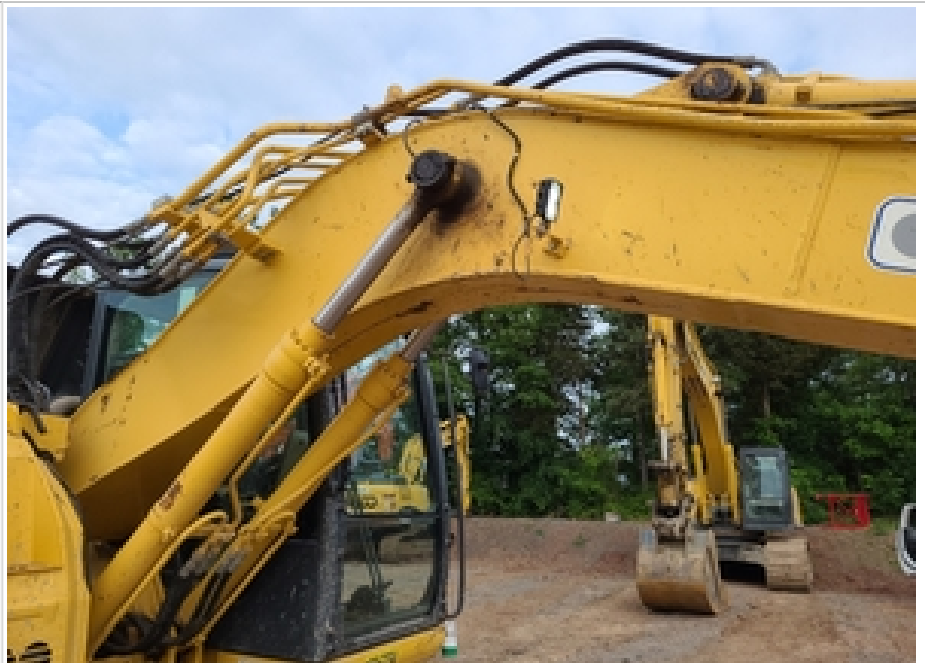
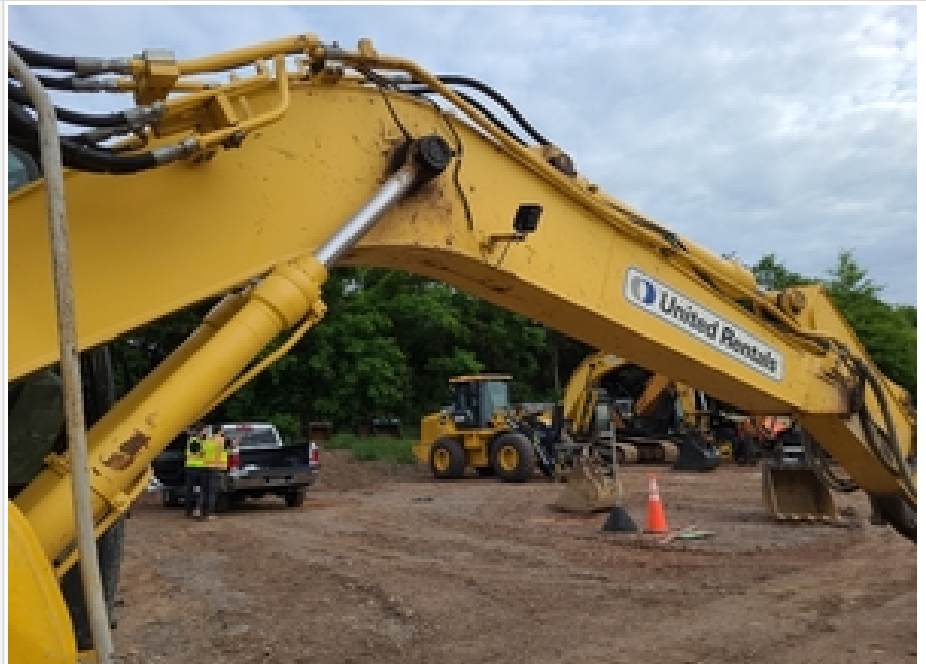
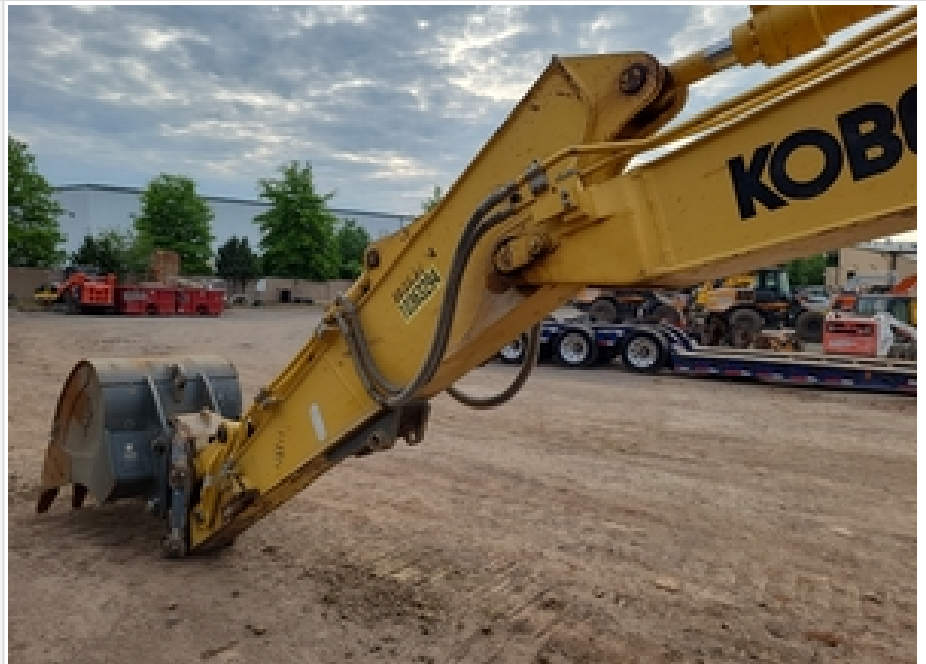
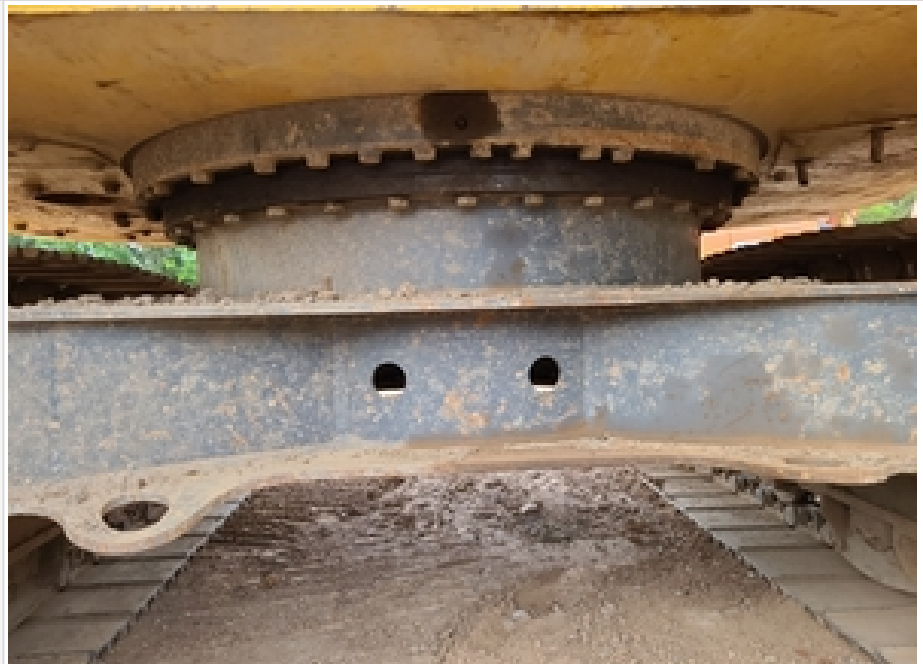
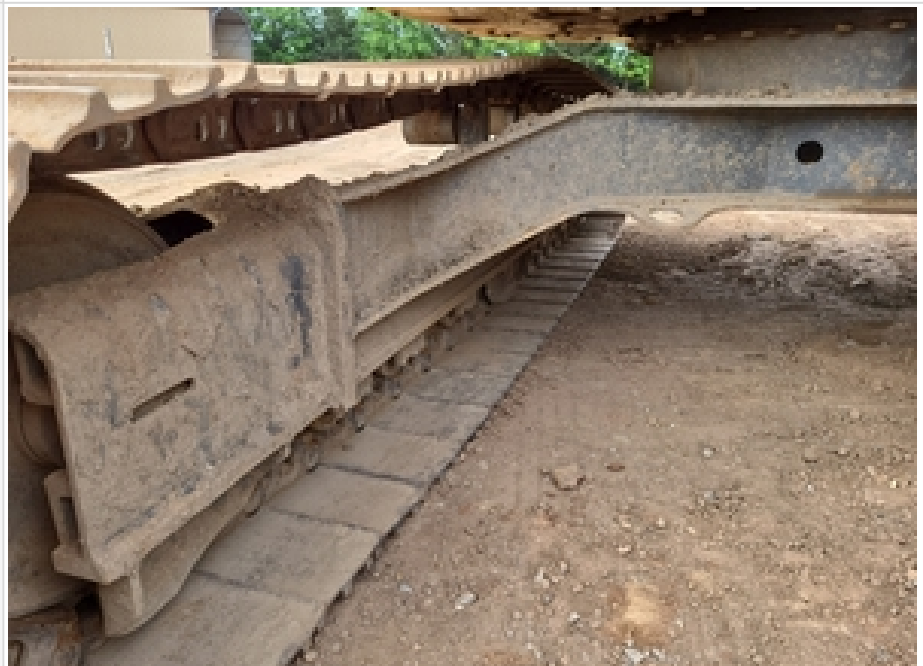
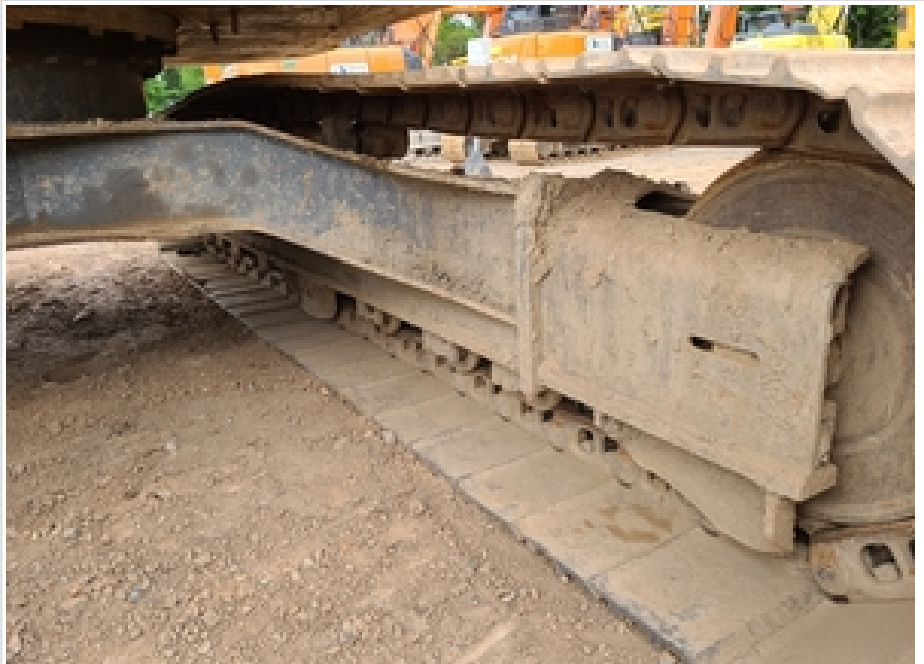
Chassis Photos

Chassis Rating	3 - Normal Wear & Tear
Comments	Boom, Stick, and main frame in solid shape with no excessive playseen in implements.

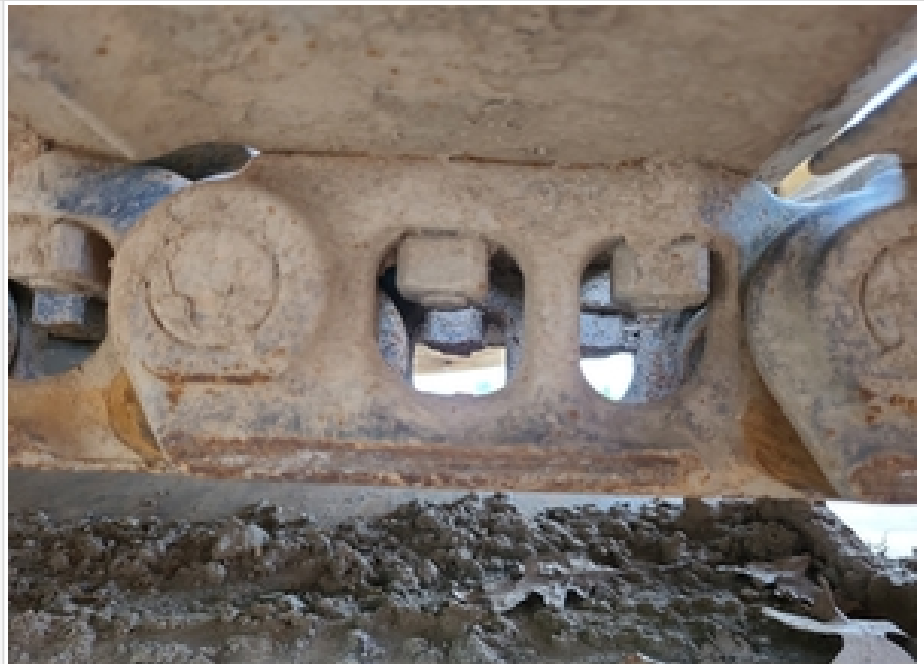
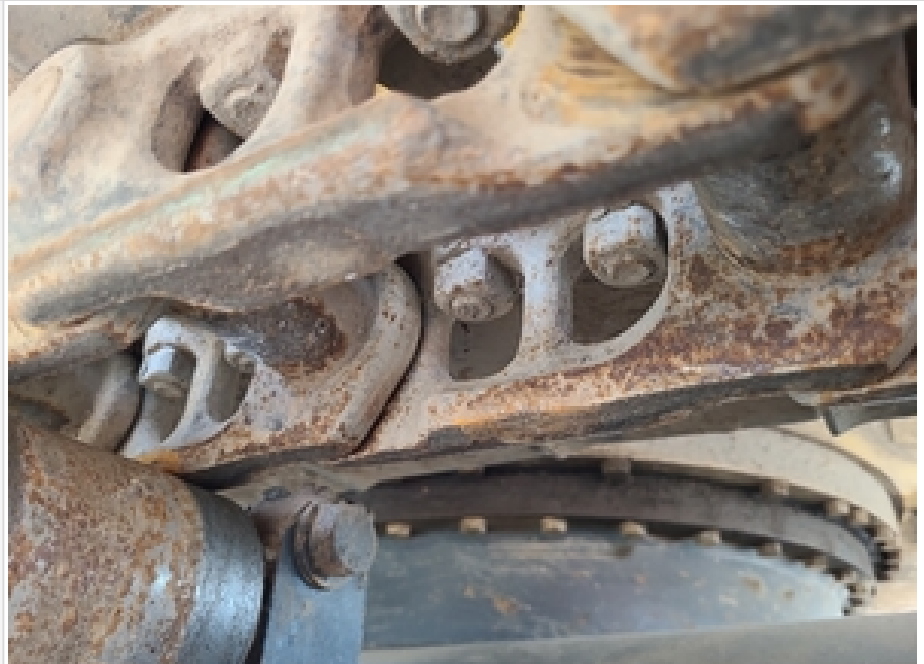
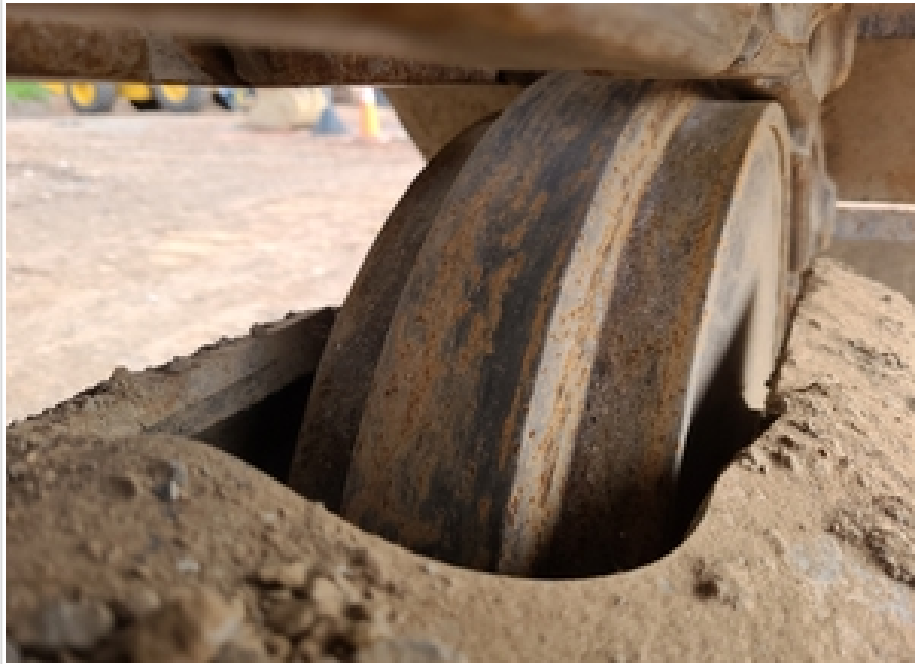
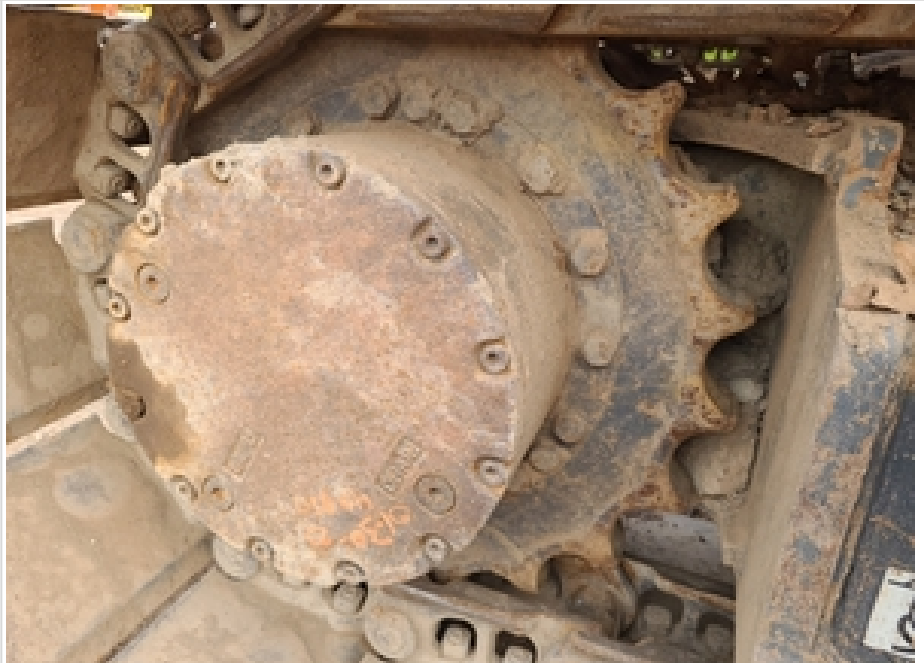
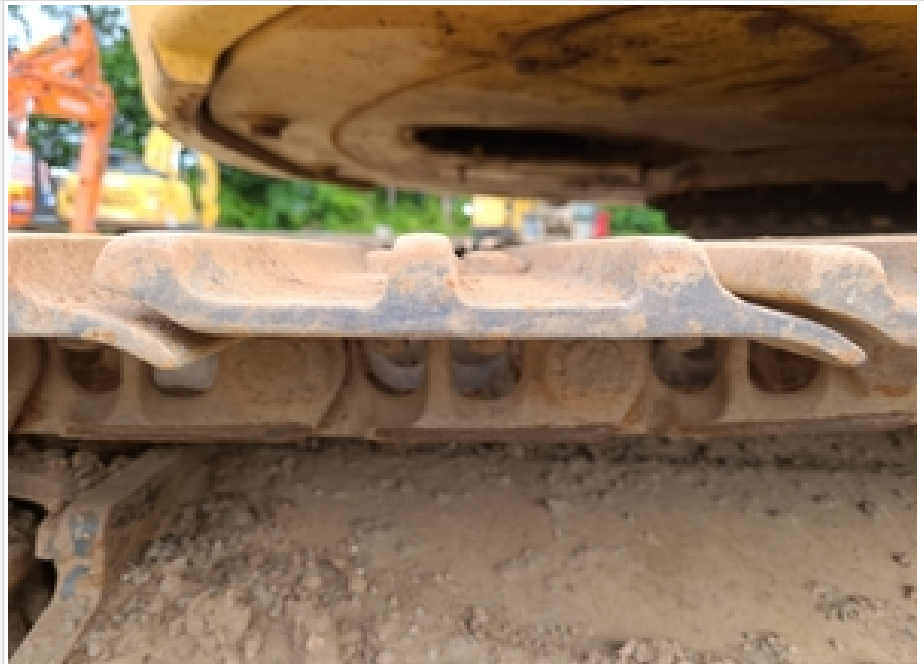
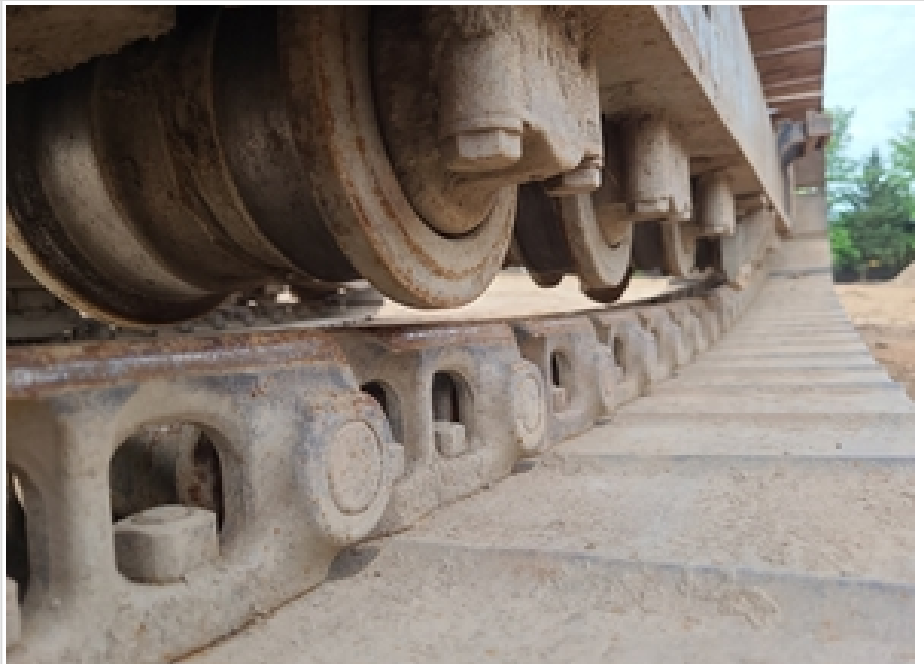
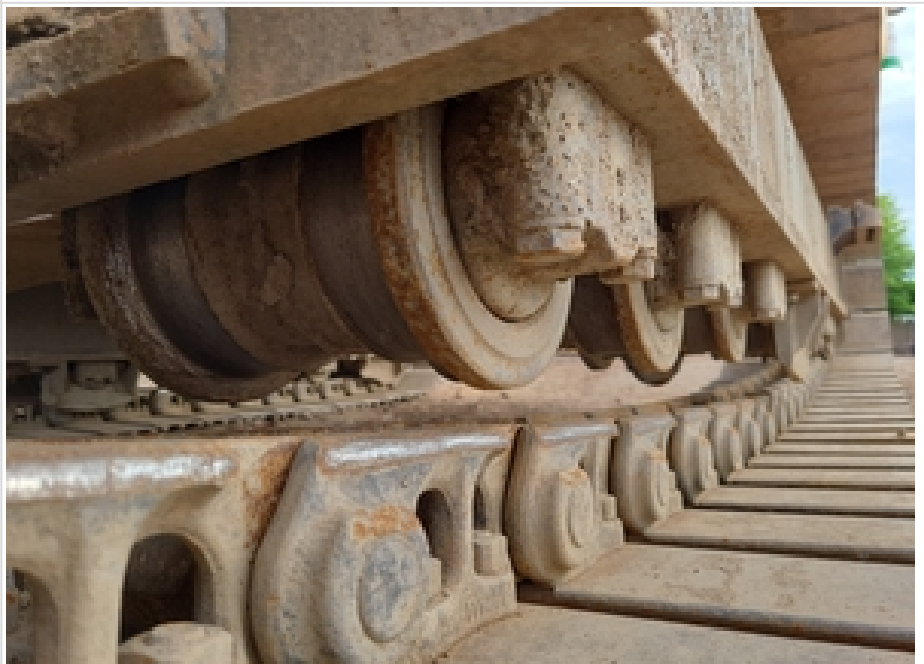
Undercarriage Photos

Undercarriage Rating	3 - Normal Wear & Tear
Undercarriage Comments	Undercarriage in great condition and both sides have plenty of life left.

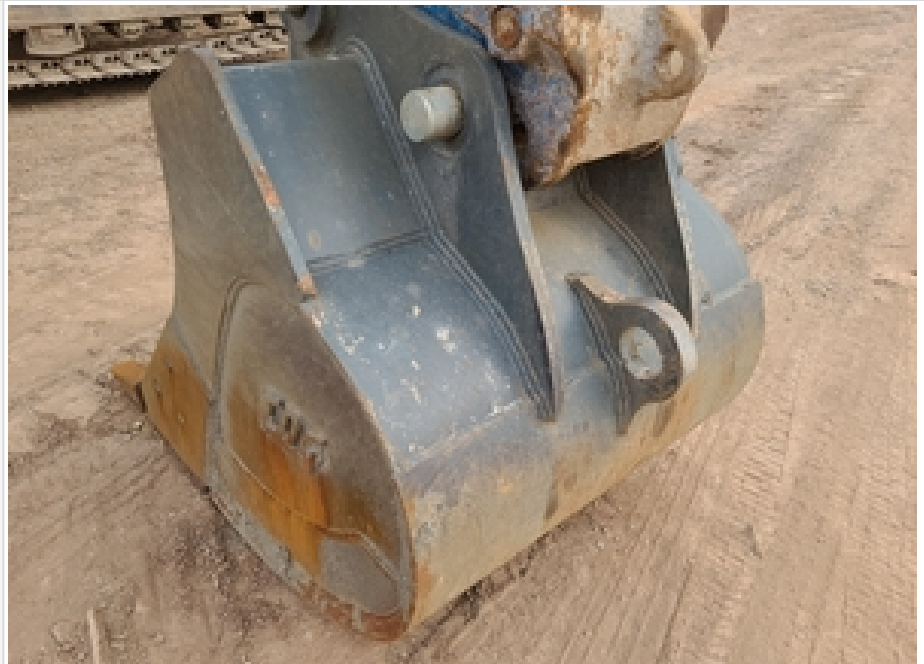
Attachment Photos	 
-------------------	--

Attachment Rating	4 - Very Light or Minimal Wear
Attachment Comments	36" bucket and quick coupler in great shape.
