General Info

Conordi IIIIC	
Category	Skid Steer
Travel System	Track Undercarriage
Comments	
Year	2017
Make	Bobcat
Model	T450
Serial Number	AUVP13481
Serial Number Plate	Bobcat. COMPACT SKID STEER TRACK LOADER MODEL *AUVP13481* PRODUCT IDENTIFICATION NUMBER MADE N CZECH REPUBLC Bobcat Company West Fargo, ND 58078 USA www.bobcat.com FOR A LIST OF UNITED STATES PATENTS THAT COVER THIS PRODUCT, GO TO:
Hour Meter Reading	1,448
-

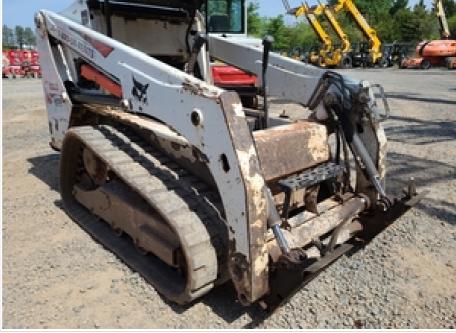
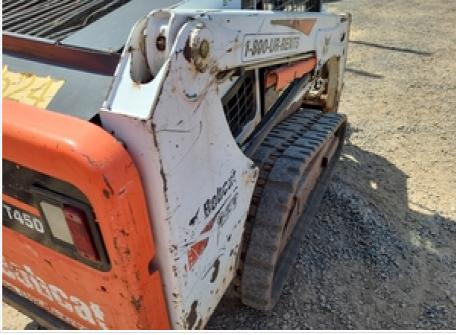
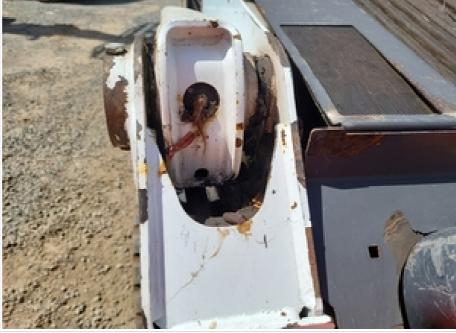
Chassis Photos

Chassis Rating	3 - Normal Wear & Tear	
Comments	Loaders arms, Tilt linkage and main frame in great shape.
