Inspection Report (Asphalt Paver)

Year	2022
Make	Dynapac
Model	Sd2550cs
Serial Number	10002161cng004212
Hour Meter Reading	40.2
Previous Application (e.g., earth moving, mining, demolition, etc)	Paving

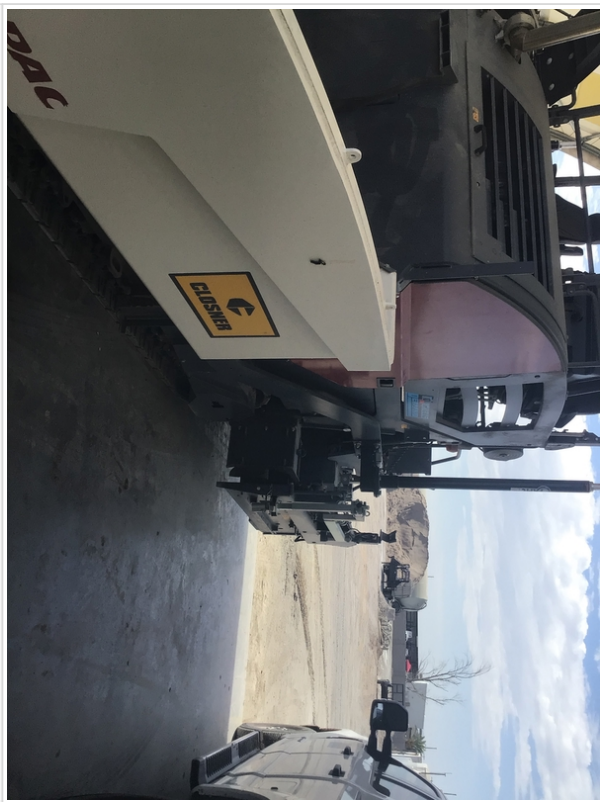
<p>Body Panels</p>	<p>3 - Normal Wear & Tear</p>
<p>Body Panel Condition</p>	<p>Visible chipped paint or dents</p>
<p>Body Panels Photos</p>

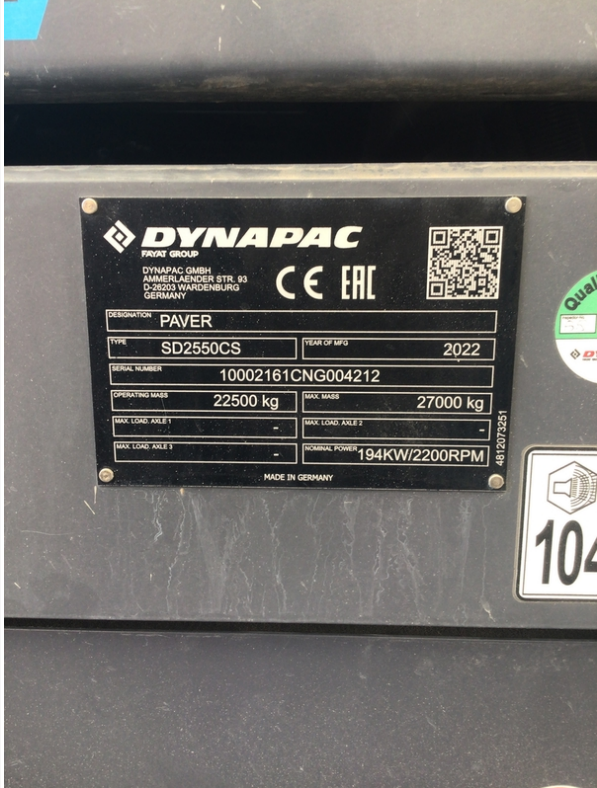
Control Station	Take close-up photos of operator control station or cab including the floors, panels, headliner, seat, controls & displays, gauges & meters, and interior lights. Note any damage or wear.
Serial Number Plate Photo

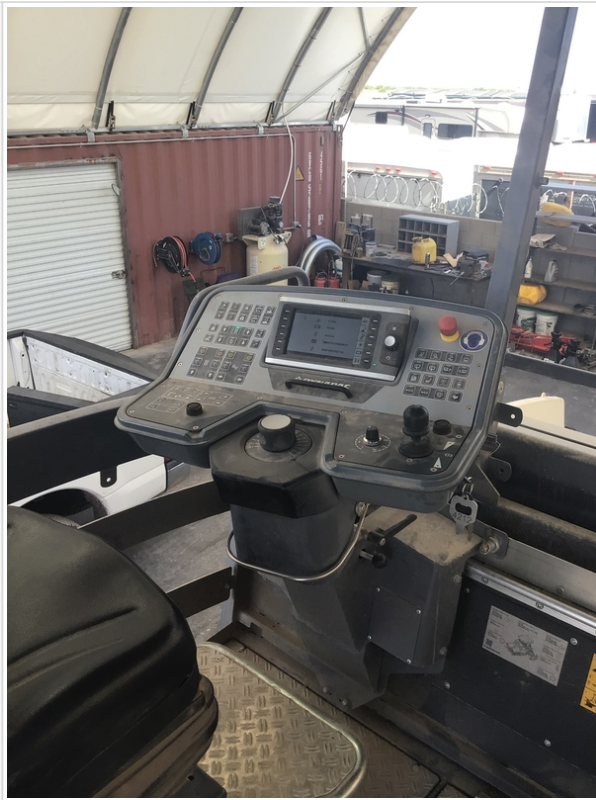
<p>Operator Cabin Photos</p>

<p>Operator Cabin Overall</p>	<p>4 - Like New, Recently Replaced</p>
<p>Operator Seat</p>	<p>4 - Like New, Recently Replaced</p>
<p>Operator Seat Photos</p>

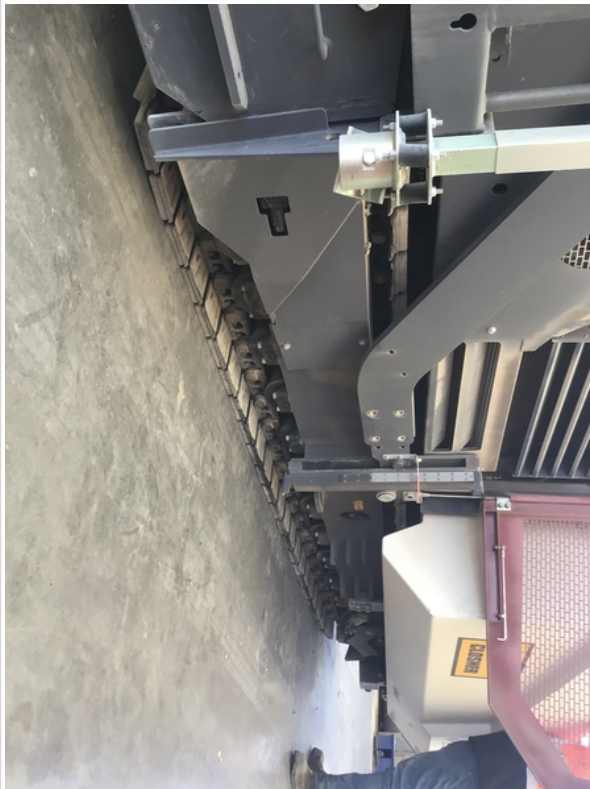
Undercarriage Photos

Track Width (inches)	1.05 feet
Roller Frames	4 - Like New, Recently Replaced
Roller Frames Photos
