General Info

Features & Configuration

360 Walkaround Photos

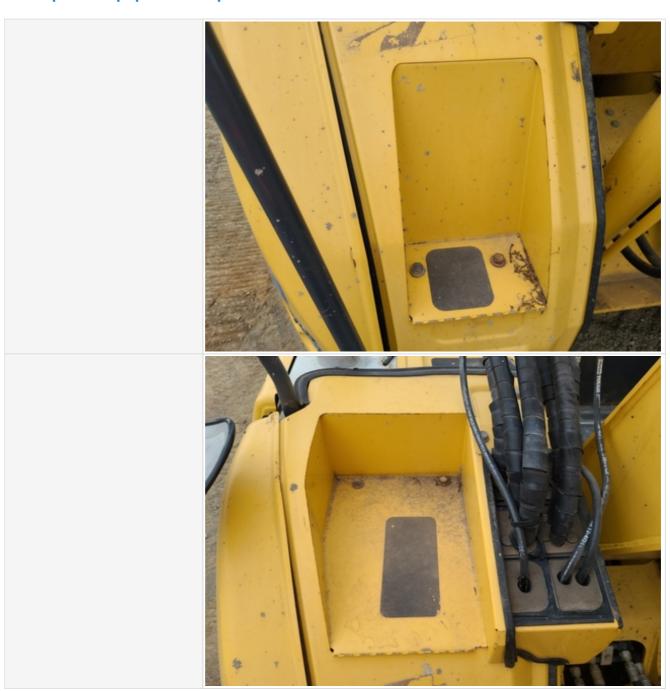
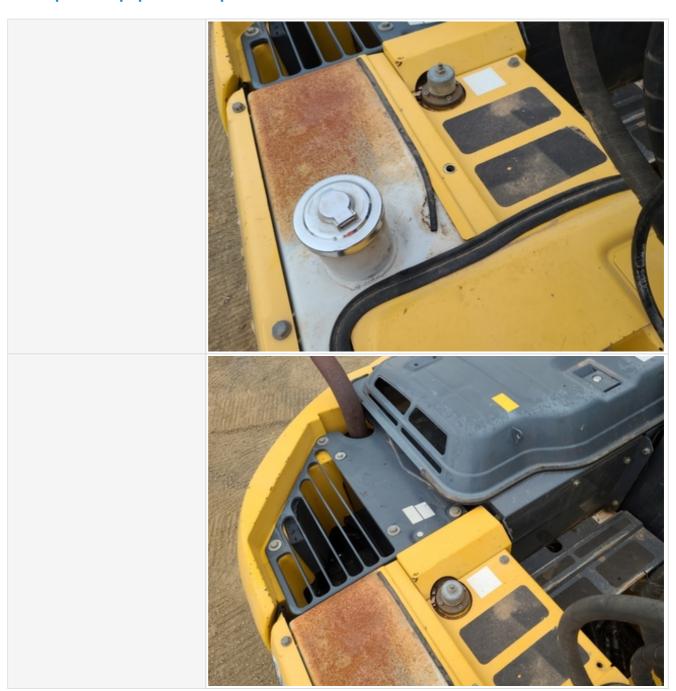
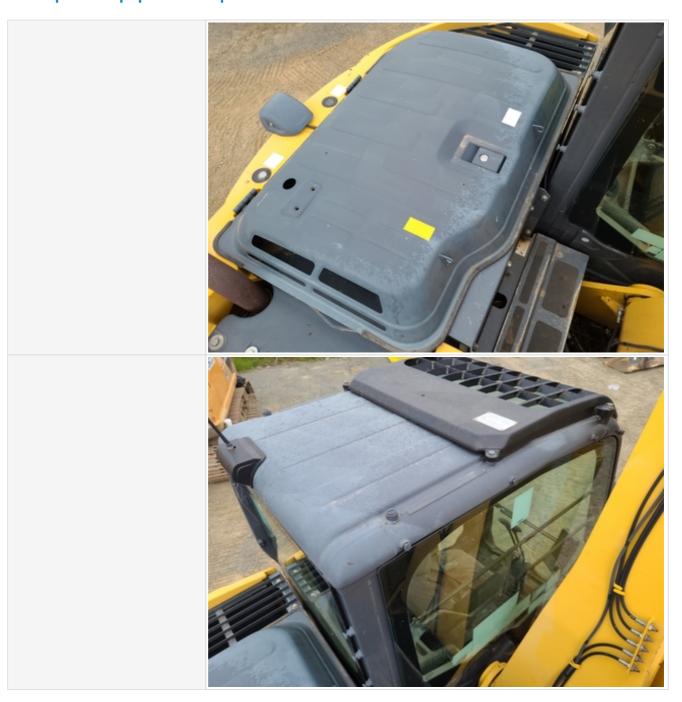
Impact Damaged

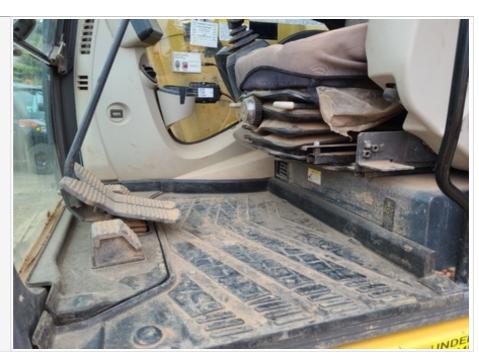
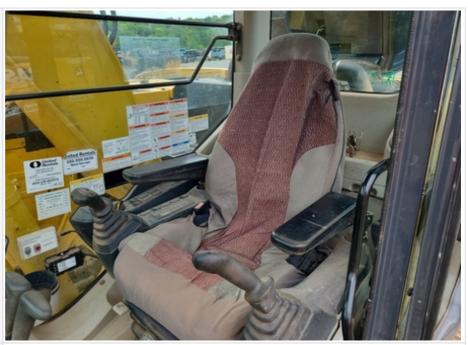
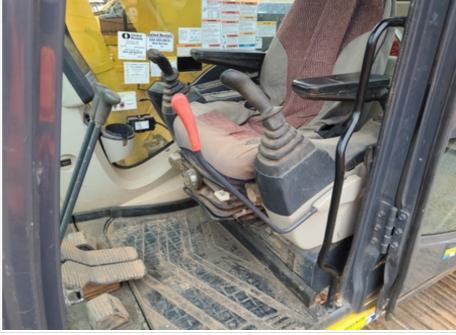
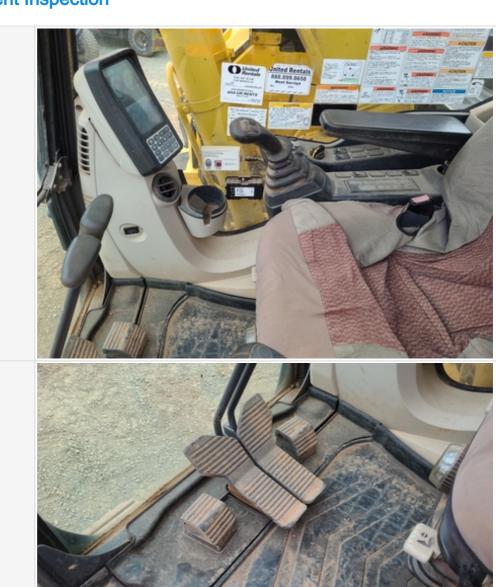
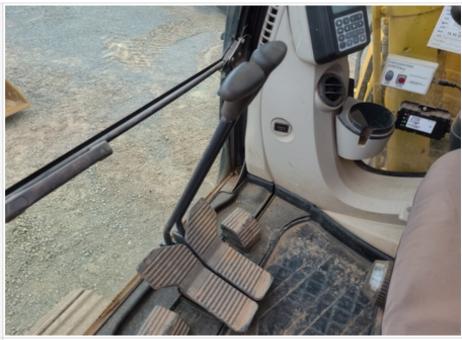
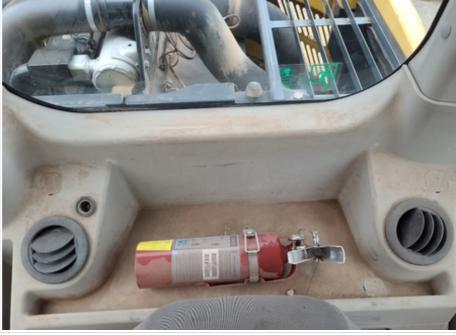
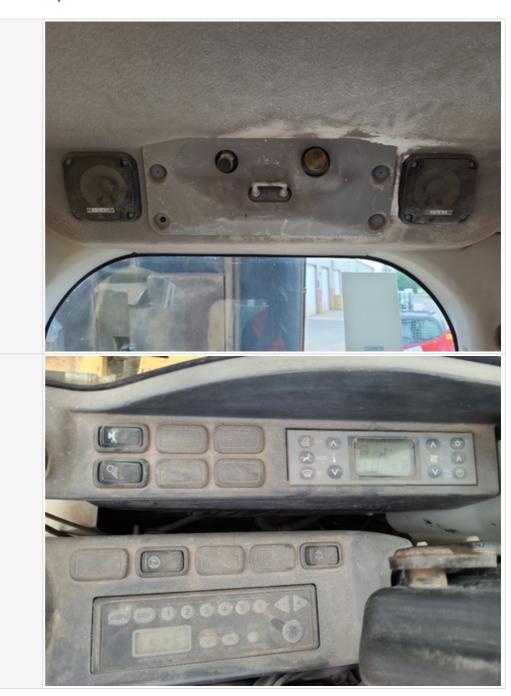
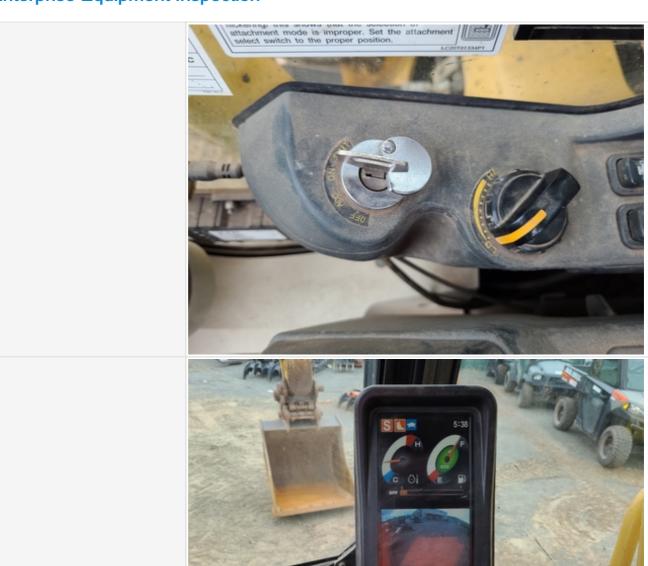
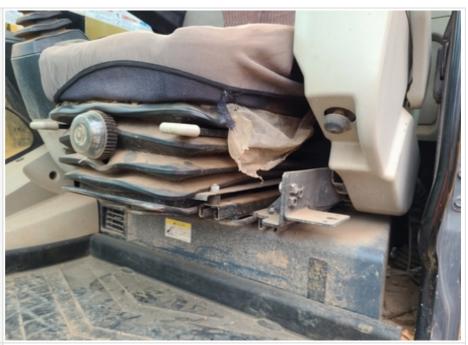
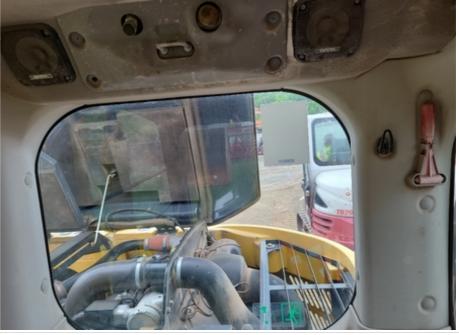
Control Station Rating	3 - Normal Wear & Tear
Control Station Overall Comments	Operator Station in good condition. Operator seat has cover and did not remove.

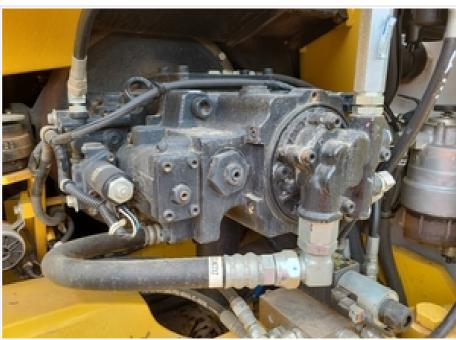
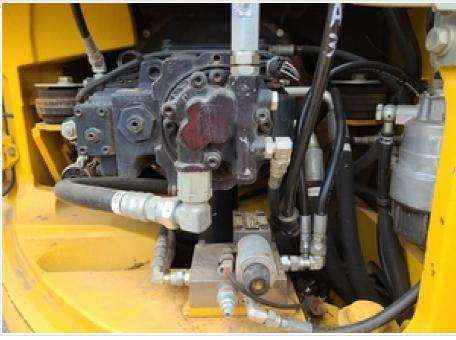
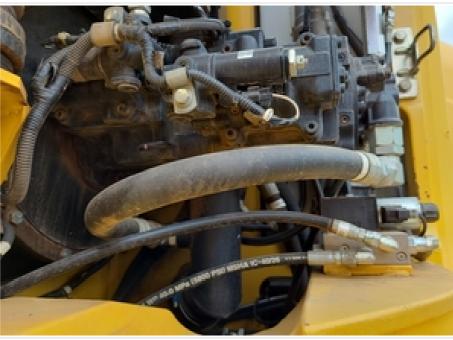
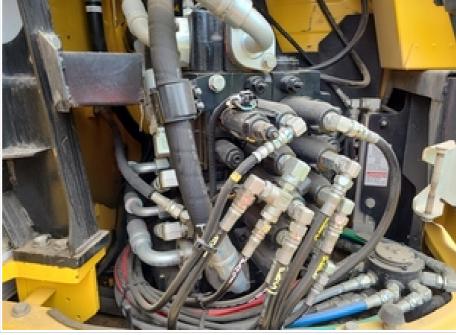
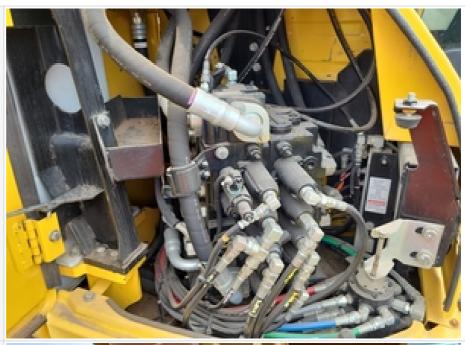
Hydraulic Pump/Fittings/Hoses

Hydraulic System in good working condition.

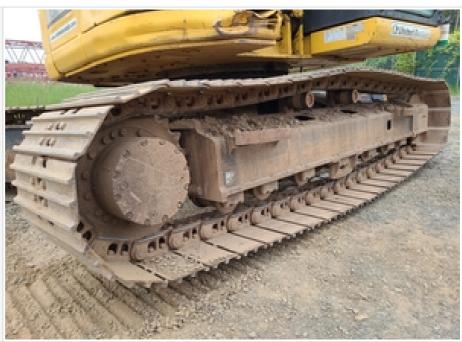
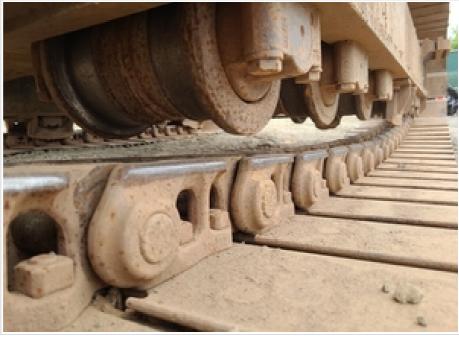
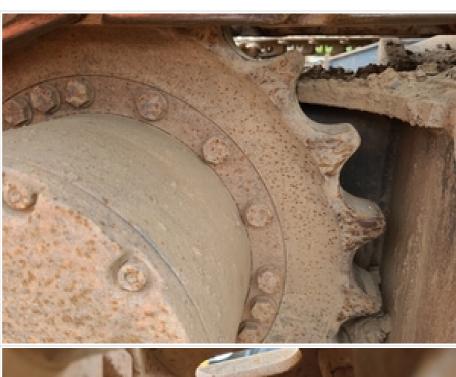
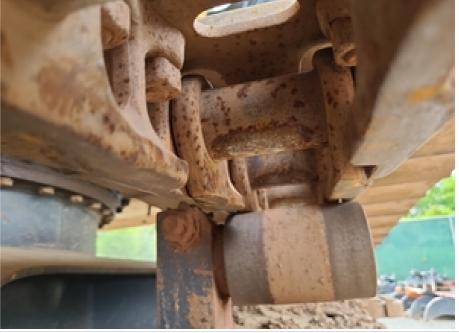
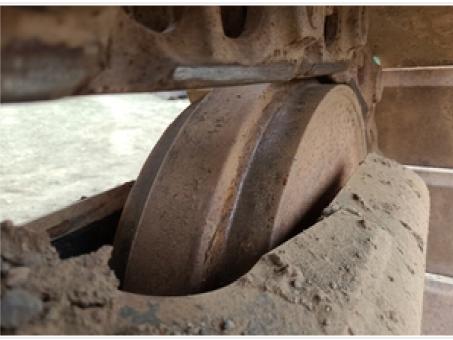
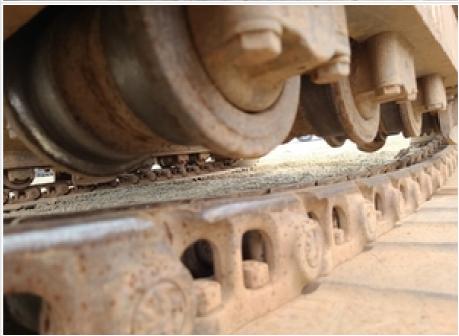
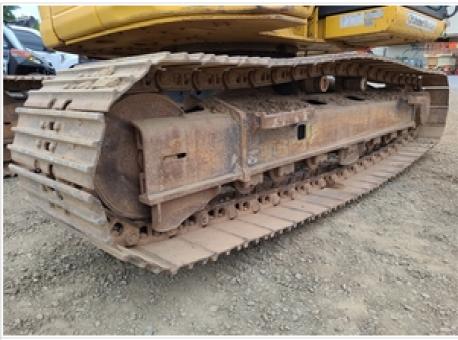
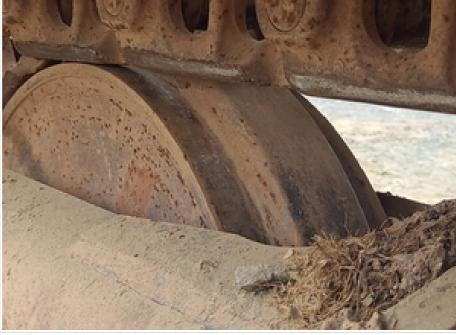
Undercarriage Photos

Undercarriage Rating	3 - Normal Wear & Tear	
Undercarriage Comments	Undercarriage in good shape and no obvious issues observed.

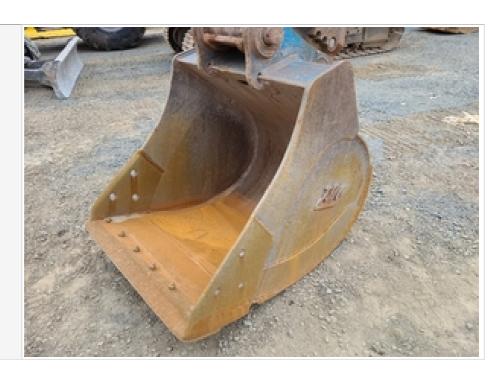
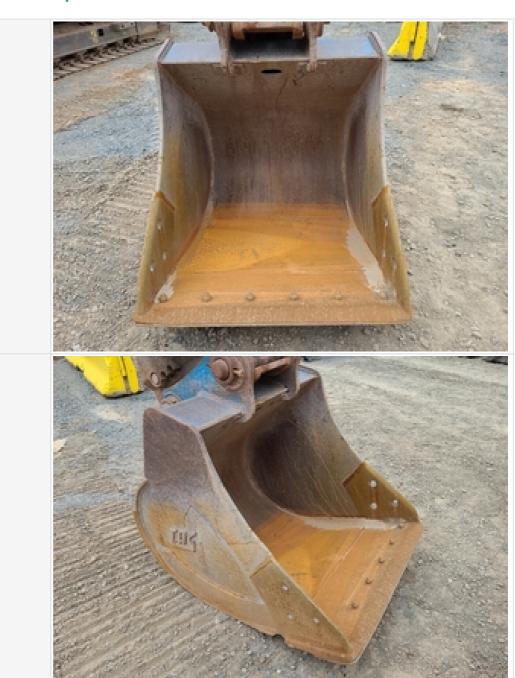
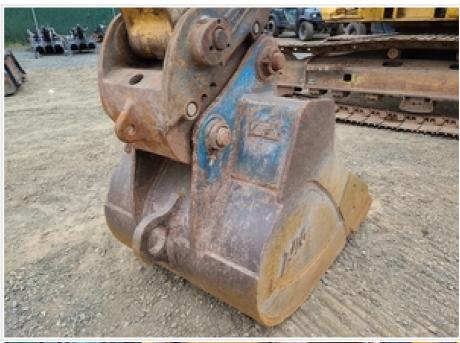
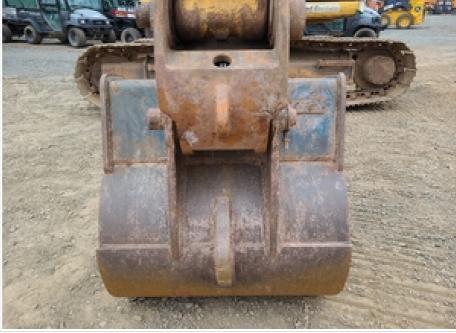
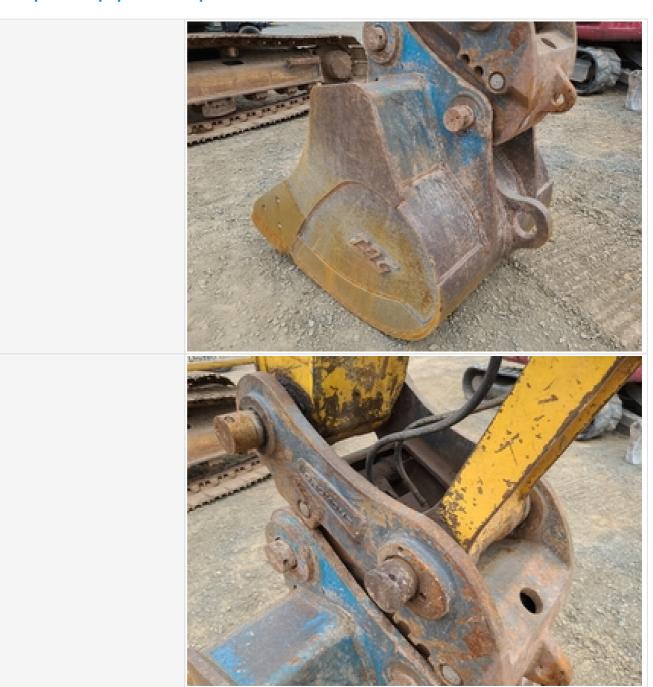
Attachment Photos

Attachment Rating	3 - Normal Wear & Tear
Attachment Comments	36"
