Enterprise Equipment Inspection

| Year | 2006 |
| Make | leeboy |
| Model | 8510T |

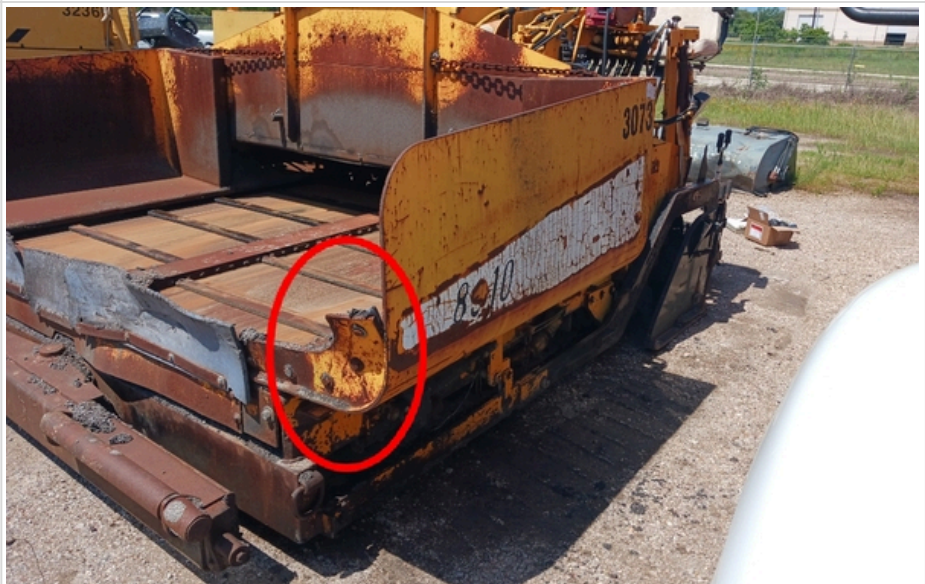
left hand side plate side wing has a bend

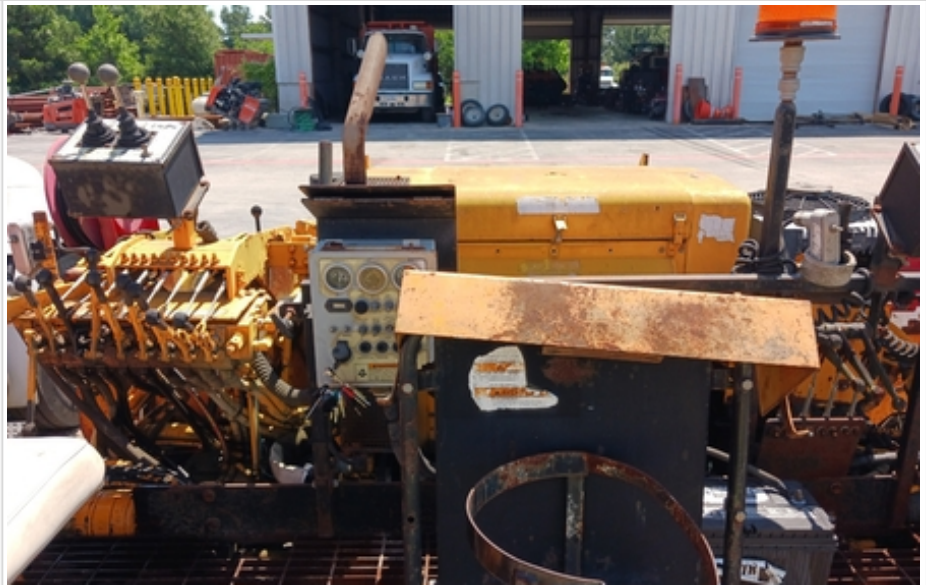
| <p>Exterior Rating</p> | <p>2 - Above Average Wear & Tear</p> |
| <p>Exterior Comments</p> | <p>There is rust and missing paint on most of the machine.</p> |

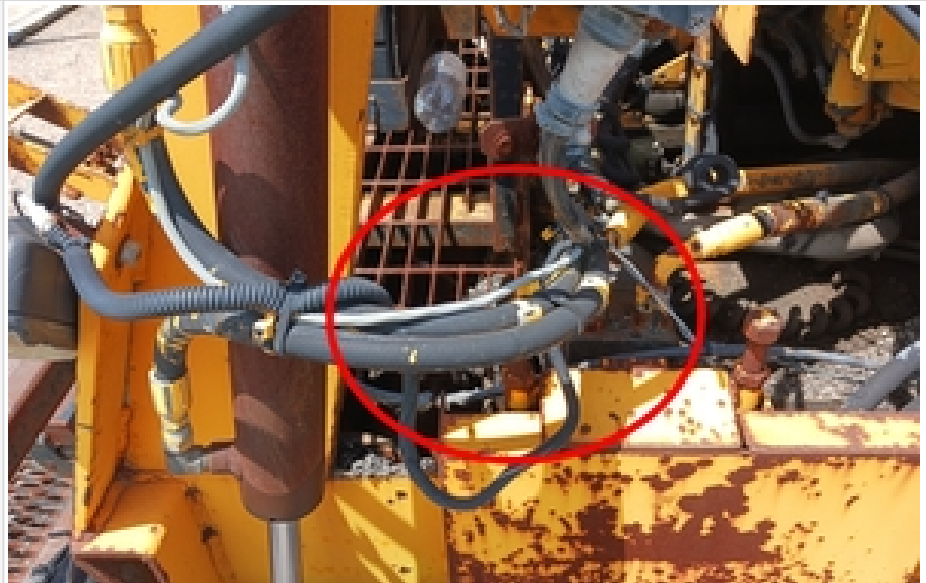
hoses have dried/discolored appearance

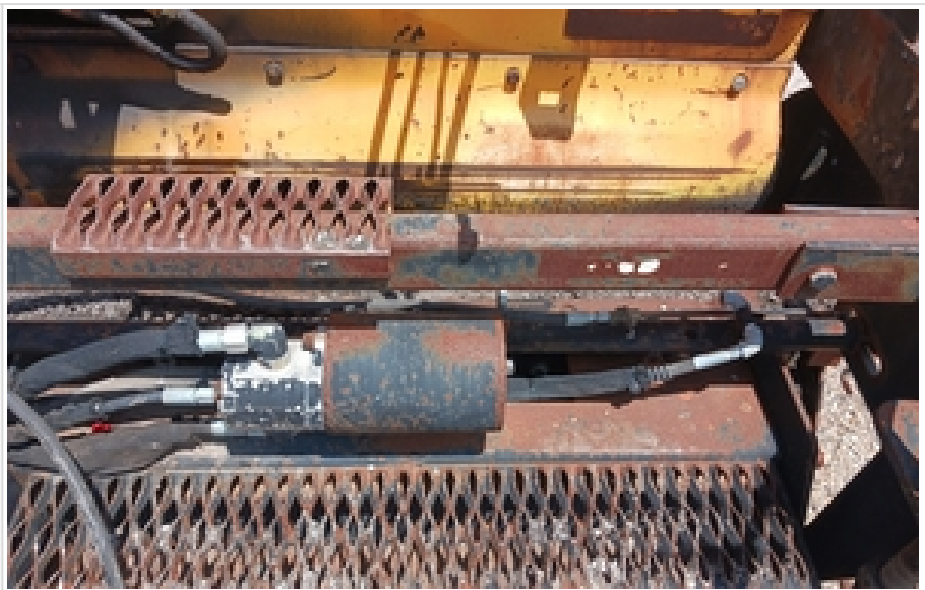
| Hydraulic System Rating | 2 - Above Average Wear & Tear |
| Hydraulic System Comments | Several hoses are dry/cracked and there are several leaks throughout the hydraulic lines |

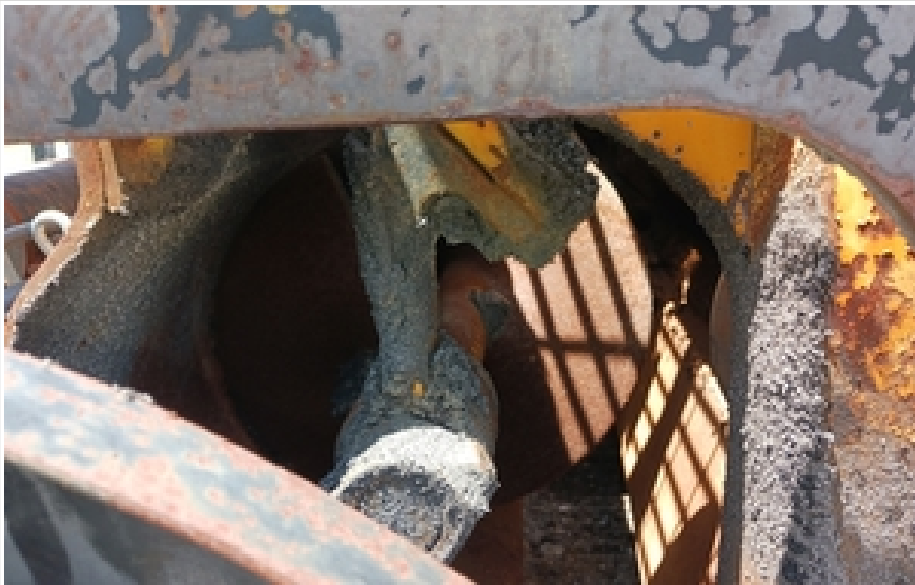
| Undercarriage Rating | 3 - Normal Wear & Tear |
| Undercarriage Comments | Undercarriage is in working condition but is covered in old asphalt. |
