Enterprise Equipment Inspection

Category	Excavator
Travel System	Track Undercarriage
Comments	
Year	2016
Make	Kobelco
Model	SK140SRLC-3
Fleet ID	10283192
Serial Number	YH07-10124
Serial Number Plate

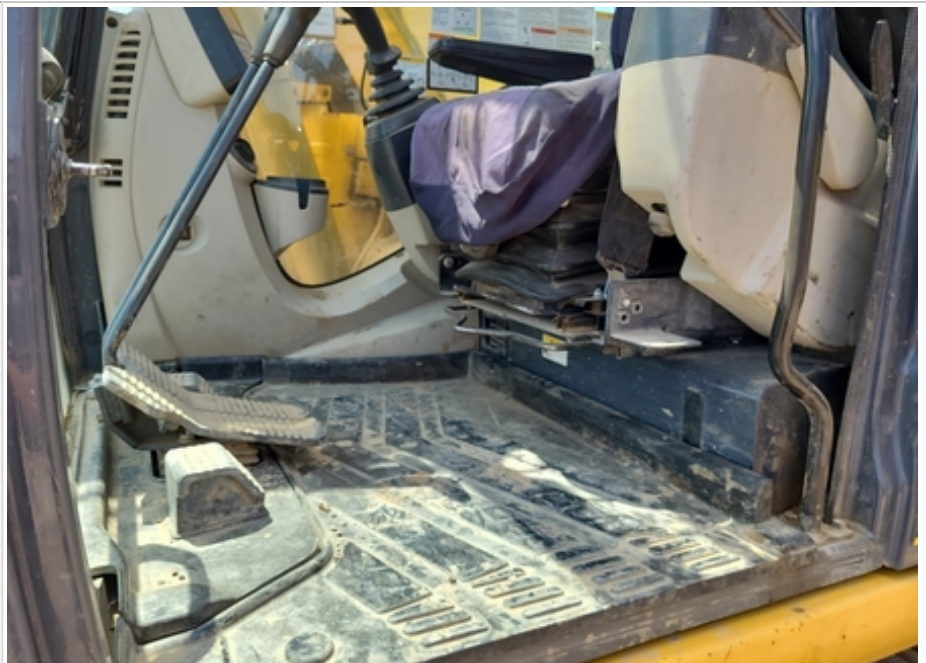
Control Station Rating	3 - Normal Wear & Tear
Control Station Overall Comments	Seat upholstery damaged

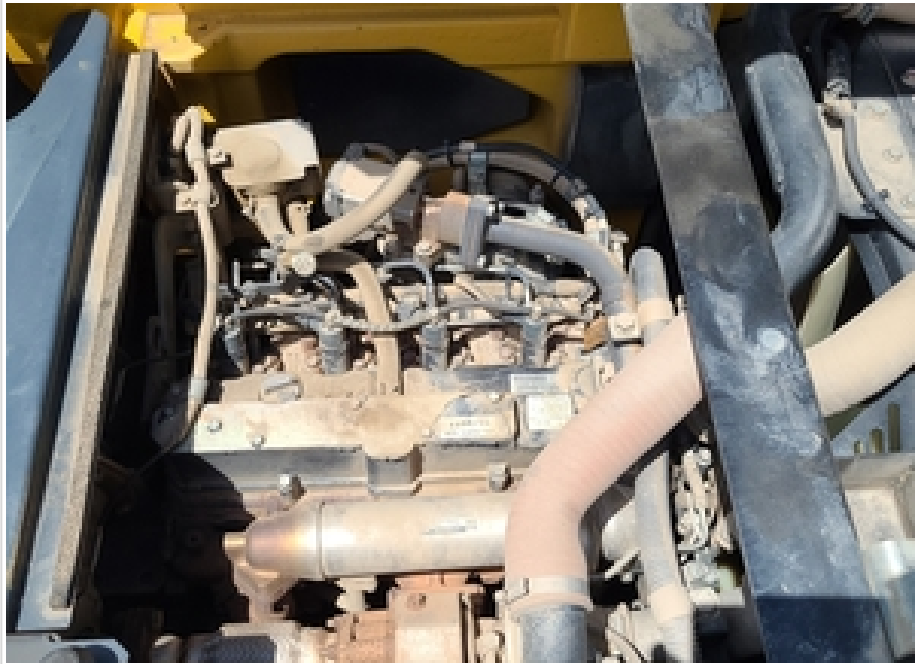
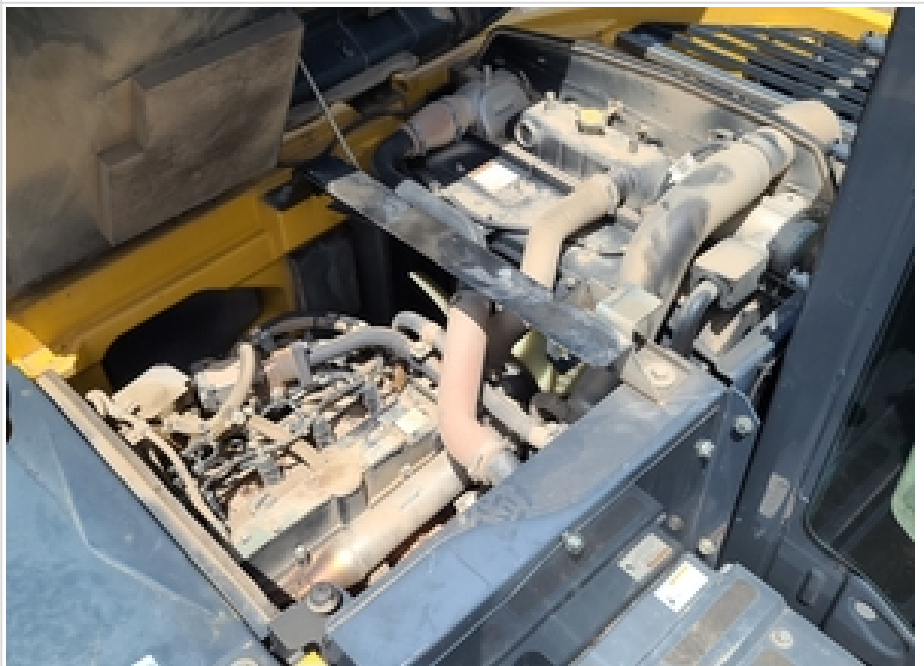
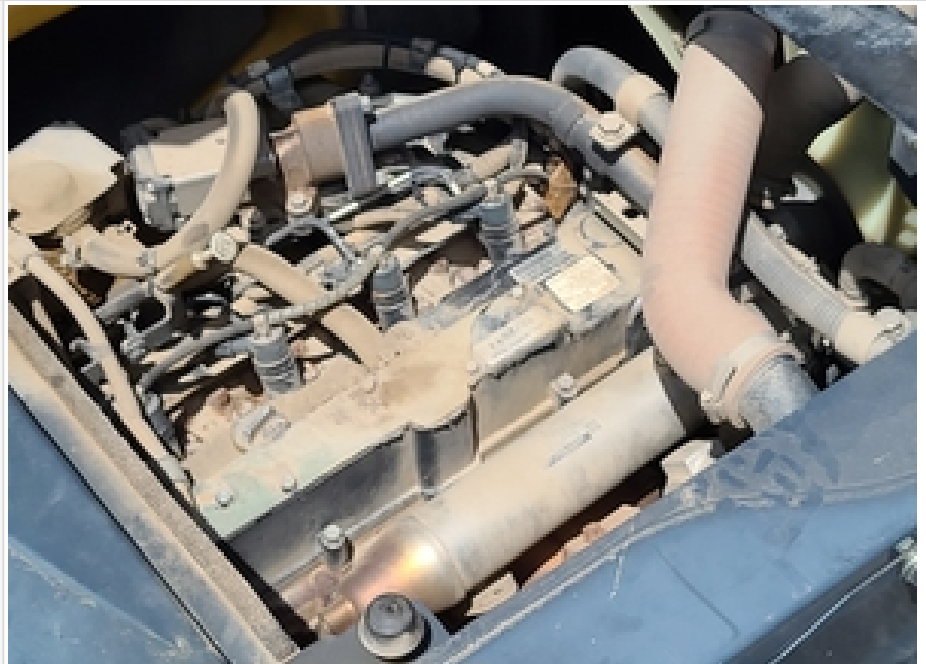
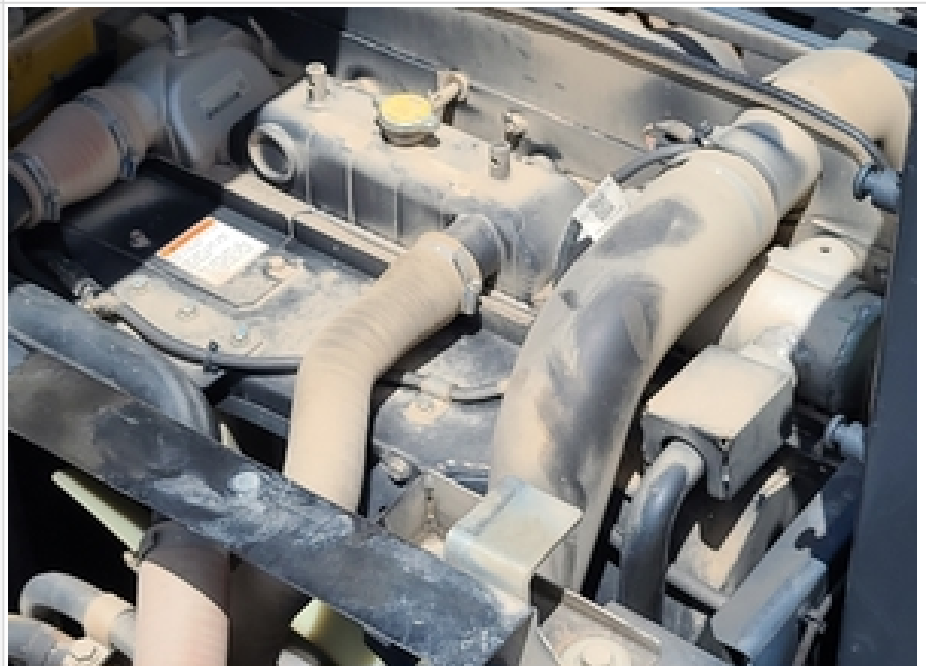
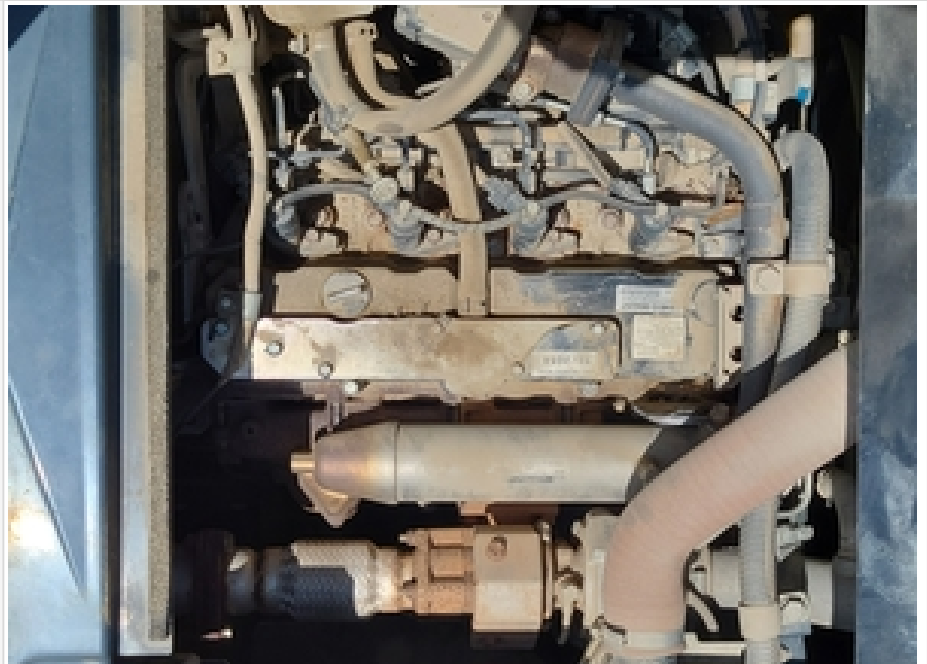
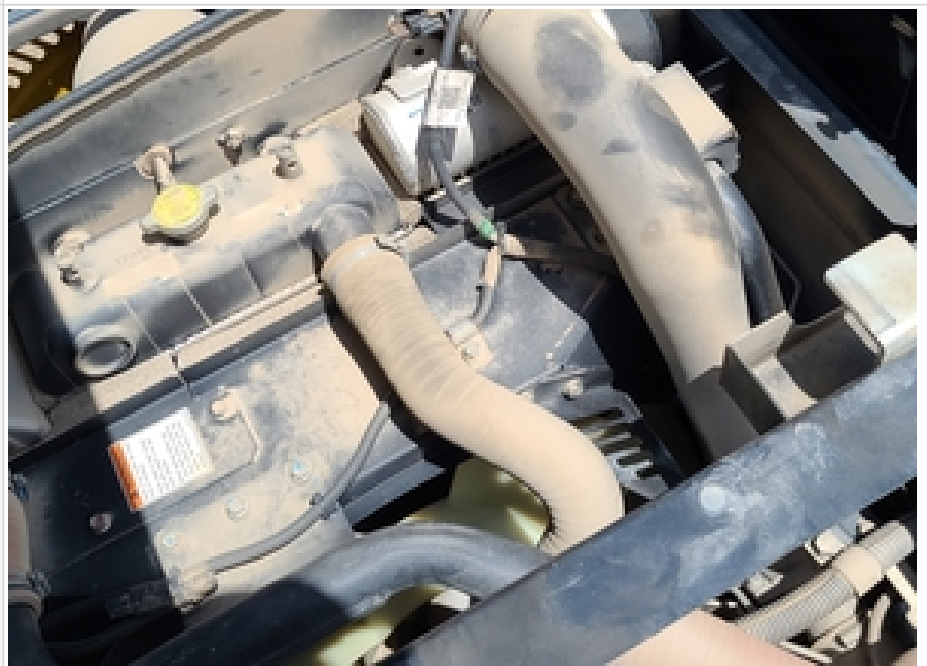
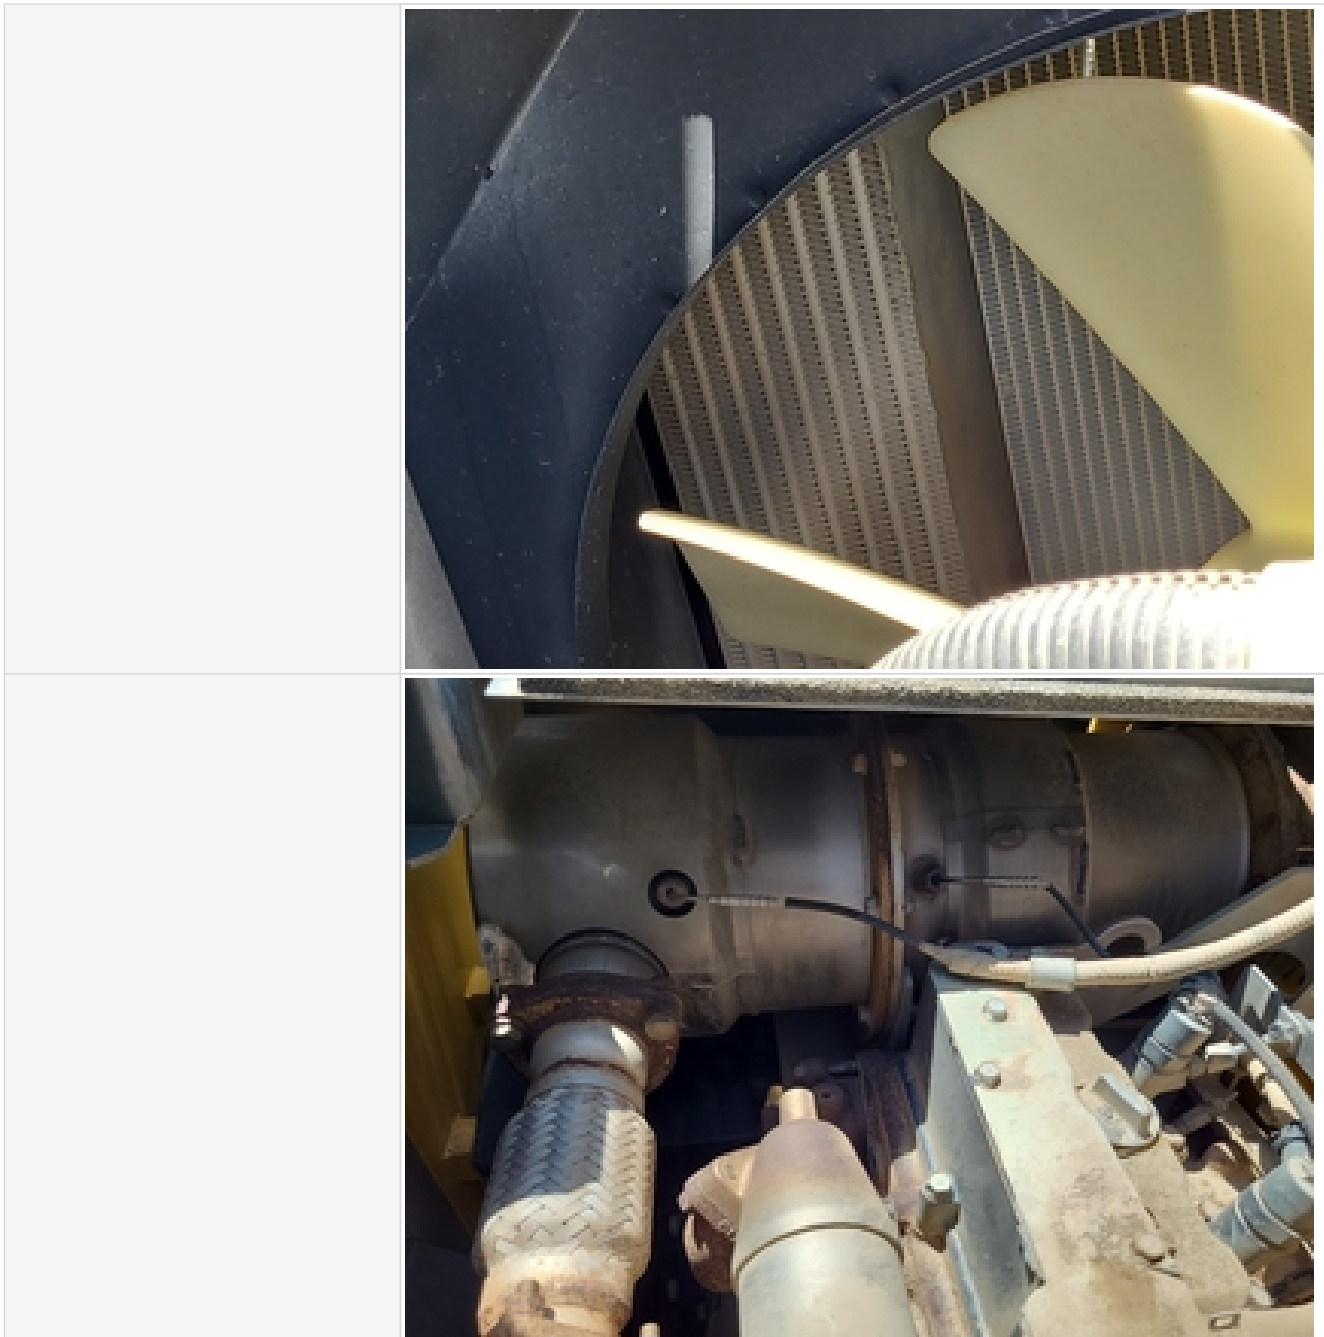
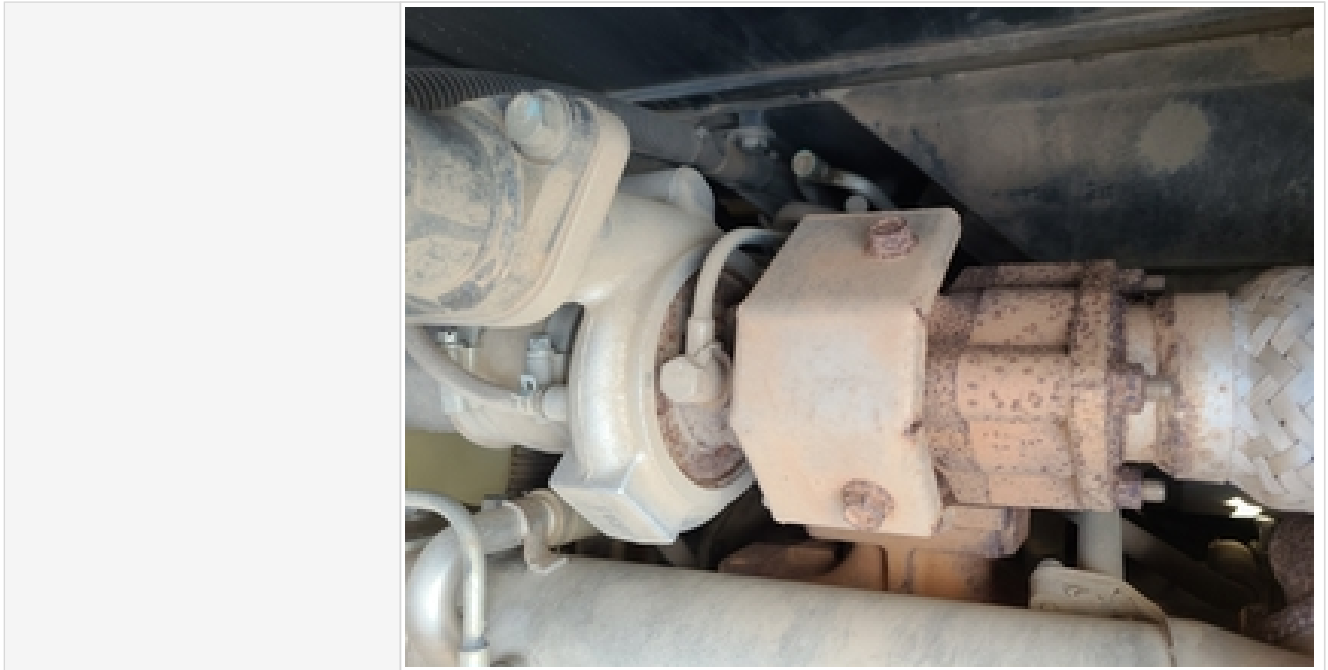
Engine Compartment

Engine Type (Make, Model, Cylinders, Hp)	Mitsubishi - 4Cyl. -
Emissions Tier	Tier 4i
Engine Rating	3 - Normal Wear & Tear
Engine Overall Comments	Engine overall in good condition with no active leaks seen from topside of engine.

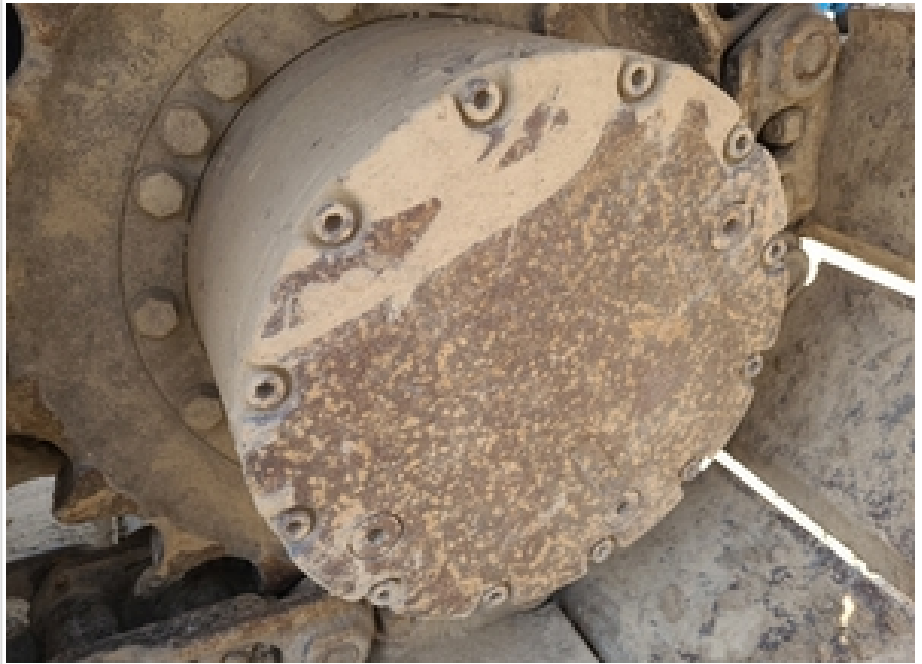
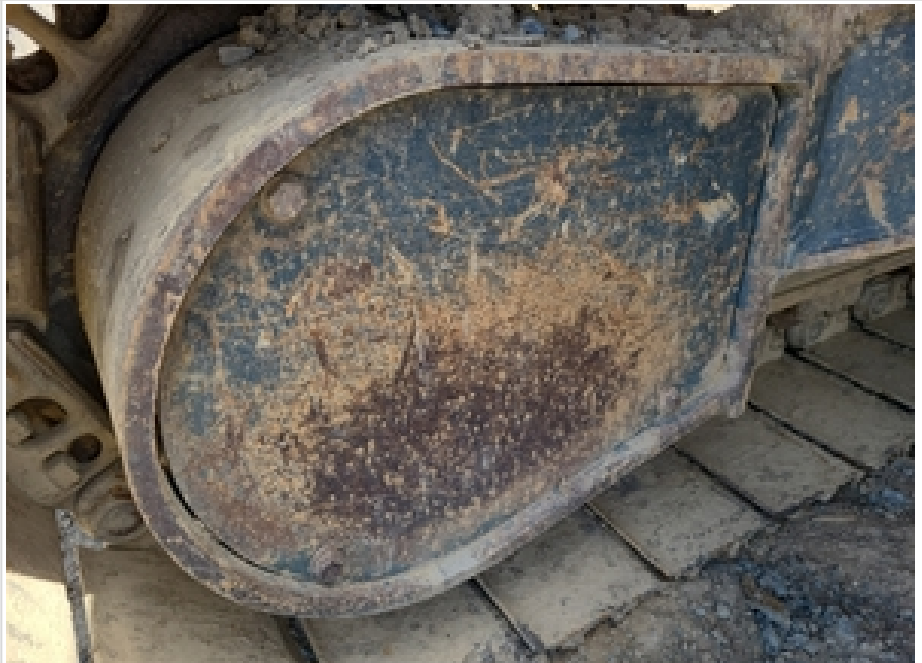
Drivetrain Photos

Hydrostatic Transmission?	Yes
2 Speed?	Yes
Hydrostatic Drive Configuration	Split Transmission
Comments	
Transmission Info (Make/Model/Speeds)	
Drivetrain Rating	3 - Normal Wear & Tear
Drivetrain Comments	Machine travels well in all directions.

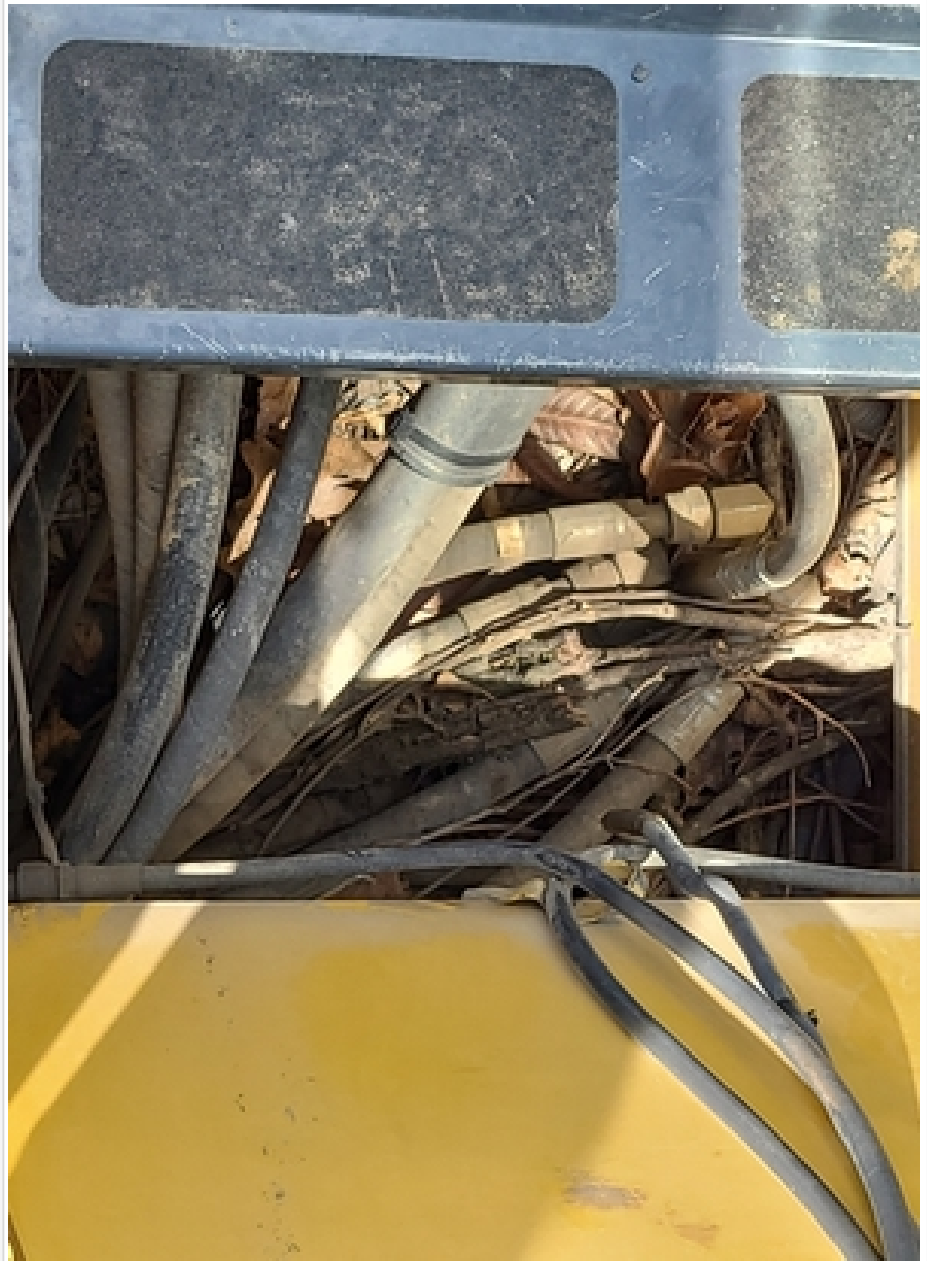
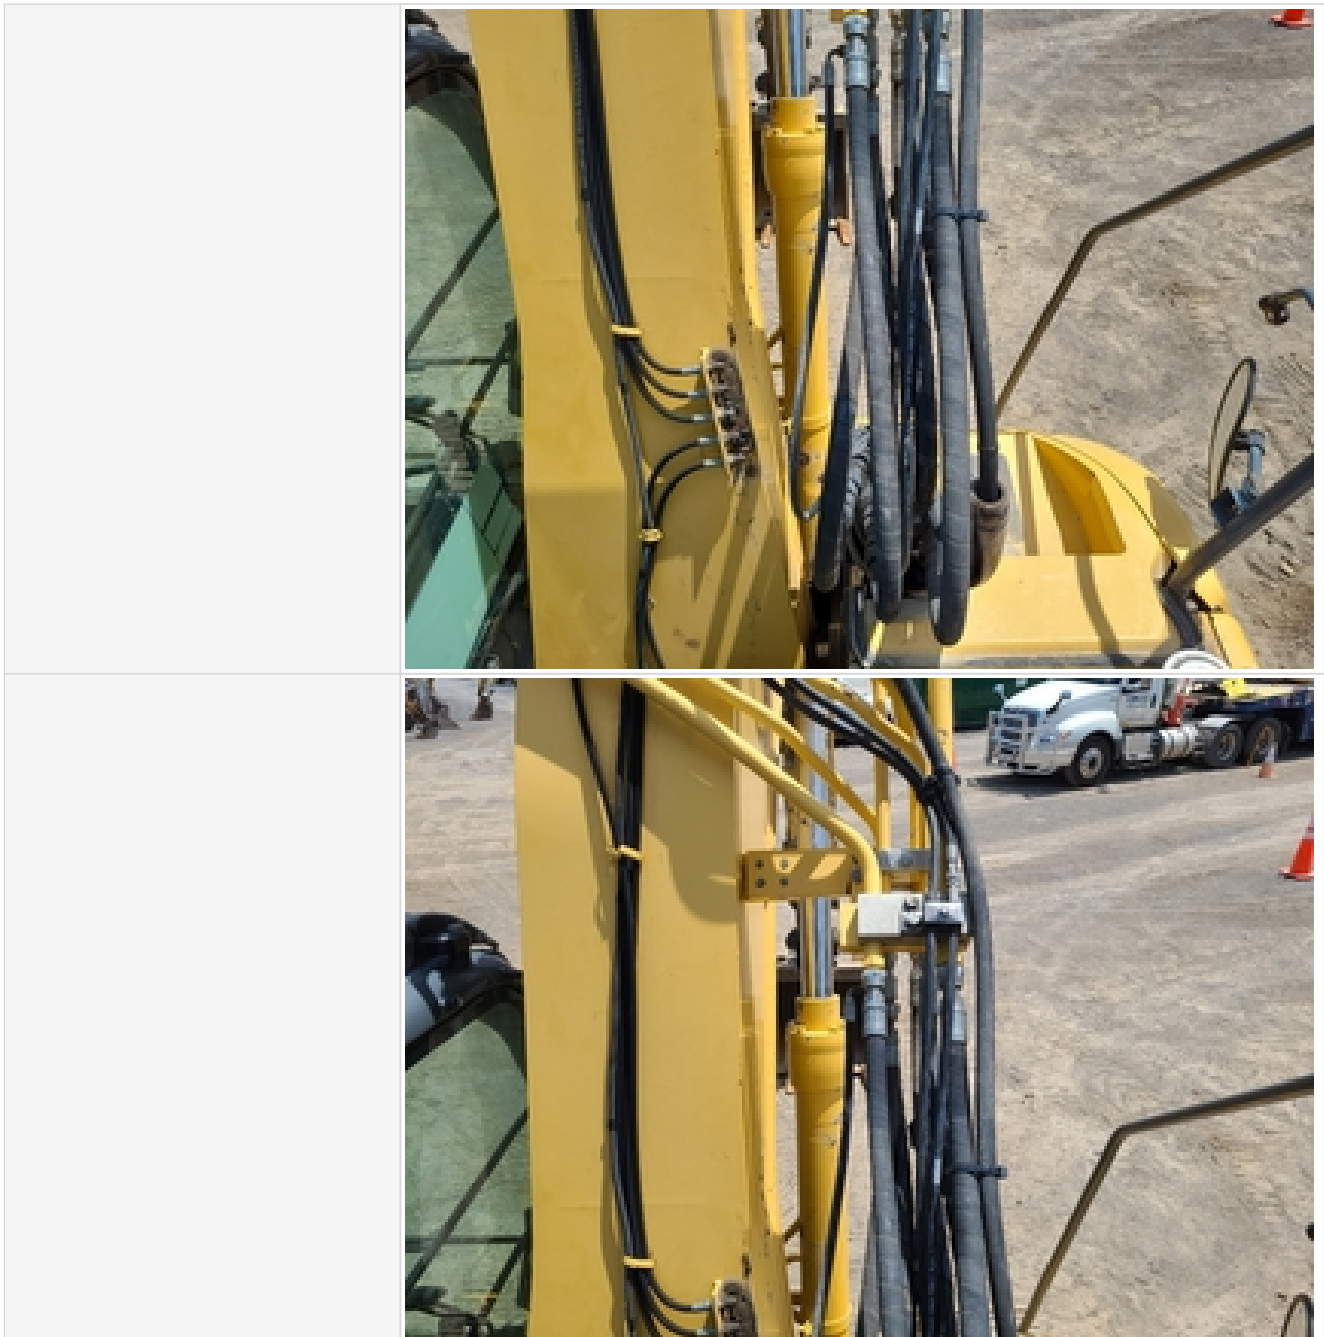
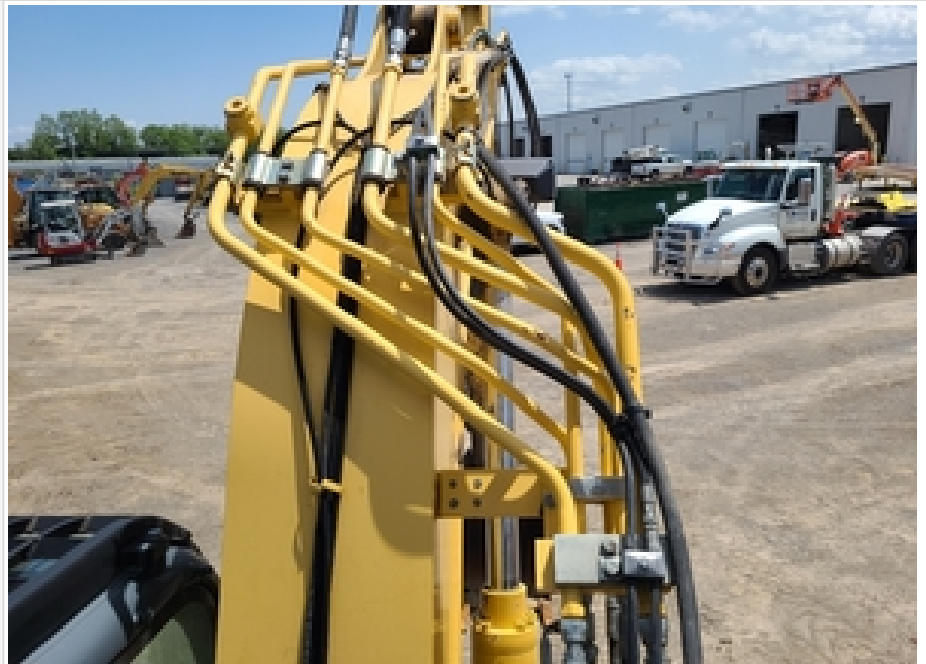
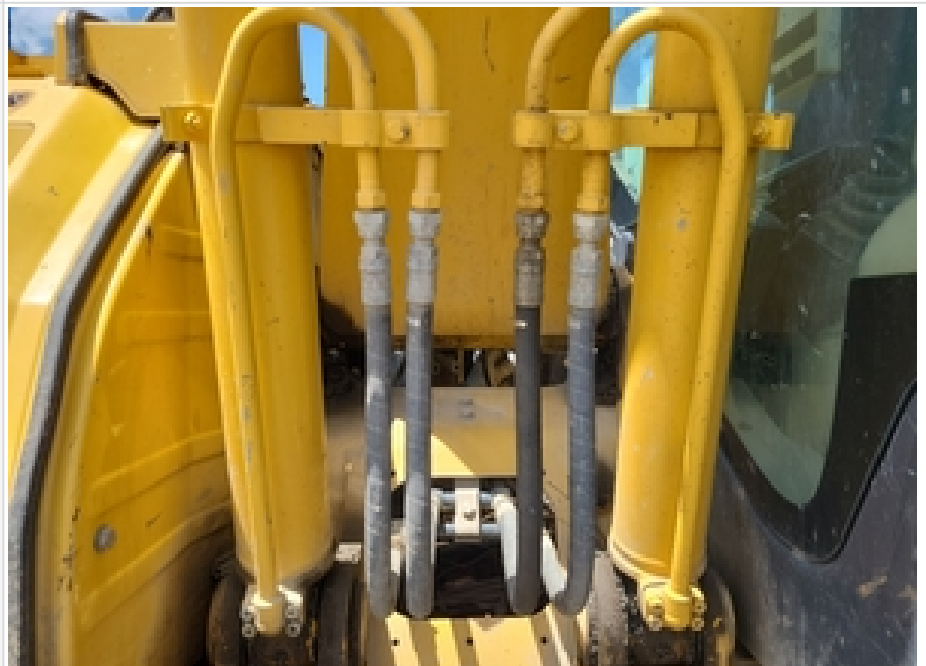
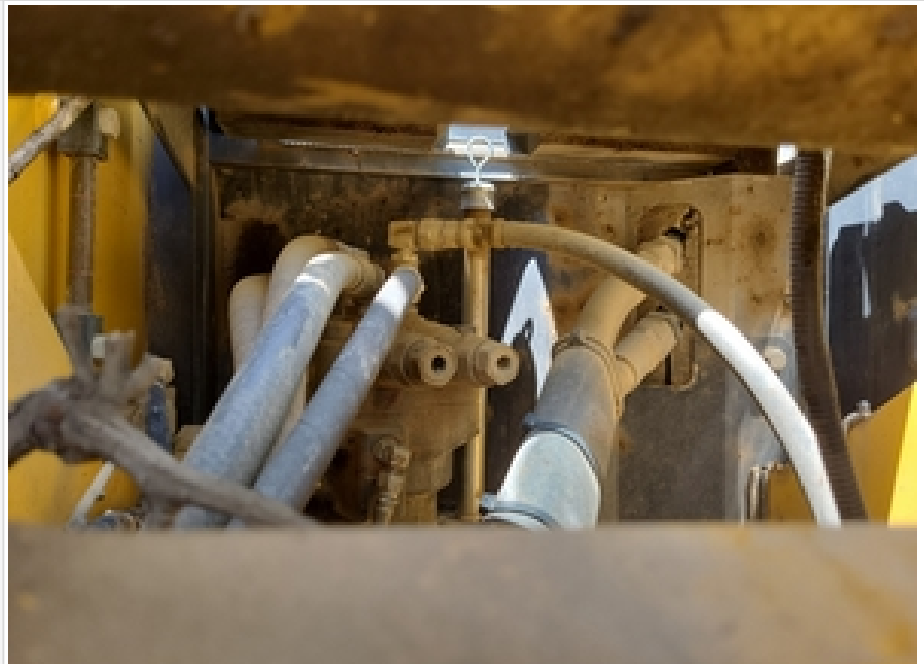
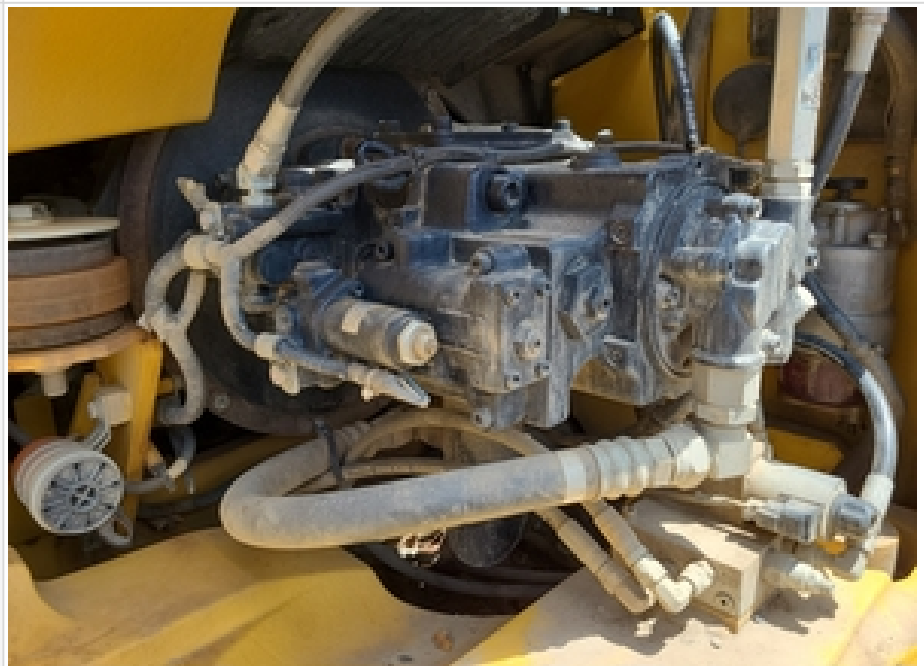
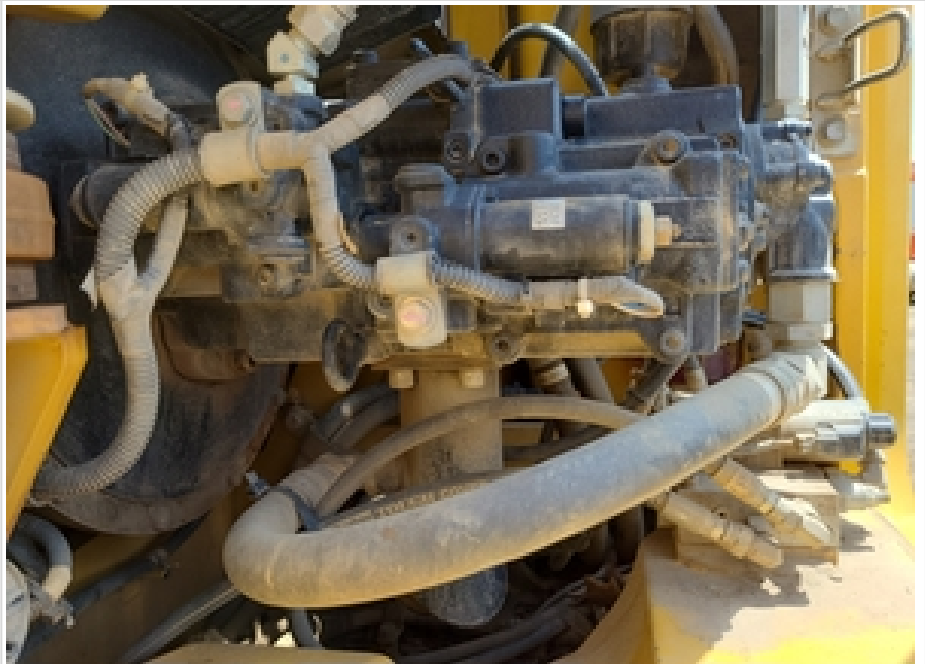
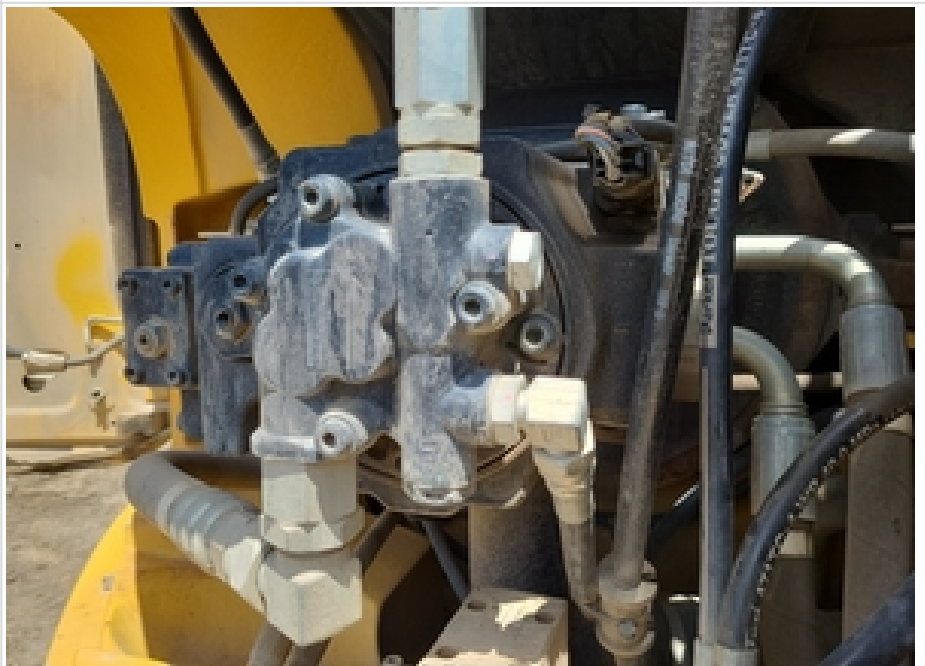
Hydraulic Pump/Fittings/Hoses

Hydraulic System Rating	3 - Normal Wear & Tear
Hydraulic System Comments	Hydraulic System in good working condition

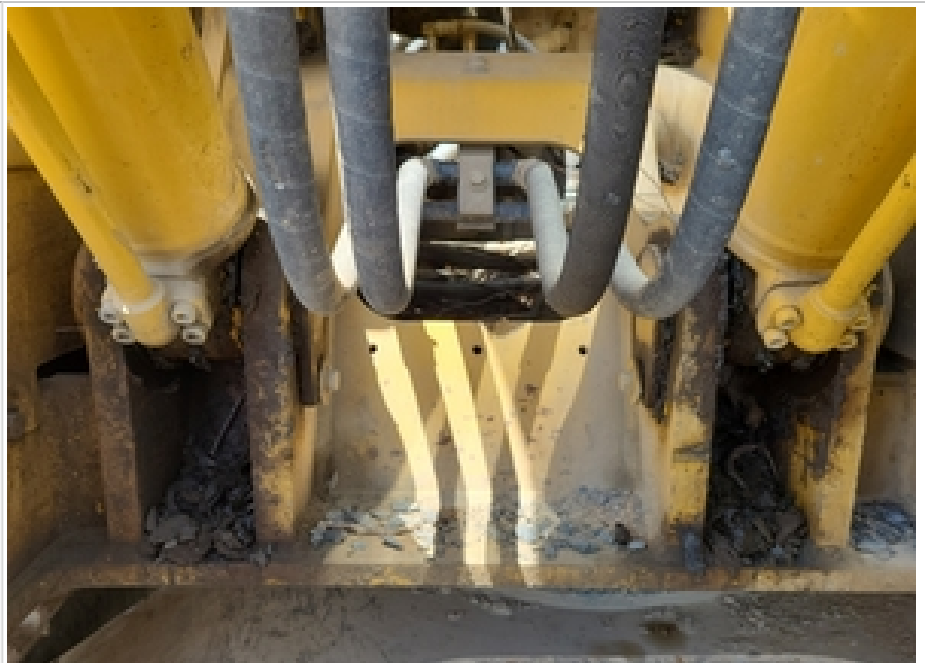
Chassis Photos

Chassis Rating	3 - Normal Wear & Tear
Comments	Some excess play seen at bucket linkage and at boom to stick connection
