Enterprise Equipment Inspection

Category	Excavator
Travel System	Track Undercarriage
Comments	
Year	2016
Make	Kobelco
Model	SK140SRLC-3
Fleet ID	10283192
Serial Number	YH07-10124
Serial Number Plate

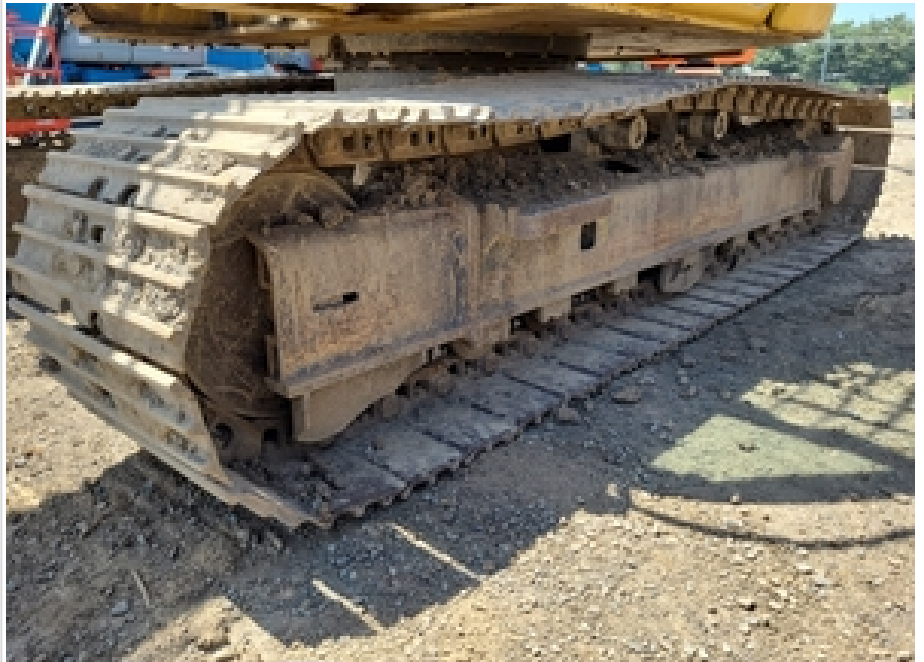
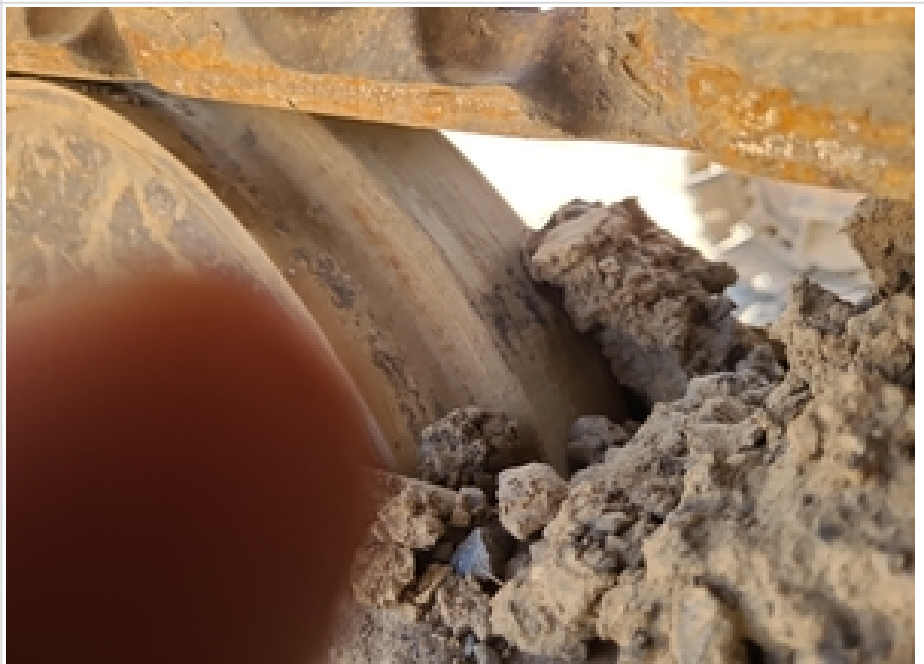
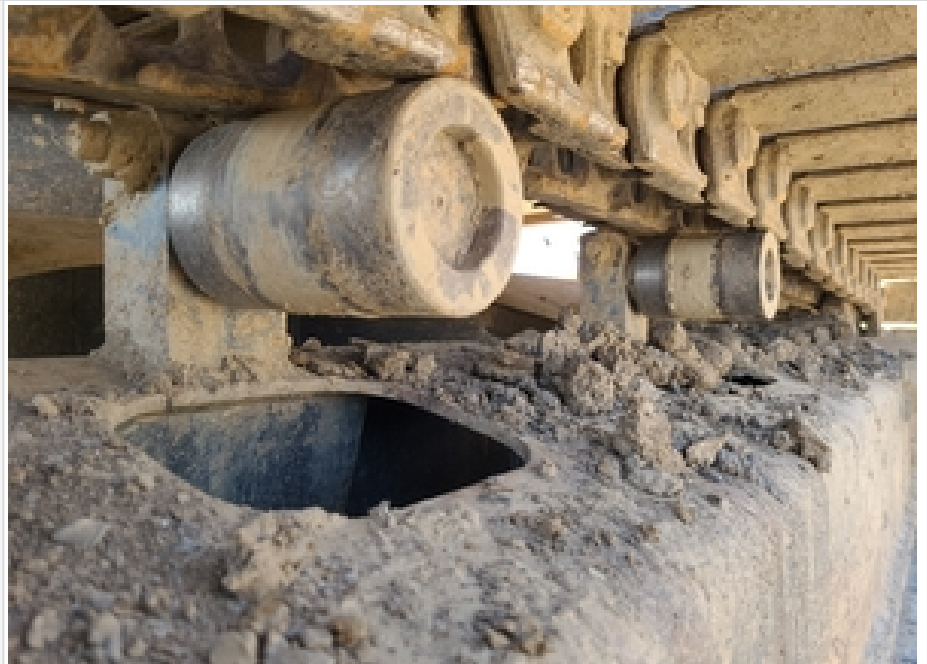
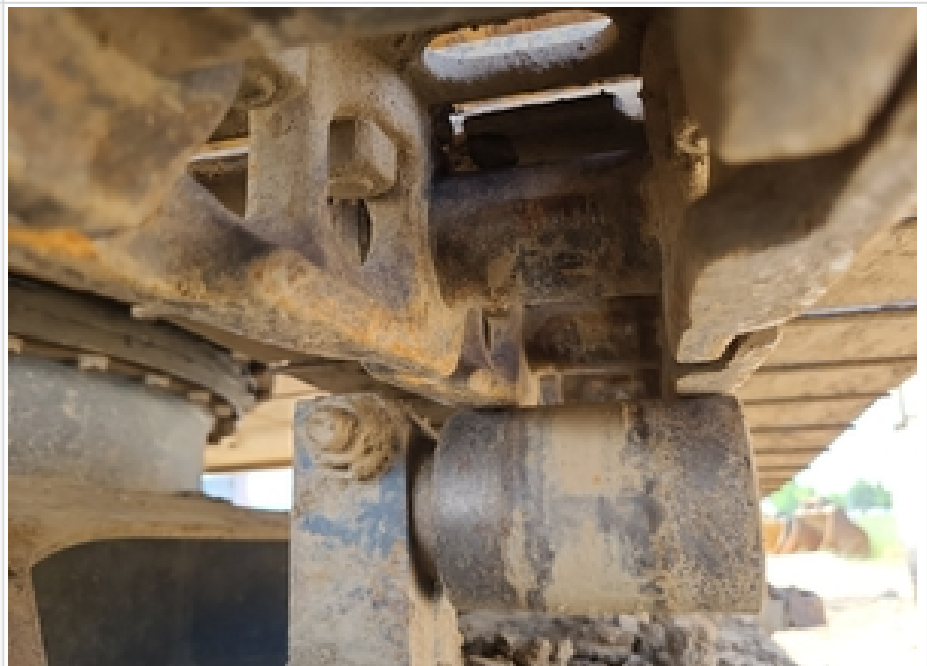
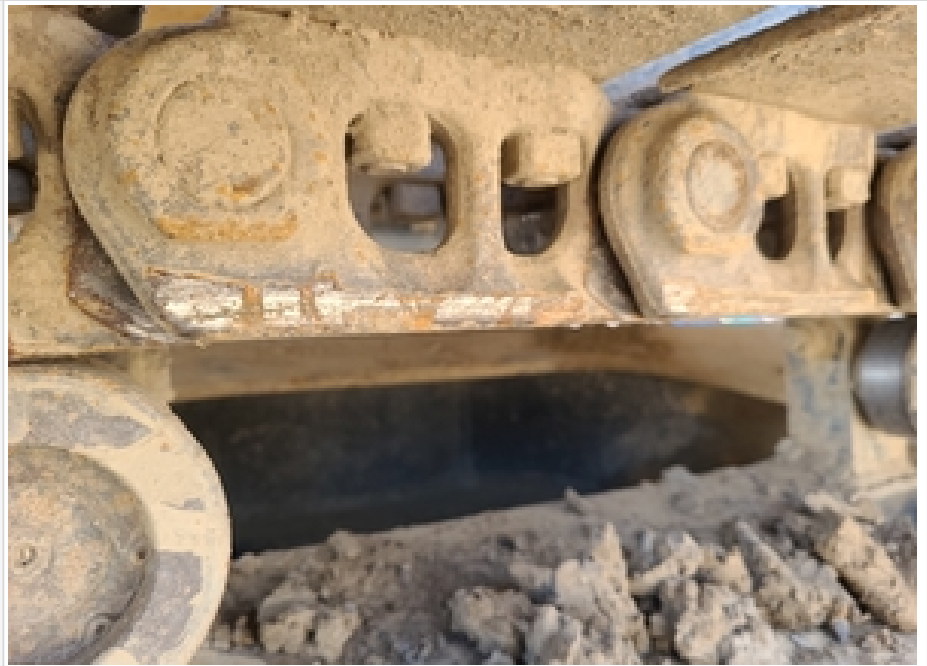
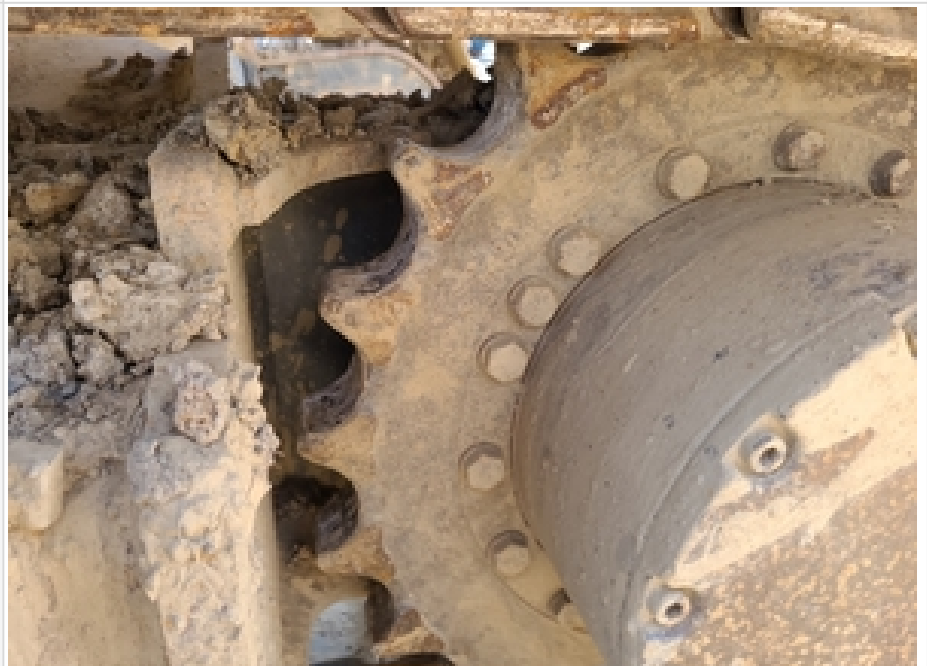
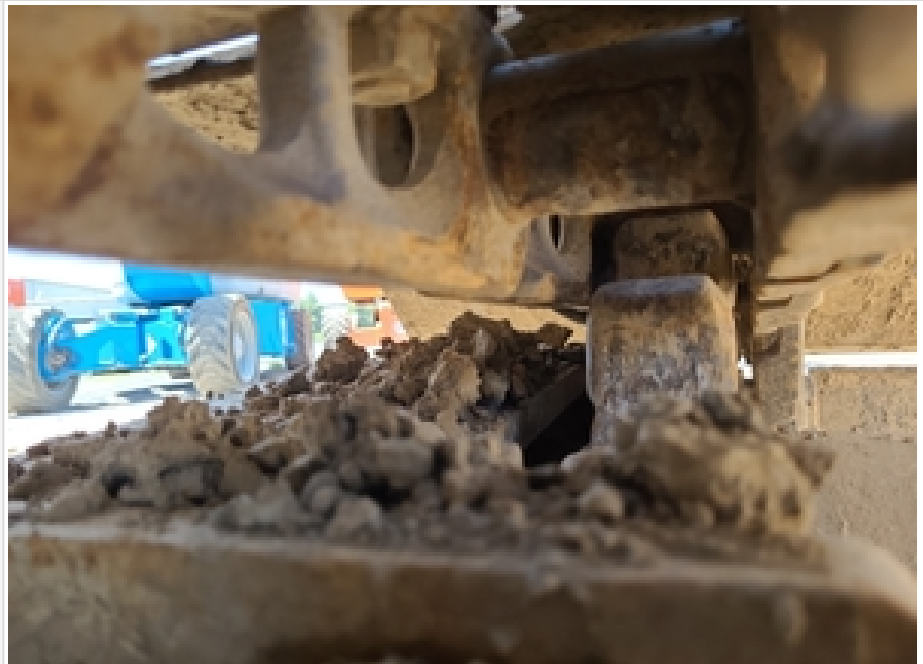
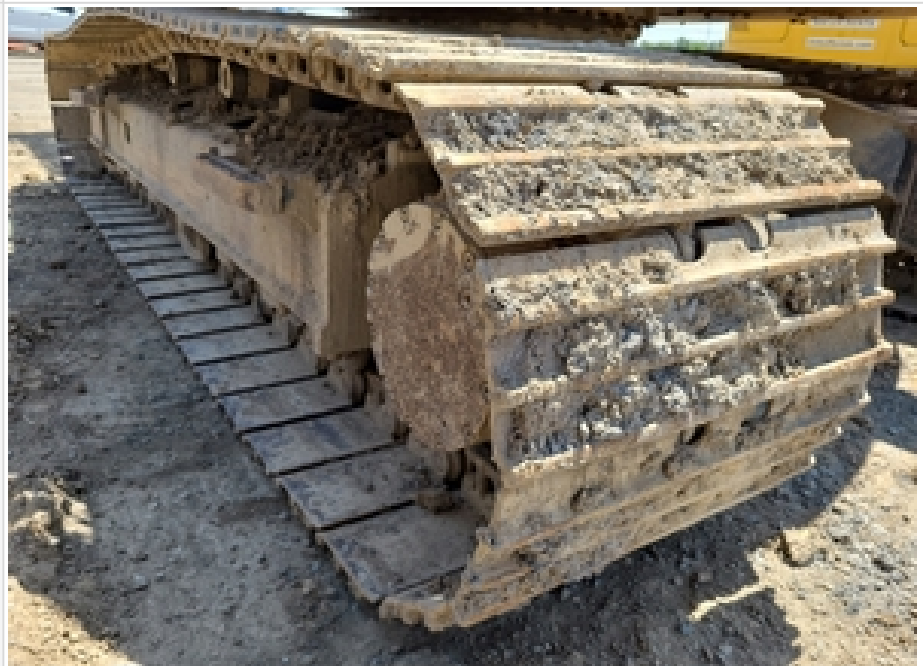
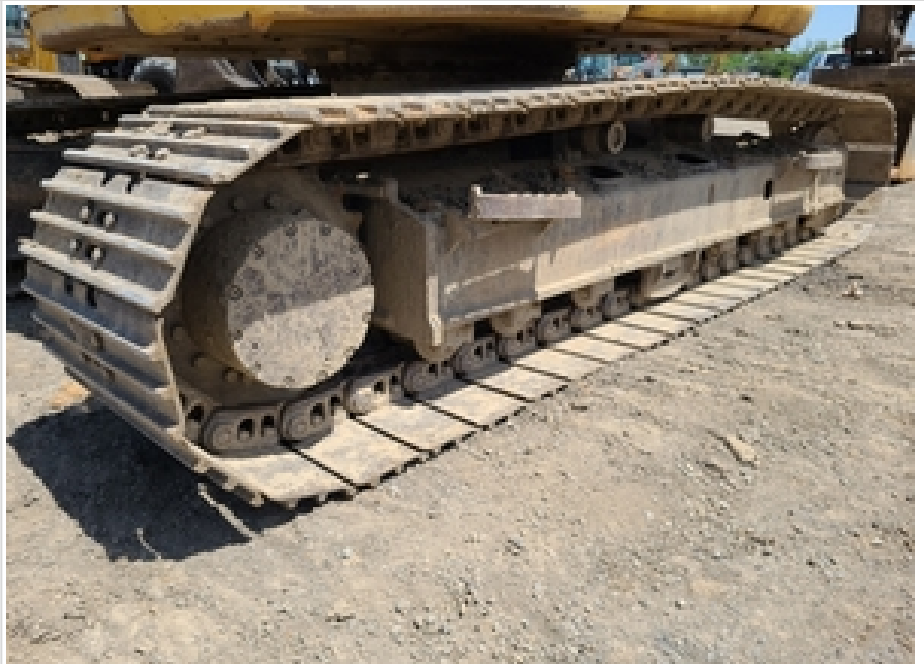
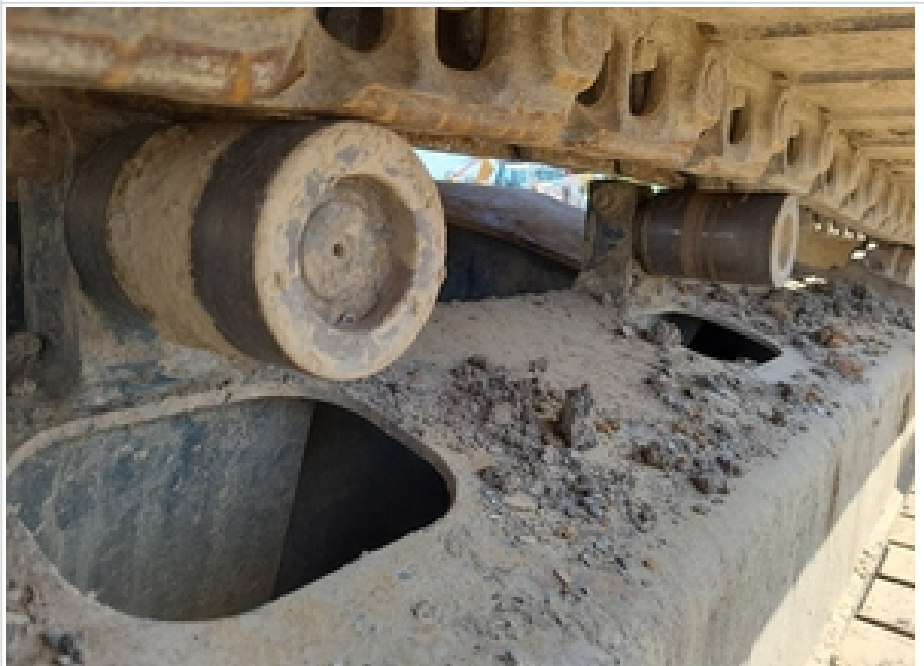
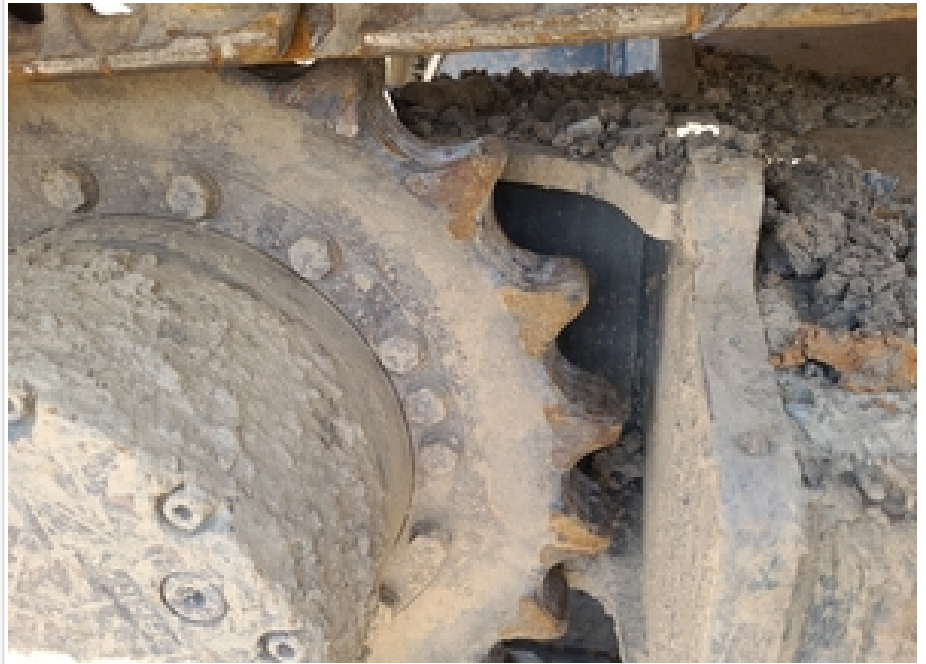
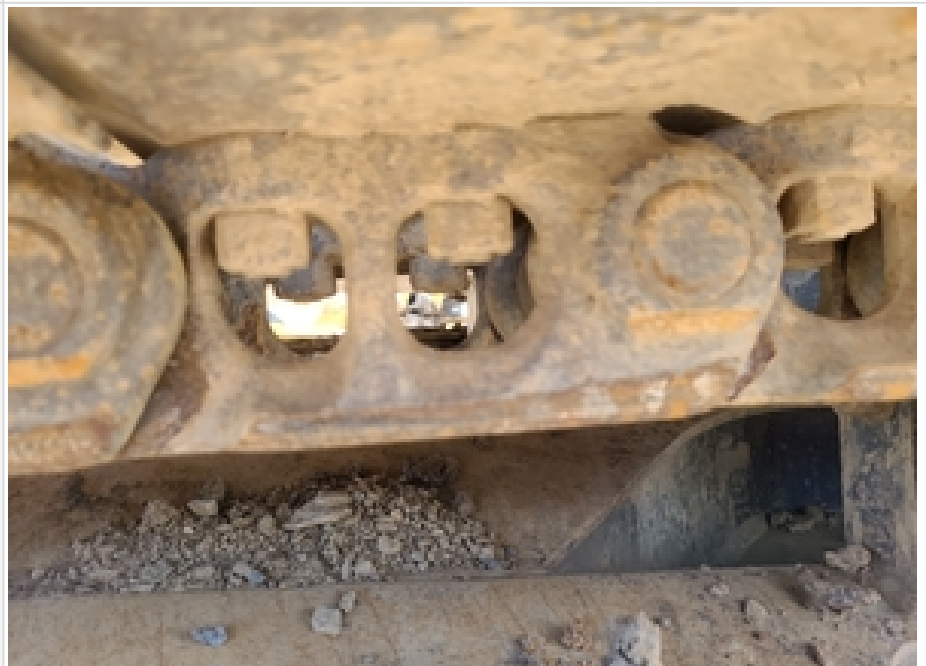
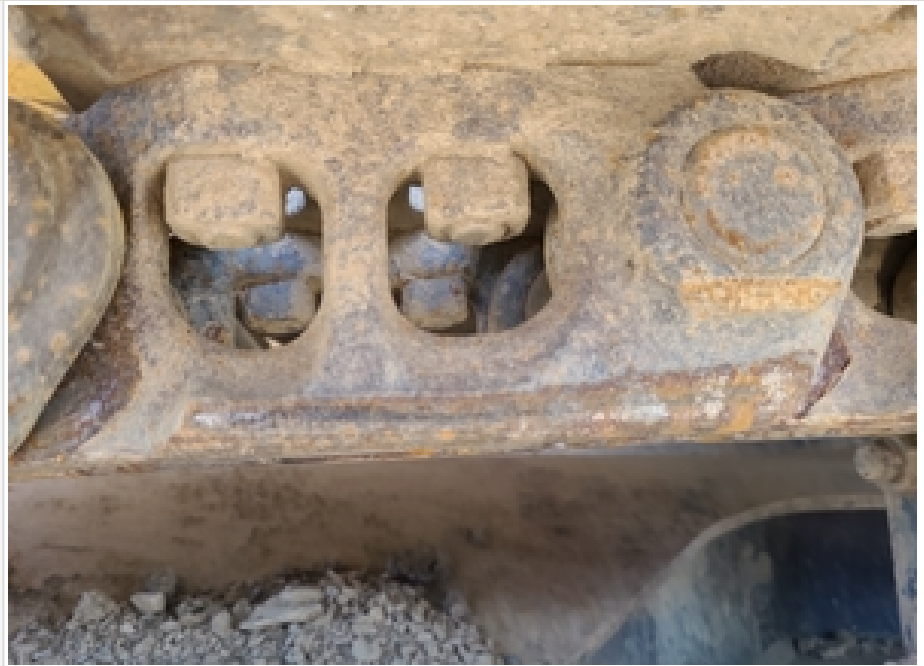
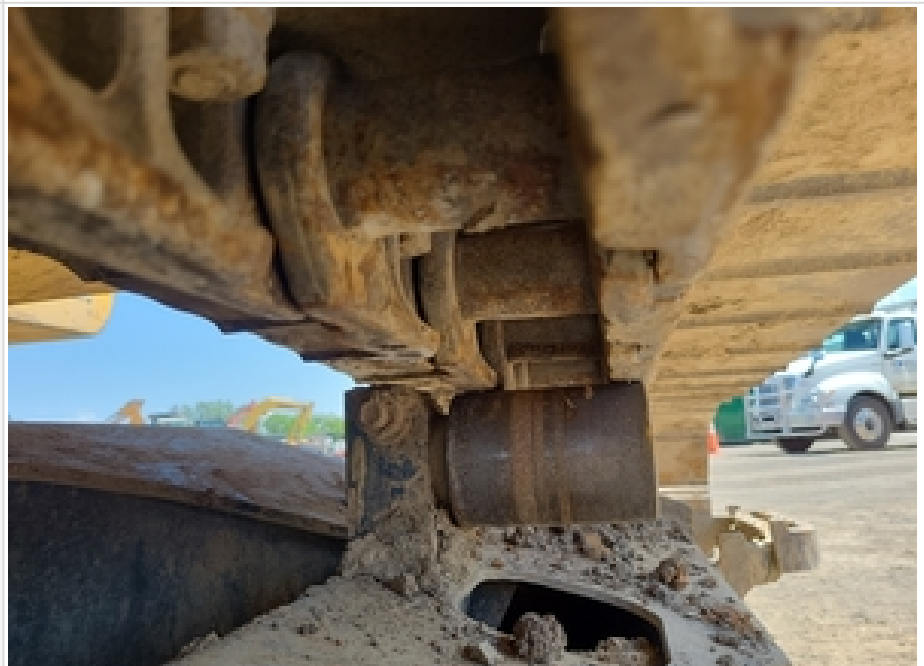
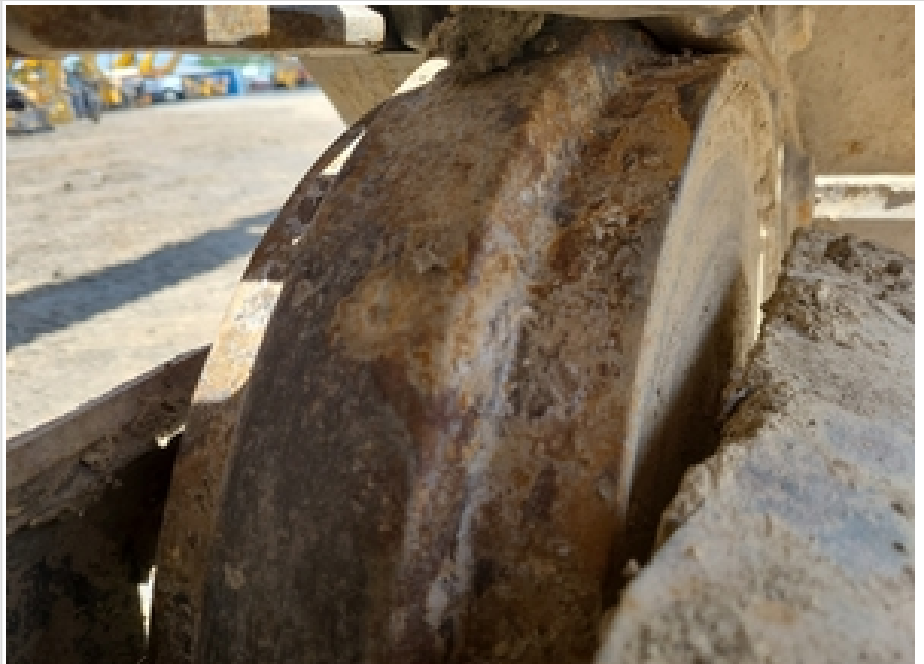
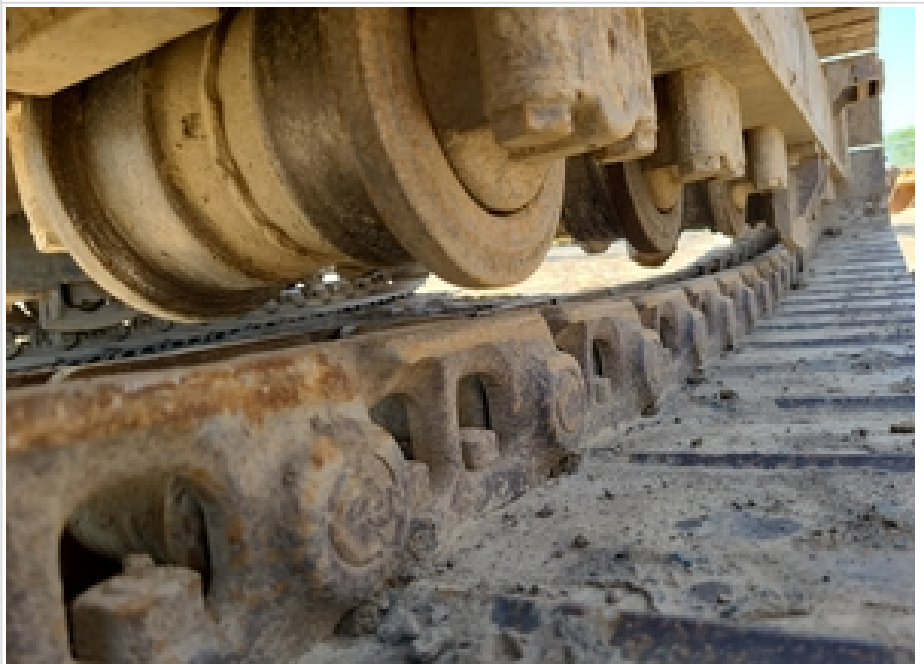
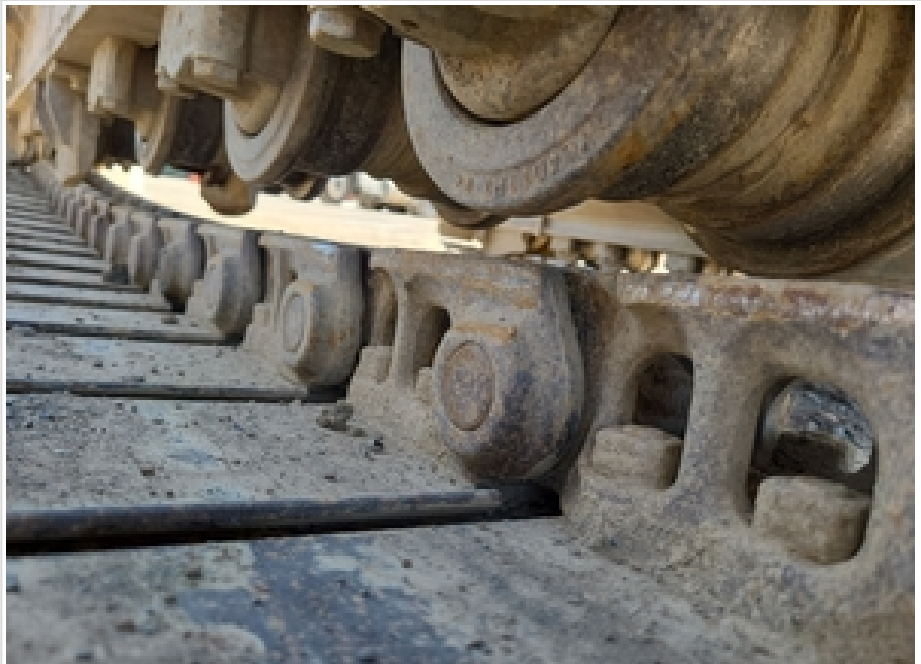
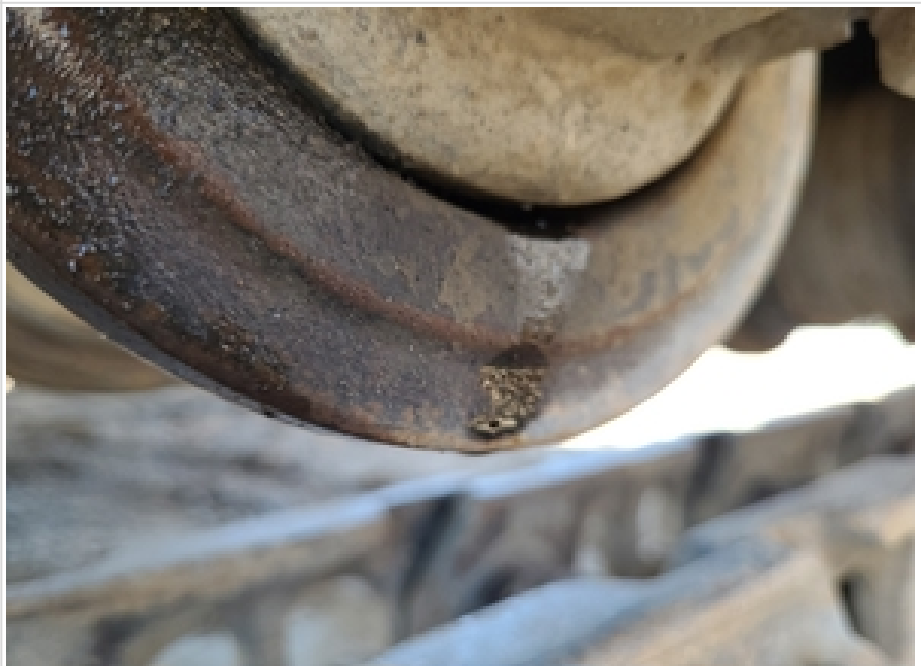
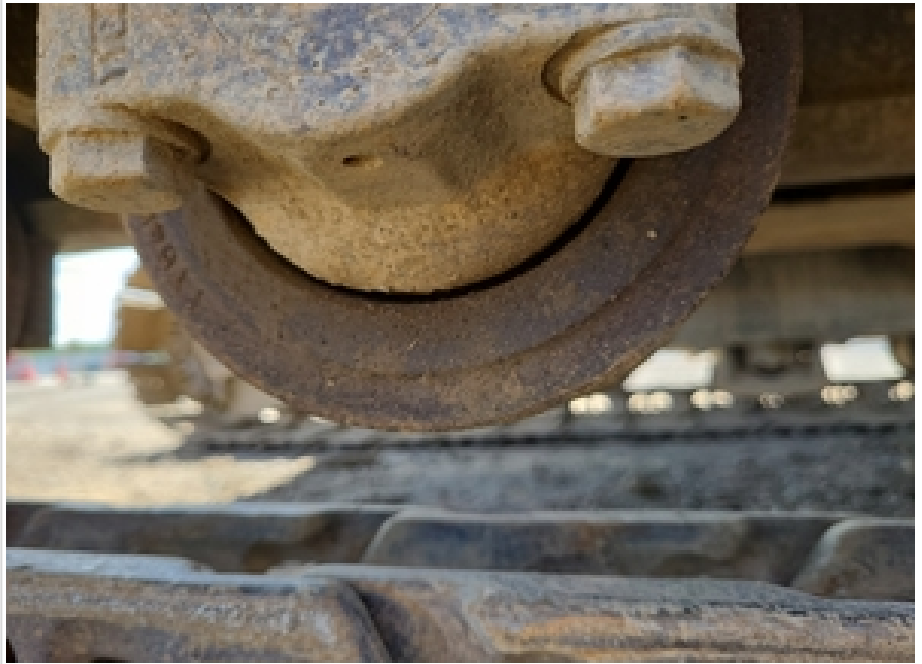
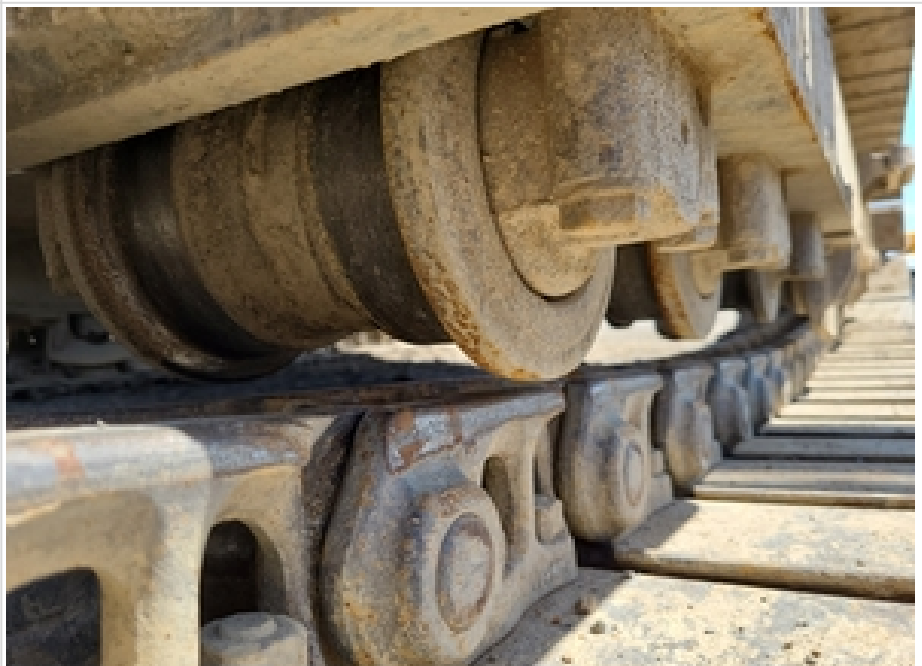
Undercarriage Photos

Undercarriage Rating	3 - Normal Wear & Tear
Undercarriage Comments	Undercarriage in good condition.

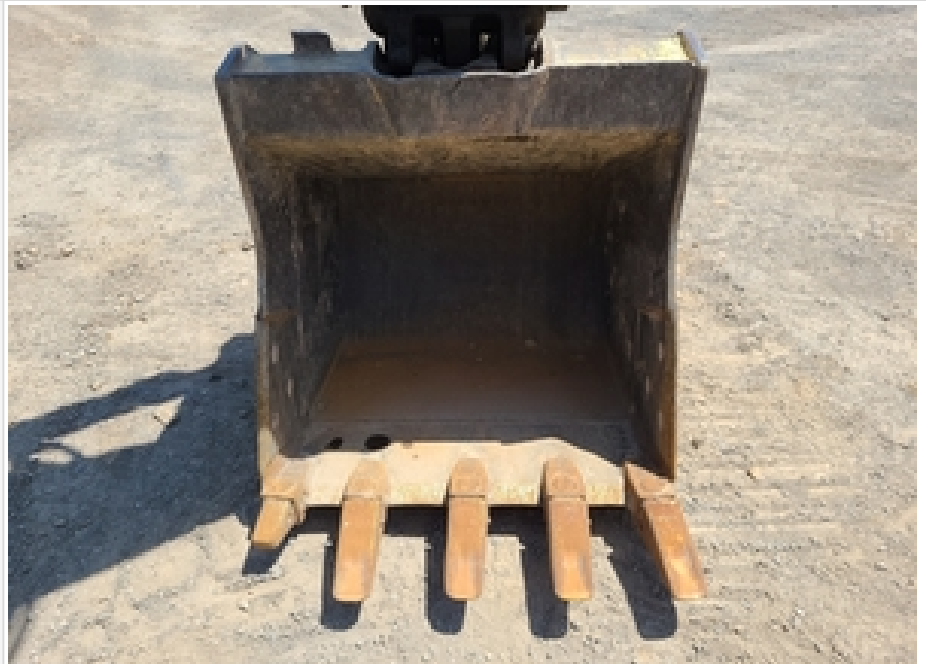
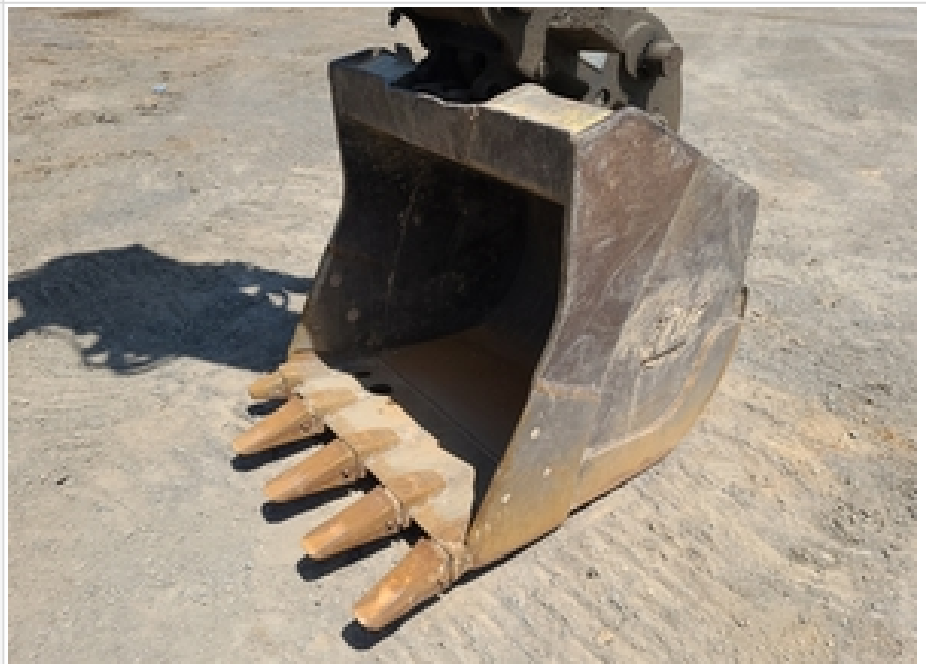
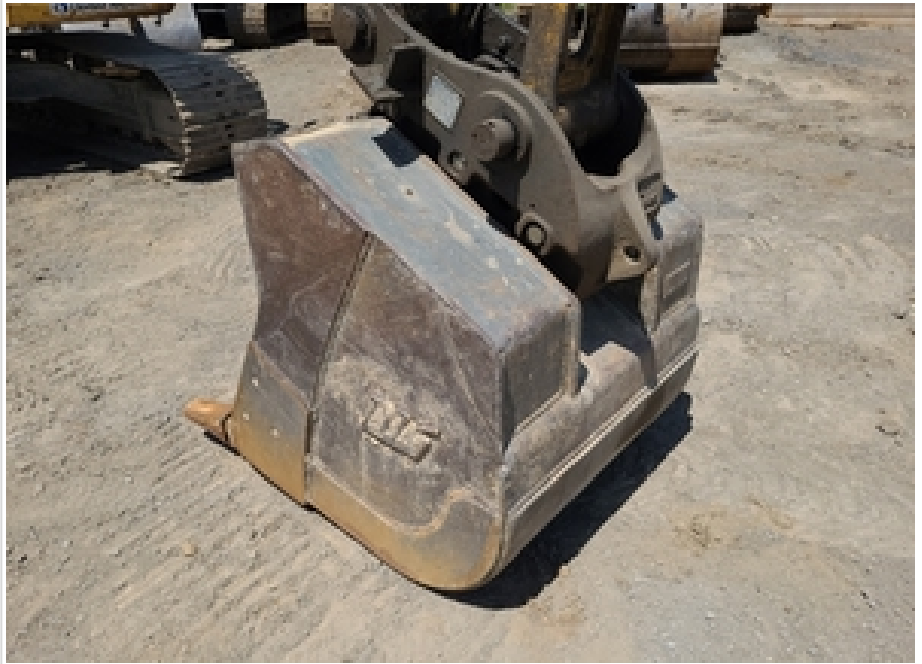
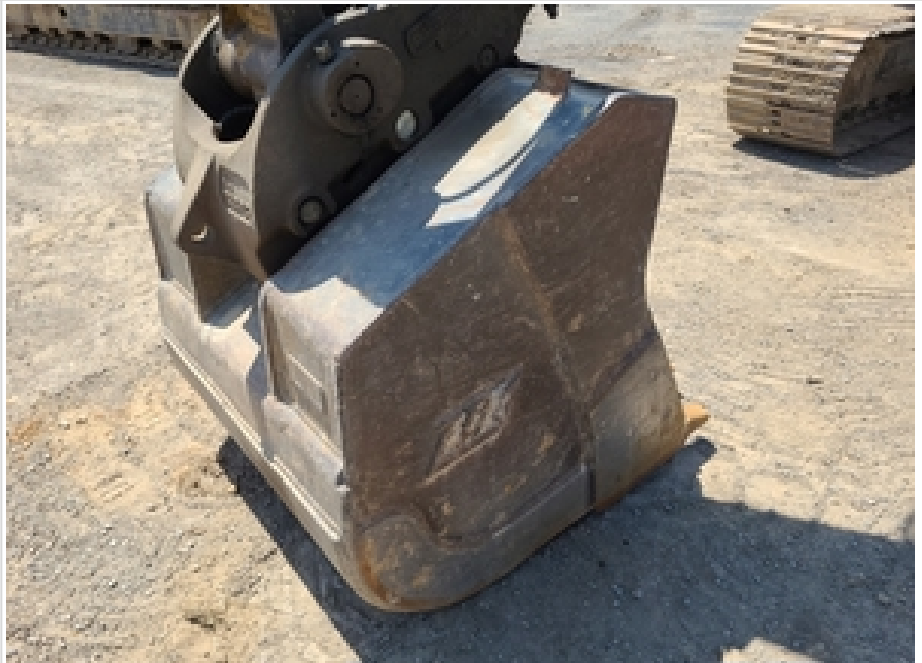
Attachment Photos	 
-------------------	--------------------------------------------------------------------------------------

Attachment Rating	3 - Normal Wear & Tear
Attachment Comments	Bucket missing 1 tooth
