Enterprise Equipment Inspection

Category	Forklift
Travel System	Wheels & Tires
Comments	
Year	2016
Make	JCB
Model	512-56
Fleet ID	10497304
Serial Number	JCB5CH2GJG2434835
Serial Number Plate

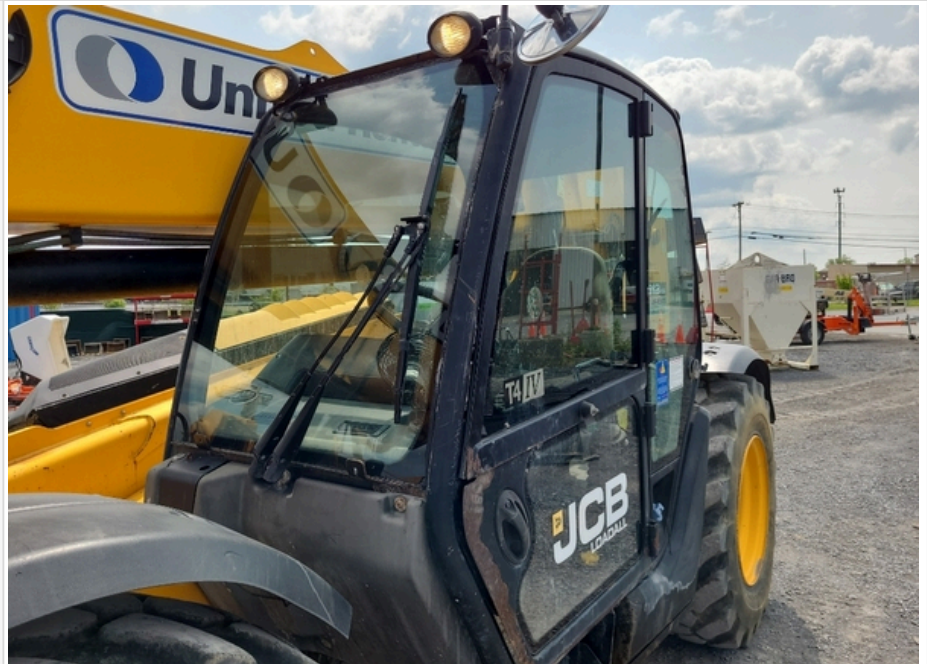
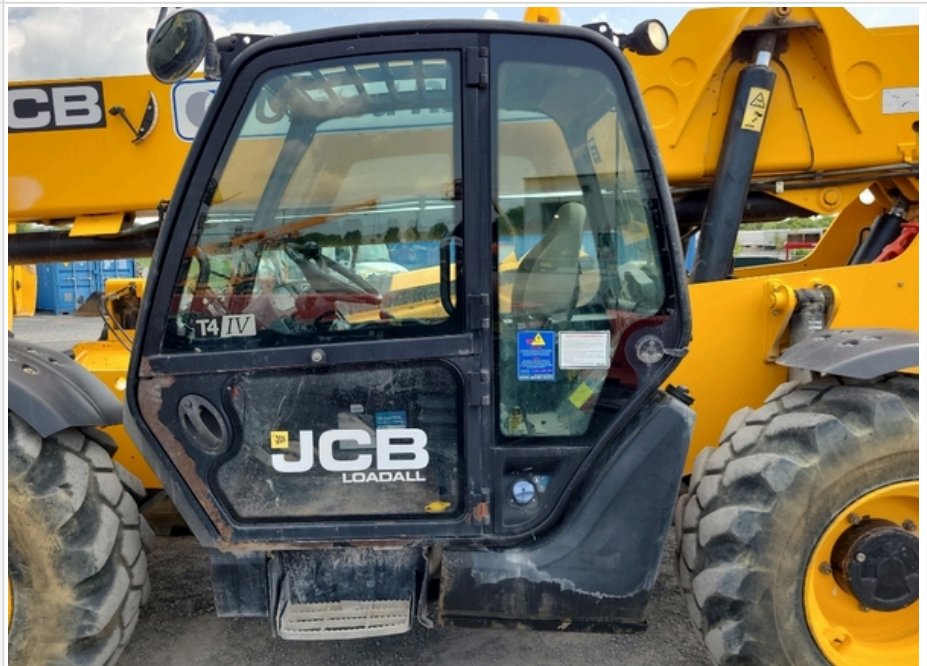
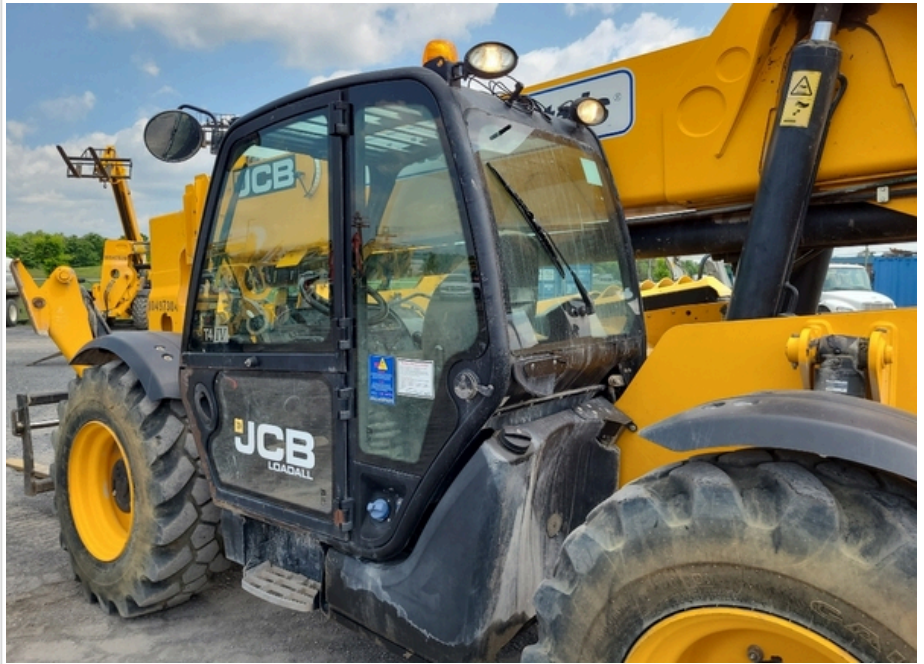
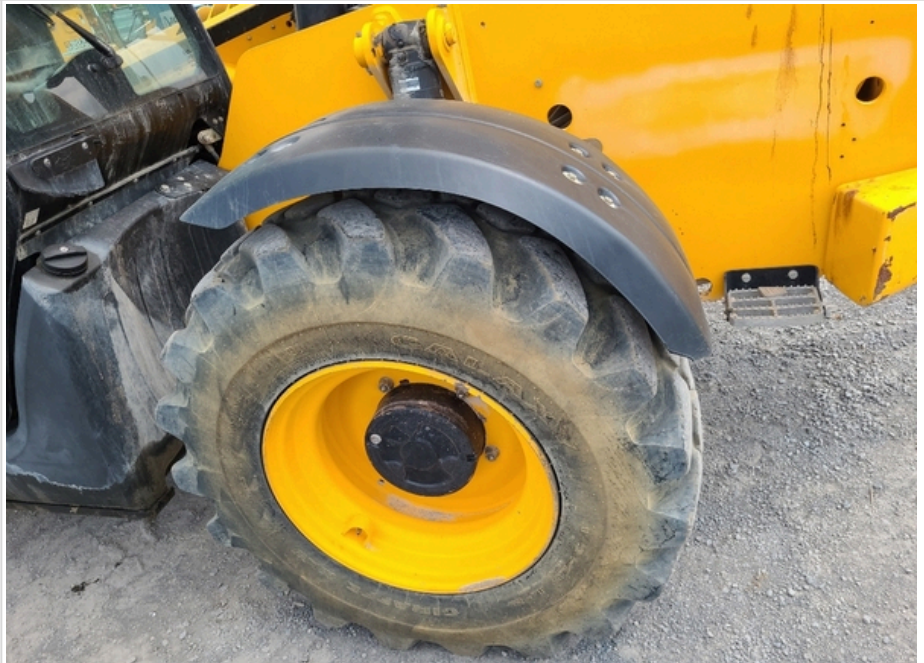
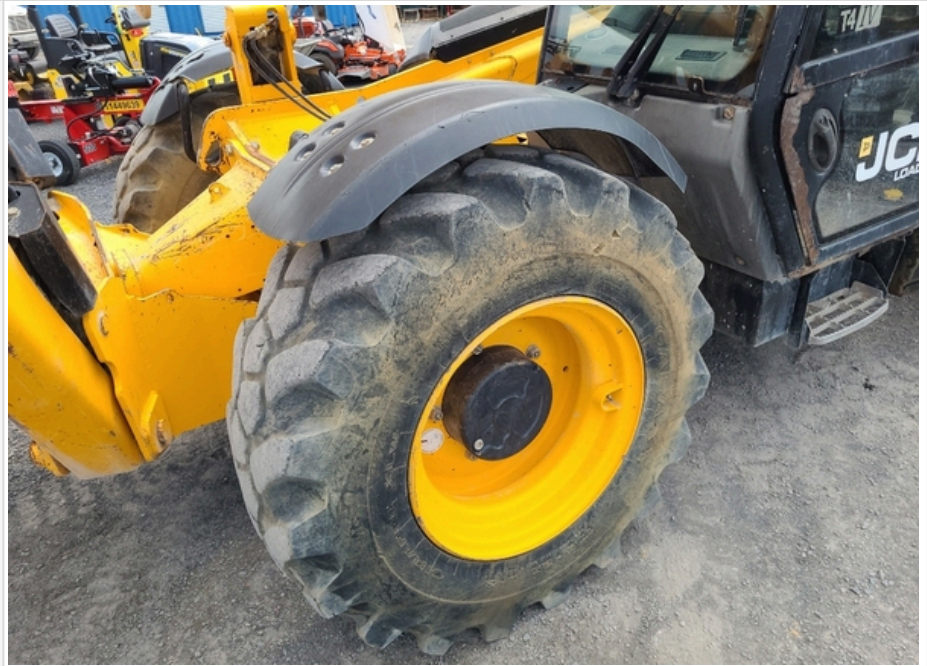
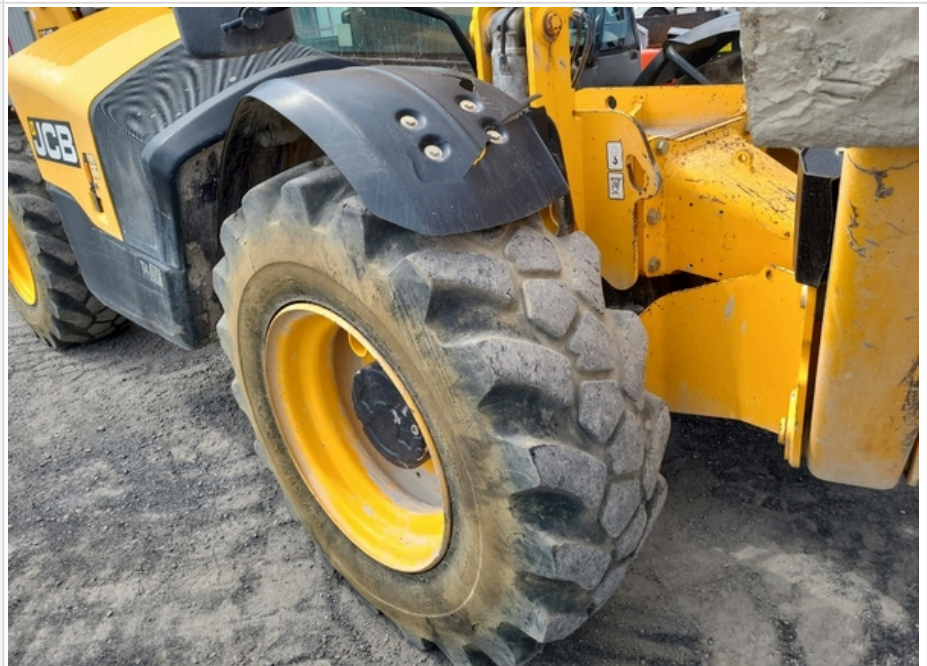
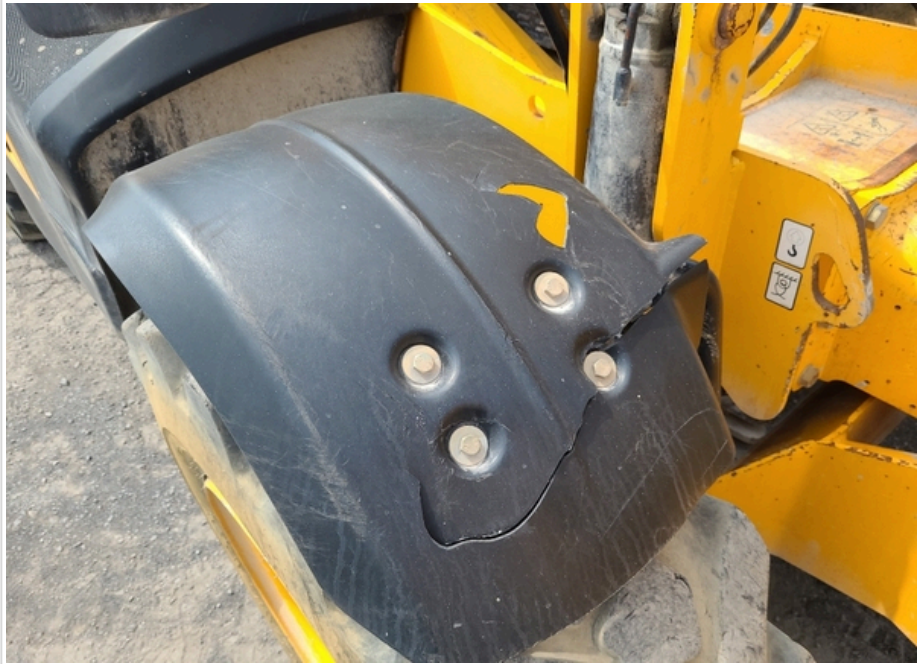
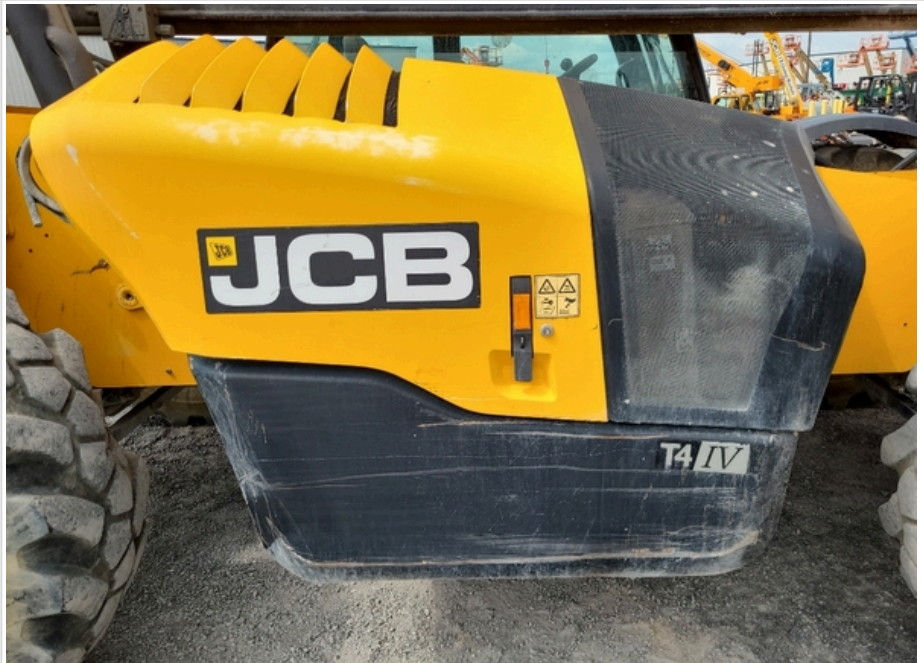
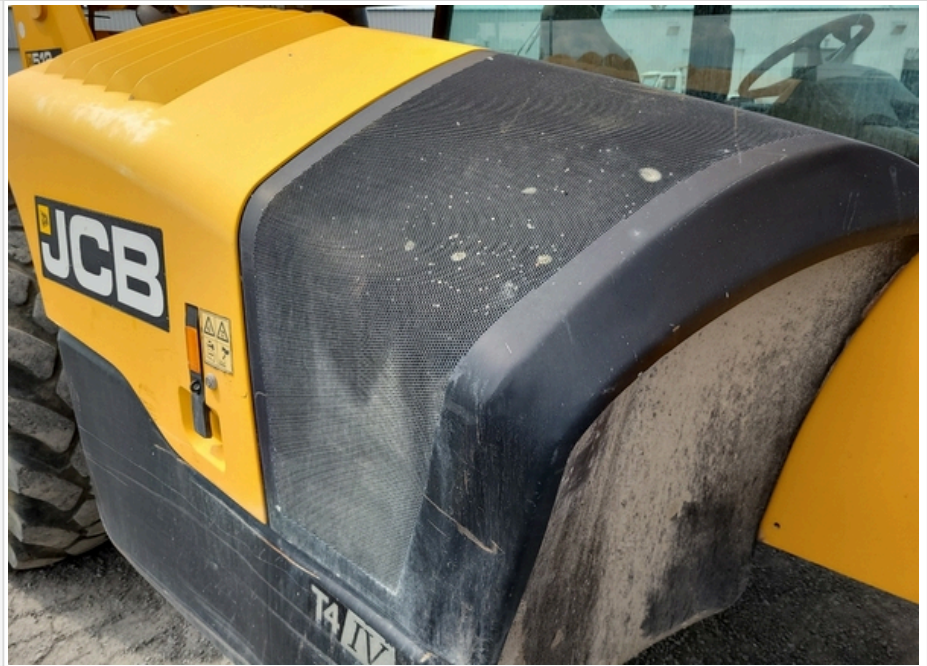
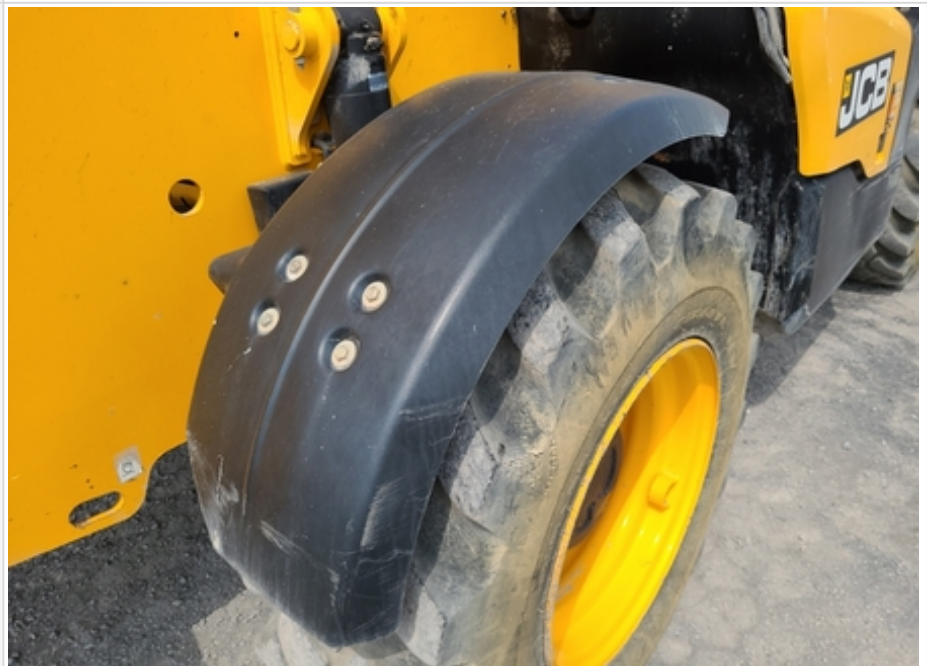
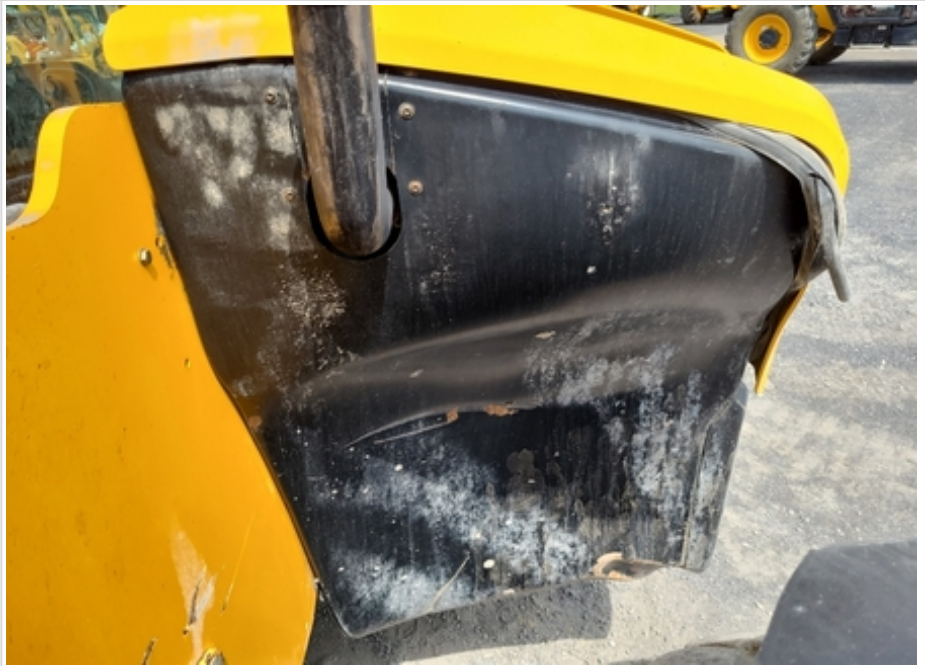
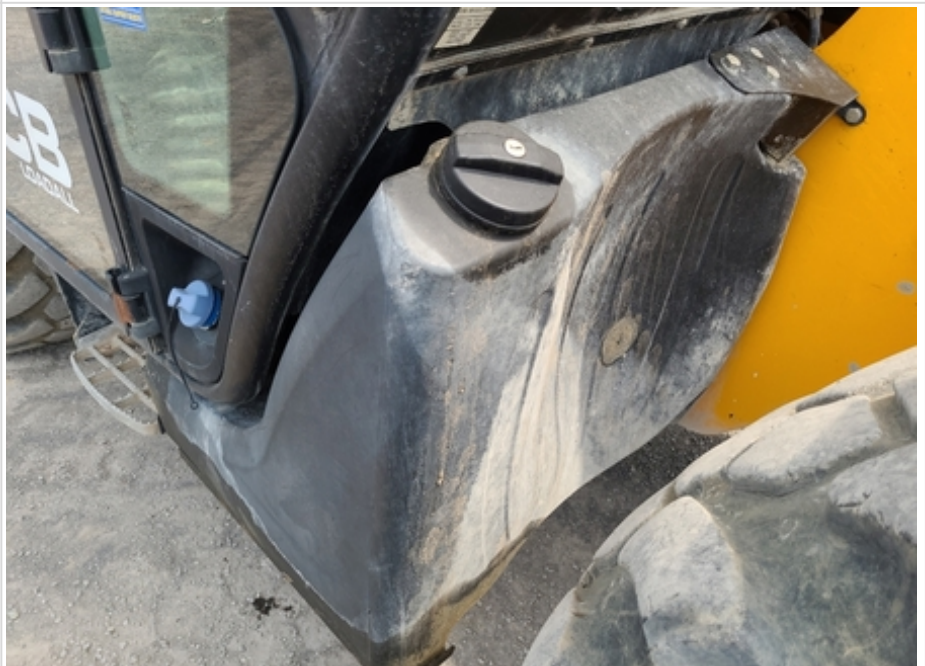
Close-Up Exterior Photos

Exterior Rating	3 - Normal Wear & Tear
Exterior Comments	Front r/s mud guard damaged, fuel tank possibly cracked (leaking?) Some mud guard retaining areas cracked.

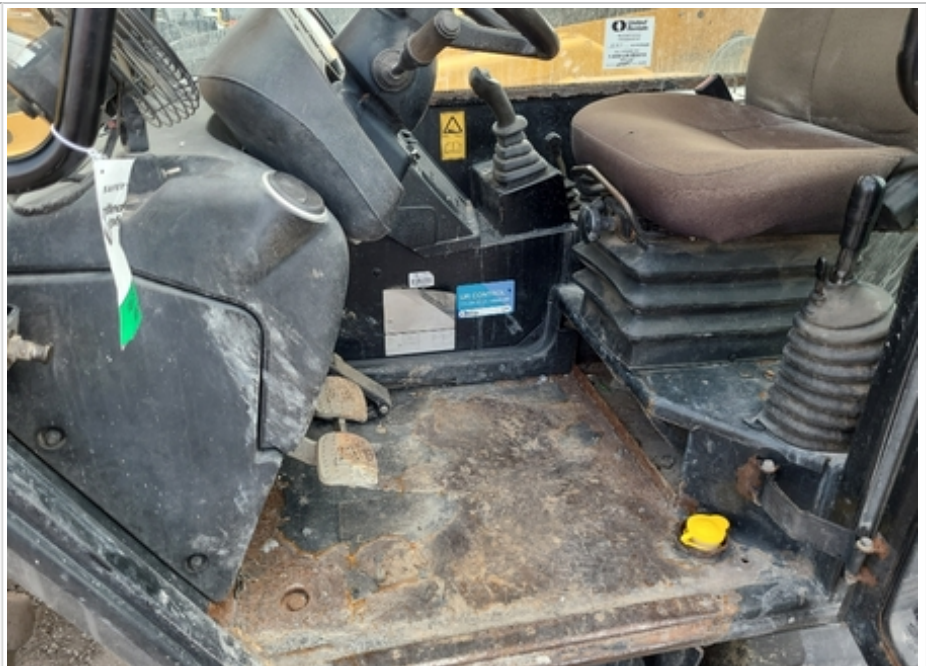
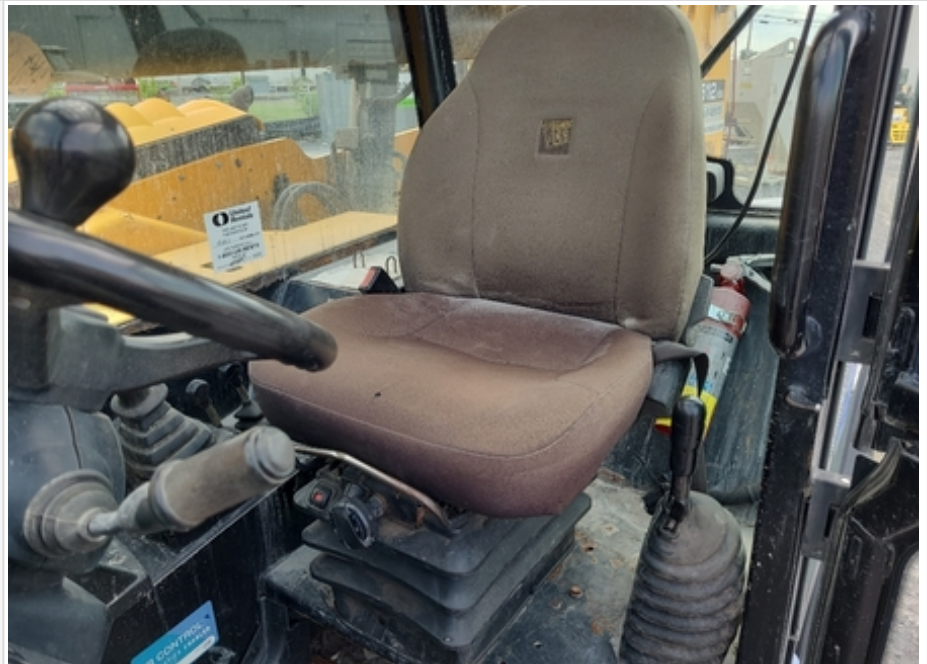
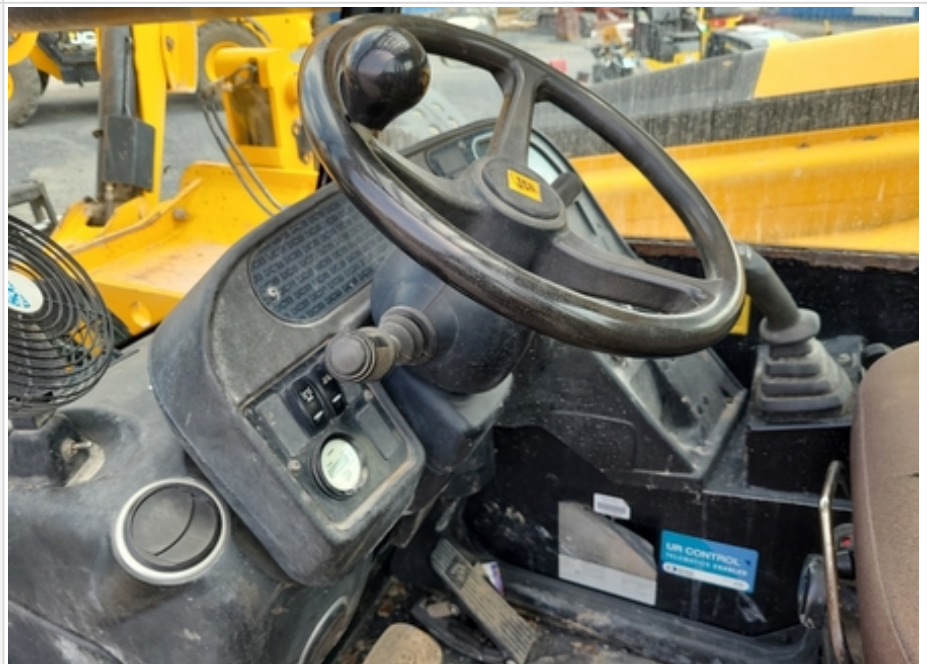
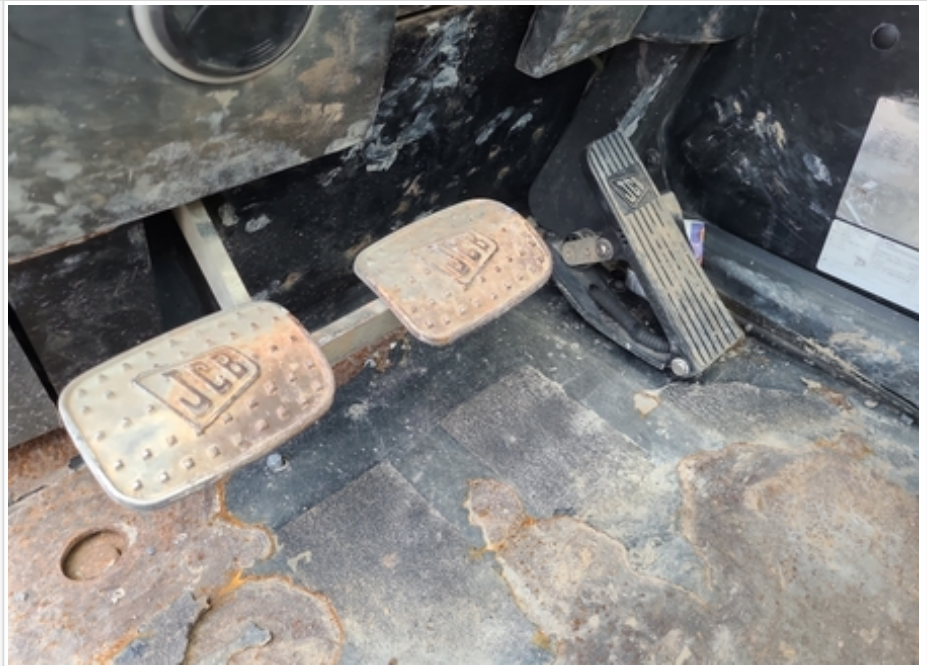
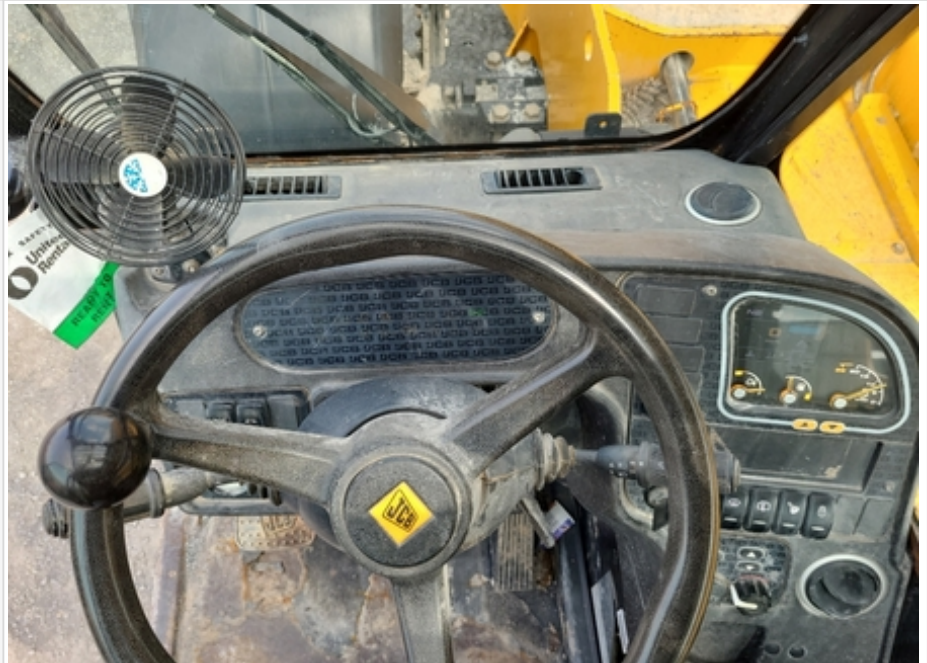
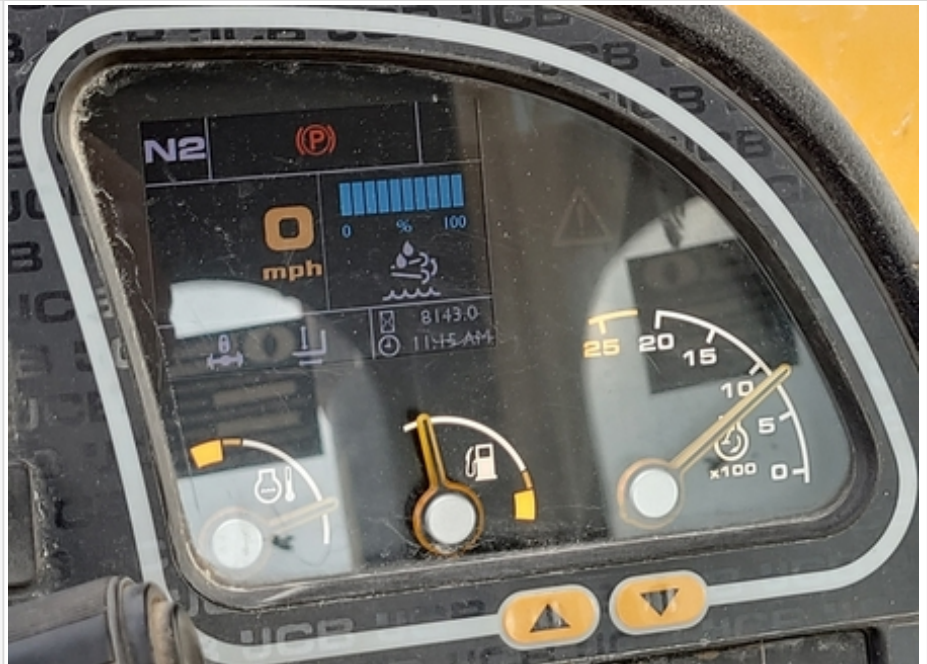
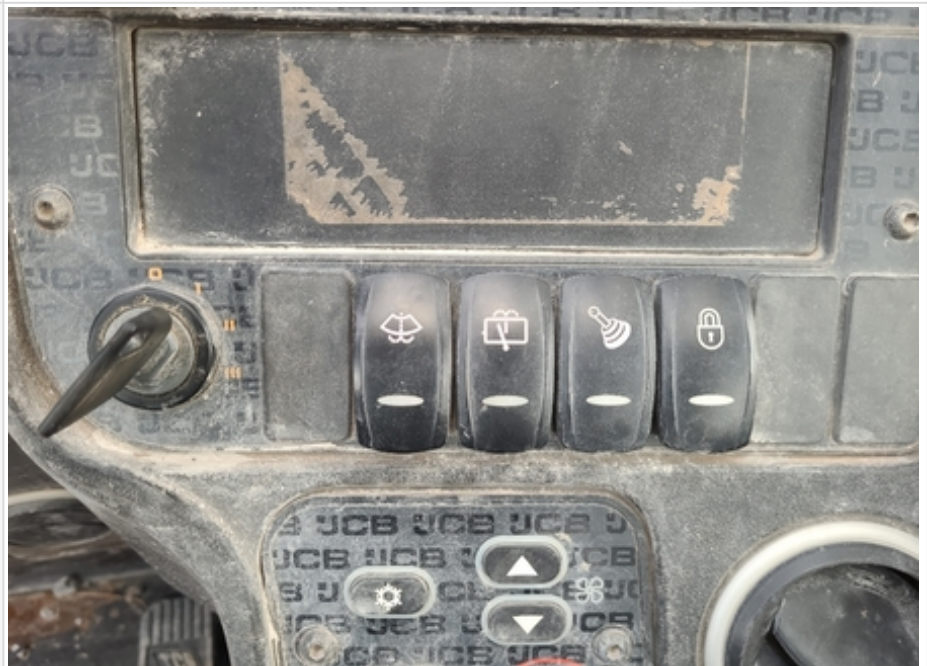
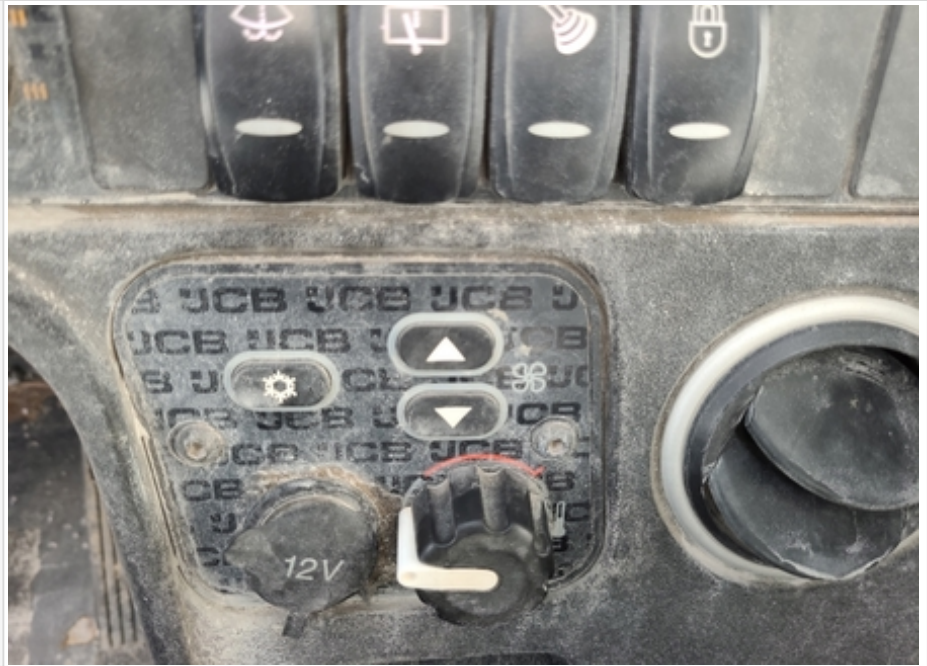
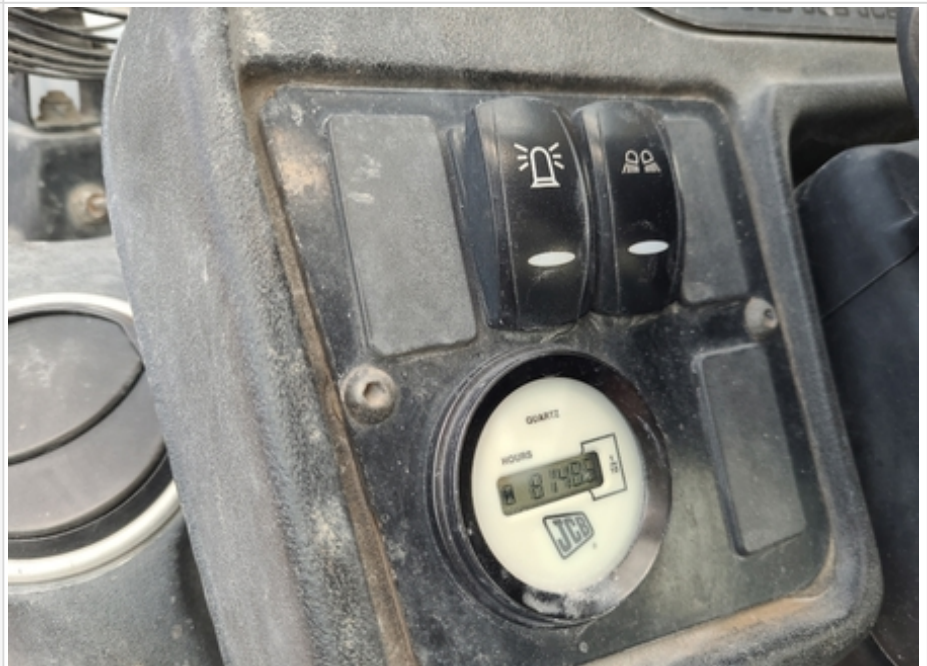
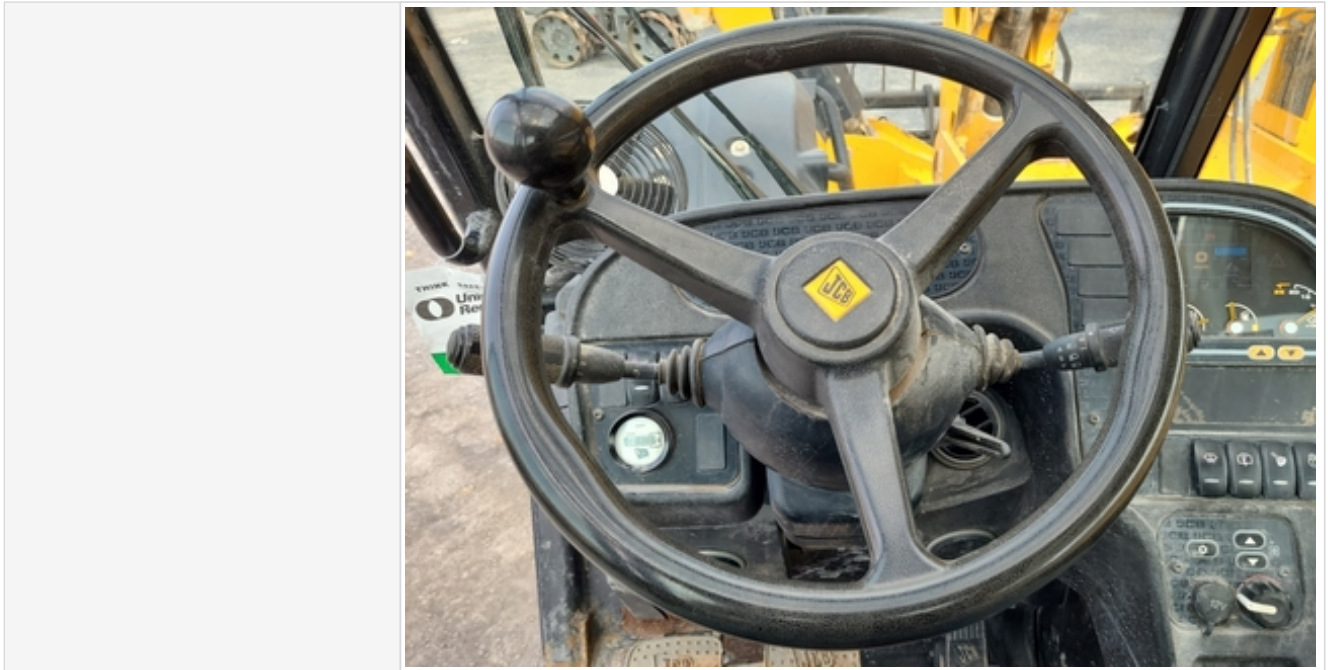
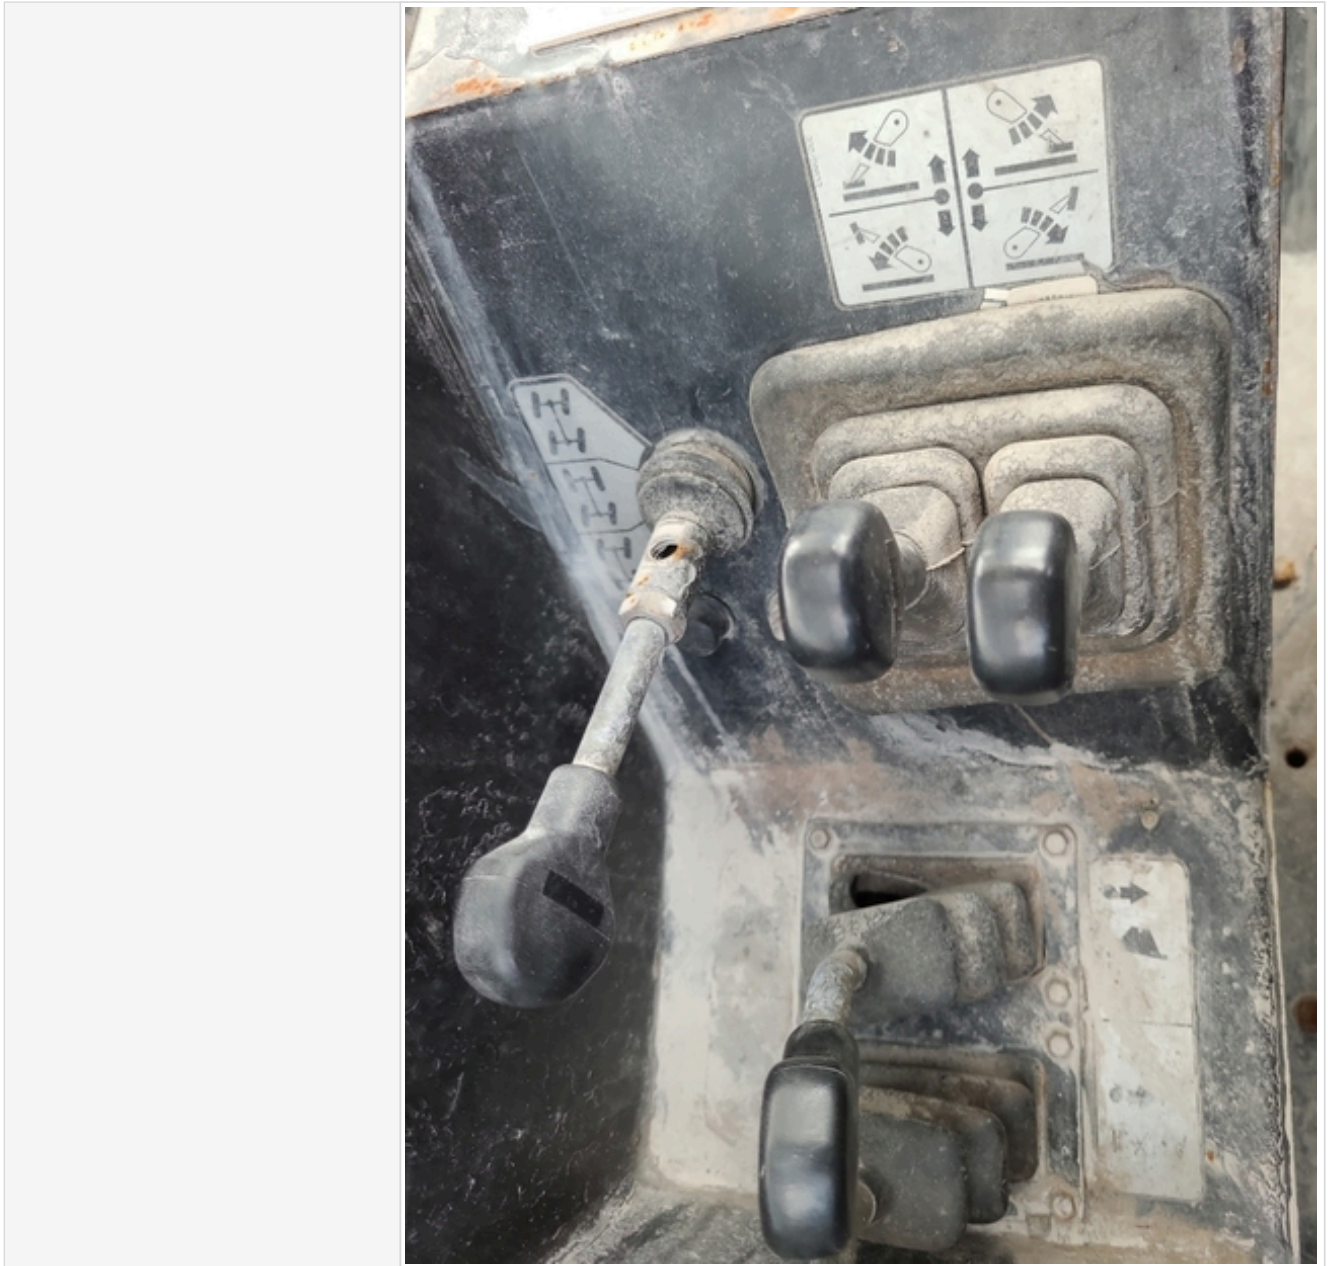
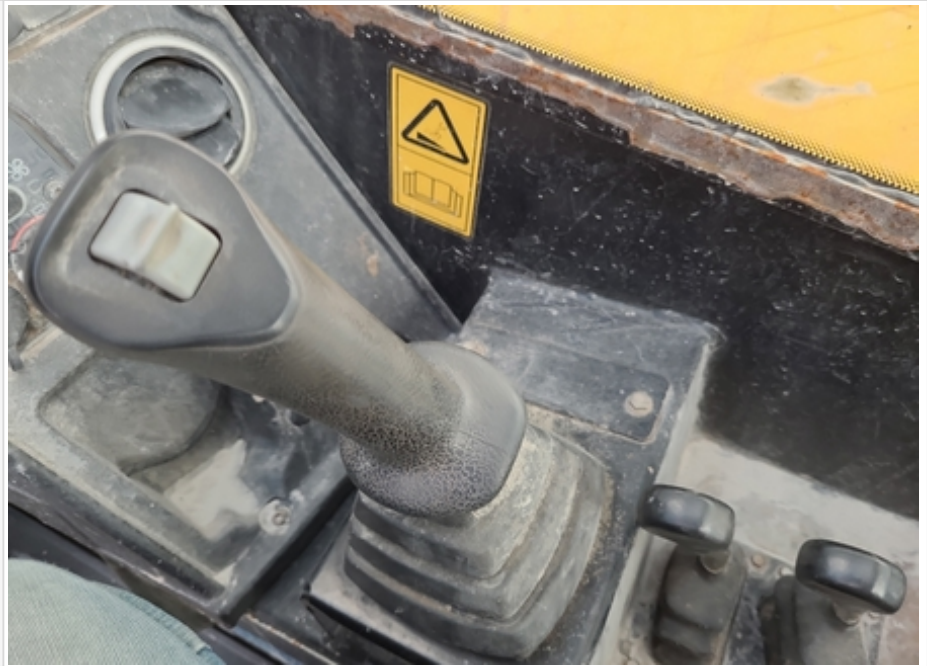
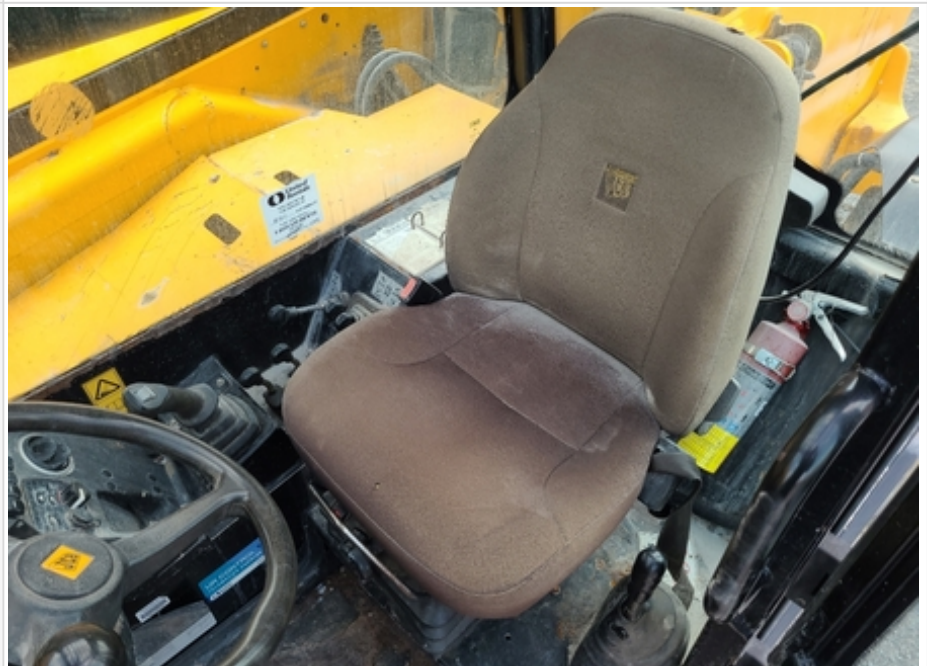
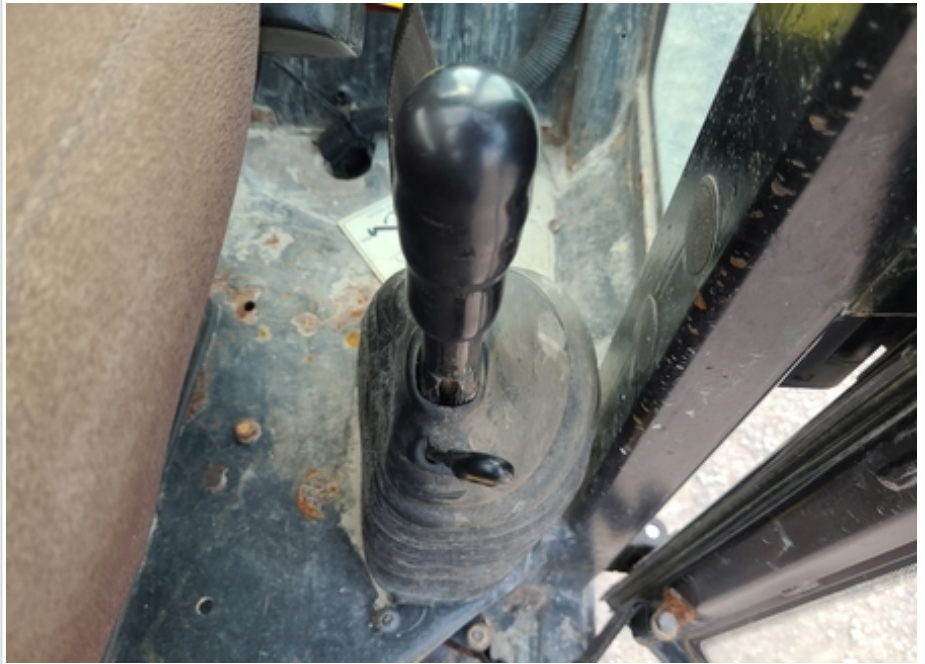
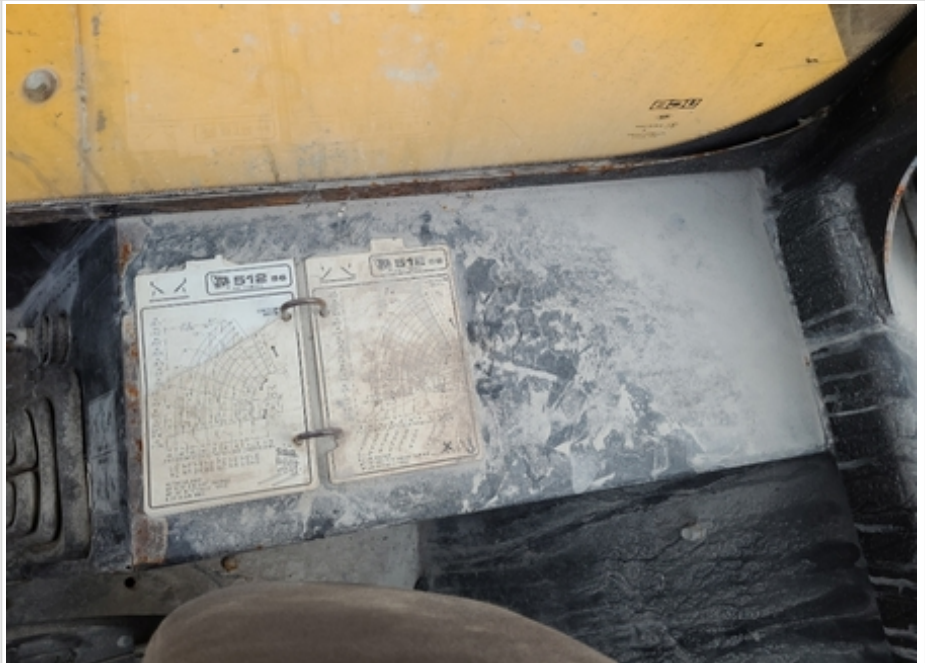
Control Station Rating	3 - Normal Wear & Tear
Control Station Overall Comments	Switch and some control decals worn

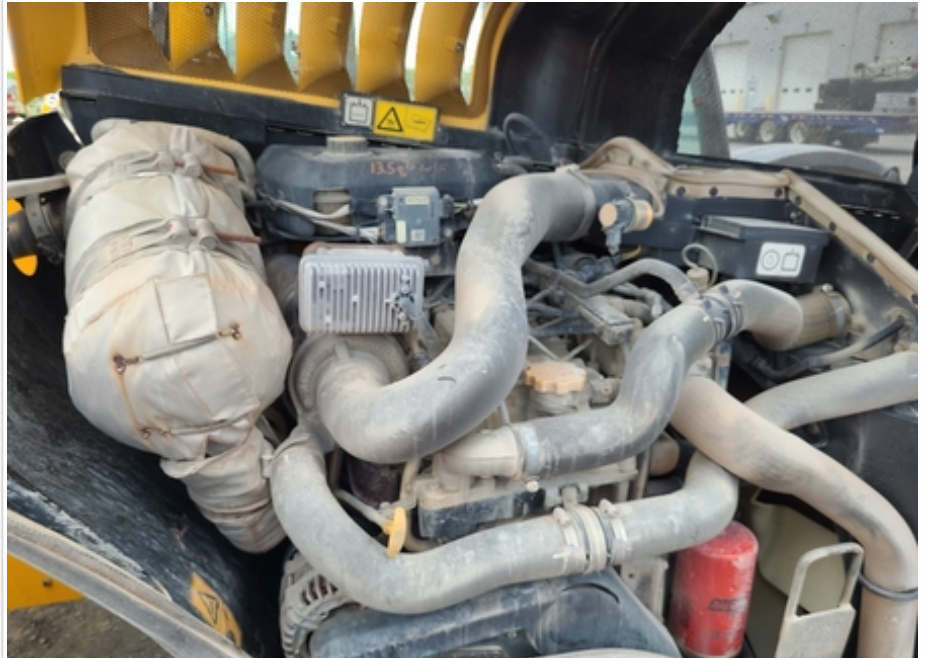
Engine Compartment

Engine Type (Make, Model, Cylinders, Hp)	JCB - 4Cyl. - 108HP - 4.4L
Emissions Tier	Tier 4F
Engine Rating	3 - Normal Wear & Tear
Engine Overall Comments	Engine in okay condition

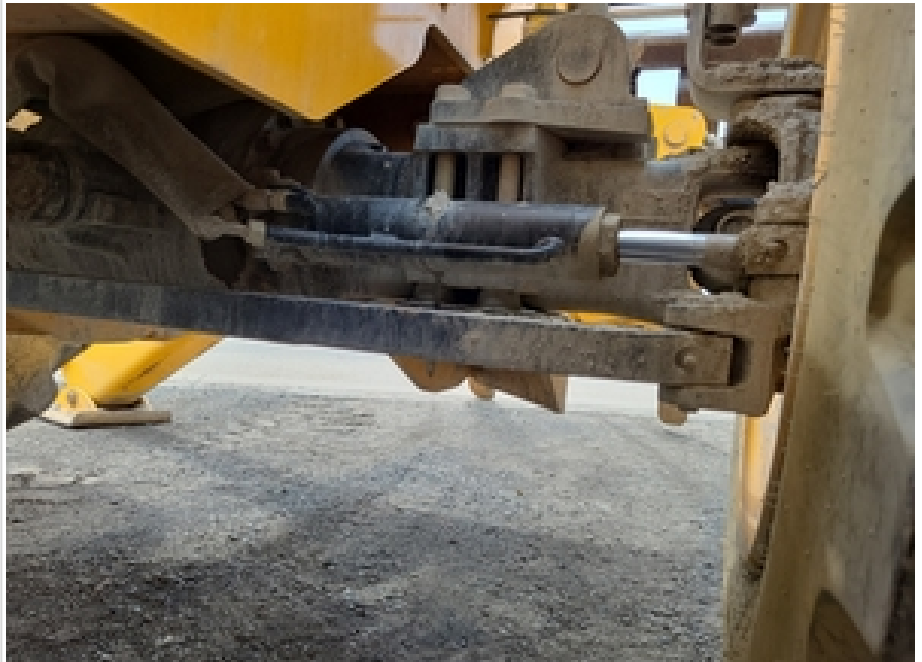
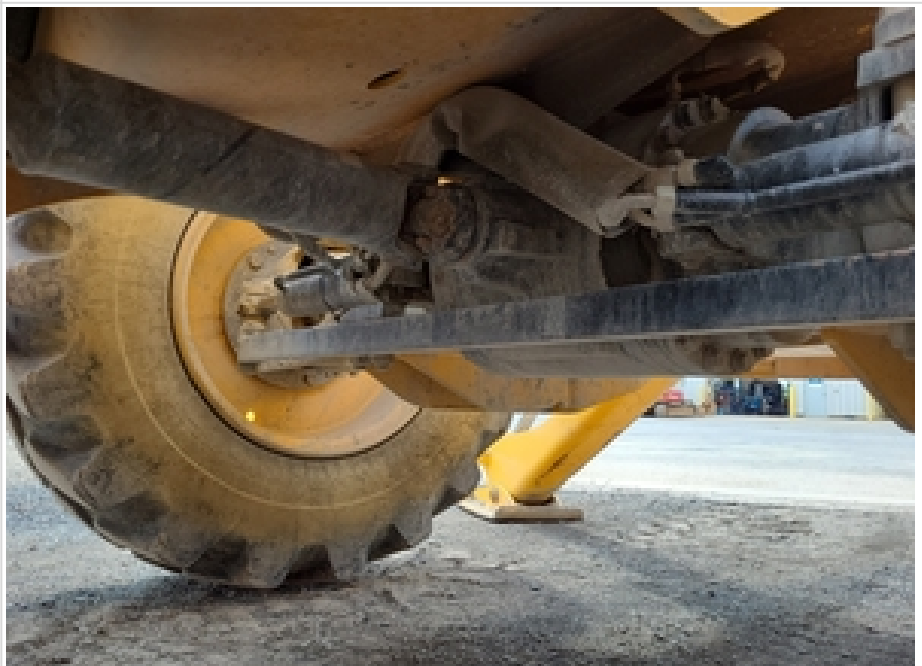
Drivetrain Photos

Hydrostatic Transmission?	No
2 Speed?	
Hydrostatic Drive Configuration	
Comments	
Transmission Info (Make/Model/Speeds)	Powershift 4spd 4x4
Drivetrain Rating	3 - Normal Wear & Tear
Drivetrain Comments	Drivetrain in good condition and working well in all directions all speeds

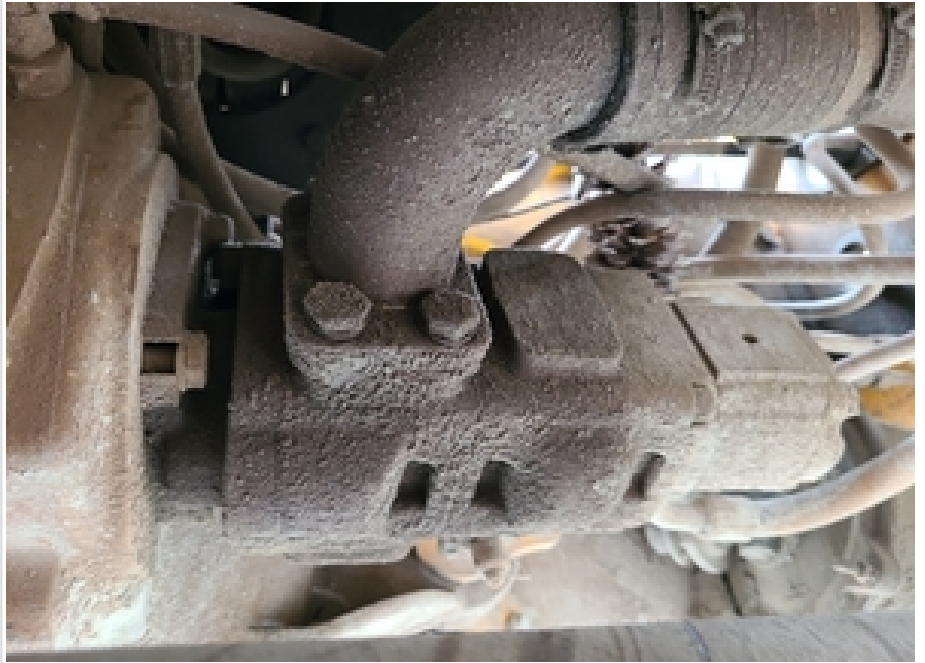
Hydraulic Pump/Fittings/Hoses

Hydraulic System Rating	3 - Normal Wear & Tear
Hydraulic System Comments	Hydraulic System in good working condition.
