Enterprise Equipment Inspection

Category	Forklift
Travel System	Wheels & Tires
Comments	
Year	2016
Make	JCB
Model	512-56
Fleet ID	10497304
Serial Number	JCB5CH2GJG2434835
Serial Number Plate

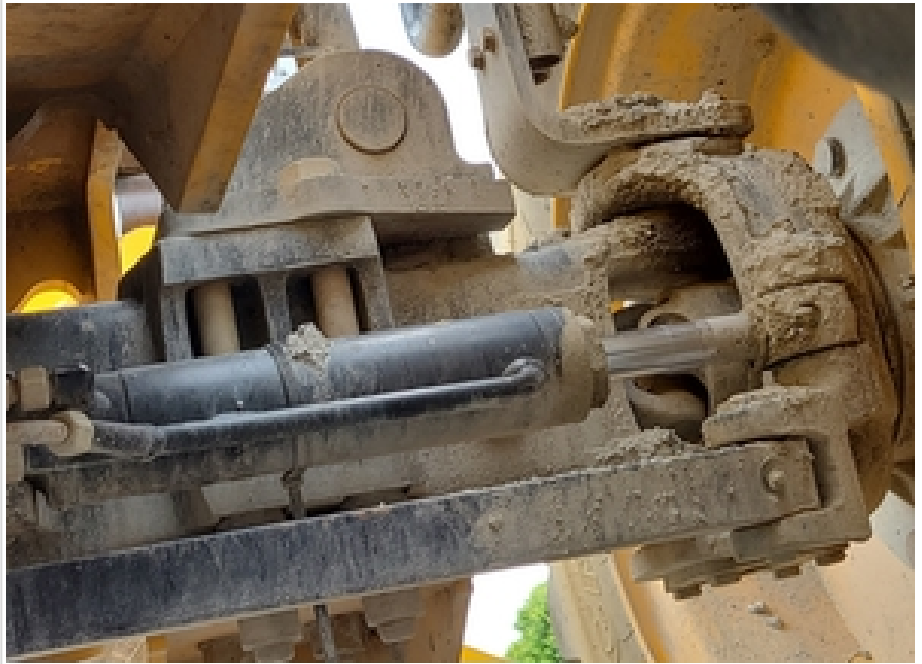
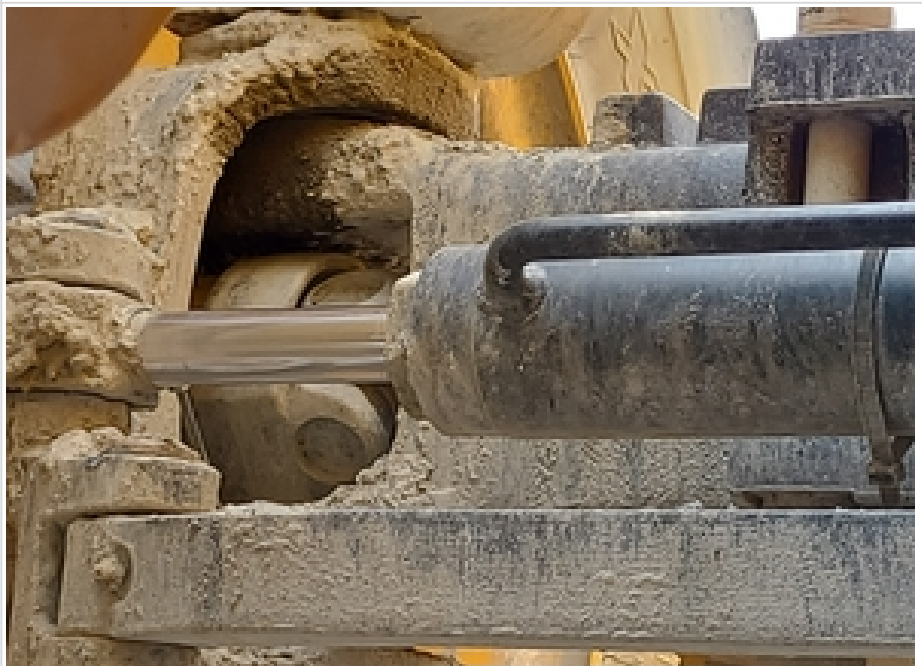
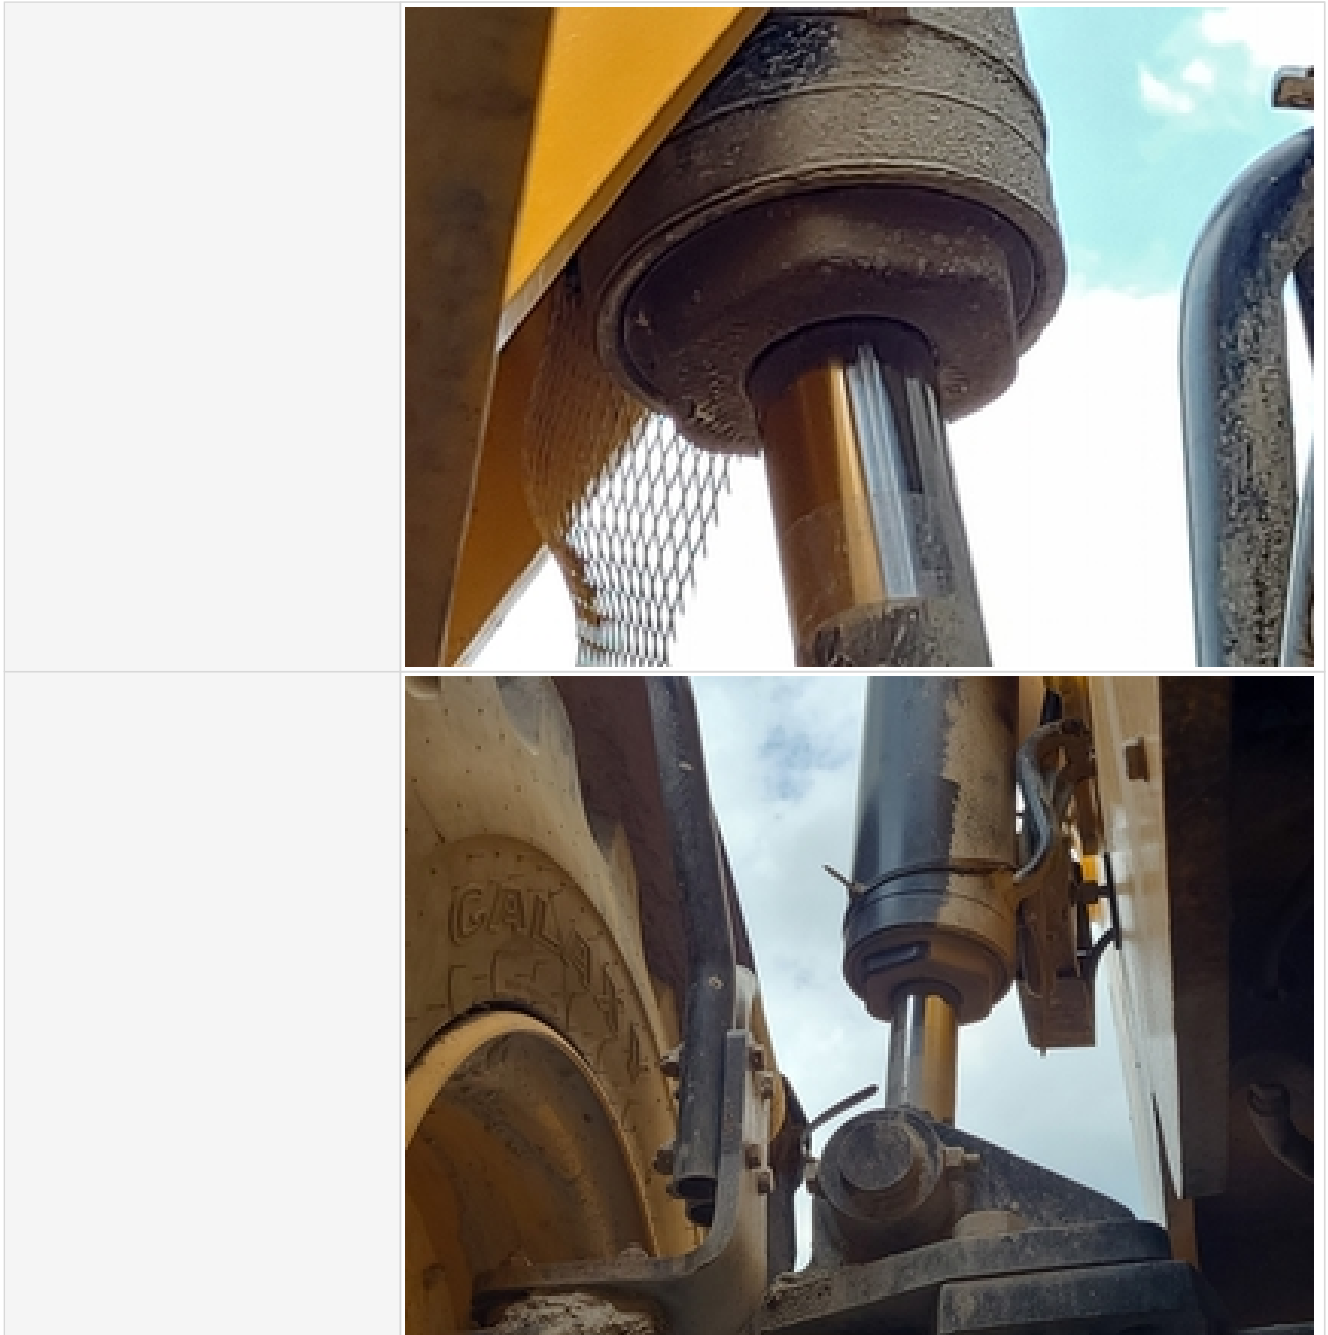
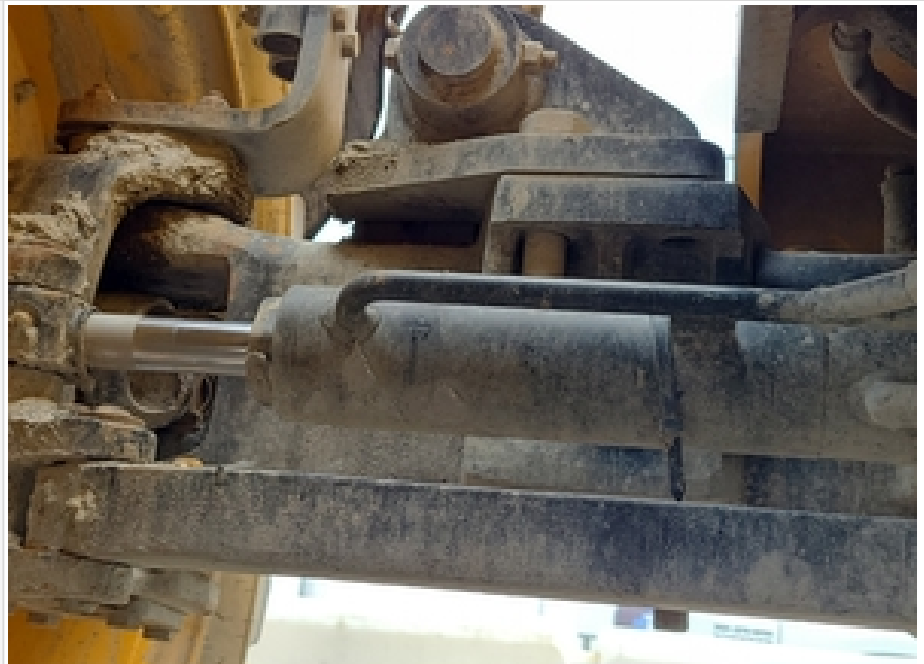
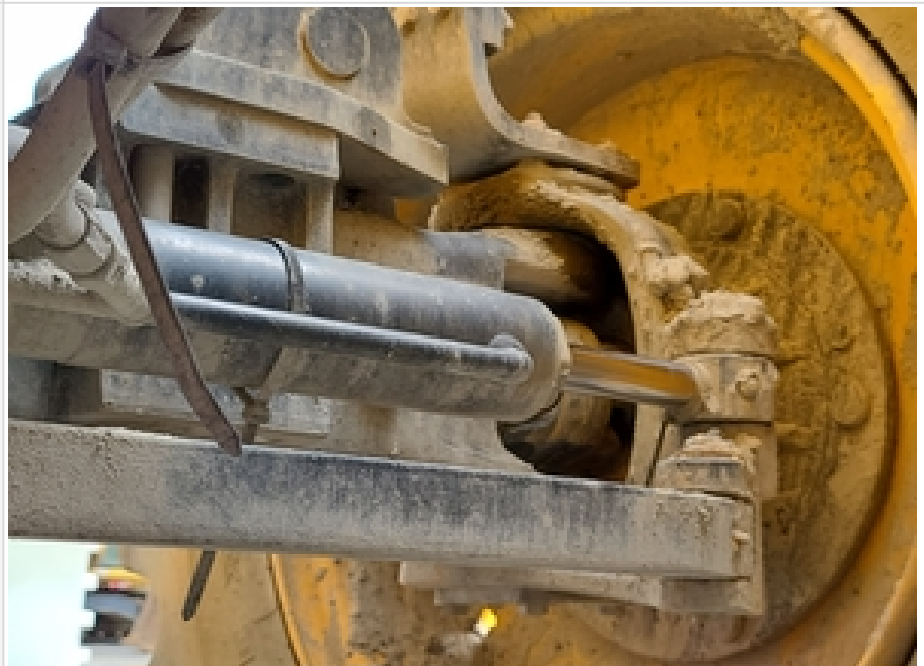
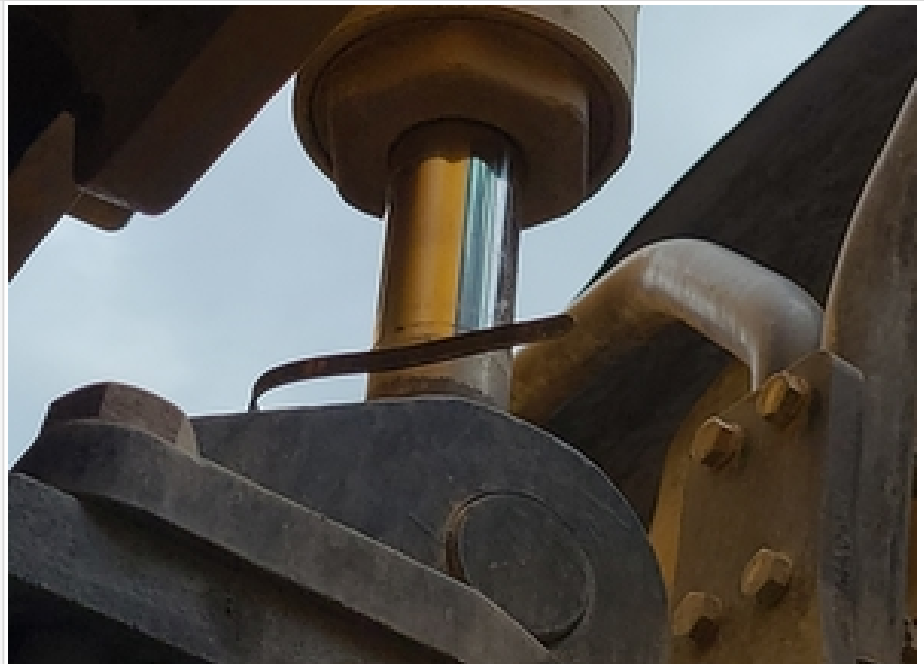
Hydraulic Cylinders & Mounting Pins

Hydraulic System Rating	3 - Normal Wear & Tear
Hydraulic System Comments	Hydraulic System in good working condition.

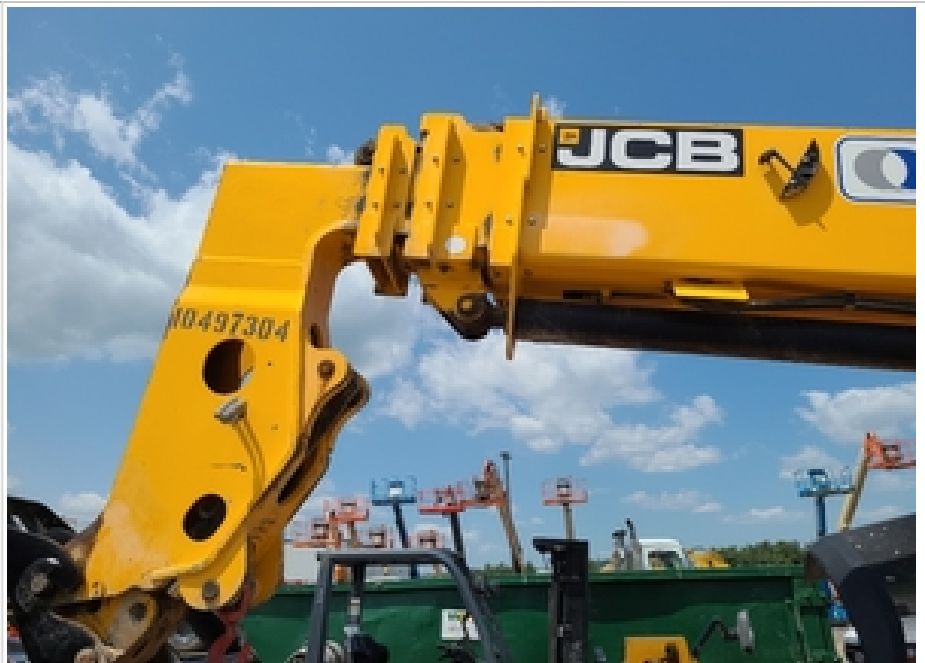
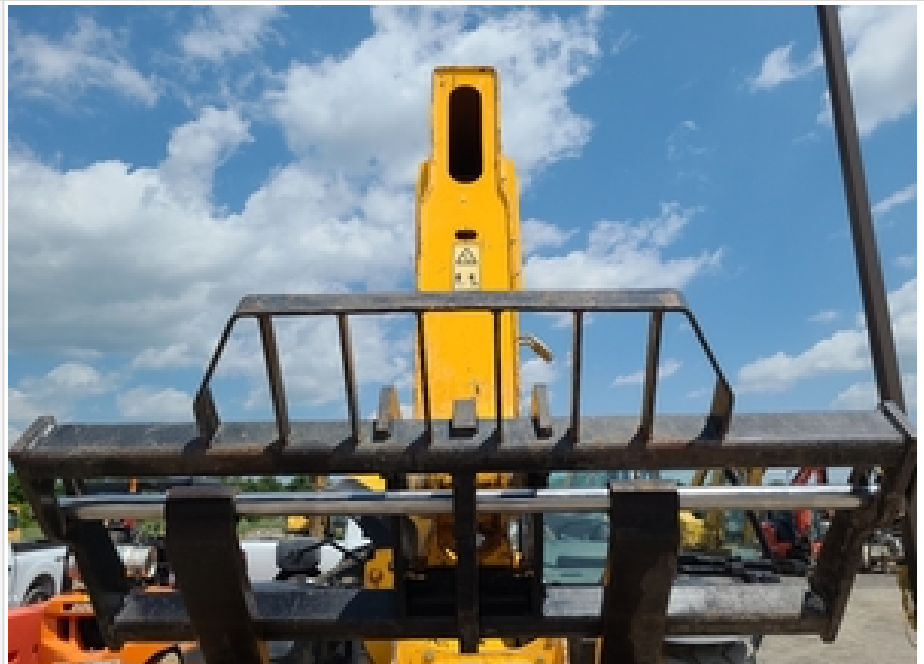
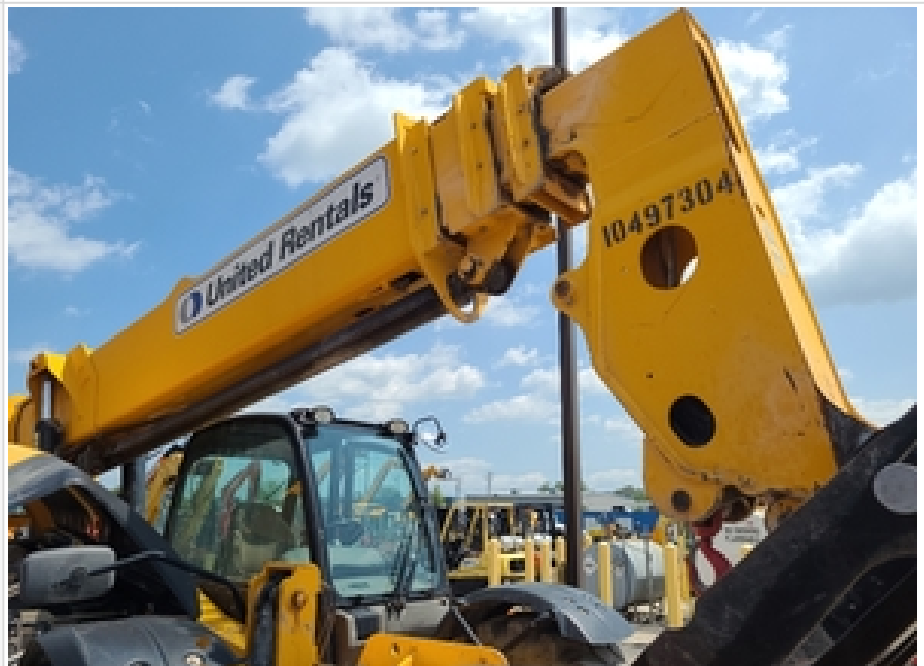
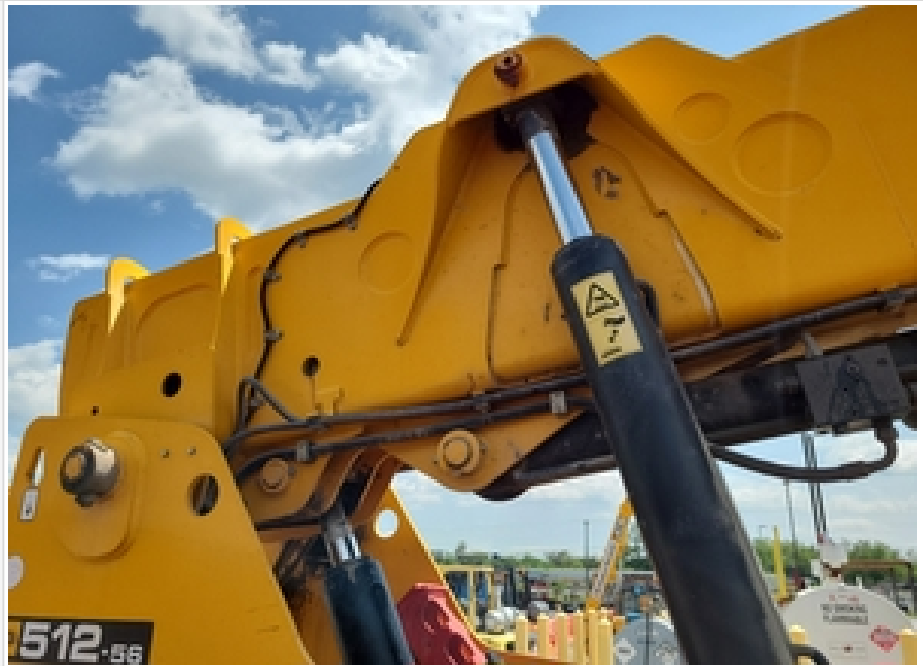
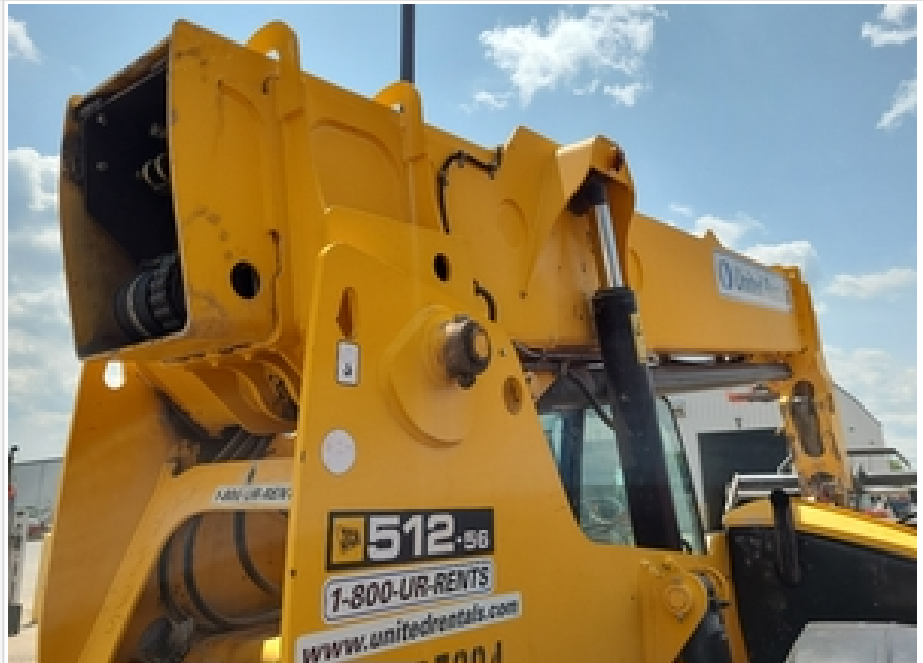
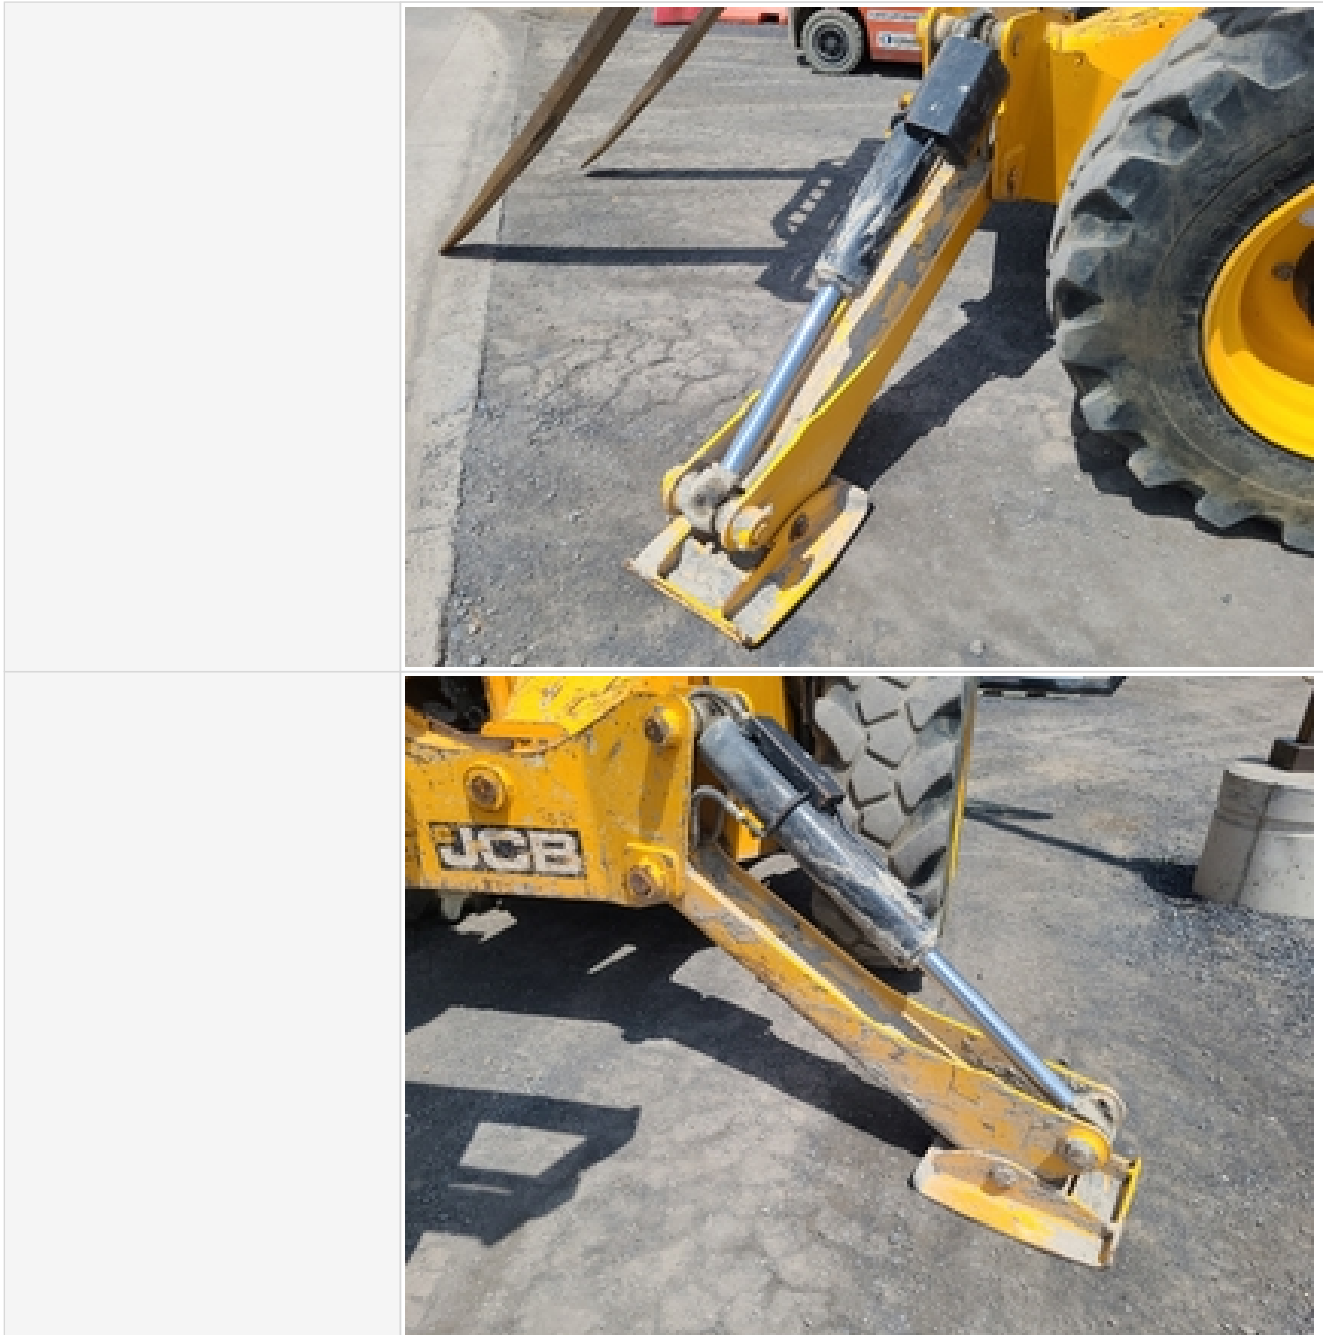
Chassis Photos

Chassis Rating	3 - Normal Wear & Tear
Comments	Frame in good condition and boom/outriggers in good shape

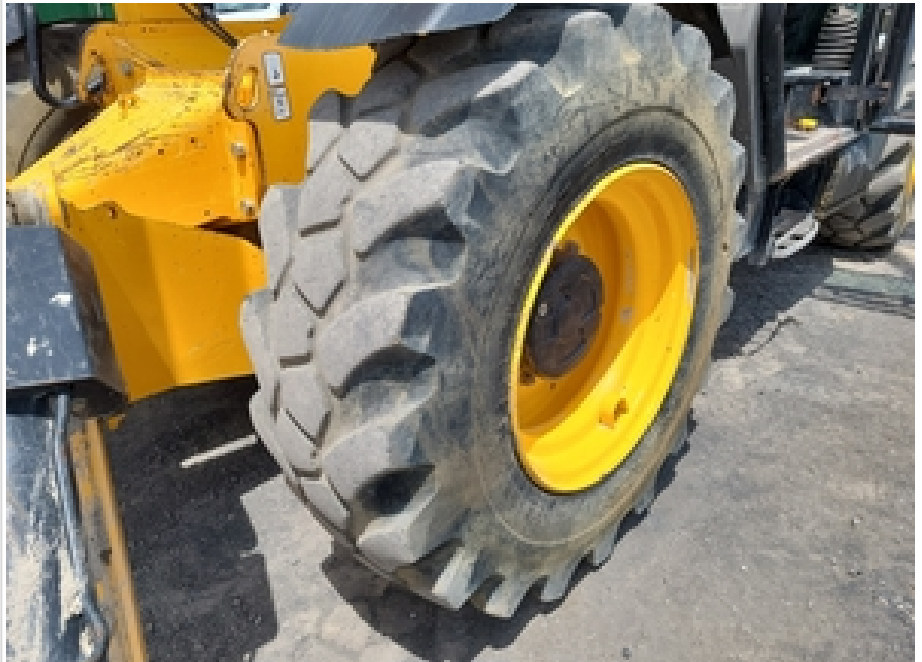
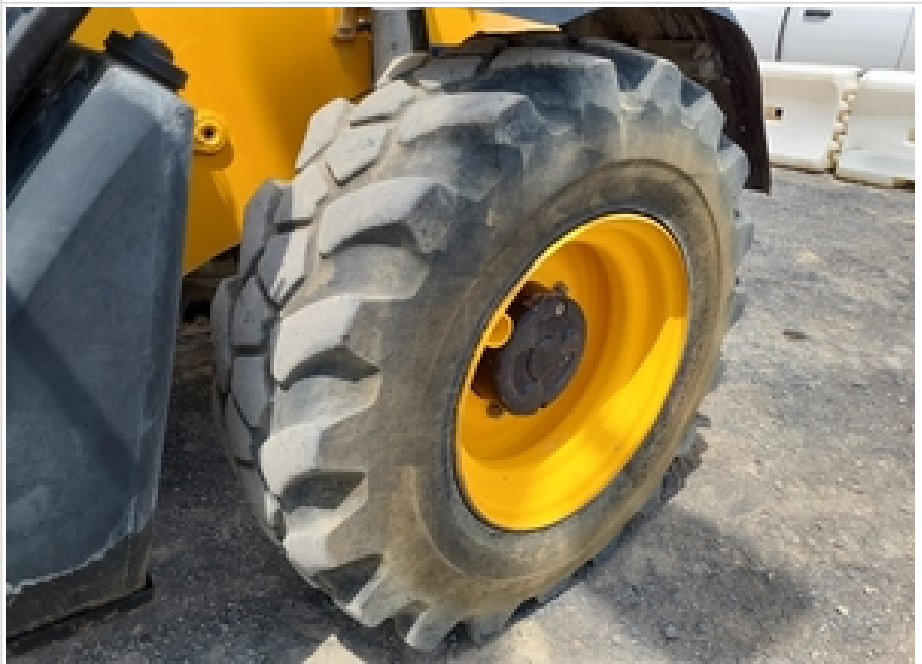
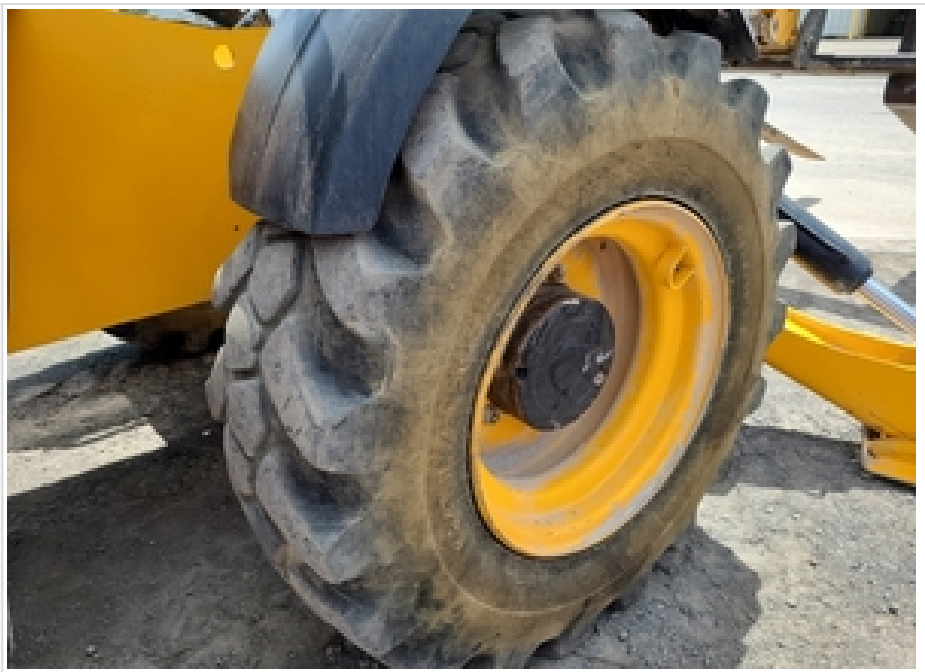
Undercarriage Photos

Undercarriage Rating	3 - Normal Wear & Tear
Undercarriage Comments	All tires Foam/Poly filled. Rear r/s tire needs to be replaced soon (missing chunk of tread)

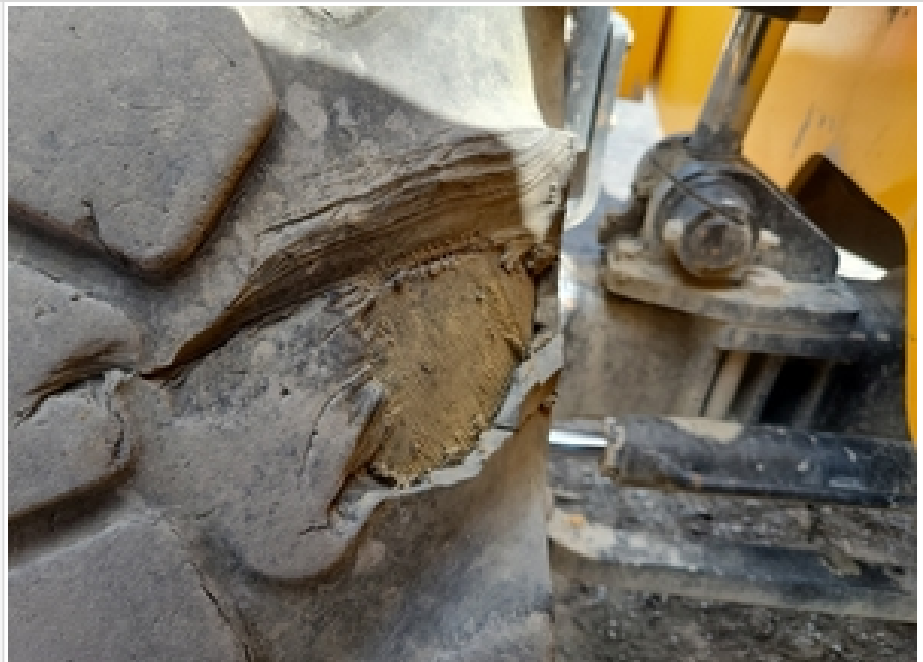
Large Rubber Tread Missing

What Needs Work	Rear R/S tire needs to be replaced soon	
Any Additional Info from the Seller?		
Date/Time	05-17-2023

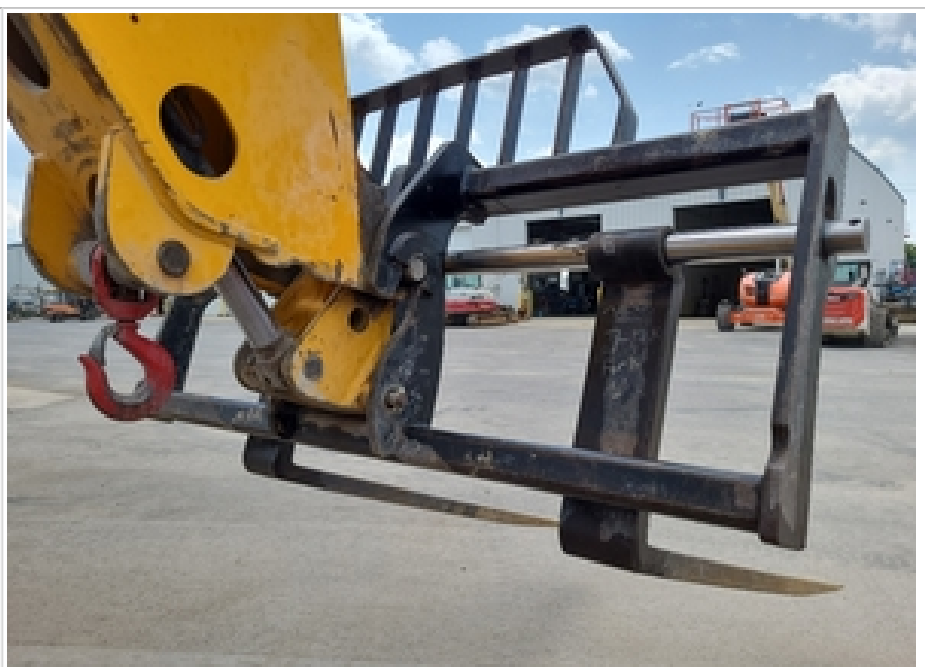
Attachment Photos

Attachment Rating	4 - Very Light or Minimal Wear
Attachment Comments	6'L x 6"W x 2"Thick. 6' Wide Backrest. 7 Ton Lifting hook attached to boom
