## Enterprise Equipment Inspection

Category	Telehandler
Travel System	Wheels & Tires
Comments	
Year	2015
Make	JCB
Model	509-42
Fleet ID	10358713
Serial Number	JCB5CFKGL02437685
Serial Number Plate

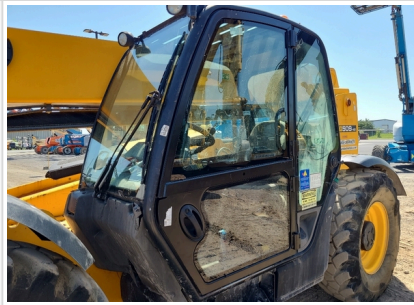
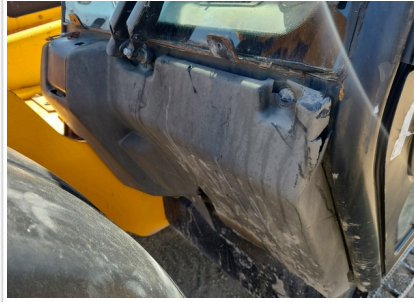
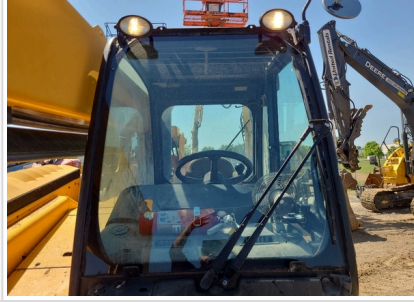
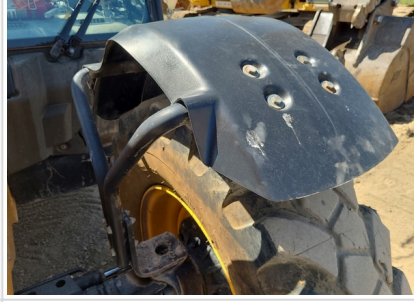
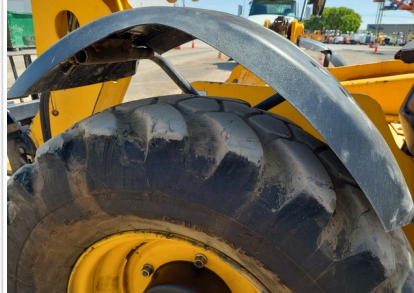
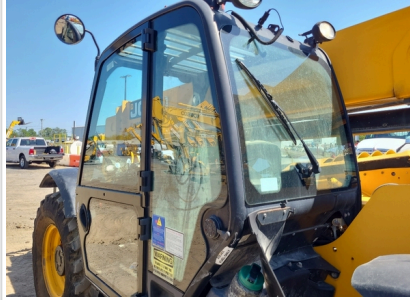
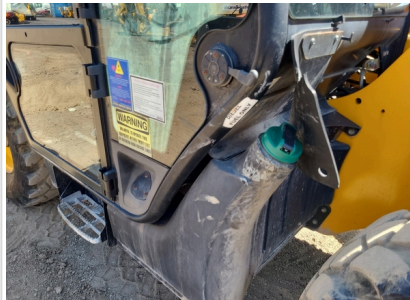
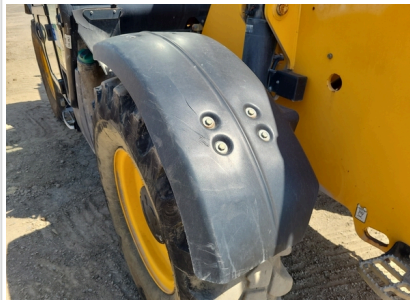
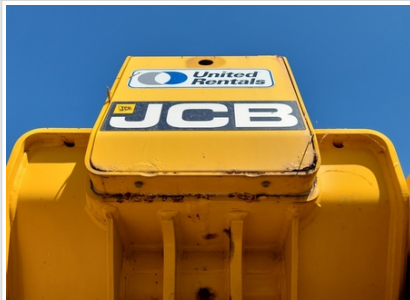
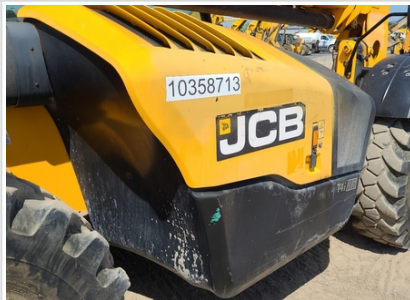
Close-Up Exterior Photos

<b>Exterior Rating</b>	3 - Normal Wear & Tear	
<b>Exterior Comments</b>	Some dents on engine hood. Front Cab Exterior panel plastic cracked.

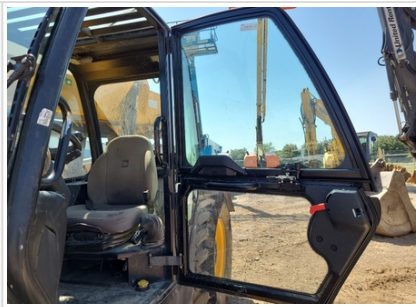
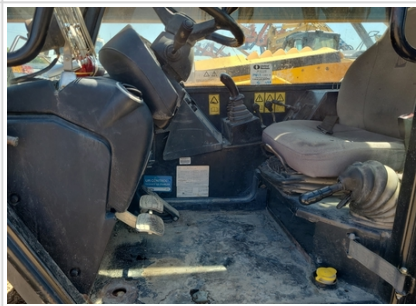
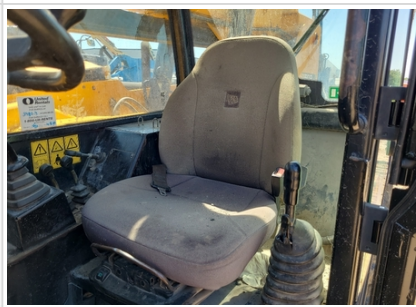
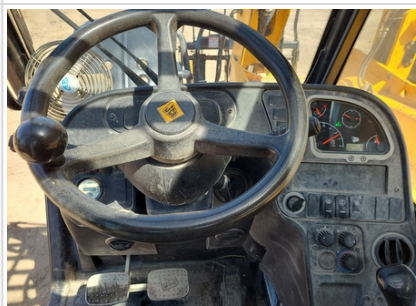
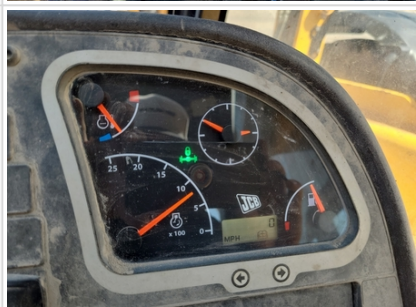
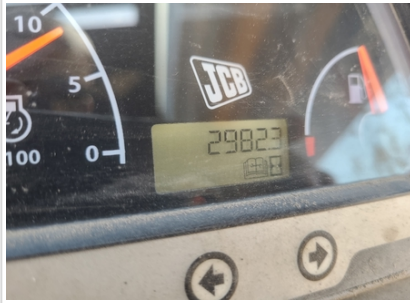
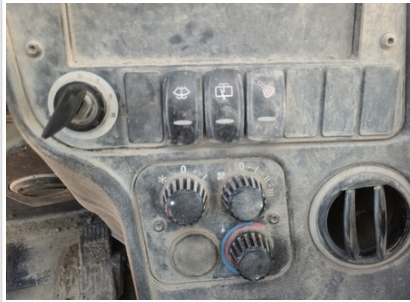
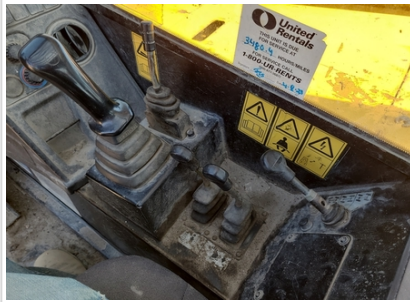
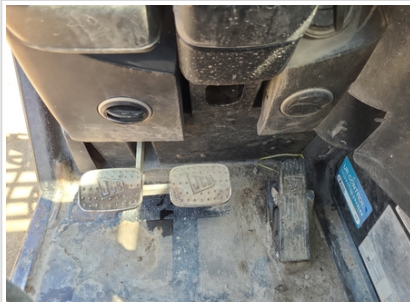
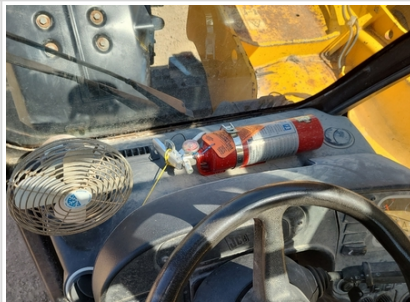
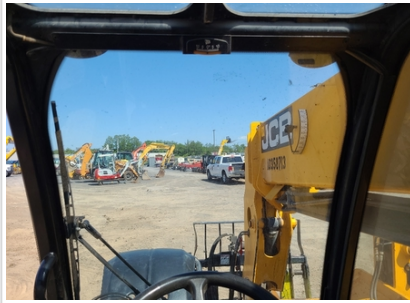
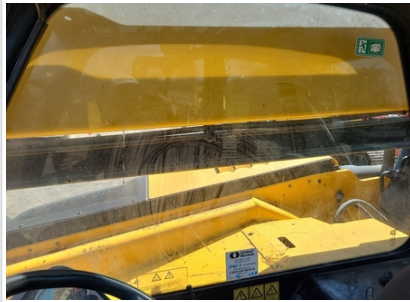
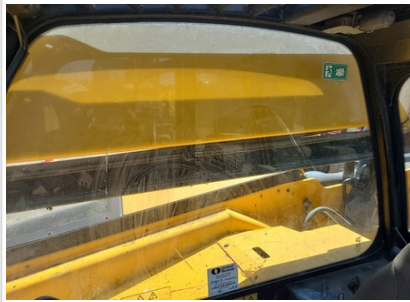
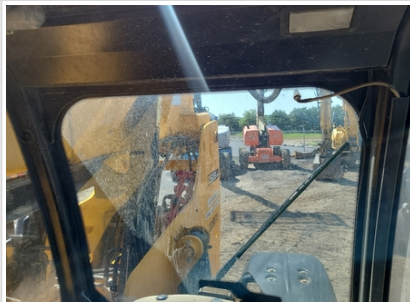
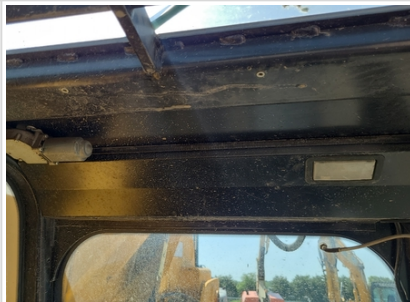
Control Station

<b>Control Station Rating</b>	3 - Normal Wear & Tear	
<b>Control Station Overall Comments</b>	Normal wear and tear. Fault code present at monitor panel.

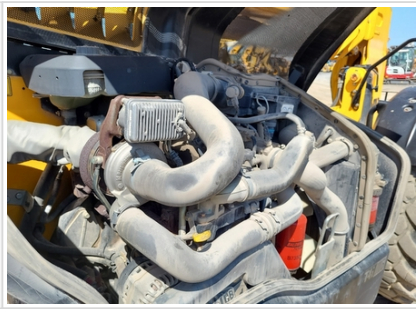
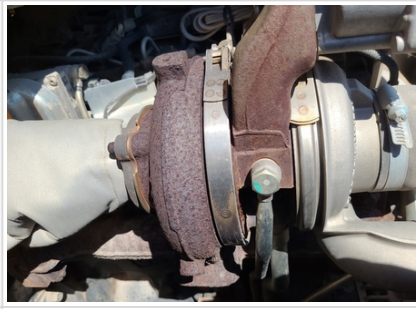
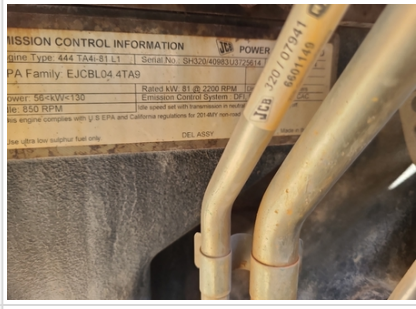
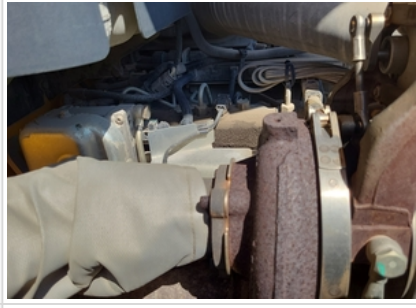
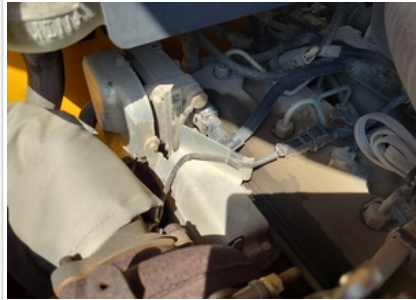
<b>Engine Compartment</b>

<b>Engine Type (Make, Model, Cylinders, Hp)</b>	JCB - 4.4L - 108HP - 4Cyl	
<b>Emissions Tier</b>	Tier 3	
<b>Engine Rating</b>	3 - Normal Wear & Tear

Engine Overall Comments	Engine in well maintained condition.
-------------------------	--------------------------------------

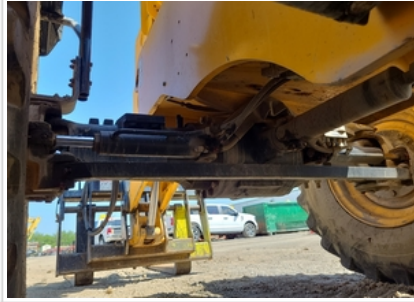
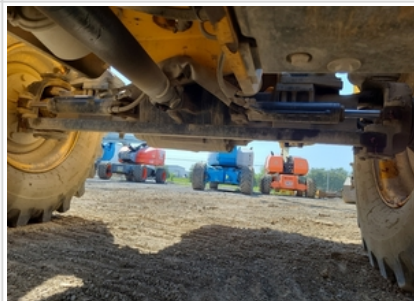
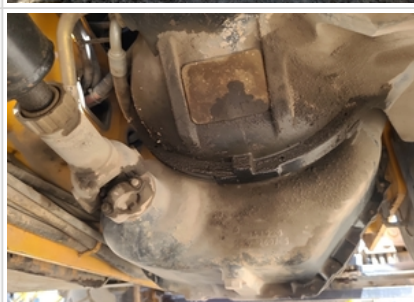
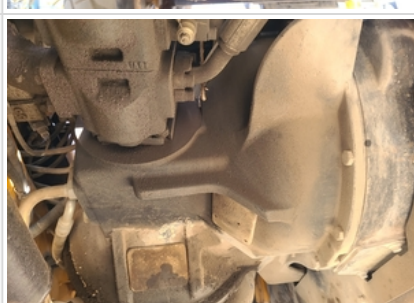
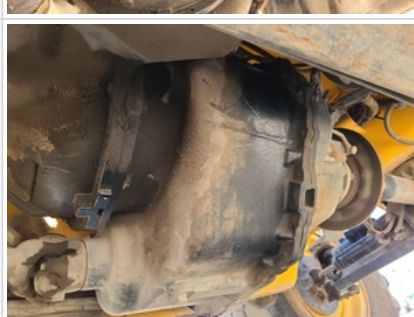
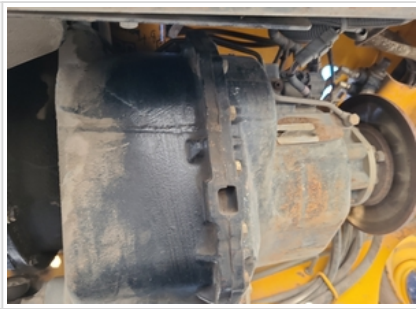
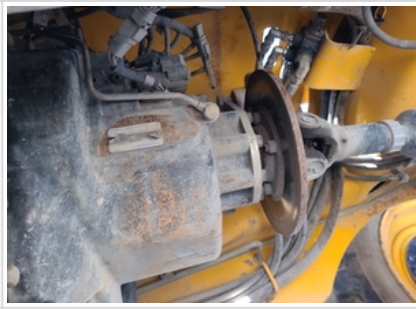
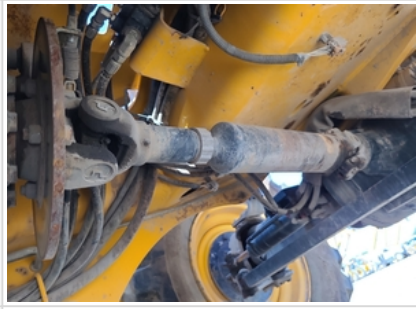
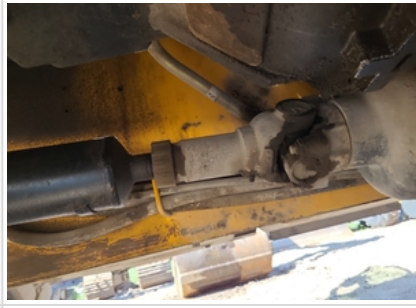
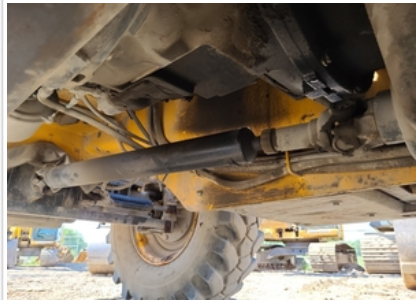
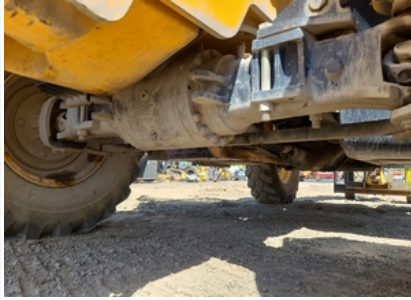
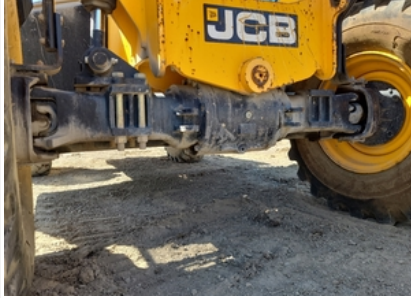
Drivetrain Photos

Hydrostatic Transmission?	No	
2 Speed?		
Hydrostatic Drive Configuration		
Comments		
Transmission Info (Make/Model/Speeds)	Powershift 4Spd	
Drivetrain Rating	3 - Normal Wear & Tear	
Drivetrain Comments	Transmission works well in all directions.

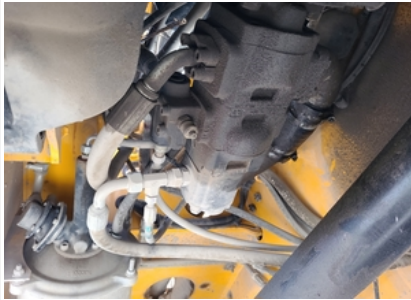
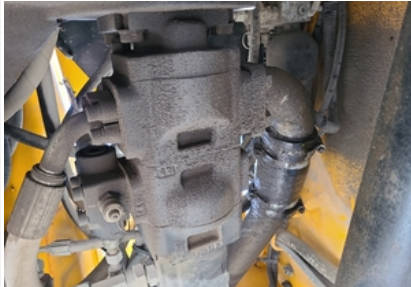
Hydraulic Pump/Fittings/Hoses

<b>Hydraulic System Rating</b>	3 - Normal Wear & Tear	
<b>Hydraulic System Comments</b>	Front r/s steer cylinder has some seepage. Minor leak at hydraulic pump hoses.

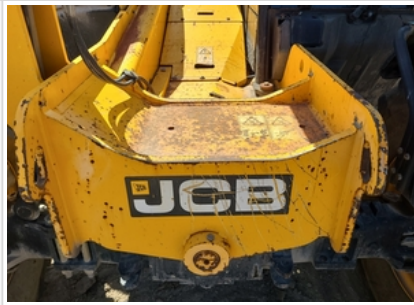
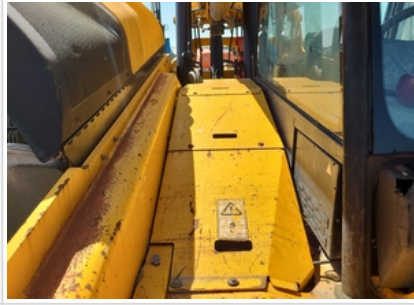
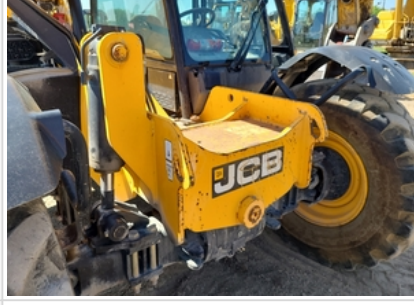
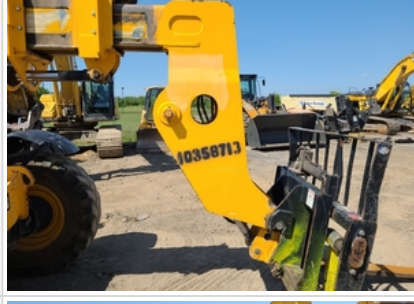
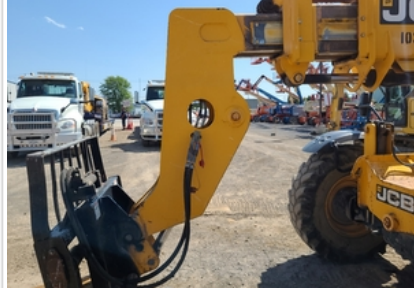
Chassis Photos

<p><b>Chassis Rating</b></p>	<p>3 - Normal Wear &amp; Tear</p>
<p><b>Comments</b></p>	<p>Frame and implements in good condition .</p>

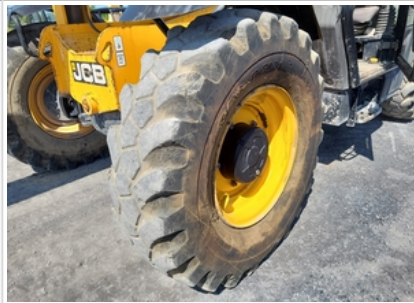
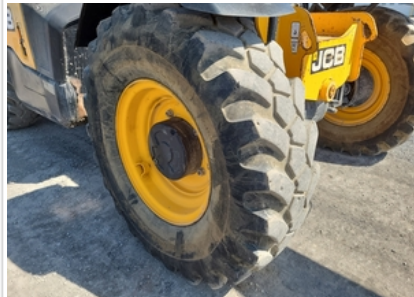
<p><b>Undercarriage Photos</b></p>

<b>Undercarriage Rating</b>	3 - Normal Wear & Tear	
<b>Undercarriage Comments</b>	All tires foam filled and have about 20% of tread life left
