Enterprise Equipment Inspection

Category	Excavator
Travel System	Track Undercarriage
Comments	
Year	2017
Make	Kobelco
Model	SK210 LC
Fleet ID	310835NF
Serial Number	YQ13 - 10835
Serial Number Plate

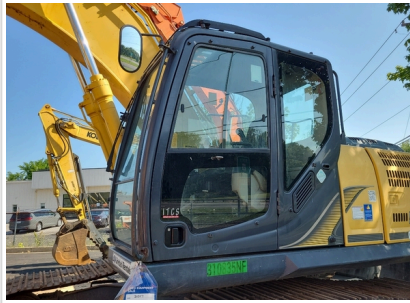
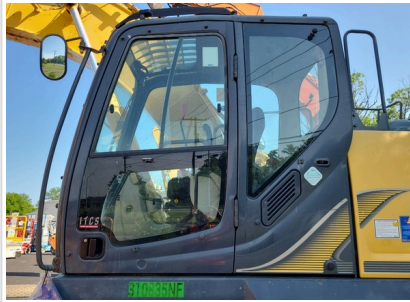
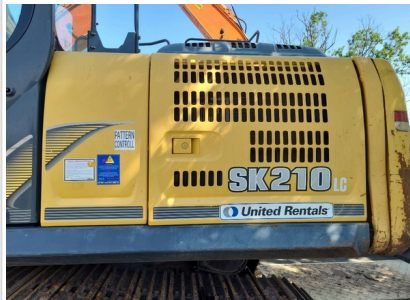
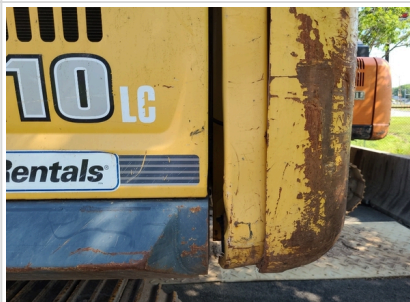
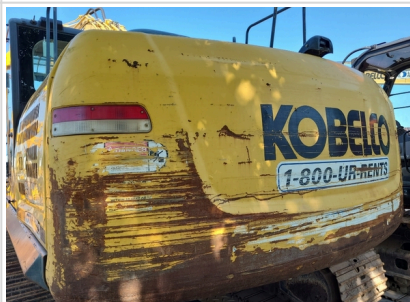
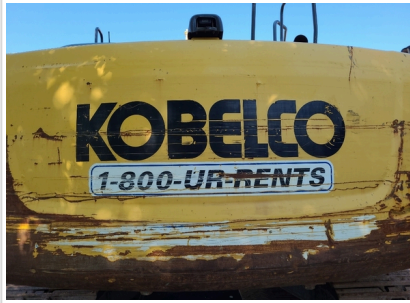
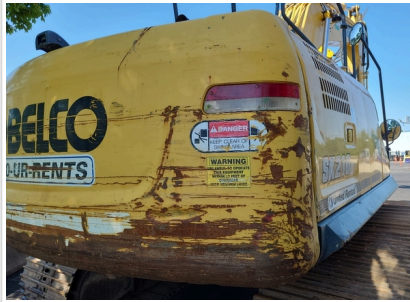
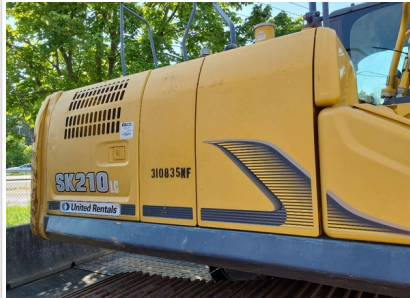
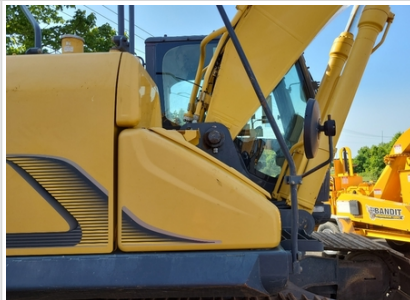
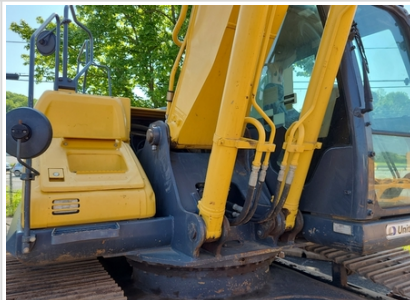
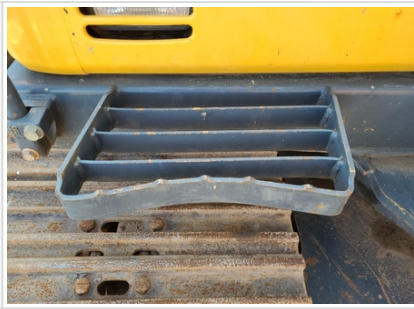
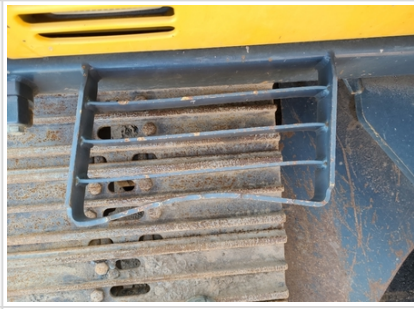
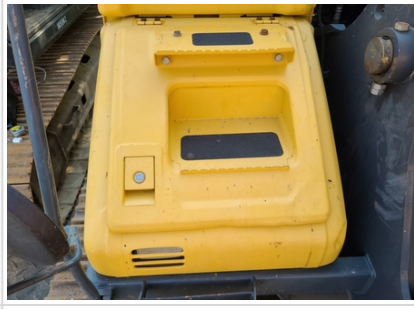
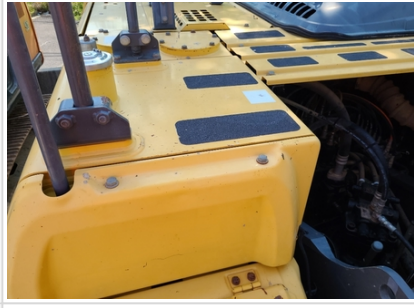
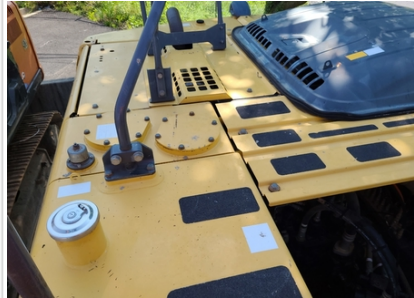
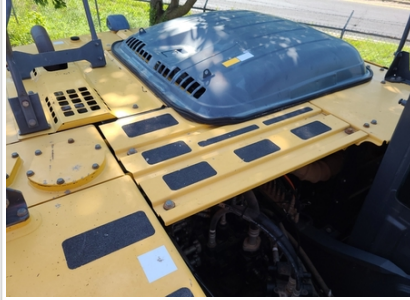
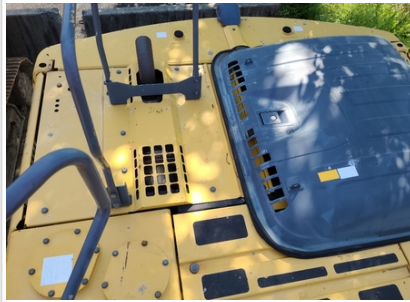
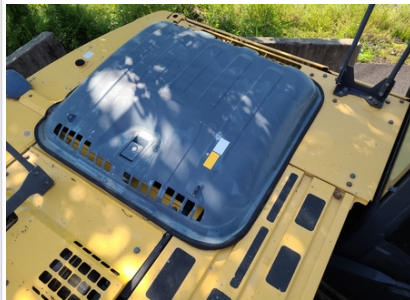
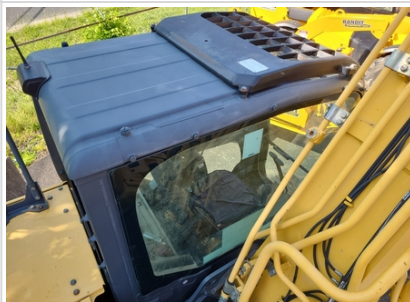
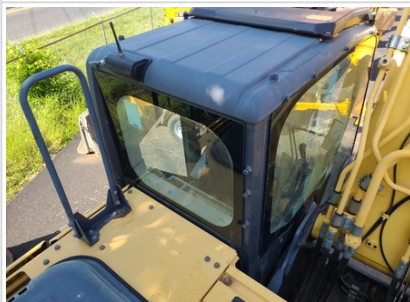
General Appearance

Exterior Rating	3 - Normal Wear & Tear
Exterior Comments	Some minor dents and scuff marks on all sides. Front r/s step bent

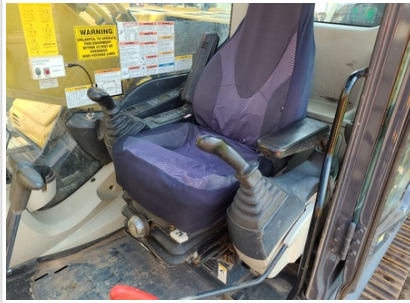
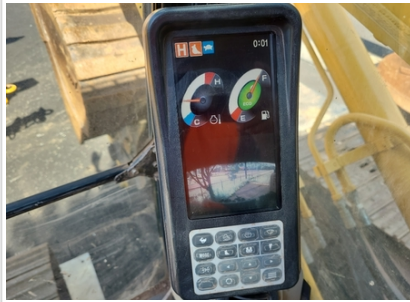
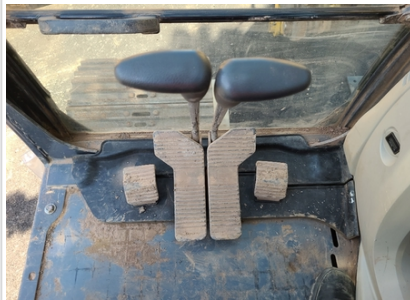
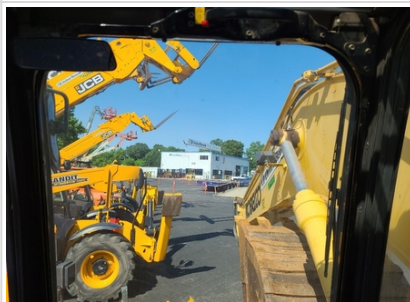
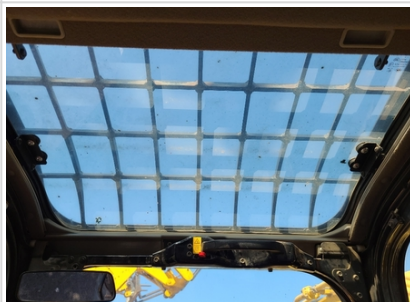
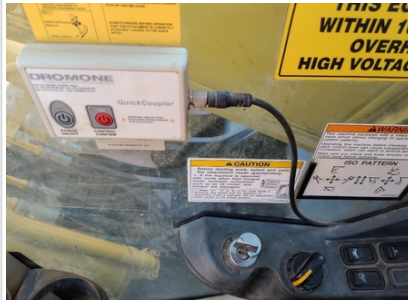
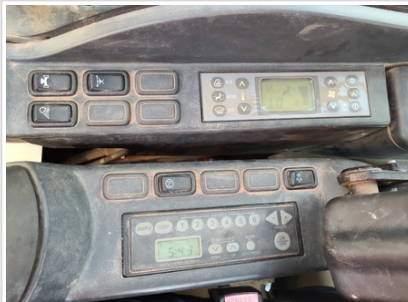
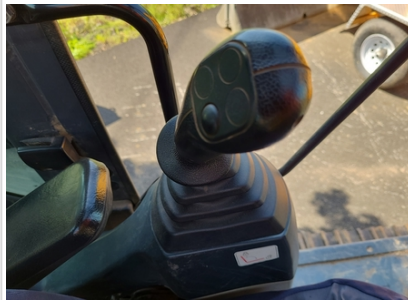
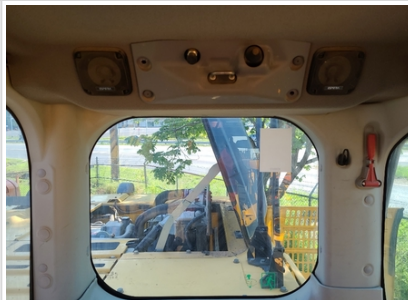
Control Station Rating	3 - Normal Wear & Tear
Control Station Overall Comments	Operator cab in good shape. Seat upholstery damaged.

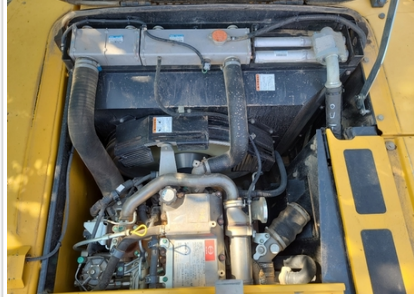
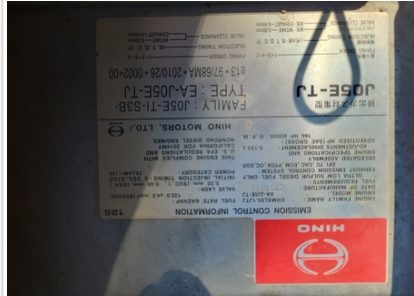
Engine Compartment

Engine Type (Make, Model, Cylinders, Hp)	Hino - 6Cyl - 166HP - 5.1L	
Emissions Tier	Tier 4i	
Engine Rating	3 - Normal Wear & Tear	
Engine Overall Comments	Engine has a clean, well maintained appearance. Engine sounds healthy at idle and under load.

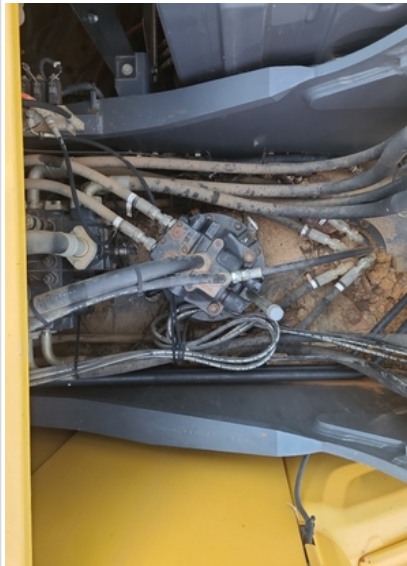
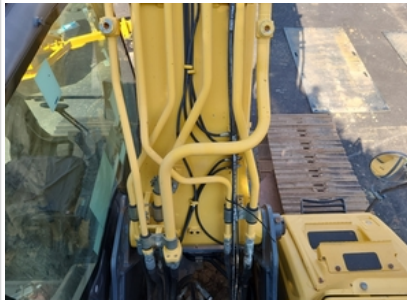
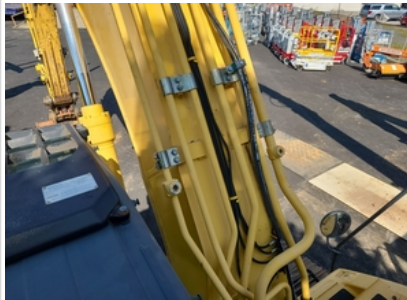
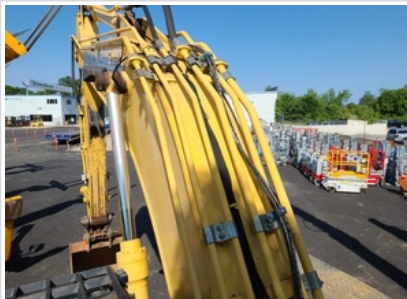
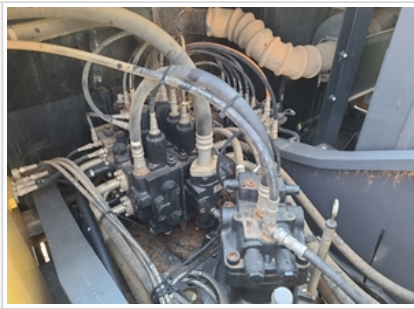
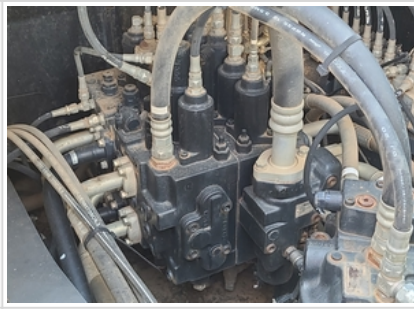
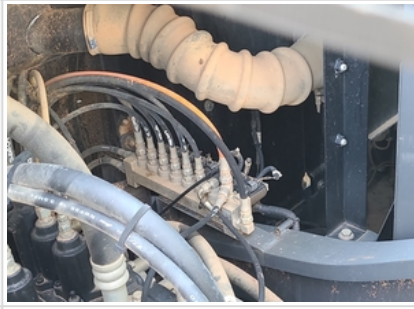
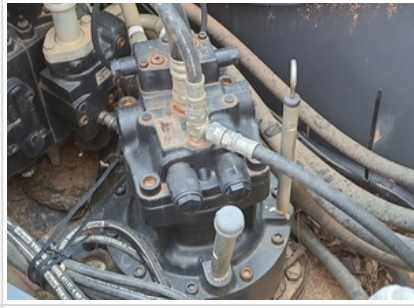
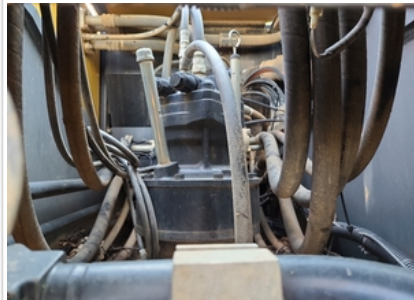
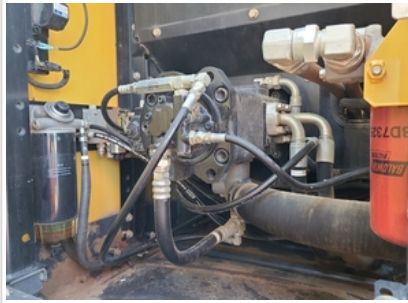
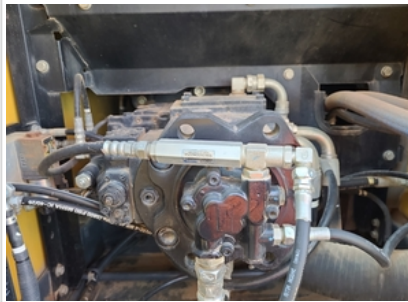
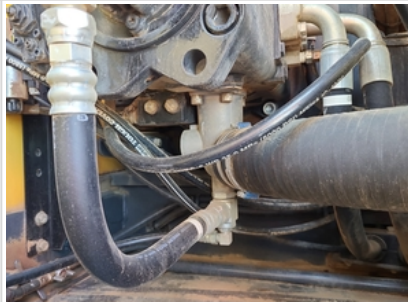
Hydraulic Pump/Fittings/Hoses

Hydraulic System Rating	4 - Very Light or Minimal Wear	
Hydraulic System Comments	Hydraulics in great condition with no active leaks seen from any major component.

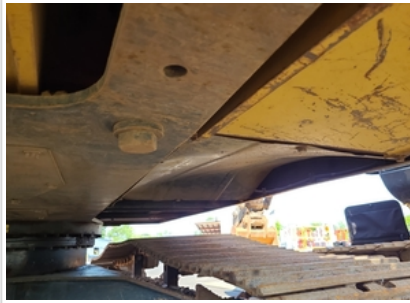
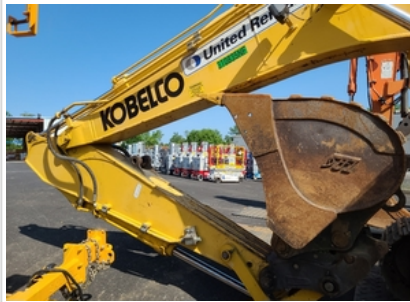
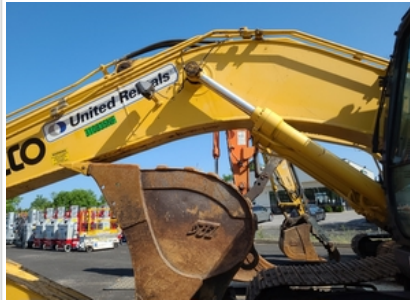
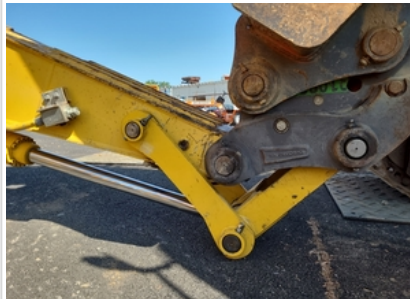
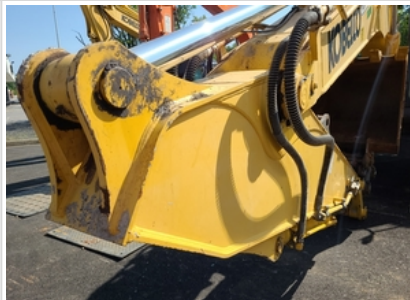
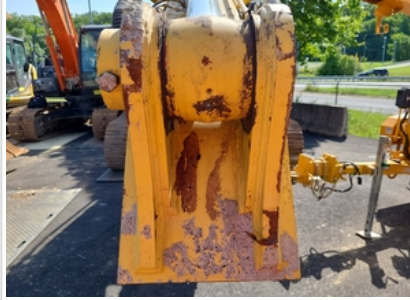
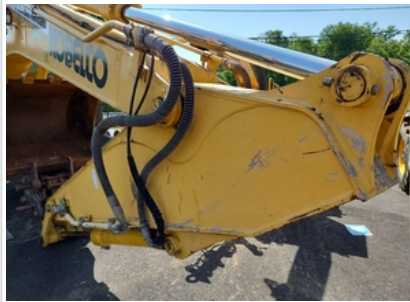
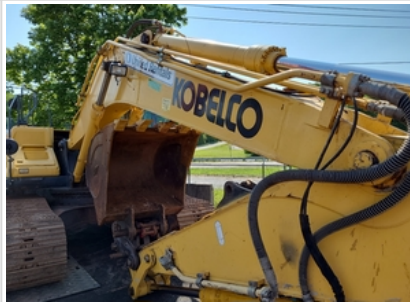
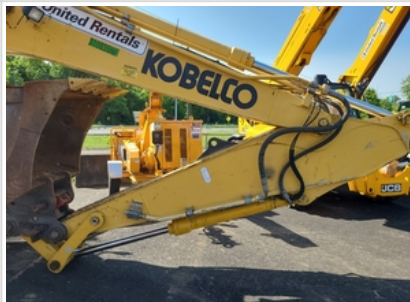
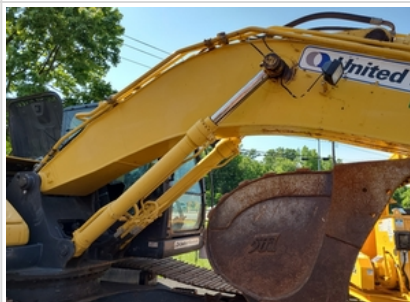
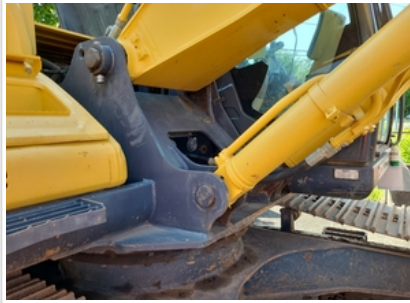
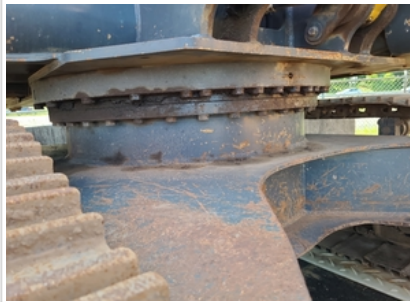
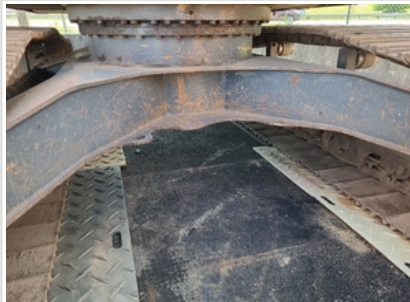
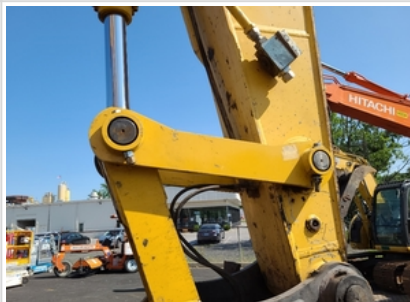
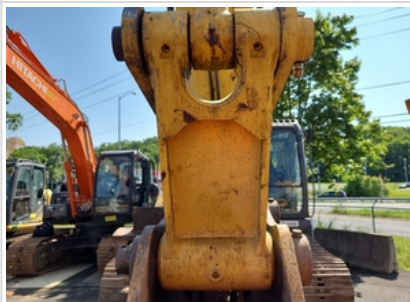
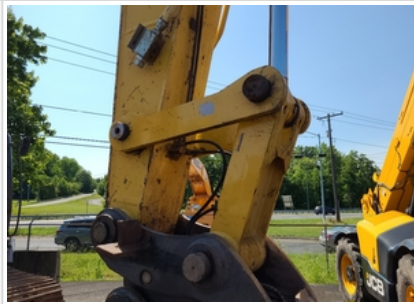
Chassis Photos

Chassis Rating	3 - Normal Wear & Tear
Comments	Main frame and implements in solid shape.

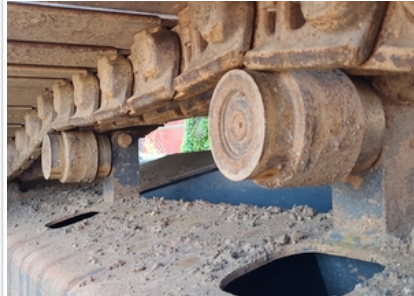
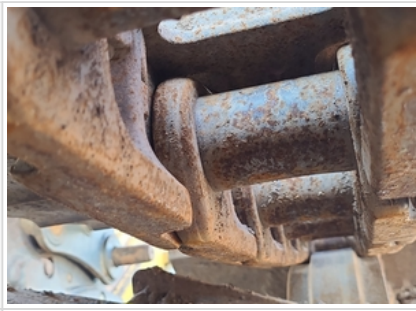
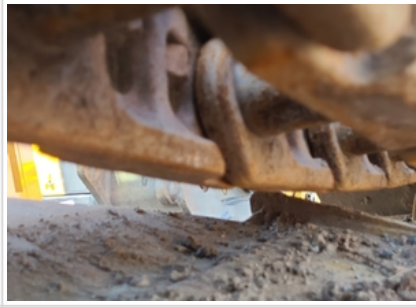
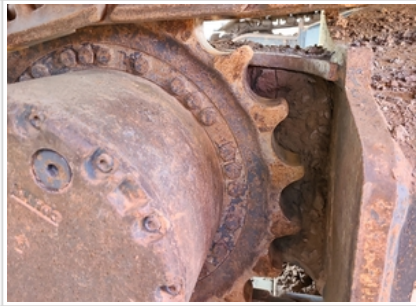
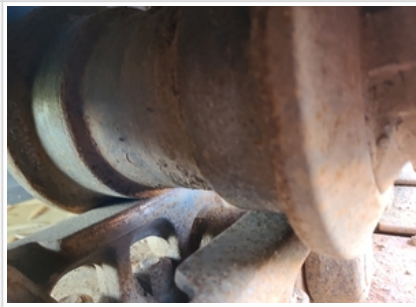
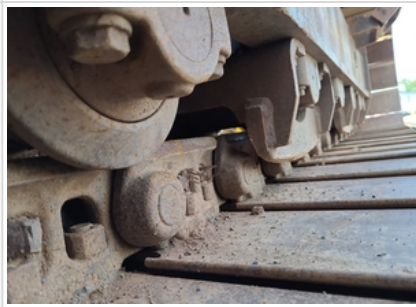
Undercarriage Photos

Undercarriage Rating	3 - Normal Wear & Tear	
Undercarriage Comments	Undercarriage in great condition.

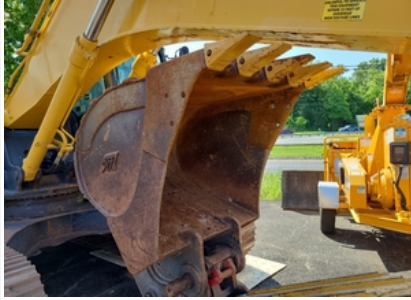
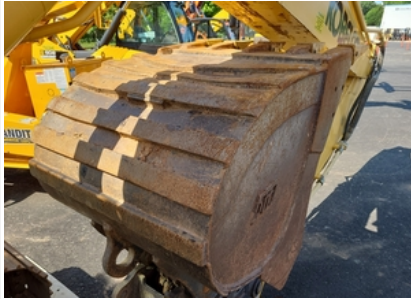
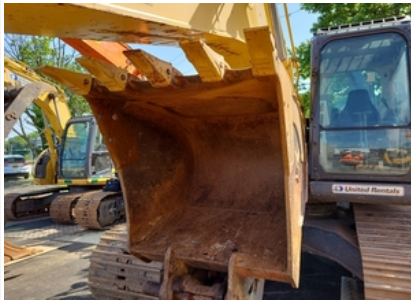
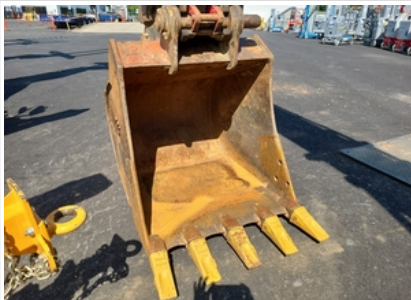
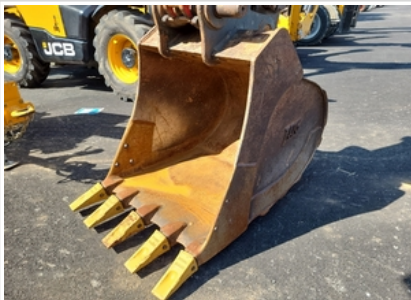
Attachment Photos

Attachment Rating	3 - Normal Wear & Tear	
Attachment Comments	41" bucket
