Enterprise Equipment Inspection

Category	Excavator
Travel System	Track Undercarriage
Comments	
Year	2016
Make	Kobelco
Model	SK140SRLC - 3
Fleet ID	10468734
Serial Number	YH07 - 10075
Serial Number Plate

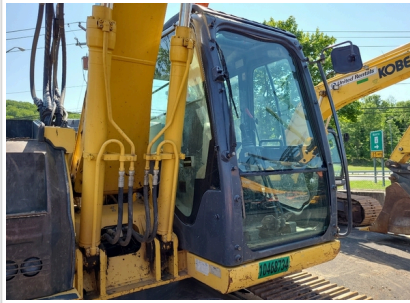
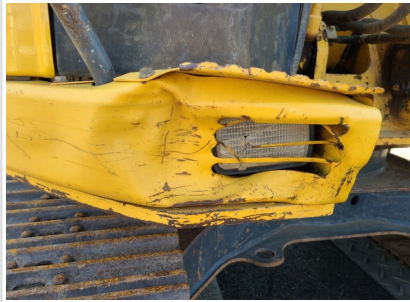
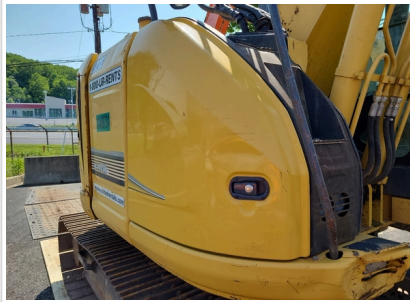
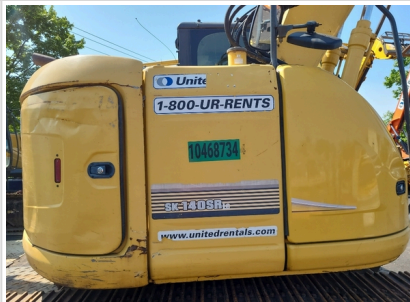
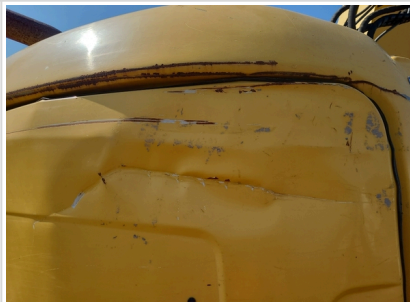
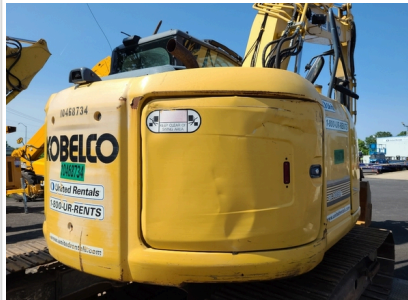
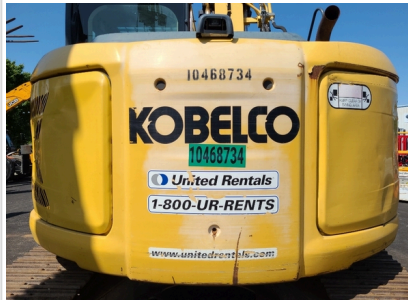
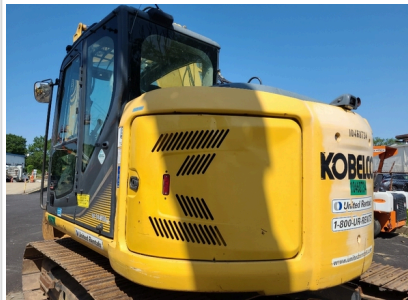
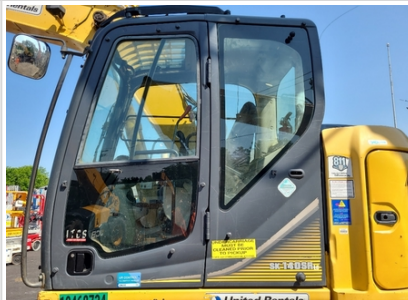
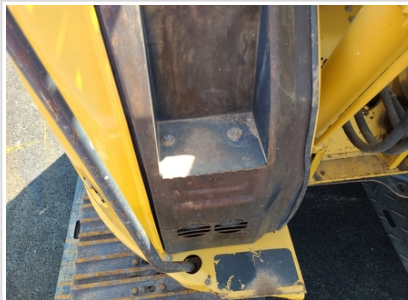
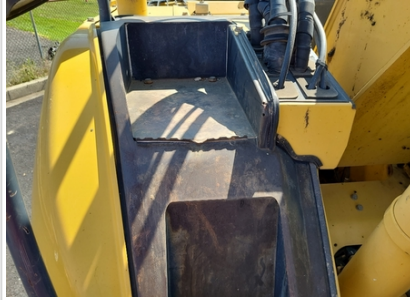
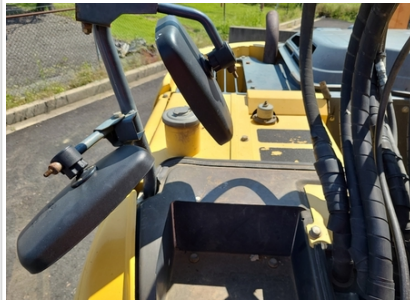
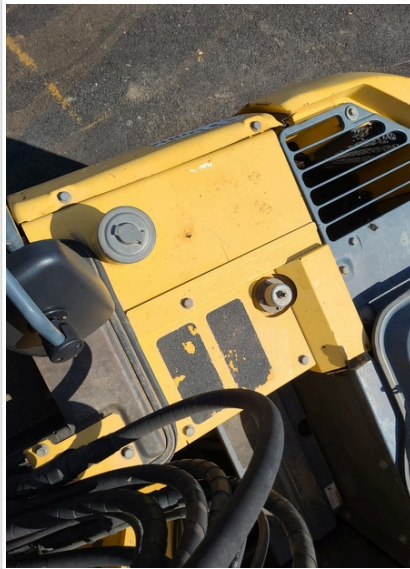
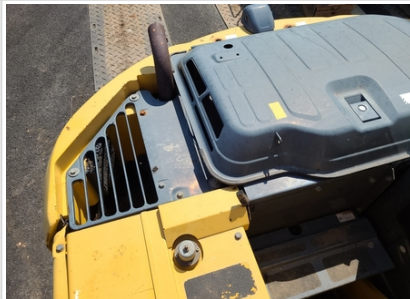
General Appearance

Exterior Rating	3 - Normal Wear & Tear	
Exterior Comments	Dents and scuff marks all around exterior panels. Front r/s, light fixture panel damaged.

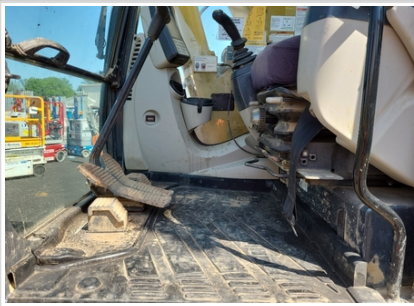
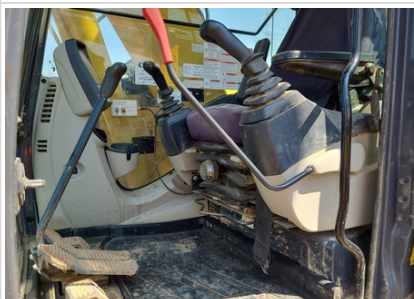
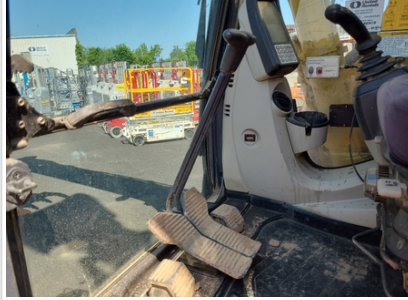
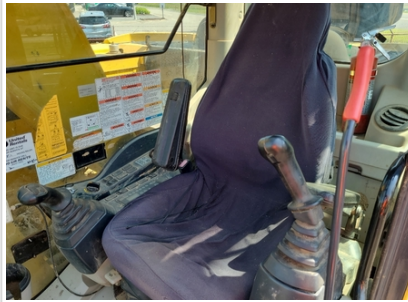
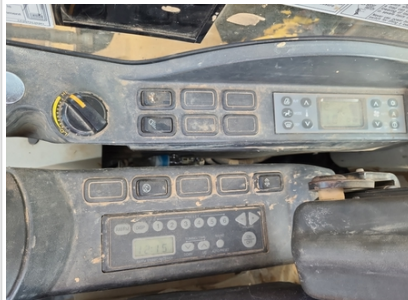
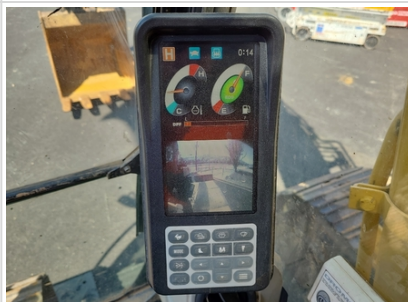
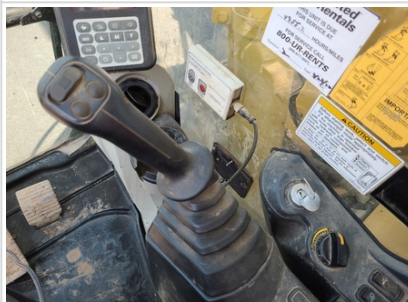
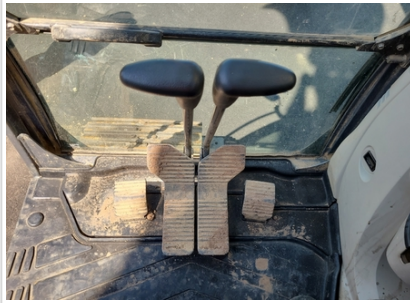
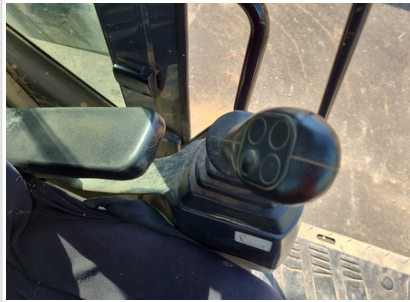
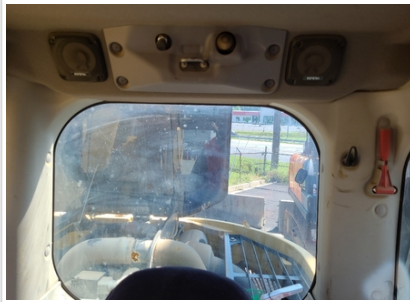
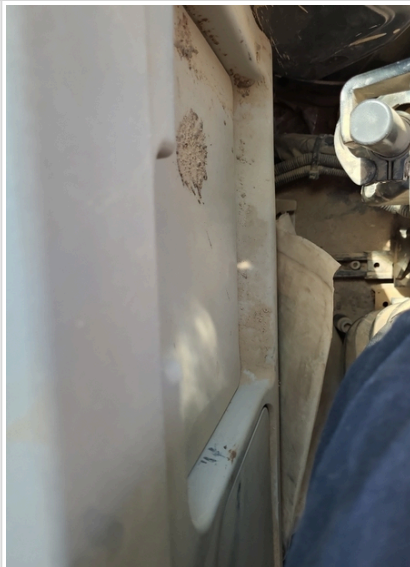
Control Station Rating	3 - Normal Wear & Tear	
Control Station Overall Comments	Seat upholstery torn. Cab in good condition.

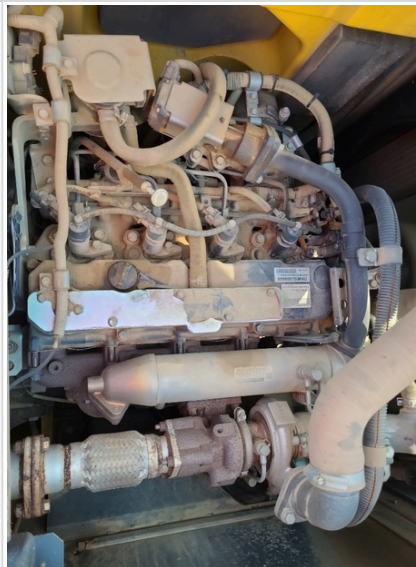
Engine Compartment

Engine Type (Make, Model, Cylinders, Hp)	Mitsubishi - 4Cyl. - 99HP - 3.3L	
Emissions Tier	Tier 4i	
Engine Rating	3 - Normal Wear & Tear	
Engine Overall Comments	Engine sounds like it has a small misfire. Engine has no major active leaks observed from the topside compartment. Blowby observed from breather hose.

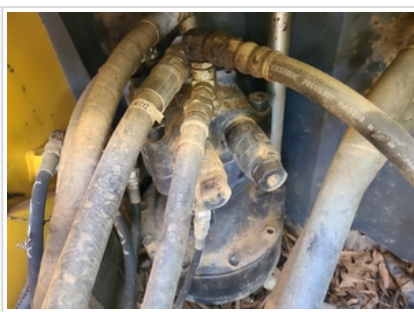
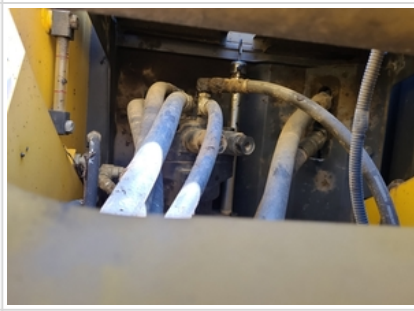
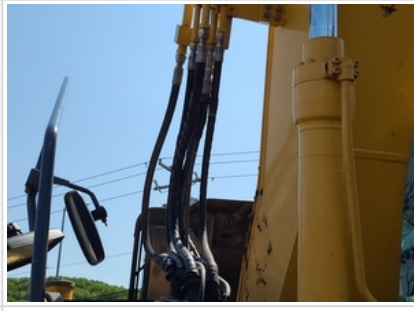
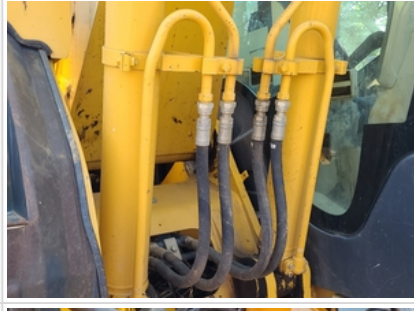
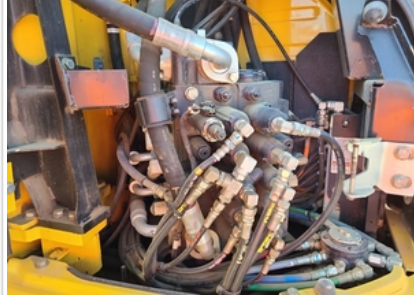
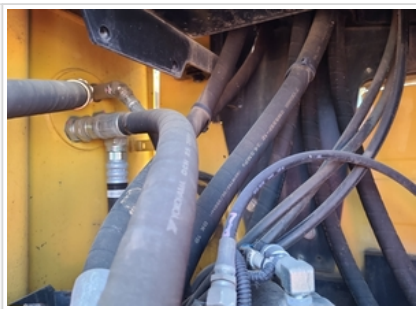
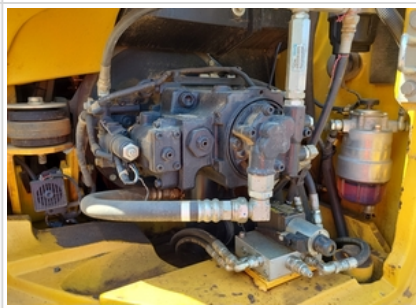
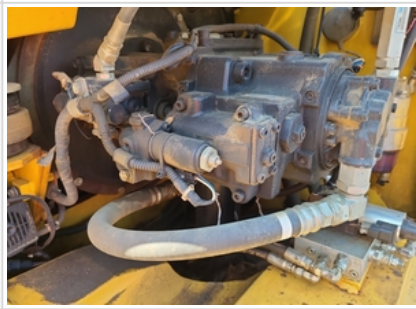
Hydraulic Pump/Fittings/Hoses

Hydraulic System Rating	3 - Normal Wear & Tear	
Hydraulic System Comments	Hydraulics in good shape with no active leaks observed.

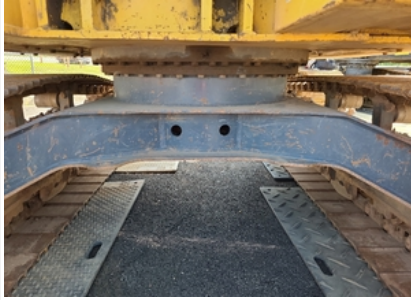
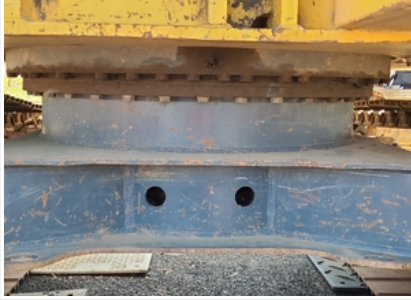
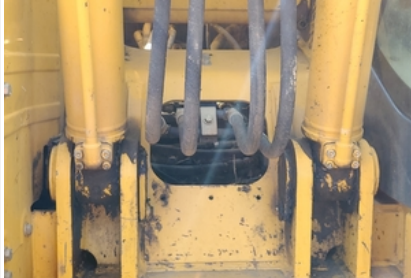
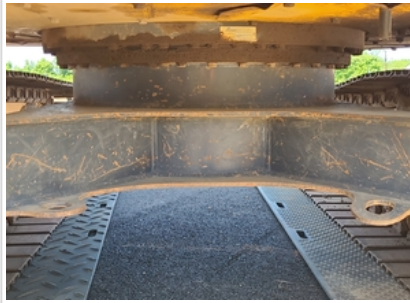
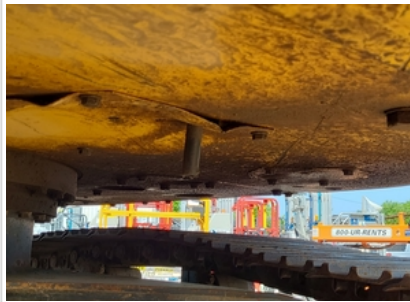
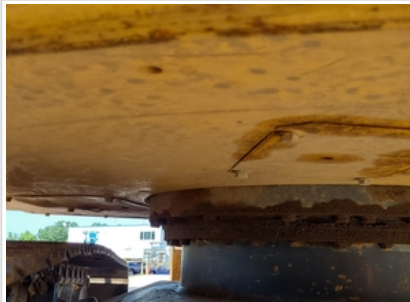
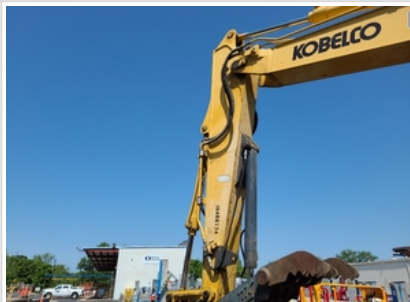
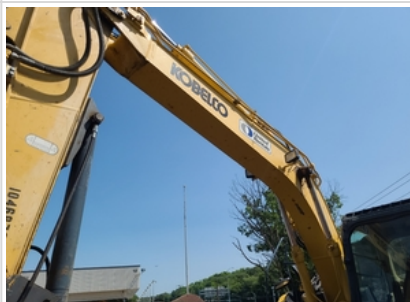
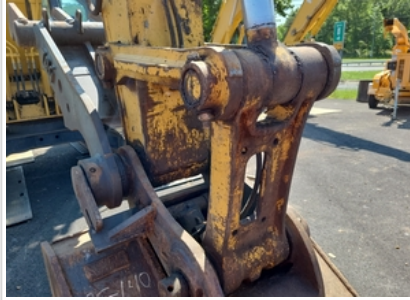
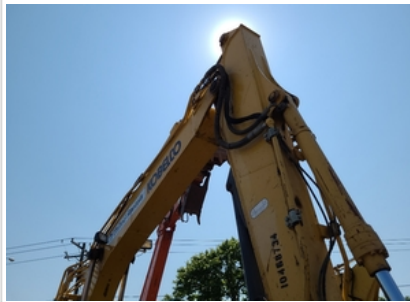
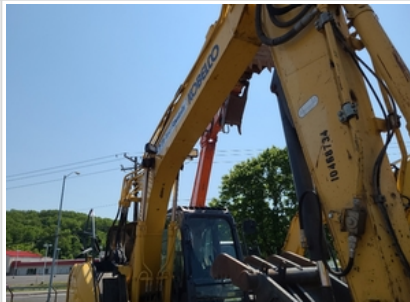
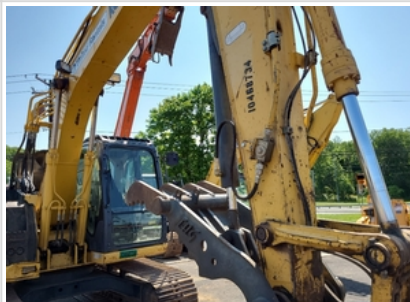
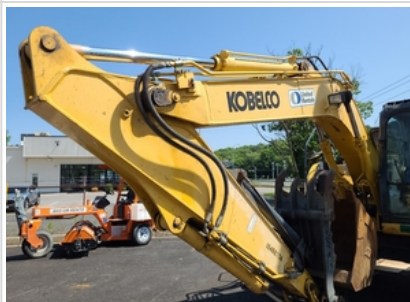
Chassis Photos

Chassis Rating	3 - Normal Wear & Tear	
Comments	Frame and implements in good condition. Minor play observed at bucket linkage.

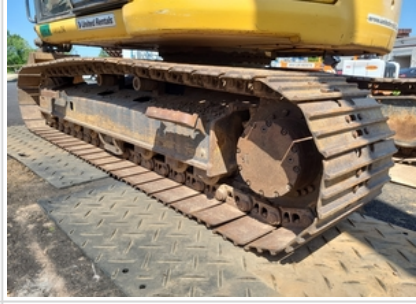
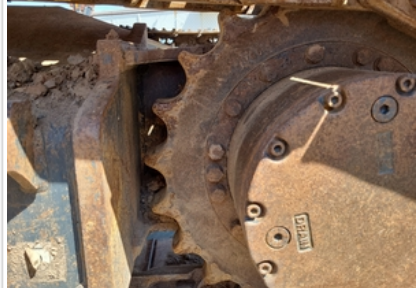
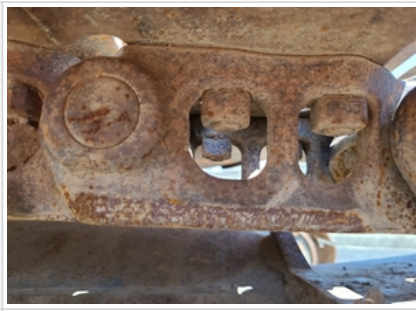
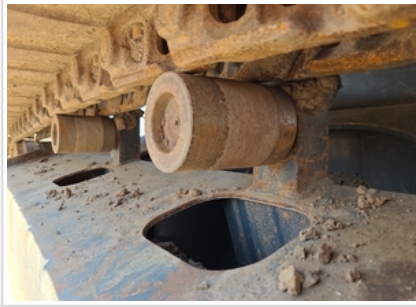
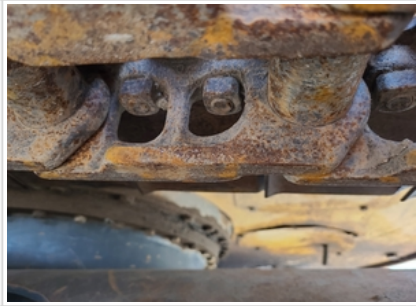
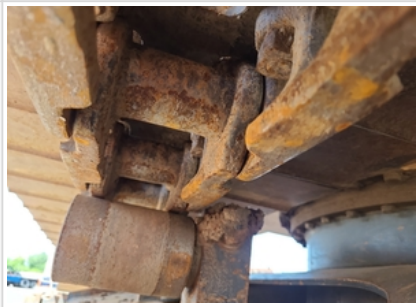
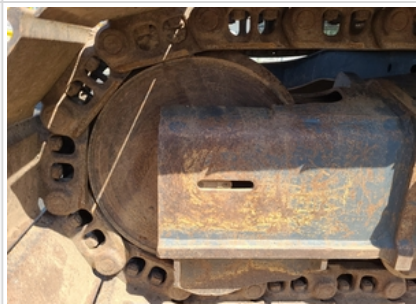
Undercarriage Photos

Undercarriage Rating	3 - Normal Wear & Tear	
Undercarriage Comments	Undercarriage in good shape.

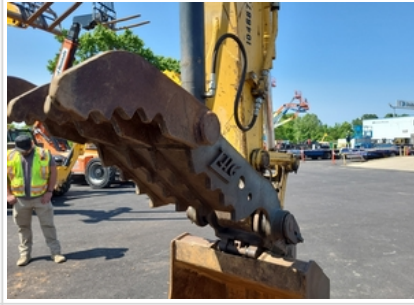
Attachment Rating	3 - Normal Wear & Tear
Attachment Comments	36" Bucket and 20" thumb
