Enterprise Equipment Inspection

Category	Excavator
Travel System	Track Undercarriage
Comments	
Year	2018
Make	Kubota
Model	KX033-4
Fleet ID	212619AH
Serial Number	12035
Serial Number Plate

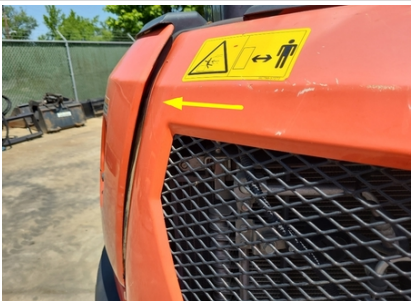
<p>Minor Hood Panel Misalignment</p>

Exterior Rating	3 - Normal Wear & Tear	
Exterior Comments	Some panel misalignment and scuff marks on exterior panels.

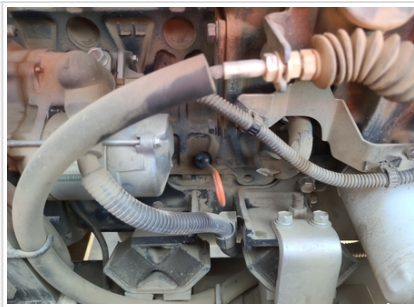
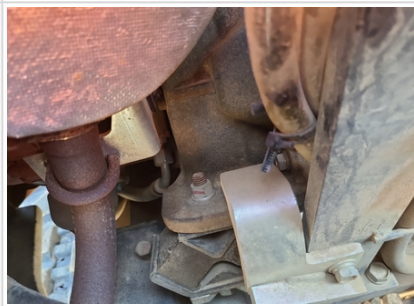
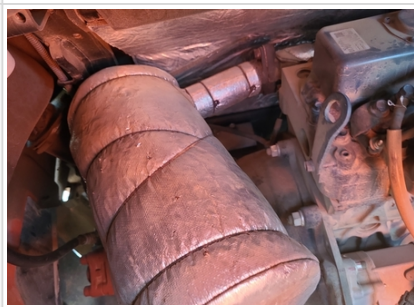
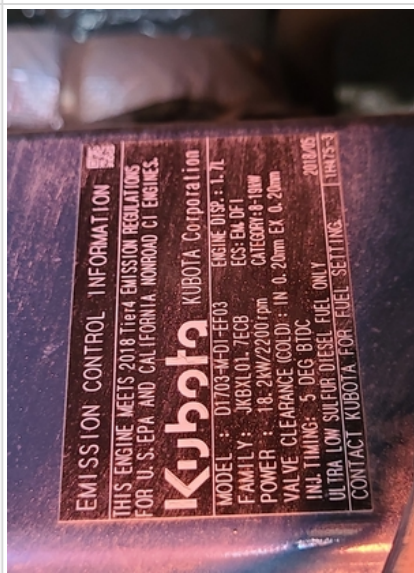
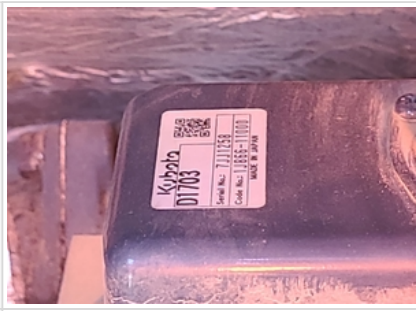
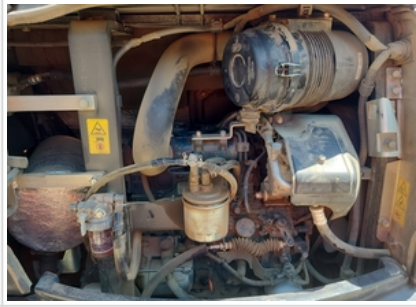
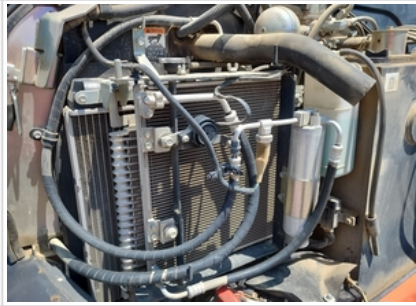
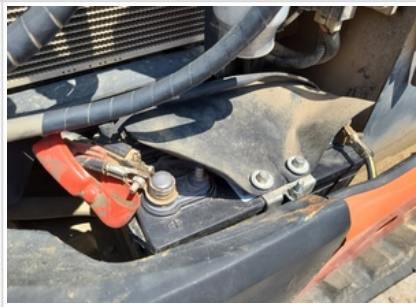
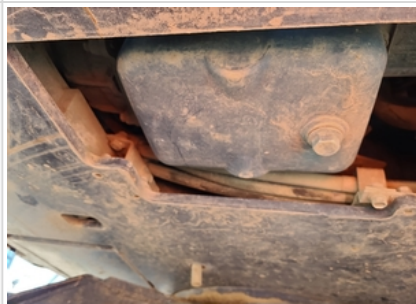
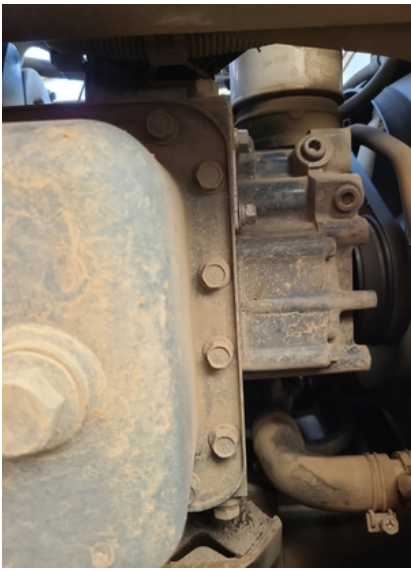
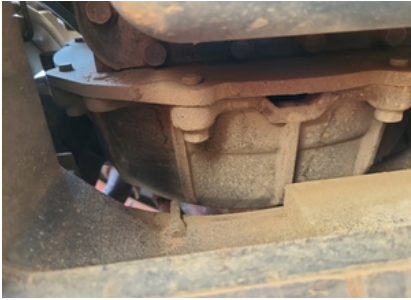
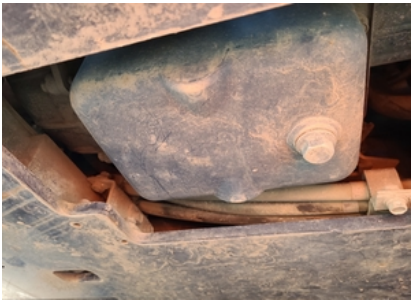
Engine Compartment	 	
---------------------------	---	--

Engine Type (Make, Model, Cylinders, Hp)	Kubota - 1.7L - 3Cyl. - 24HP	
Emissions Tier	Tier 4F	
Engine Rating	4 - Very Light or Minimal Wear	
Engine Overall Comments	Engine has low hours and has healthy appearance with no active leaks or issues observed.

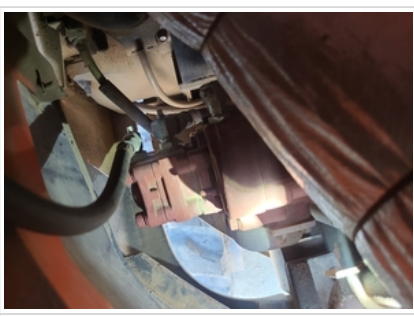
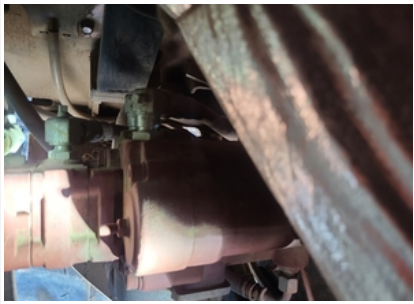
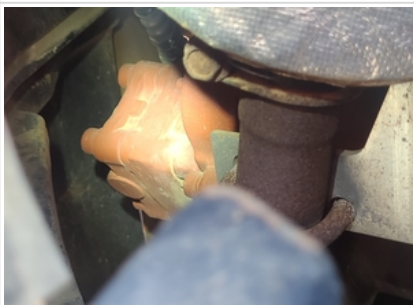
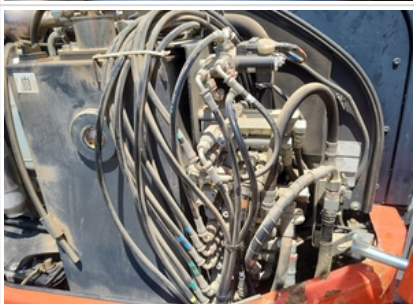
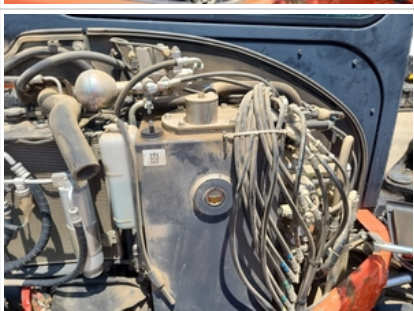
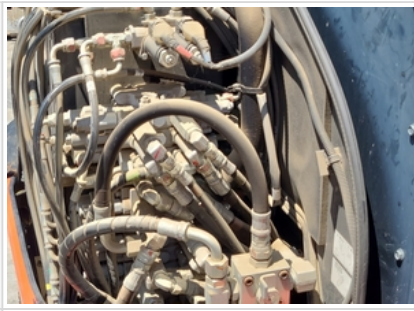
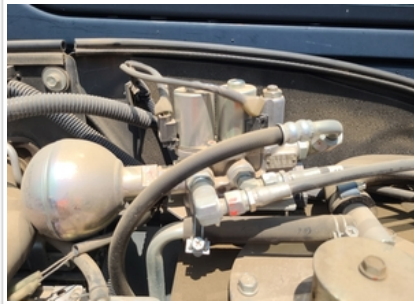
Hydraulic Pump/Fittings/Hoses

Hydraulic System Rating	4 - Very Light or Minimal Wear	
Hydraulic System Comments	Hydraulic System in good shape.

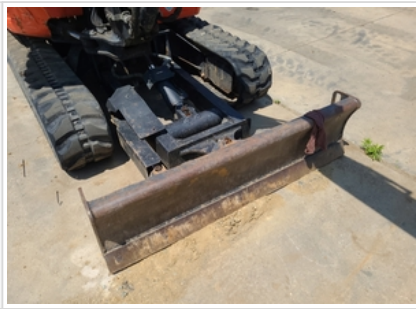
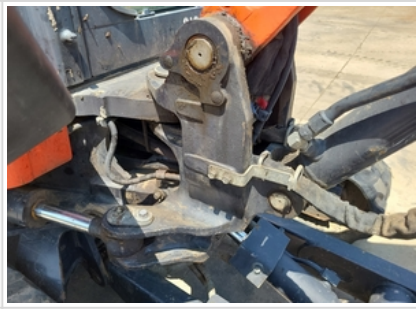
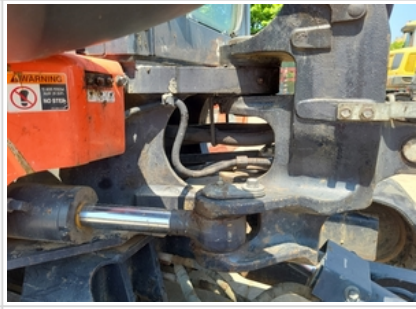
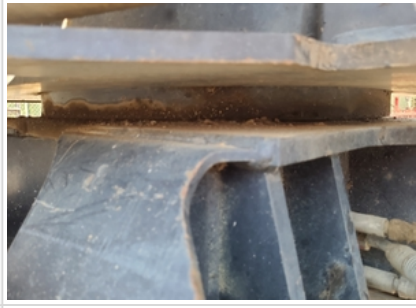
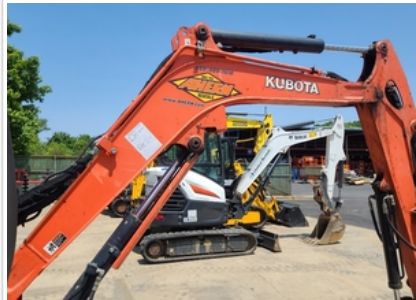
Chassis Photos	 	
-----------------------	---	--

Chassis Rating	4 - Very Light or Minimal Wear	
Comments	Main Frame and Implements in good condition.

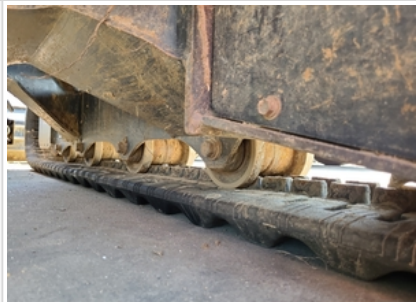
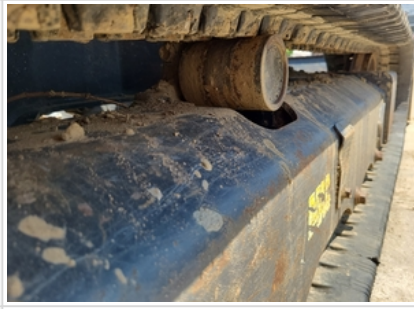
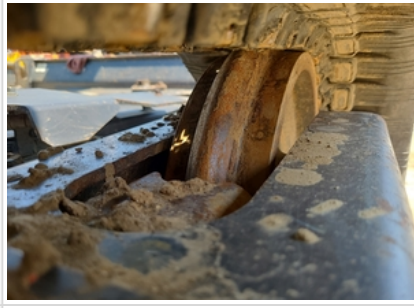
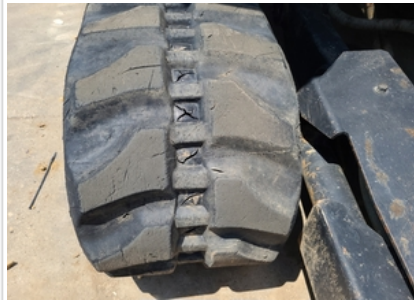
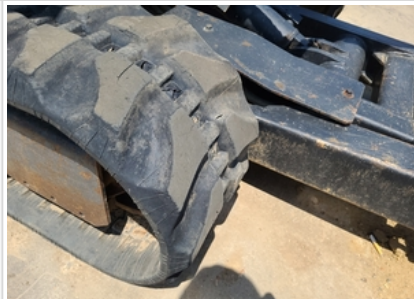
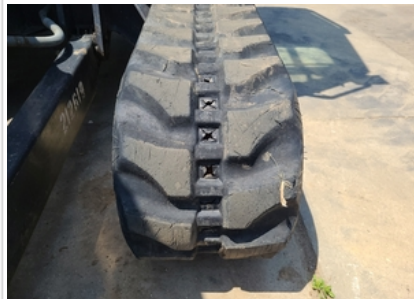
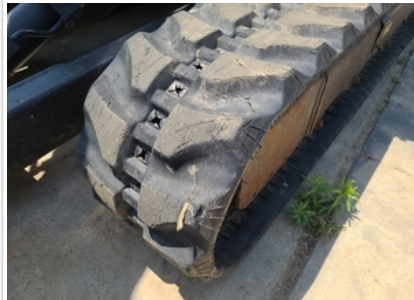
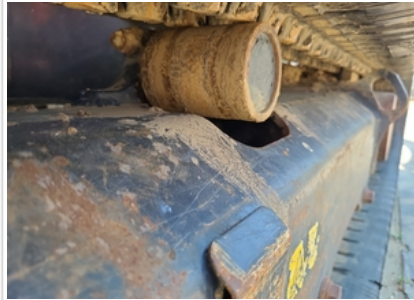
Undercarriage Photos	 	
-----------------------------	---	--

Undercarriage Rating	4 - Very Light or Minimal Wear	
Undercarriage Comments	Undercarriage 75% to 80% of life left.
