General Info

Category Skid Steer Travel System Wheels & Tires Comments Pear Year 2017 Make Bobcat Model S650 Fleet ID 46280BLA Serial Number ALJ820042 Serial Number Plate Plate Bobcat	General IIIIO			
Year 2017 Make Bobcat Model S650 Fleet ID 46280BLA Serial Number Plate Serial Number Plate Hour Meter Reading 1,117 Hour Meter Photo	Category	Skid Steer		
Year 2017 Make Bobcat Model S650 Fleet ID 46280BLA Serial Number Plate Serial Number Plate Hour Meter Reading 1,117 Hour Meter Photo	Travel System	Wheels & Tires		
Make Model Sefo Fleet ID 46280BLA Serial Number ALJ820042 Serial Number Plate Hour Meter Reading Hour Meter Photo	Comments			
Model S650 Fleet ID 46280BLA Serial Number ALJ820042 Serial Number Plate Hour Meter Reading 1,117 Hour Meter Photo	Year	2017		
Fleet ID Serial Number ALJ820042 Serial Number Plate Hour Meter Photo Hour Meter Photo	Make	Bobcat		
Serial Number Plate Hour Meter Photo Hour Meter Photo	Model	S650

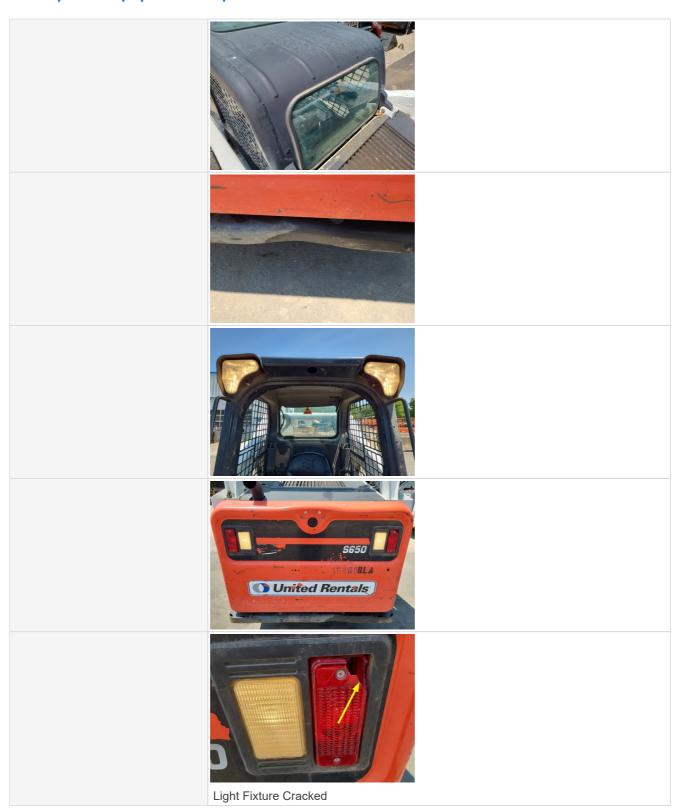
Exterior Rating	3 - Normal Wear & Tear
Exterior Comments	Minor scuff marks all around and small dent at back bumper. Rear r/s running lamp corner light fixture cracked.

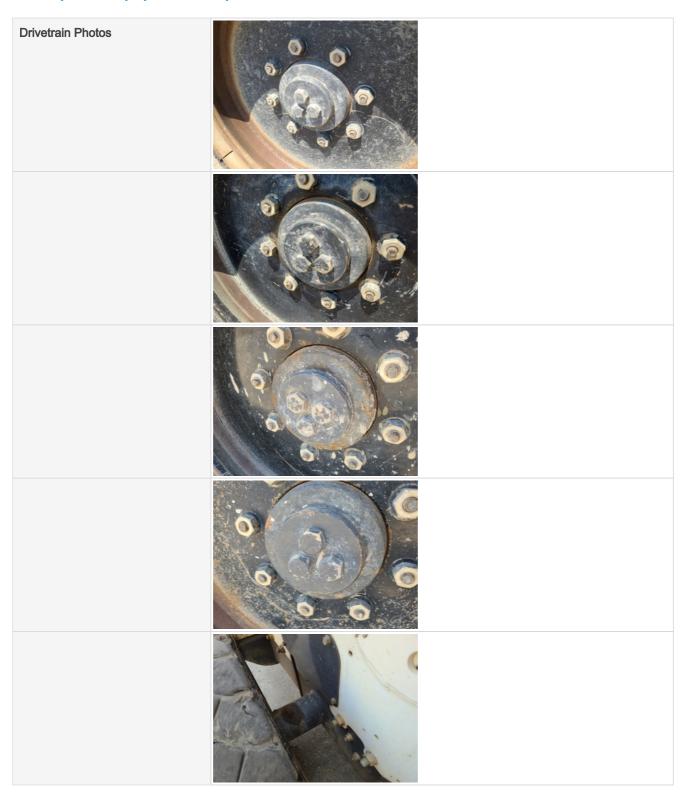
2 Speed?	No
Hydrostatic Drive Configuration	Split Transmission
Comments	
Transmission Info (Make/Model/Speeds)	
Drivetrain Rating	3 - Normal Wear & Tear
Drivetrain Comments	Some axles showing signs of grease leaking past seals.
