Inspection Report (Vibratory Compactor)

Year	2012
Make	Hamm
Model	HD12
Serial Number	H20Q1545
Hour Meter Reading	859.6
Previous Application (e.g., earth moving, mining, demolition, etc)	asphalt roller

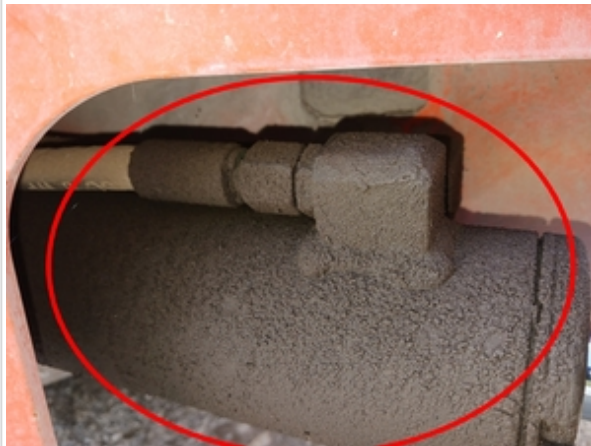
damp dirty area
