Inspection Report (On-Highway Flatbed Truck)

Year	2008
Make	Kenworth
Model	T300
Serial Number	2NKMHN6X78M222818
Truck Odometer Reading	240,289Miles. 7,764Hrs.
Current Inspection / State Cert / DOT	N/A
Previous Application (e.g., earth moving, mining, demolition, etc)	Service Truck

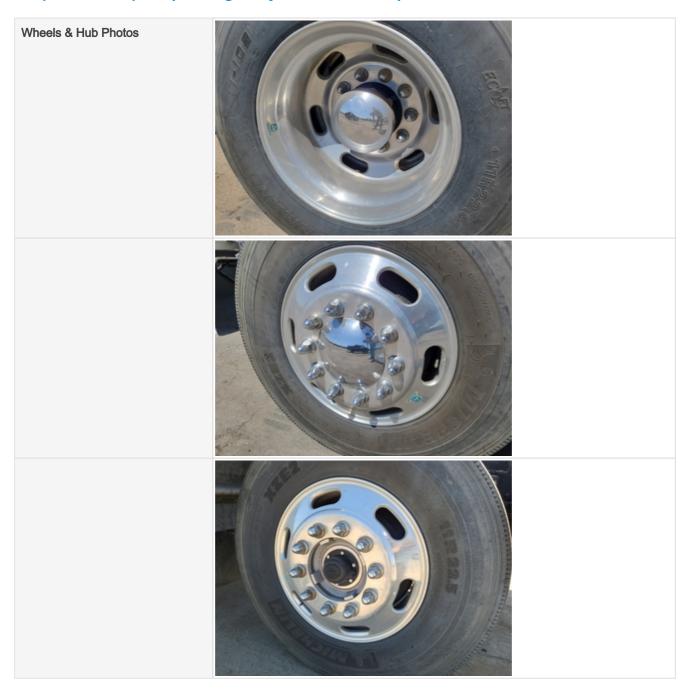
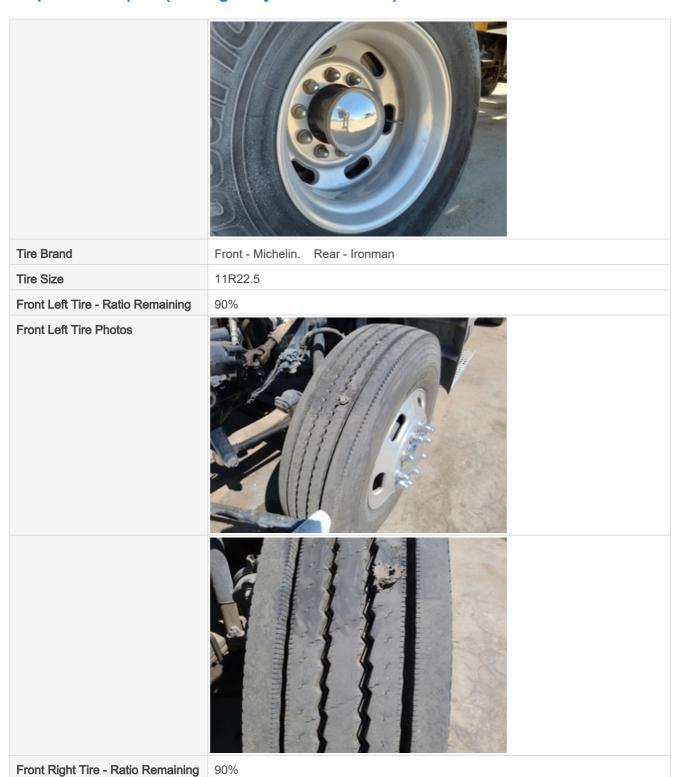
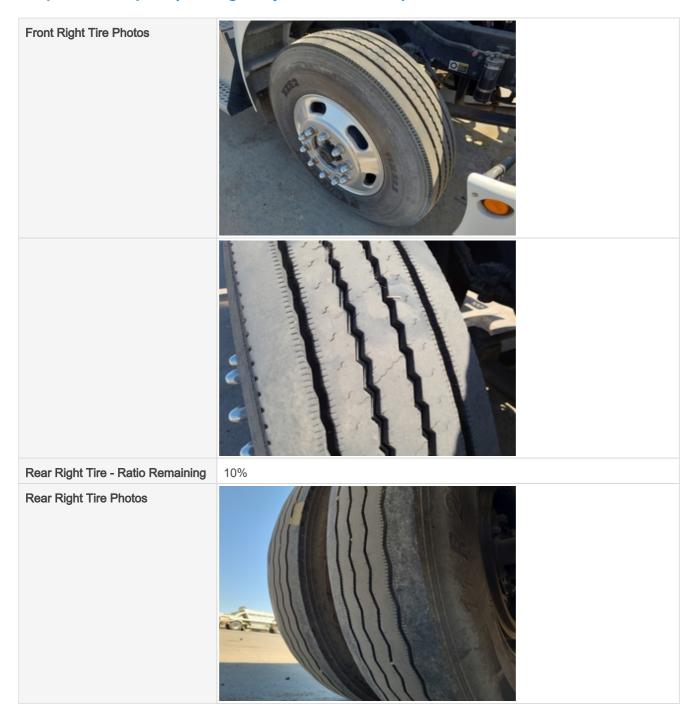
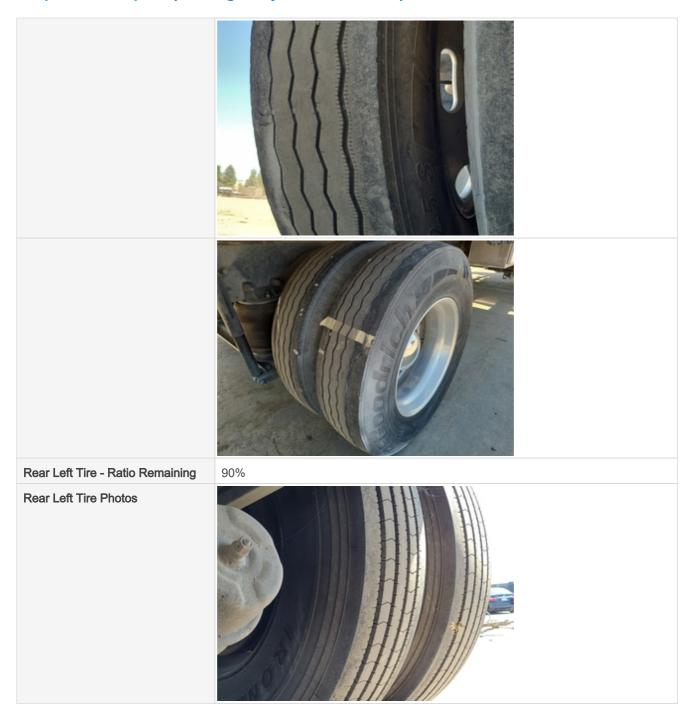
Wheels & Hub Condition	3
------------------------	---

Shocks and rear brake shoe's should be replaced.
