Inspection Report (Bulldozer)

B&B Stock Number	1
Year	2021
Make	CAT
Model	D3
Serial Number	XKW00589
Hour Meter Reading	626 Hrs.
Previous Application (e.g., earth moving, mining, demolition, etc)	Landscaping

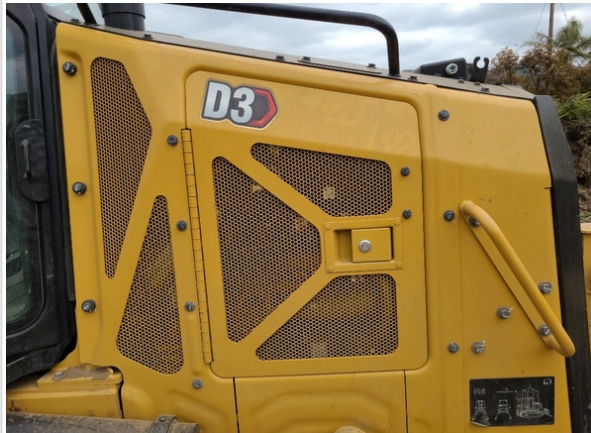
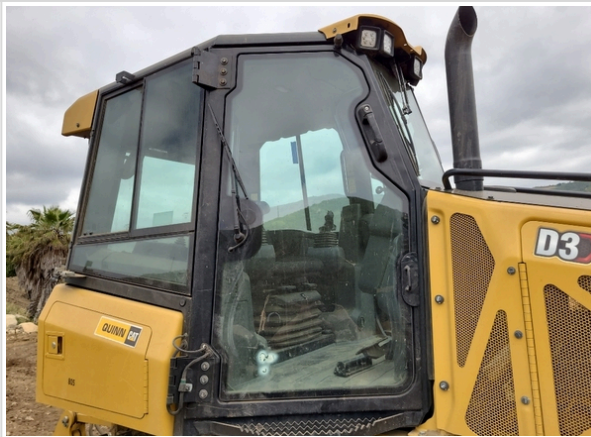
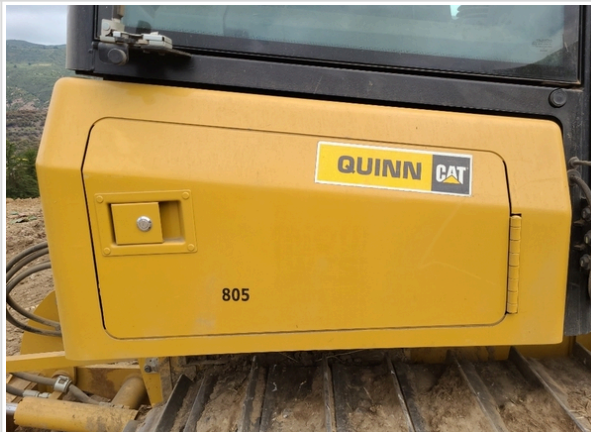
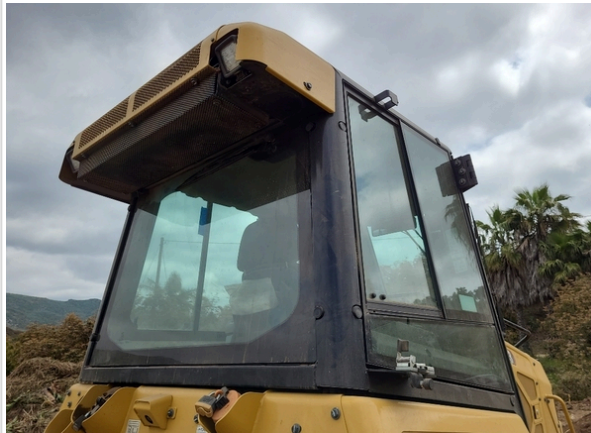
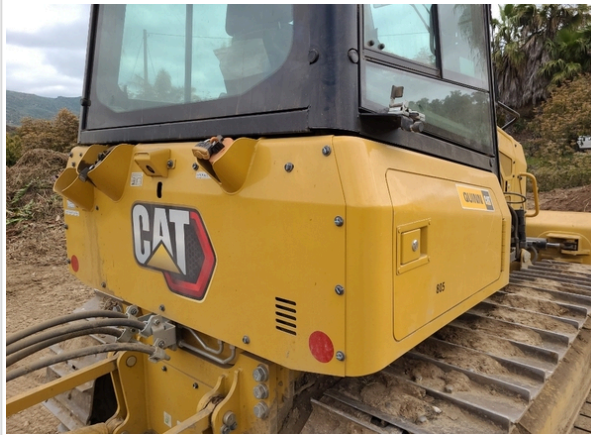
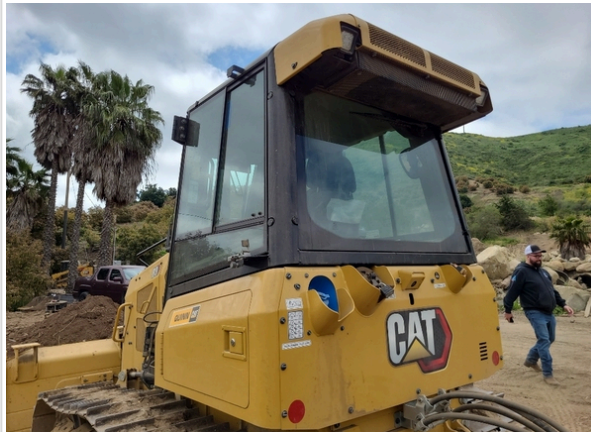
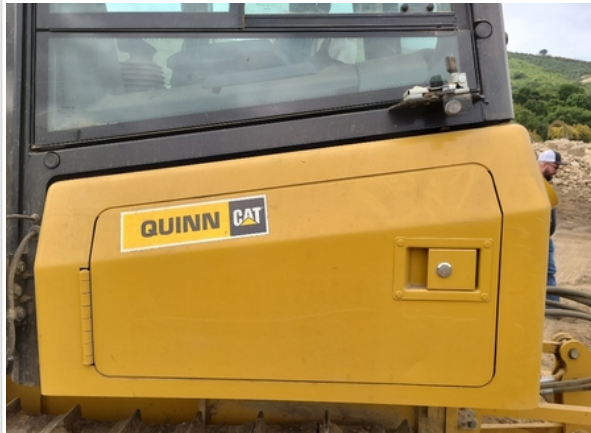
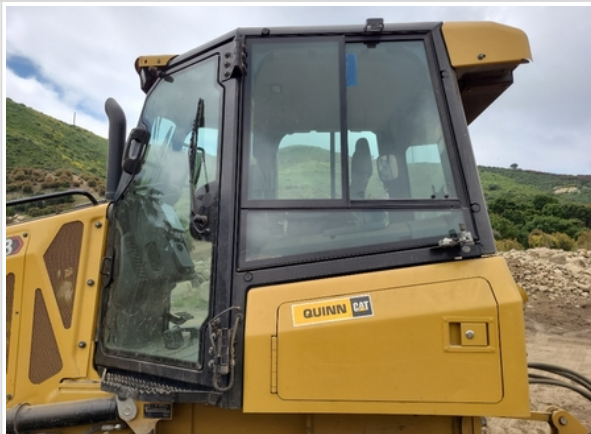
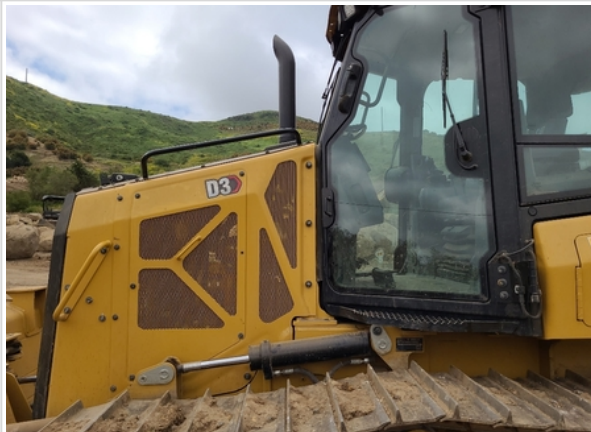
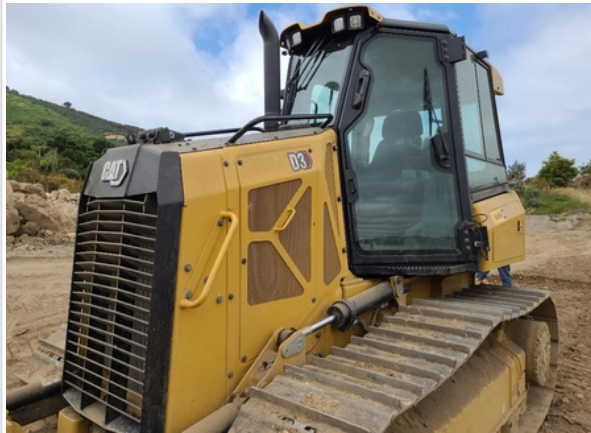
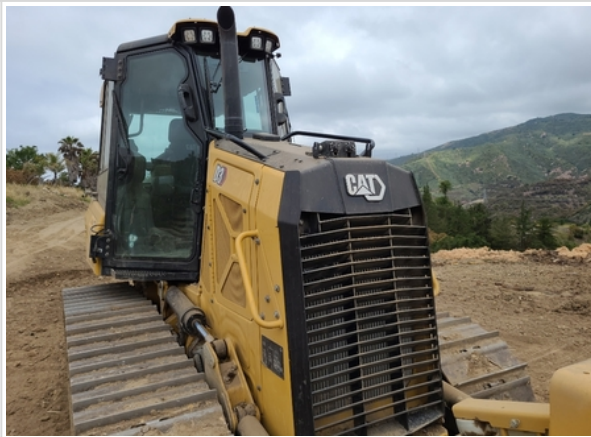
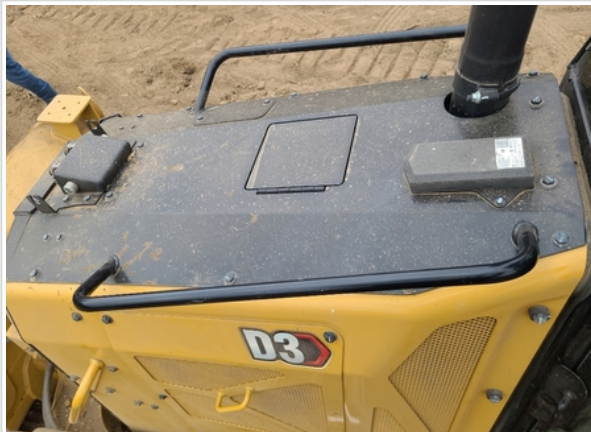
Close-up Exterior Photos

Body Panels	4 - Very Light or Minimal Wear
Body Panel Condition	No visible damage, good paint condition and panel fitment
Doors / Canopy Latches	4 - Very Light or Minimal Wear
Doors / Canopy Latches Condition	No visible damage
Steps / Ladders	4 - Very Light or Minimal Wear
Steps / Ladders Condition	Steps/ladders are fully intact and appear structurally sound
Handrails	4 - Very Light or Minimal Wear

Glass	4 - Very Light or Minimal Wear
Glass Condition	Glass intact, no visible damage
Mirrors	4 - Very Light or Minimal Wear
Mirror Condition	Mirrors present and intact, no visible damage
Exterior Lights	4 - Very Light or Minimal Wear
Exterior Lights Condition	No visible damage, lighting system is operational

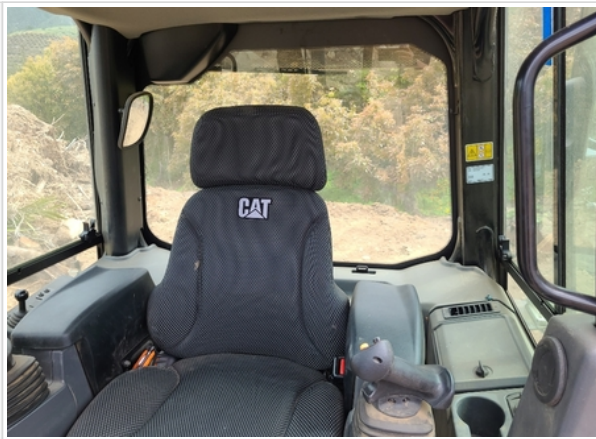
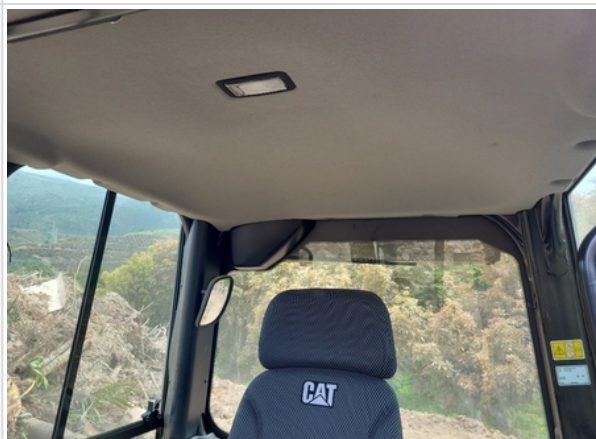
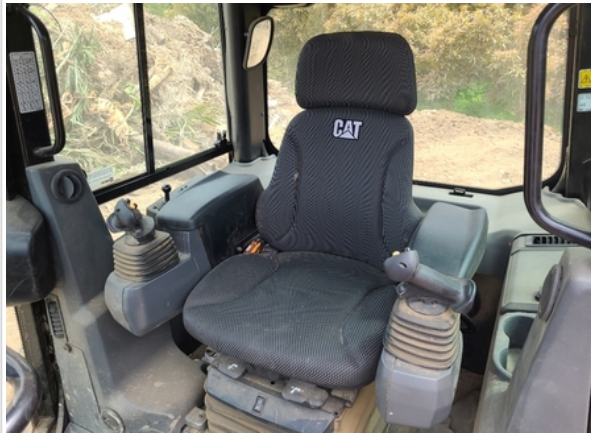
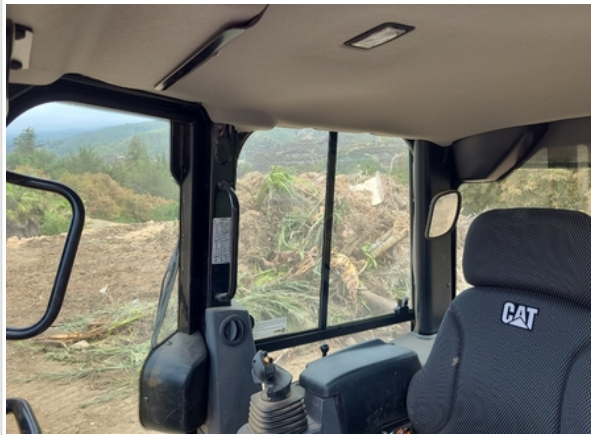
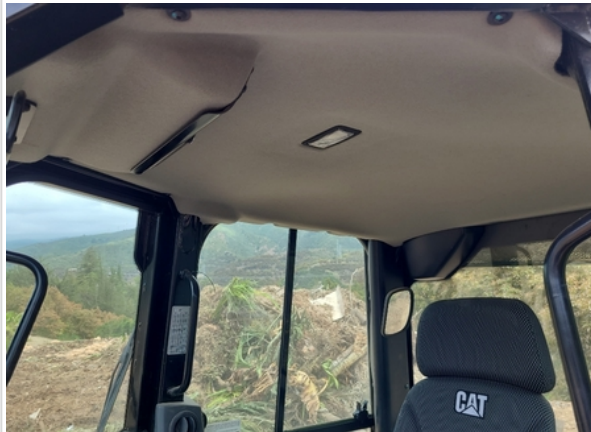
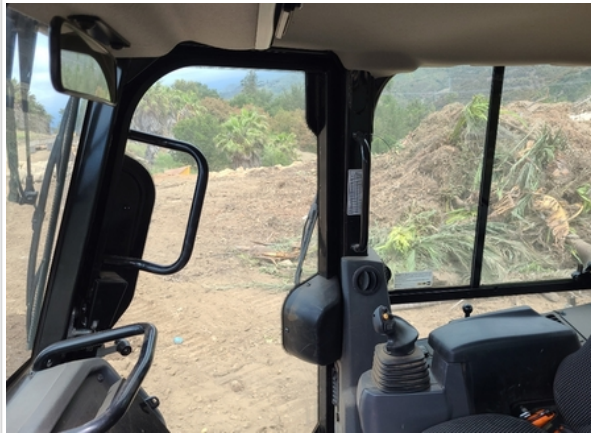
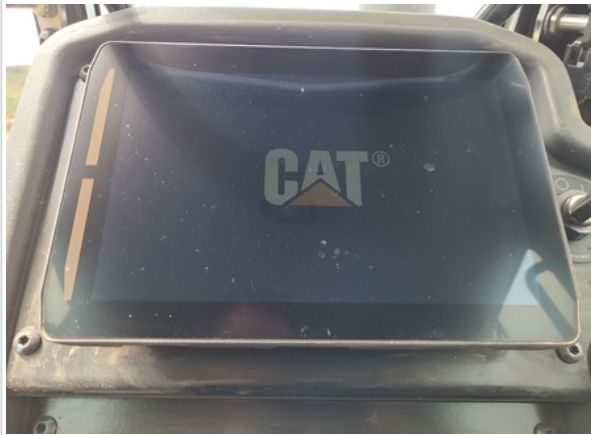
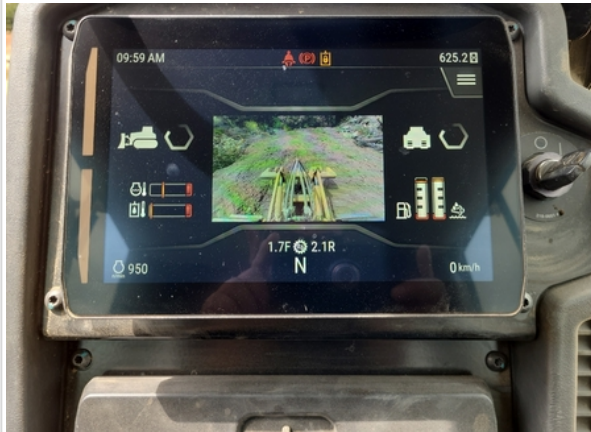
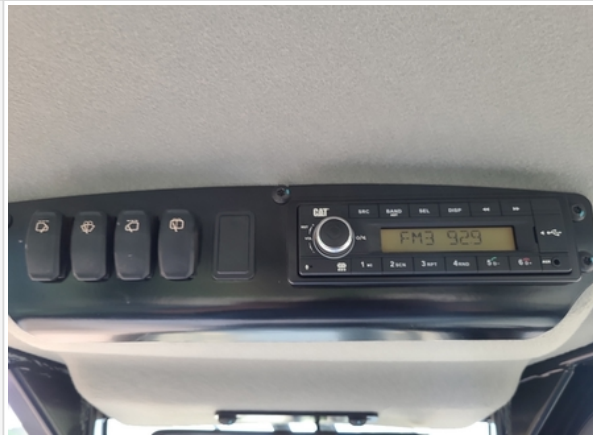
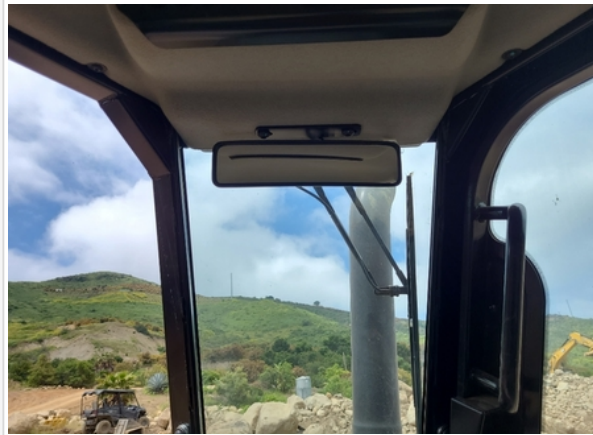
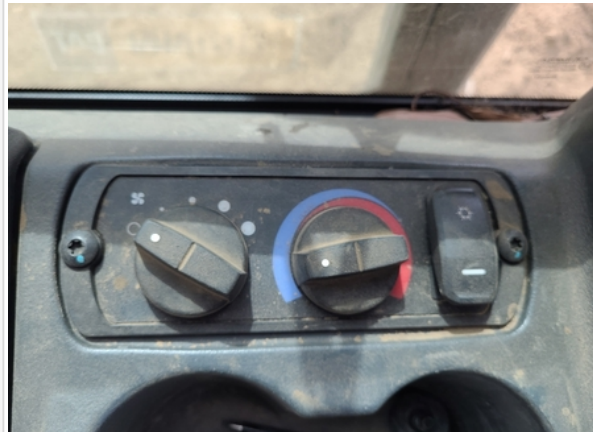
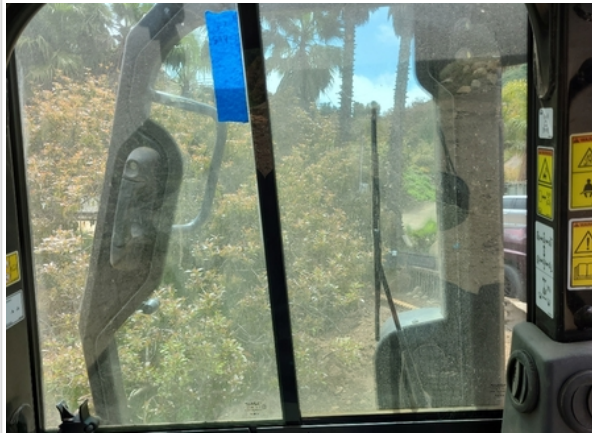
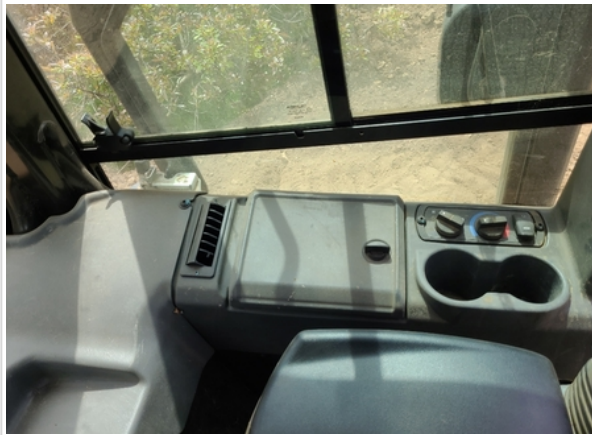
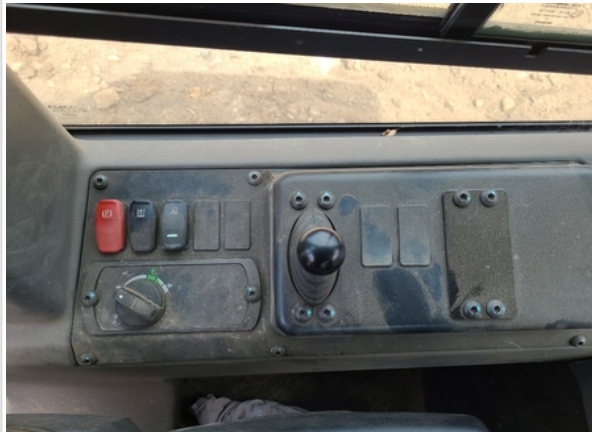
Control Station Photos

Control Station Overall Rating	4 - Very Light or Minimal Wear
Control Station Overall Condition	Good cabin appearance, solid floors, panels, and ceiling
Operator Seat	4 - Very Light or Minimal Wear
Operator Seat Condition	Seat(s) in good condition, no stains or tears in upholstery
Cabin Lights	5 - Like New, Recently Replaced
Safety Lock Out / Stop	5 - Like New, Recently Replaced
Controls & Switches	4 - Very Light or Minimal Wear
Controls & Switches Condition	All switches are installed and functional
Hour Meter Activity	5 - Like New, Recently Replaced
Other Gauge Activity	5 - Like New, Recently Replaced
Heater & A/C	5 - Like New, Recently Replaced
Travel Alarm	5 - Like New, Recently Replaced
Horn	5 - Like New, Recently Replaced
Backup Camera	5 - Like New, Recently Replaced

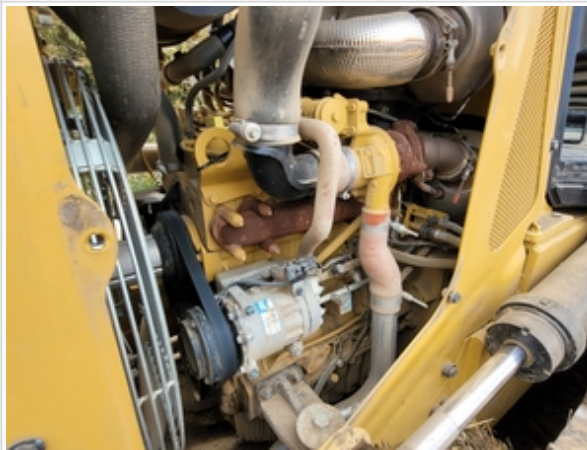
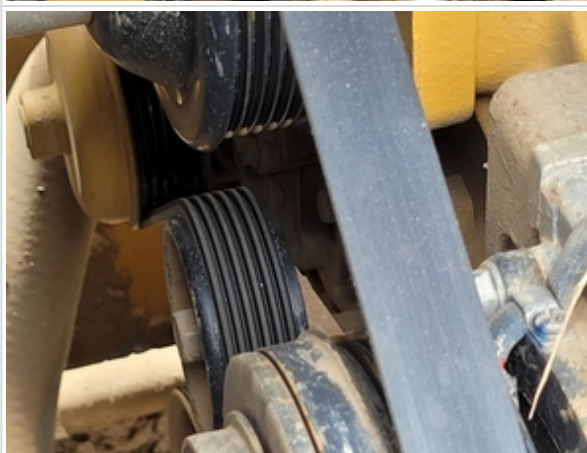
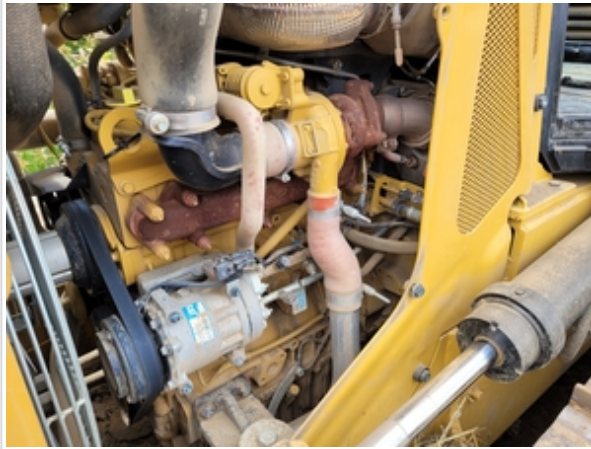
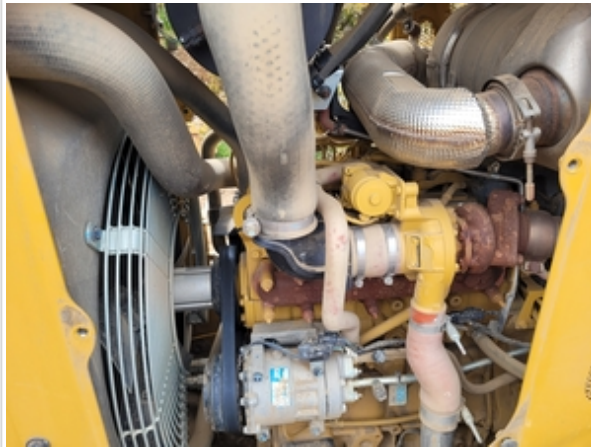
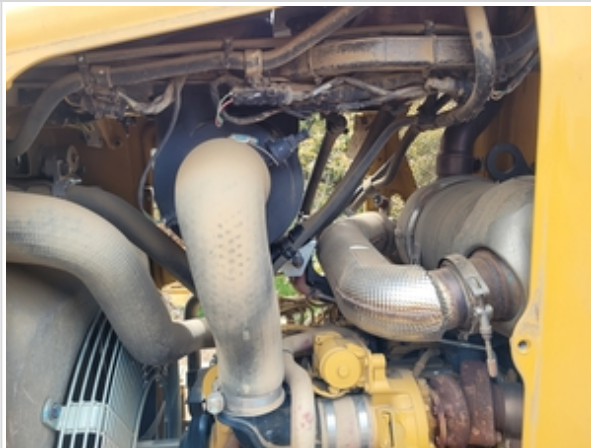
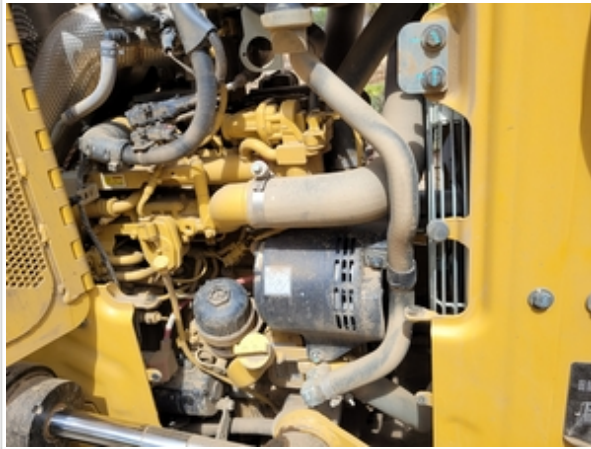
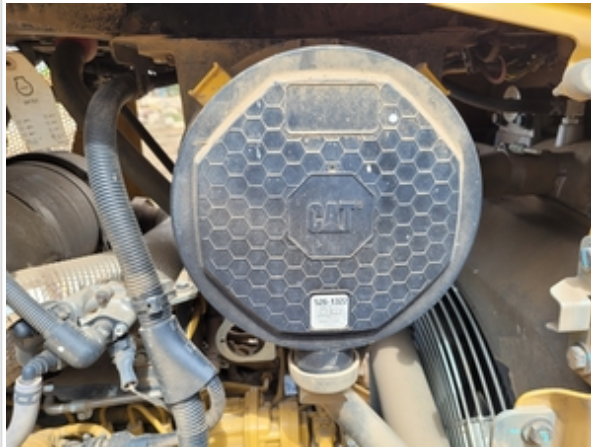
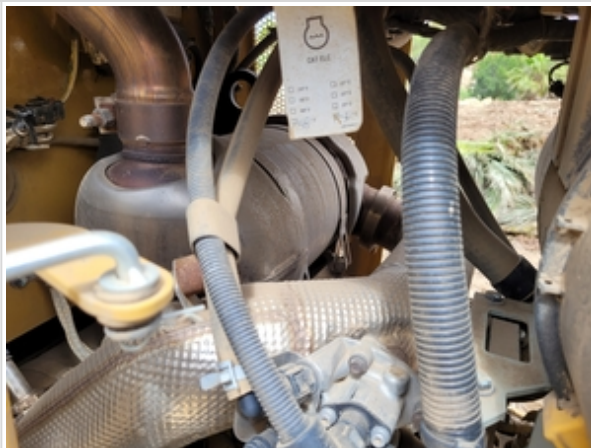
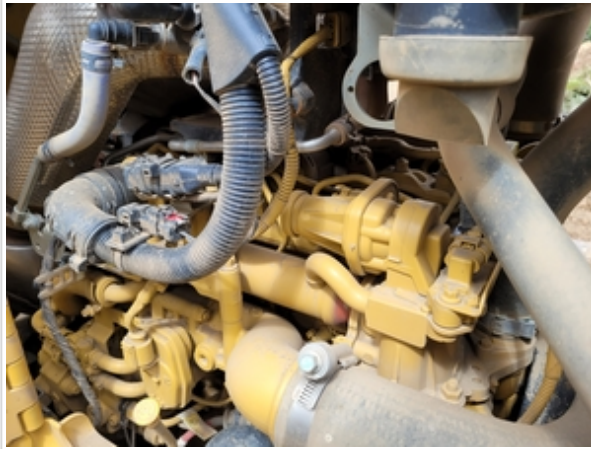
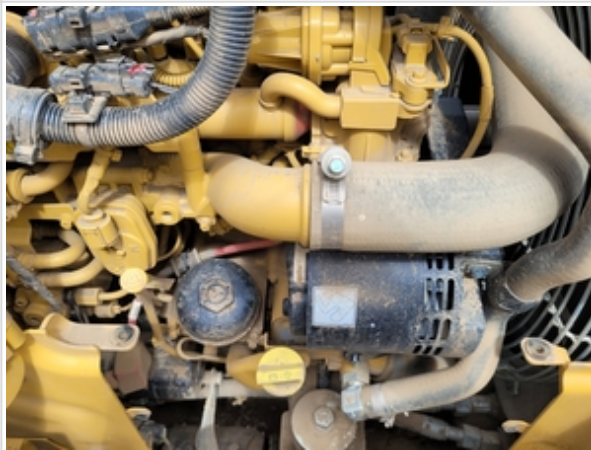
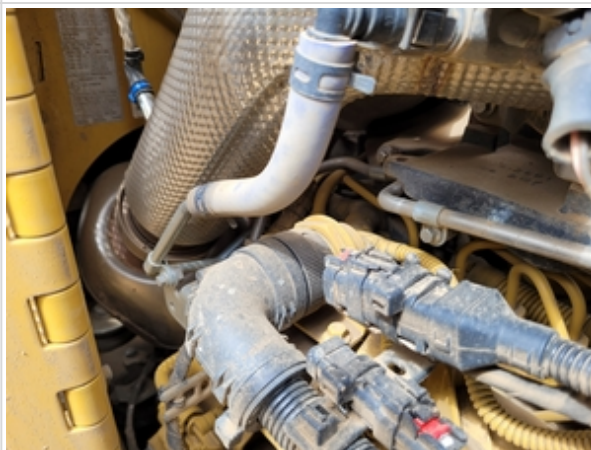
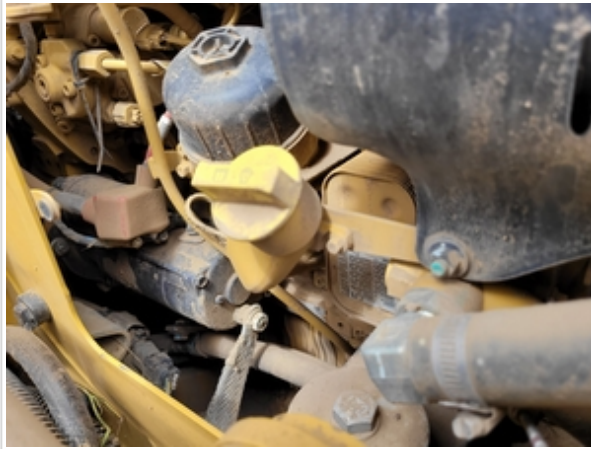
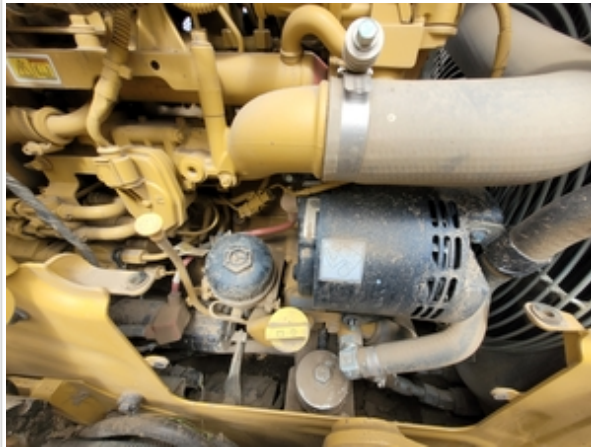
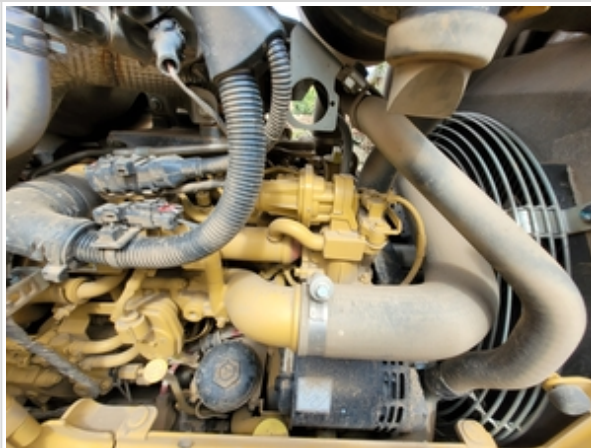
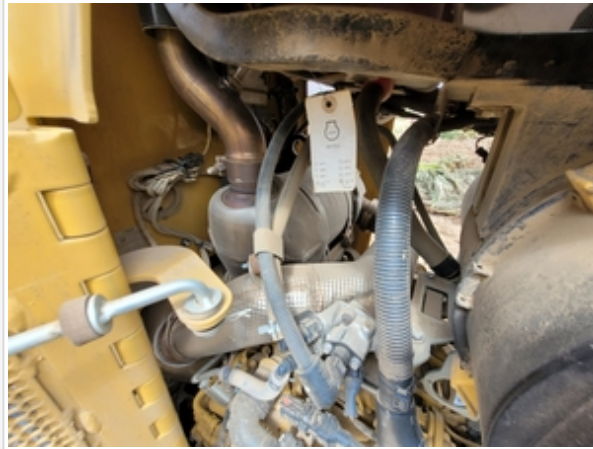
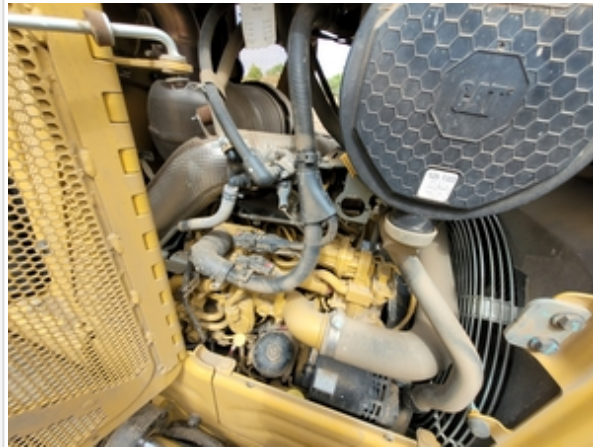
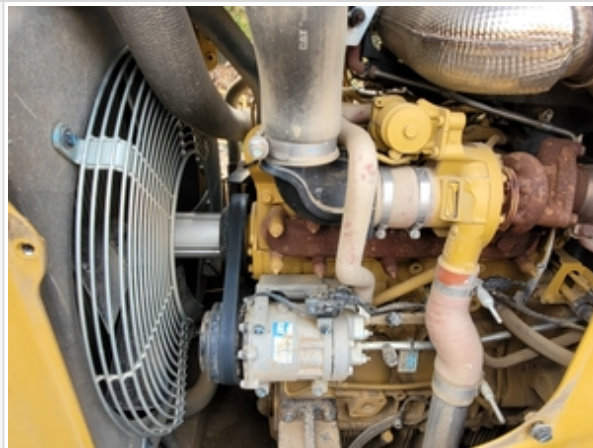
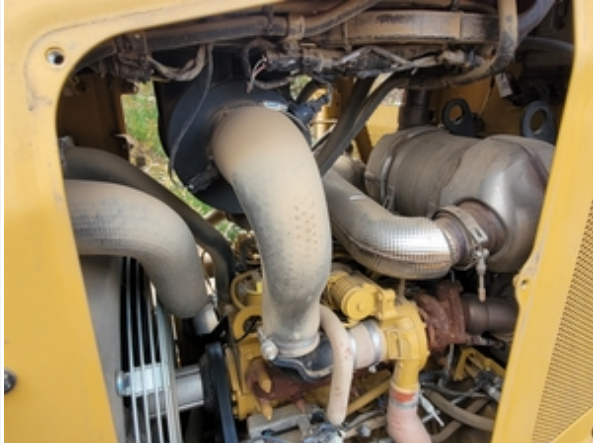
Engine Compartment Photos

Engine Type (Make, Model, Cylinders, Hp)	CAT - C3.6 - 4Cyl. - 104HP
Emissions Tier	Tier 4F
Engine Serial Number	J3634562
Engine Fuel Type	Diesel
Blow-by (Visual Observation Check)	No
Unusual Noises (Upon Start-up, Idle, Shutdown)	No
Engine Smoke (Upon Start-up, Idle, Shutdown)	No
Engine Exhaust Color	Clear
Battery	4 - Very Light or Minimal Wear
Battery Condition	Like new, recently replaced
Radiator	4 - Very Light or Minimal Wear
Radiator Condition	Radiator fins & components appear to be in good working order, no signs of damage or leaks
Belts	4 - Very Light or Minimal Wear
Belt Condition	Belts appear in good condition & alignment with proper tension
Hoses	4 - Very Light or Minimal Wear
Hose Condition	Firm, pliant hoses with no signs of wear or leaks
Water Pump	4 - Very Light or Minimal Wear
Water Pump Condition	No unusual pump noises heard
Cooling System Leaks	No
Coolant Color / Appearance	4 - Very Light or Minimal Wear

Coolant Color/Appearance Notes	Normal Translucent appearance, no visual signs of contamination
Oil Leaks	No
Oil Color / Appearance	4 - Very Light or Minimal Wear

Oil Color / Appearance Notes	Clean oil appearance, no signs of cross contamination, Appropriate oil level
Fuel Leaks	No
Equipped with DPF (Diesel Particulate Filter)	Yes
DPF Condition	4 - Very Light or Minimal Wear
DPF Condition Notes	Filter housing is intact with no signs of damage or malfunction, DPF indicator is not illuminated
Requires DEF (Diesel Exhaust Fluid)	Yes
DEF Tank	4 - Very Light or Minimal Wear
DEF Tank Condition	Area around DEF tank cap is clean, fluid is clear & appears free of contaminants
Overall Engine Rating	4 - Very Light or Minimal Wear
Overall Engine Appearance	Clean & dry, Dusty & dry
Overall Engine Comments	Engine in great condition with no issues observed.

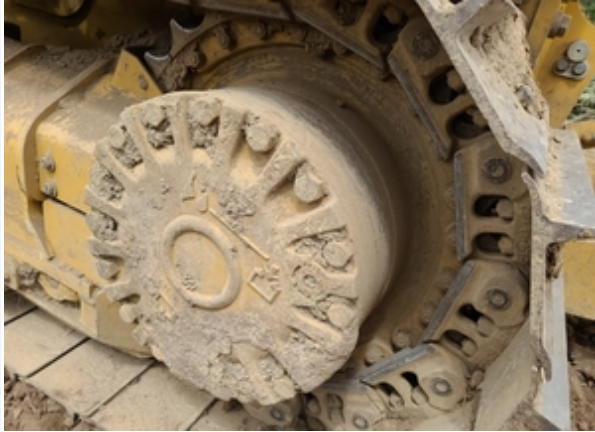
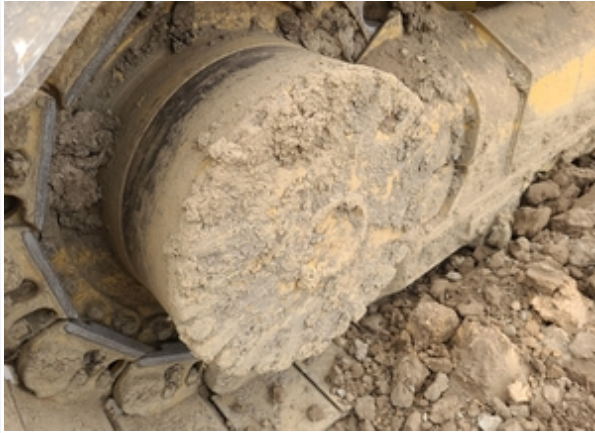
Drivetrain Photos

Hydrostatic Transmission?	Yes
2 Speed?	Yes

Hydrostatic Drive Configuration	Other (see comments)
Comments	Variable Speed Controlled Transmission
Transmission Components	4 - Very Light or Minimal Wear
Transmission Condition	Good forward and reverse function
Drive Motors	4 - Very Light or Minimal Wear
Parking Brake	4 - Very Light or Minimal Wear
Parking Brake Function	Good brake function
Overall Drivetrain Comments	Drivetrain working well and in overall great condition.

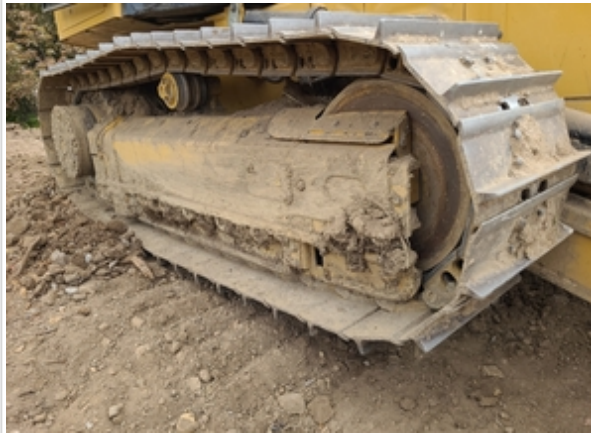
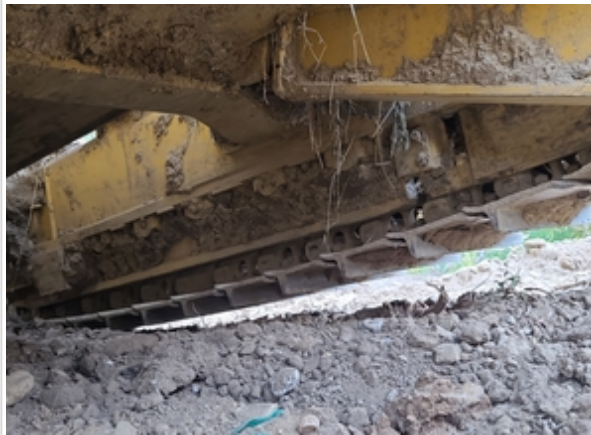
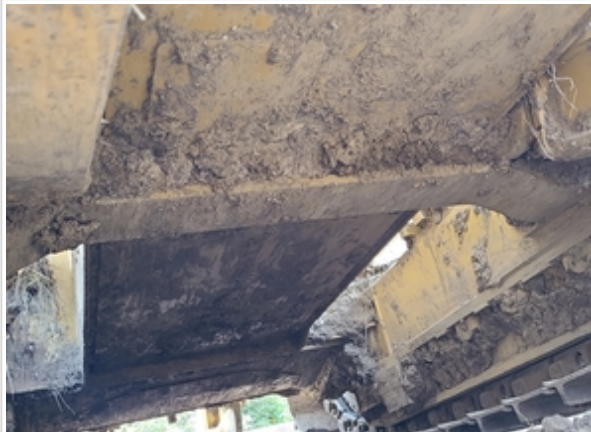
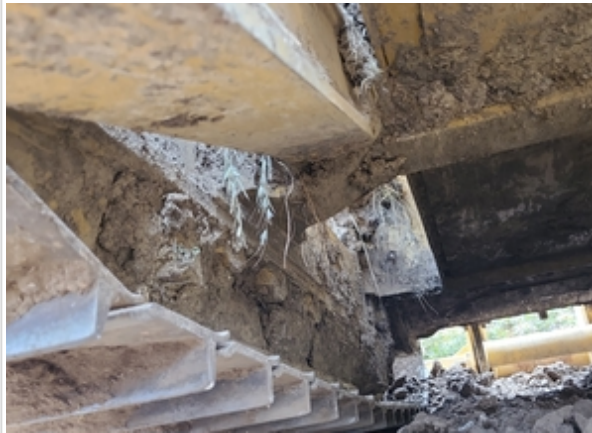
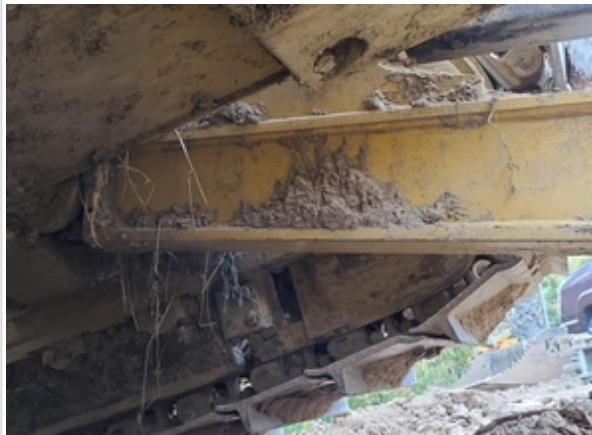
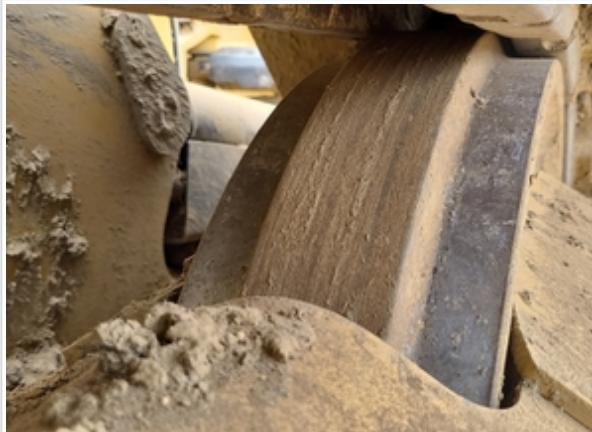
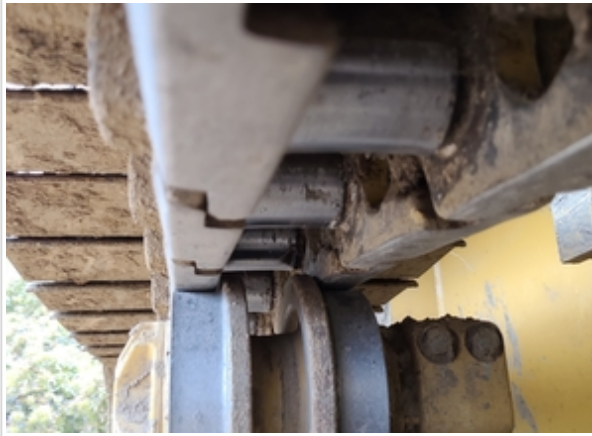
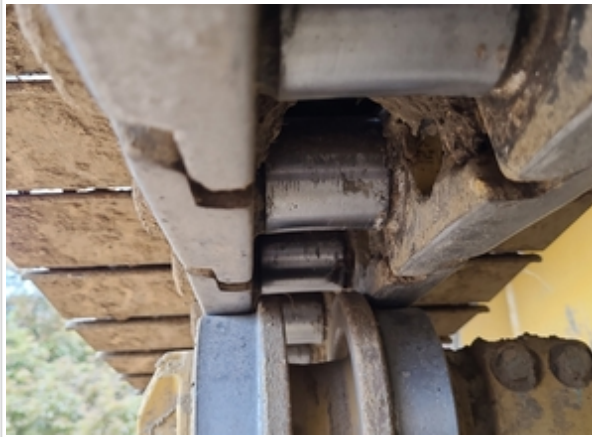
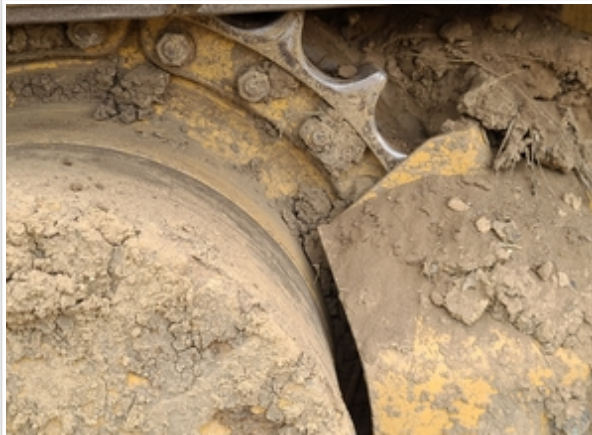
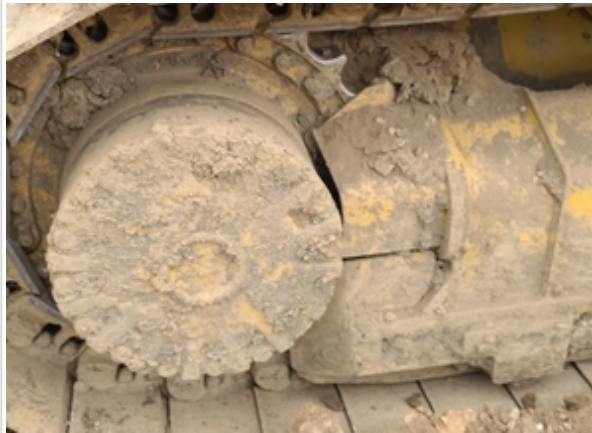
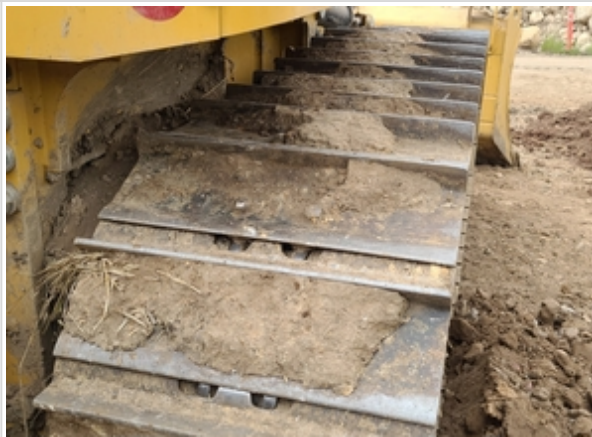
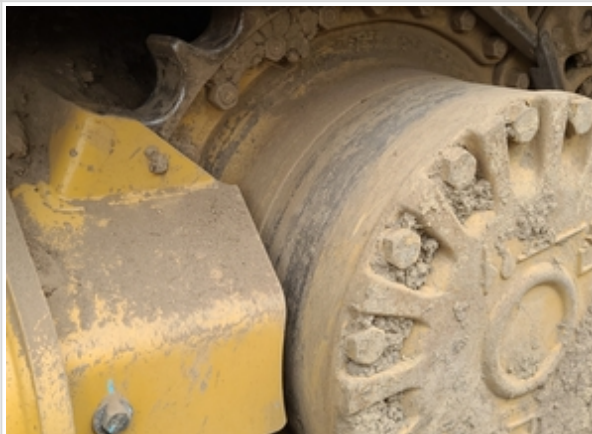
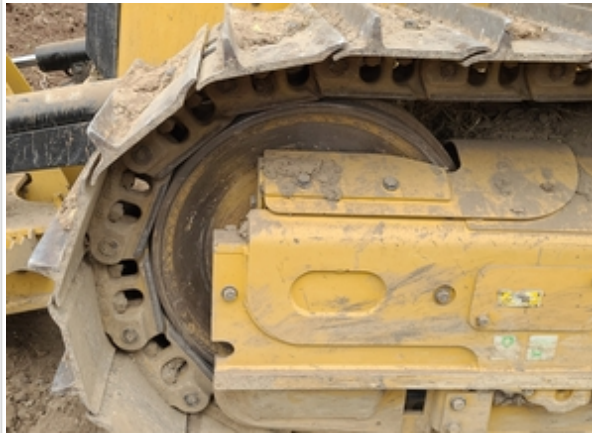
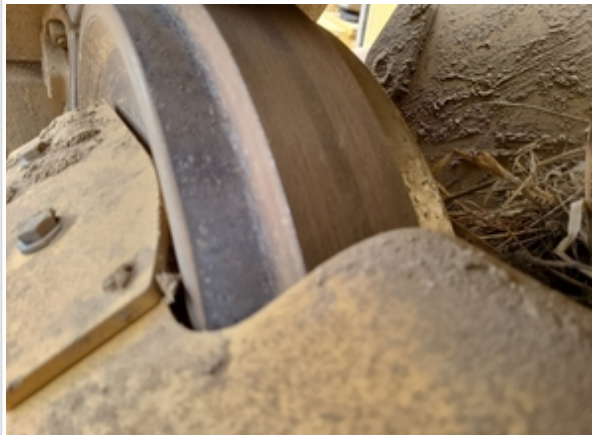
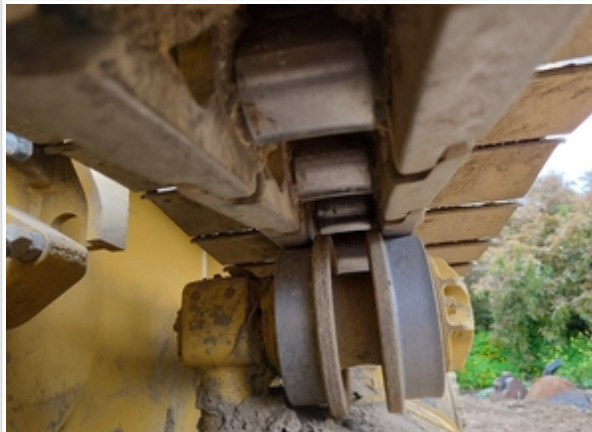
Undercarriage Photos	 
----------------------	--

Sprocket Teeth	3 - Normal Wear & Tear
Track Bushings	3 - Normal Wear & Tear
Track Frames	4 - Very Light or Minimal Wear
Pivot Shafts	0
Equalizer Bar & Joints	0
Front Idler	3 - Normal Wear & Tear
Track Tensioner	4 - Very Light or Minimal Wear
Track links	4 - Very Light or Minimal Wear
Bottom Rollers	4 - Very Light or Minimal Wear
Carrier Rollers	4 - Very Light or Minimal Wear
Overall Undercarriage	4 - Very Light or Minimal Wear
Overall Undercarriage Comments	Undercarriage in good condition with no obvious issues observed.

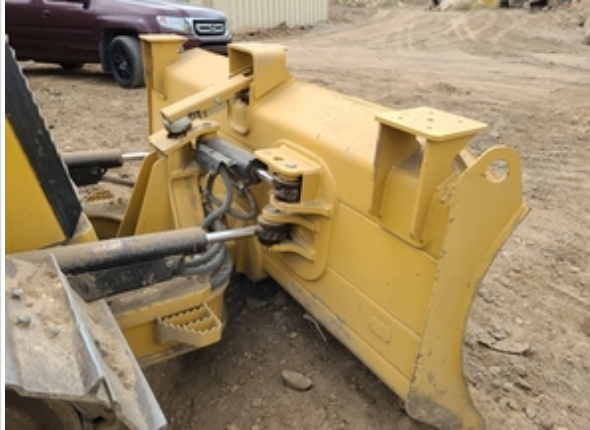
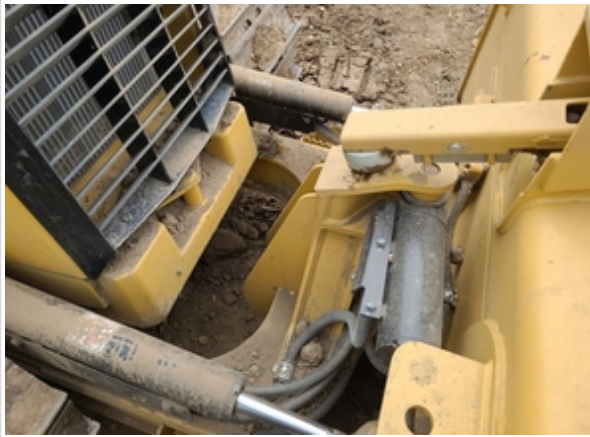
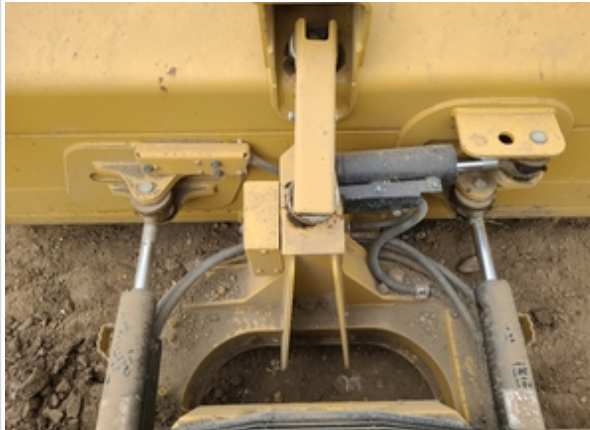
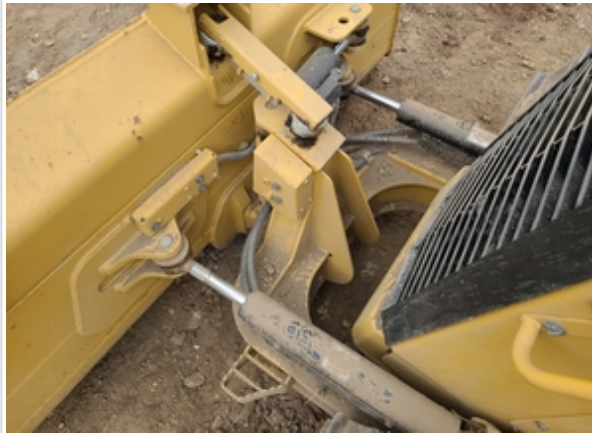
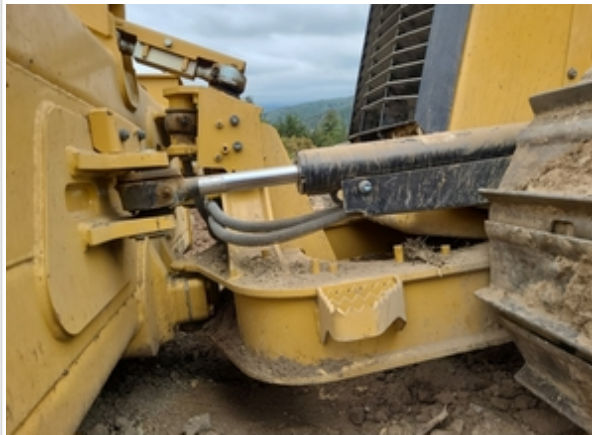
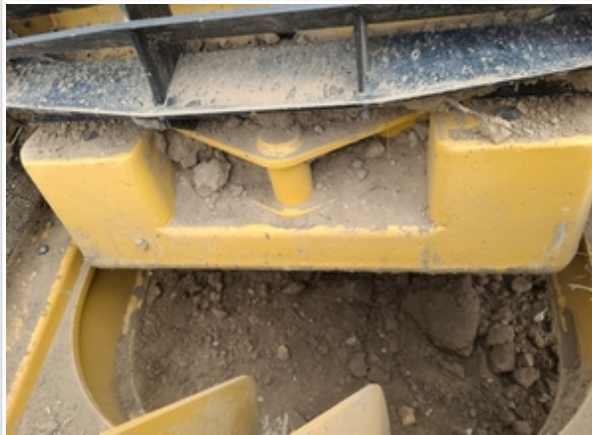
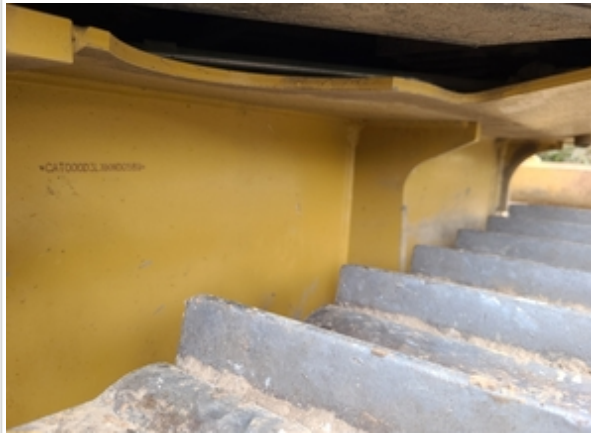
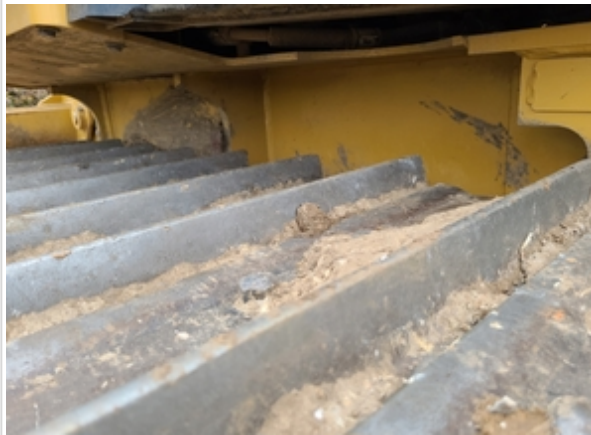
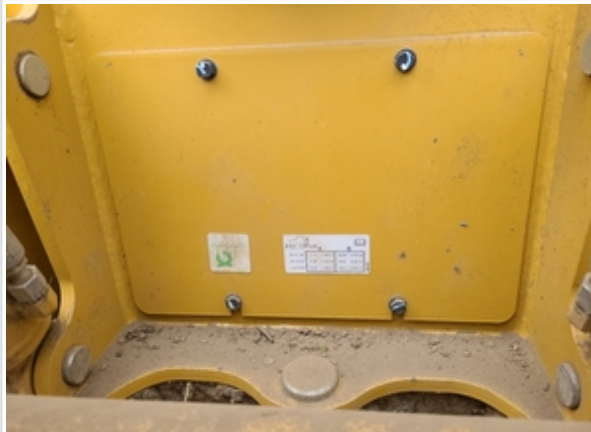
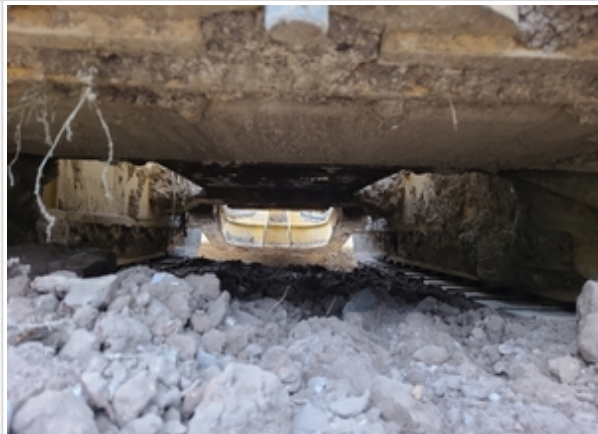
Chassis Photos

Push Arm / C-Frame Condition	4 - Very Light or Minimal Wear
Push Arm Pivot / C-Frame Trunnions Condition	4 - Very Light or Minimal Wear
Tilt Linkage Pin & Bushings	4 - Very Light or Minimal Wear
Angle Linkage Pin & Bushings	4 - Very Light or Minimal Wear
Blade Trunnions / Bushings	4 - Very Light or Minimal Wear
Frame Condition	4 - Very Light or Minimal Wear
Belly Pans	4 - Very Light or Minimal Wear
Overall Chassis	4 - Very Light or Minimal Wear
Overall Chassis Comments	Main frame and implements and connections all in great condition.

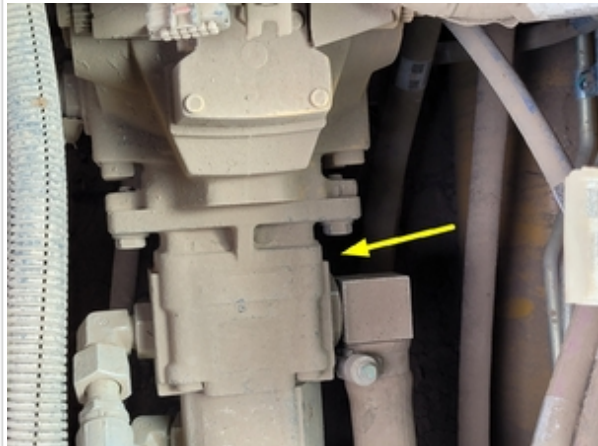
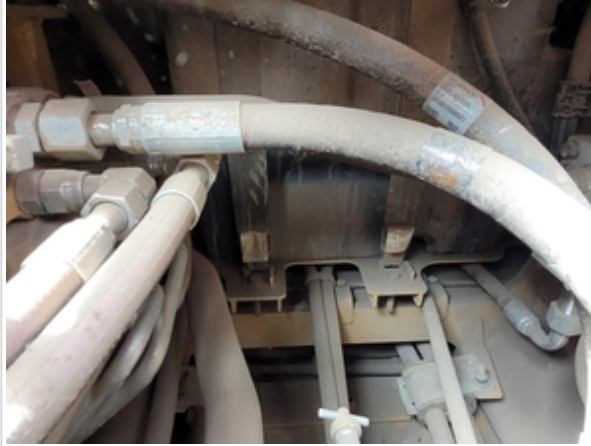
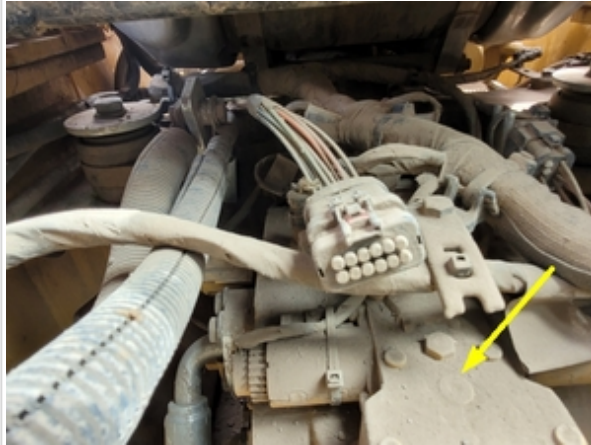
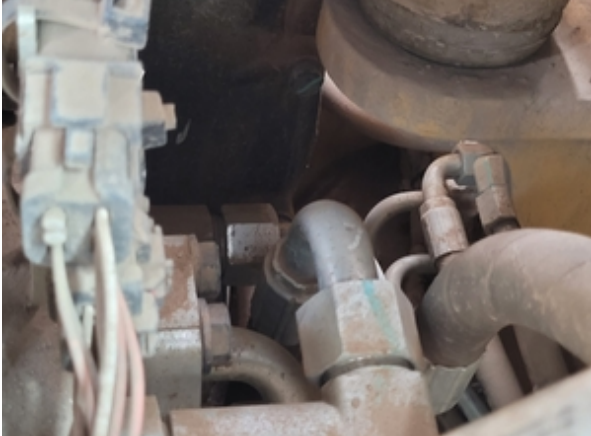
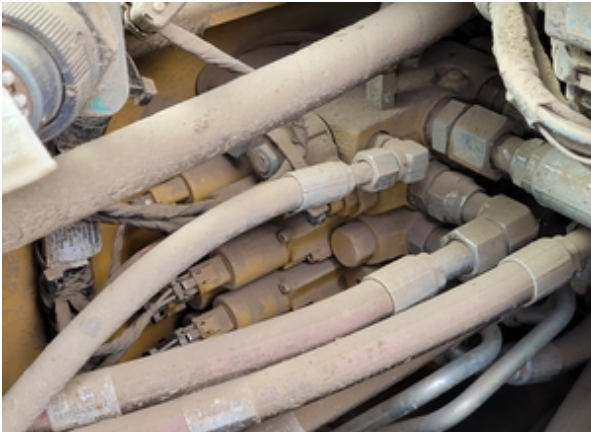
Hydraulic System Photos

Wet or Damp Hydraulic Lines / Fittings	No
Appearance of Hydraulic Lines / Fittings	4 - Very Light or Minimal Wear
Hydraulic Lines / Fittings Condition	Hydraulic lines & fittings are clean and in good condition
Hydraulic Pump(s)	4 - Very Light or Minimal Wear
Unusual Noises (Hydraulic Pump)	No
Hydraulic Pump Notes	No unusual noises heard during operation
