Inspection Report (Bulldozer)

B&B Stock Number	1
Year	2021
Make	CAT
Model	D3
Serial Number	XKW00589
Hour Meter Reading	626 Hrs.
Previous Application (e.g., earth moving, mining, demolition, etc)	Landscaping

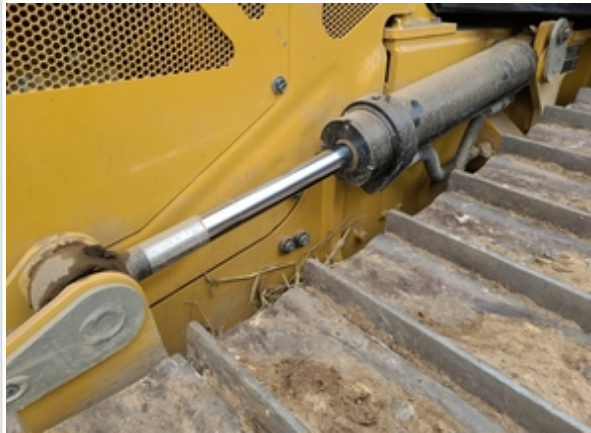
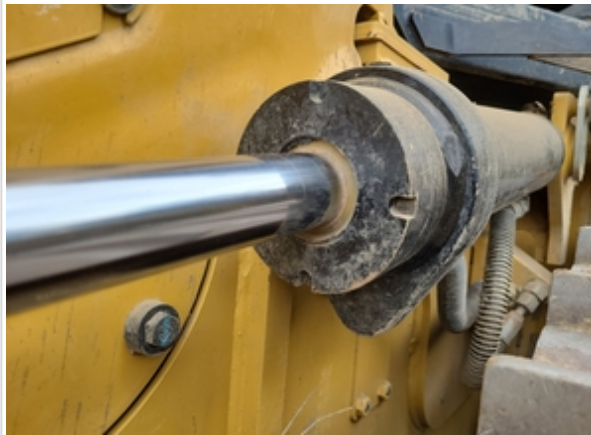
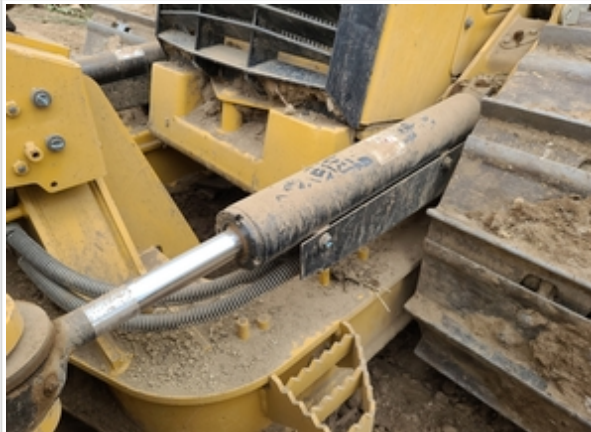
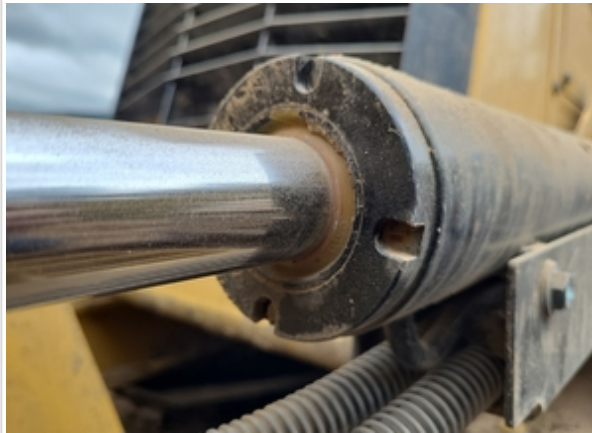
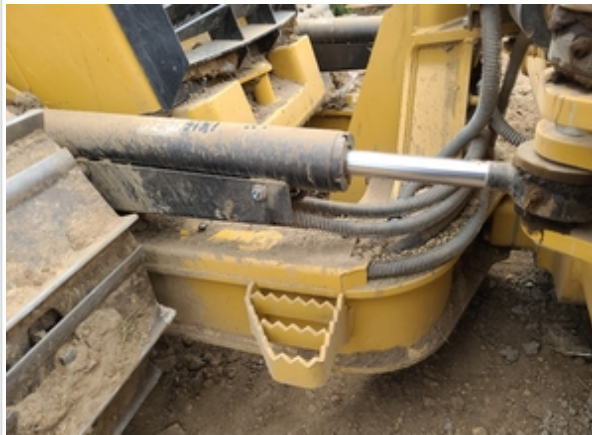
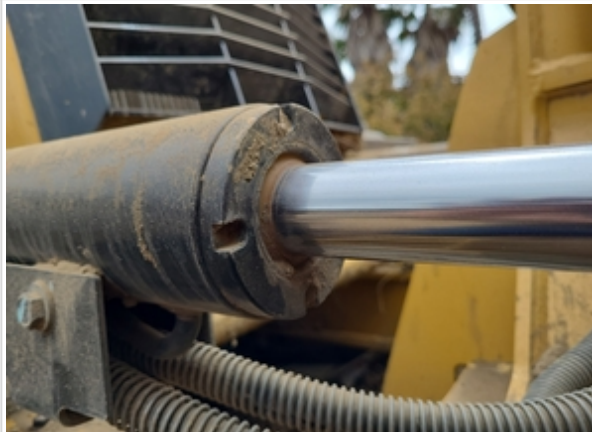
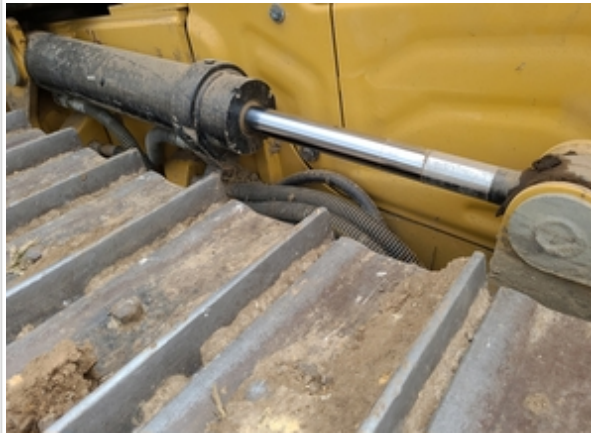
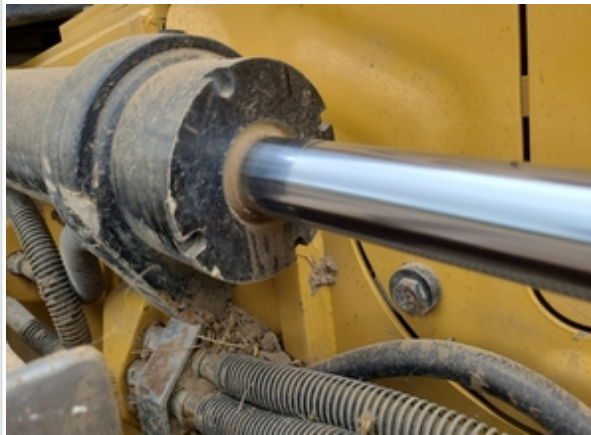
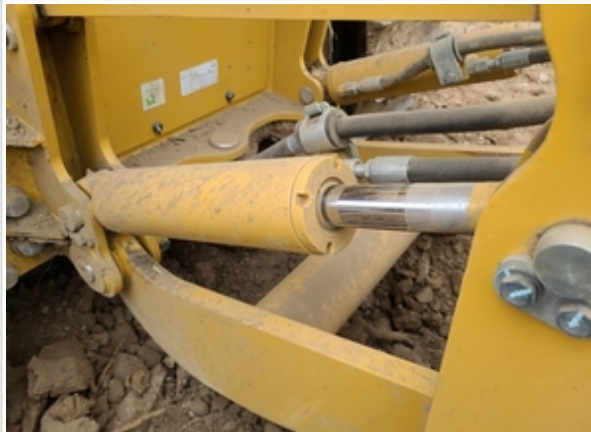
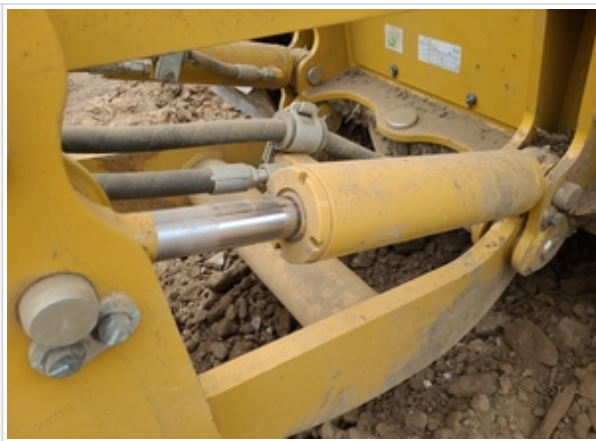
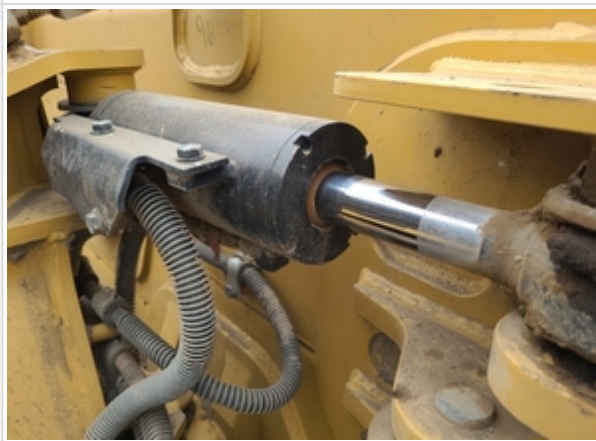
Hydraulic Cylinder(s) Photos

Hydraulic Cylinder(s) Condition	4 - Very Light or Minimal Wear
Mounting Pins	4 - Very Light or Minimal Wear
Cylinder: Oil Leaks	No

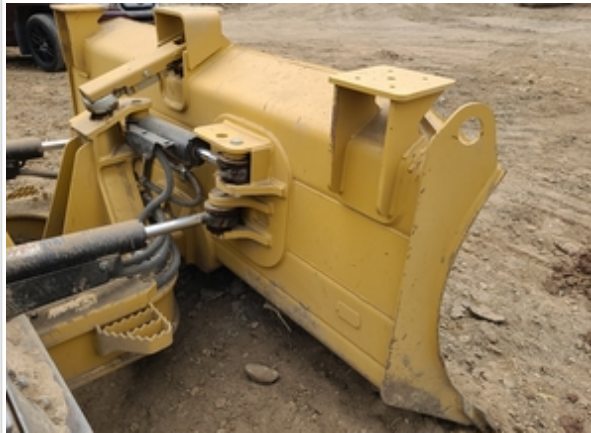
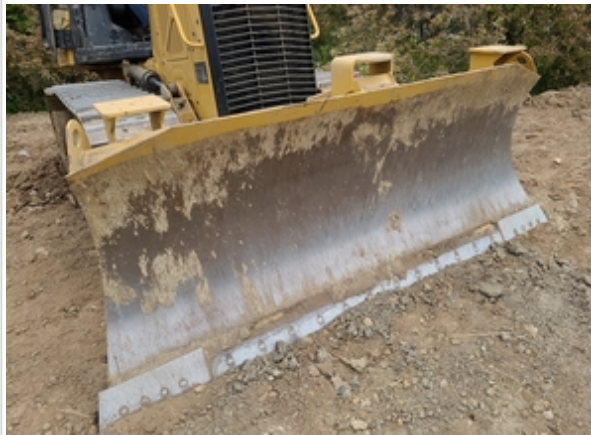
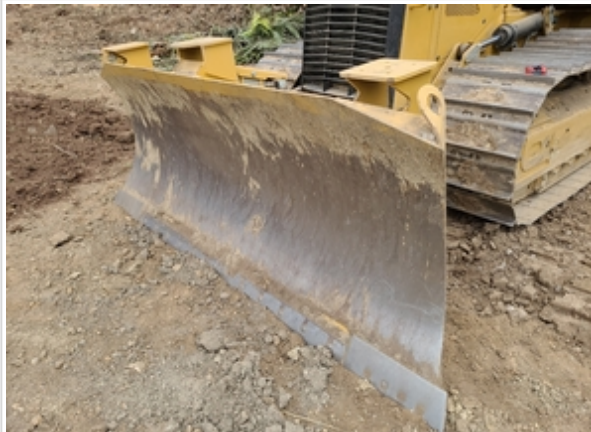
Attachment Photos

Attachment Type	6 Way Blade
Attachment Make	CAT
Attachment Size / Specs	9' Wide
Attachment Condition	4 - Very Light or Minimal Wear
Comments	Top Left Corner Hook/Ring Bent

What's Great About the Machine	Machine has low hours and no issues found during inspection. Machine is autograde equipped and has a six-way blade.	
What Needs Work	Front blade corner hook slightly bent inwards.	
Date/Time	05-31-2023
