Inspection Report (Excavator)

Year	2021
Make	CAT
Model	308 CR
Serial Number	JGG801957
Hour Meter Reading	450 Hrs.
Previous Application (e.g., earth moving, mining, demolition, etc)	Landscape/Rock Removal

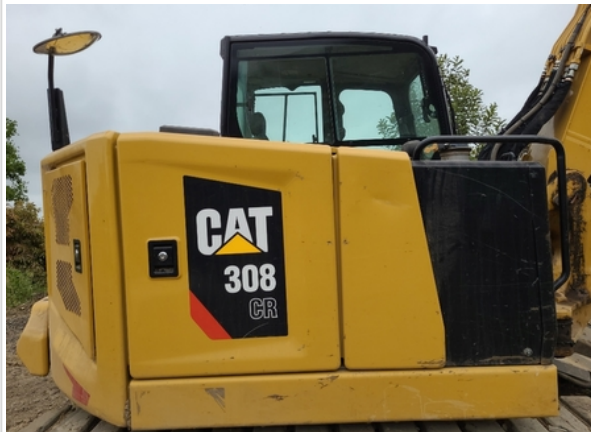
Panel dented

<p>Minor Panel Misalignment</p>
Body Panels	3 - Normal Wear & Tear
Body Panel Condition	No visible damage, good paint condition and panel fitment, Some panel misalignment observed
Comments	R/S Radiator/Air Filter Door Panel slightly bent
Doors / Canopy Latches	3 - Normal Wear & Tear
Doors / Canopy Latches Condition	No visible damage
Steps / Ladders	3 - Normal Wear & Tear
Steps / Ladders Condition	Steps/ladders are fully intact and appear structurally sound
Handrails	3 - Normal Wear & Tear
Handrails Condition	Handrails are fully intact and appear structurally sound
Glass	3 - Normal Wear & Tear
Glass Condition	Glass intact, no visible damage
Mirrors	3 - Normal Wear & Tear
Mirror Condition	Mirrors present and intact, no visible damage
Exterior Lights	4 - Like New, Recently Replaced
Exterior Lights Condition	No visible damage, lighting system is operational

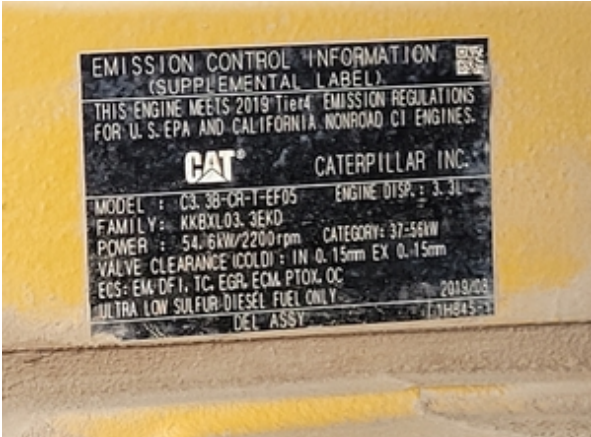
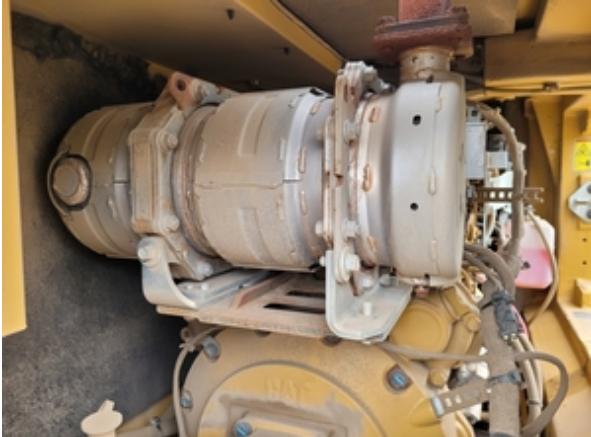
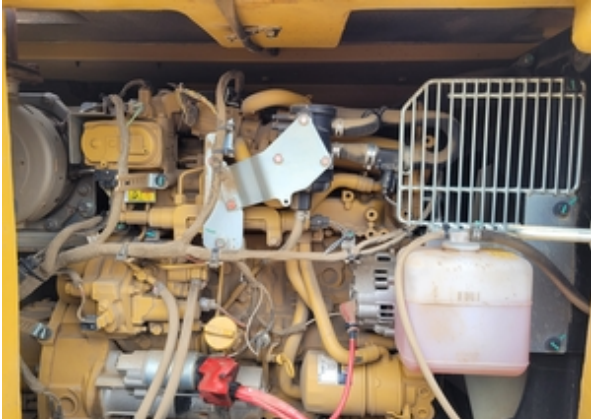
Engine Type (Make, Model, Cylinders, Hp)	CAT - 3.3L - 4Cyl. - 73HP
Emissions Tier	Tier 4F
Engine Serial Number	N/A
Engine Fuel Type	Diesel
Engine Photos

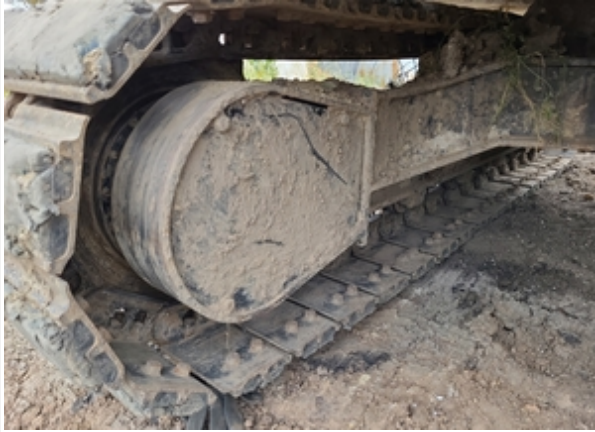
Hydrostatic Transmission?	Yes
2 Speed?	Yes
Hydrostatic Drive Configuration	Split Transmission
Transmission Components	3 - Normal Wear & Tear
Transmission Condition	Good forward and reverse function
Drive Motors	3 - Normal, Operating as Expected
Comments	Drive motors covered and no oil leakage seen
Parking Brake	4 - Operating Within Factory Specs
Parking Brake Function	Good brake function
Overall Drivetrain Comments	Machine travels well in all directions and in all speeds.

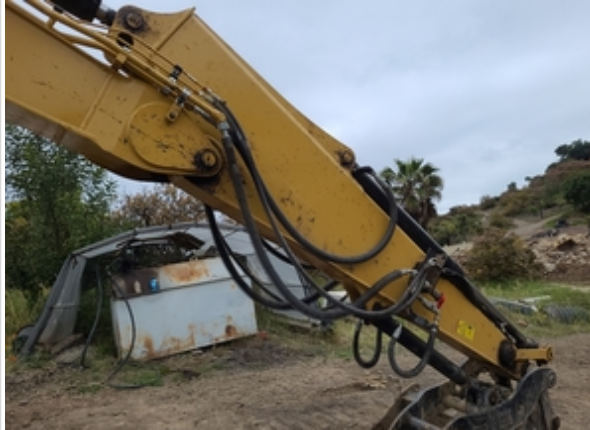
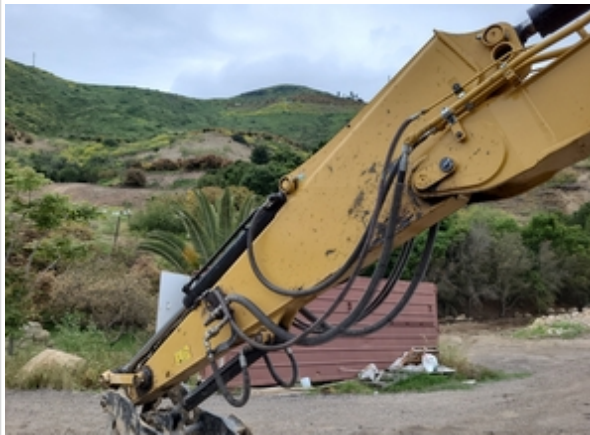
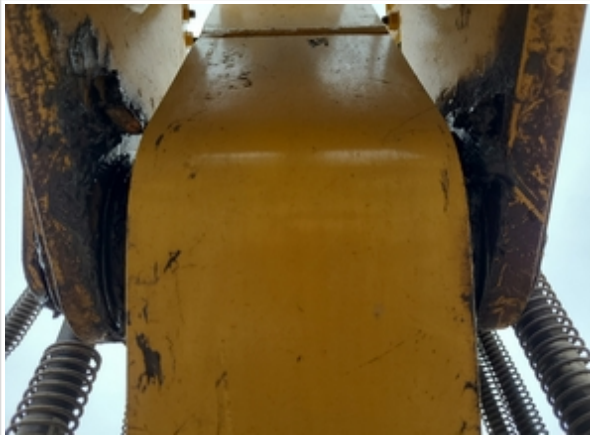
Stick Photos

<p>Stick Condition</p>	<p>3 - Normal Wear & Tear</p>

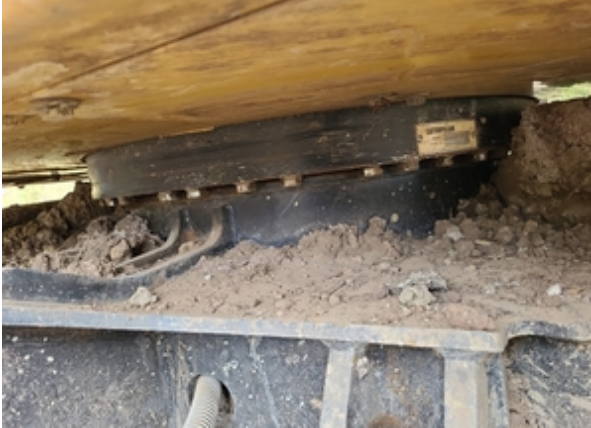
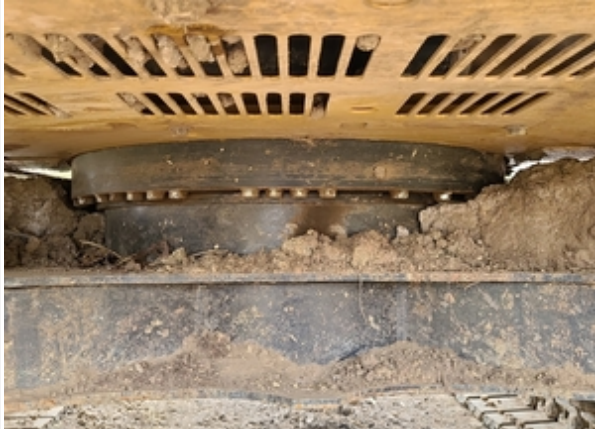
Boom Base Pin & Bushings	4 - Like New, Recently Replaced	
Boom to Stick Pin & Bushings	4 - Like New, Recently Replaced	
Stick to Bucket Pin & Bushings	4 - Like New, Recently Replaced	
Turntable Bearing	4 - Like New, Recently Replaced	
Turntable Bearing Photos

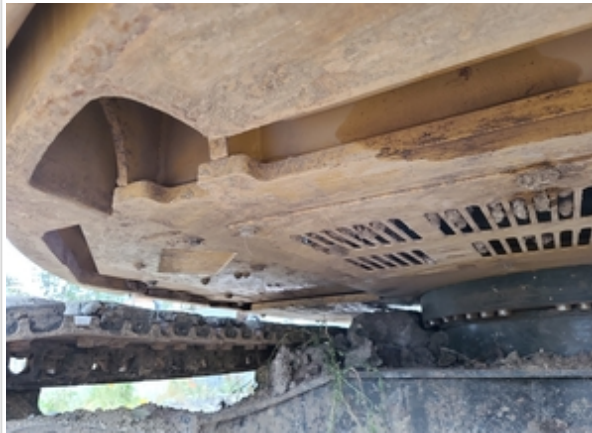
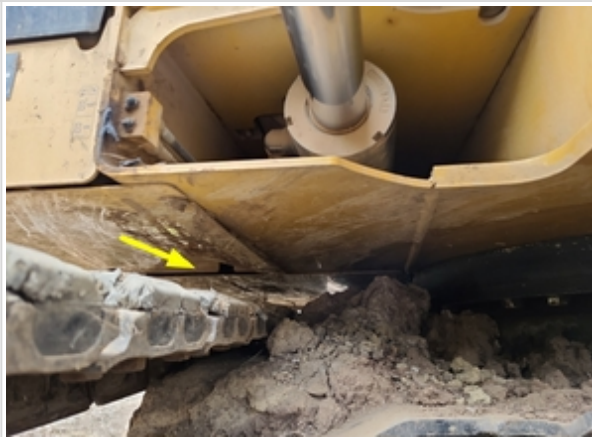
Bottom Covers	3 - Normal Wear & Tear	
Comments	Some scuff marks and minor dents observed.	
Bottom Covers Photos

Bottom cover dented

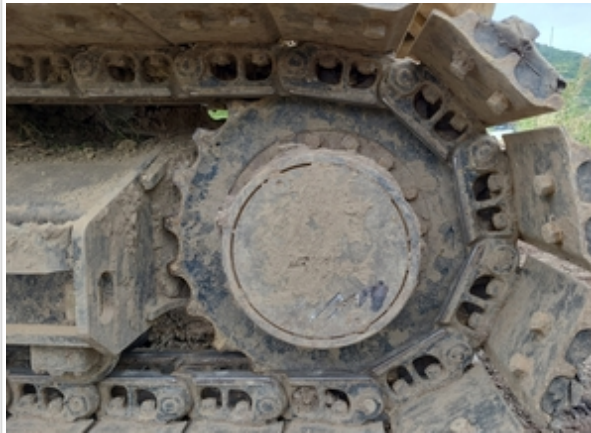
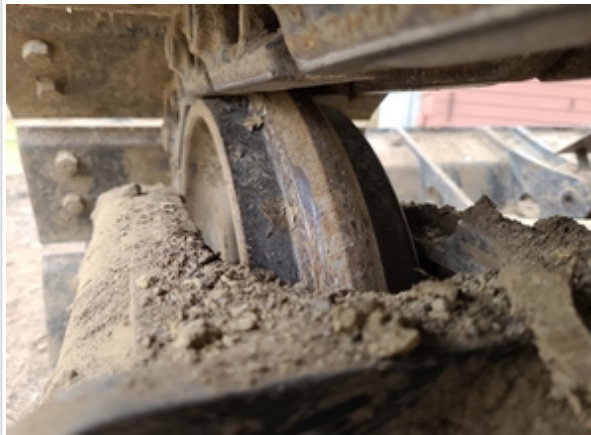
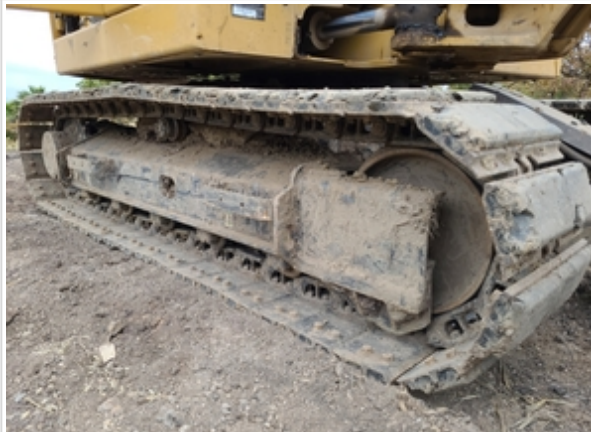
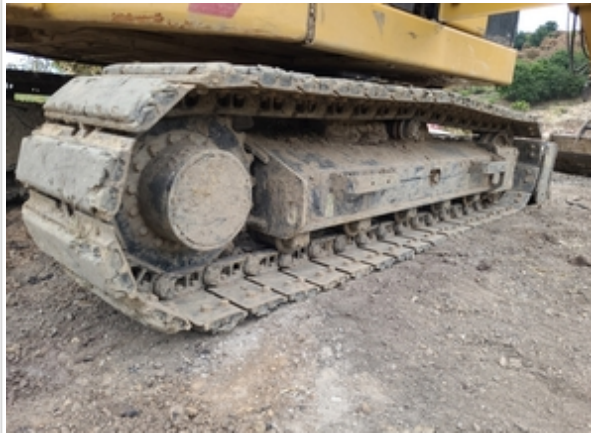
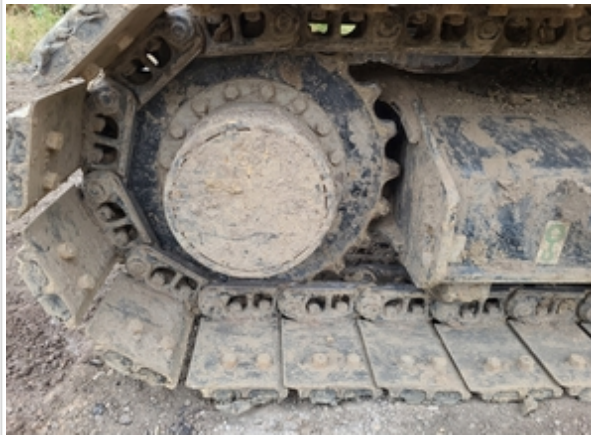
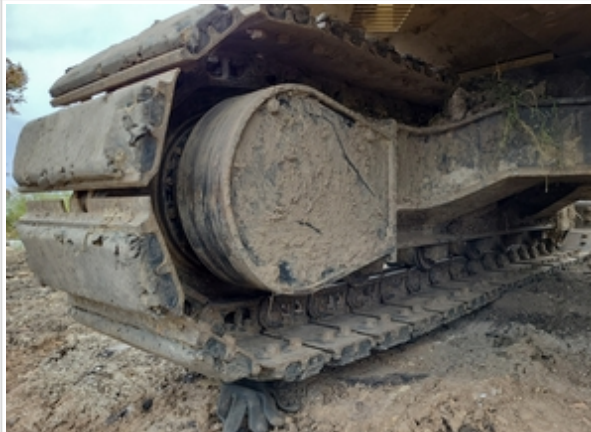
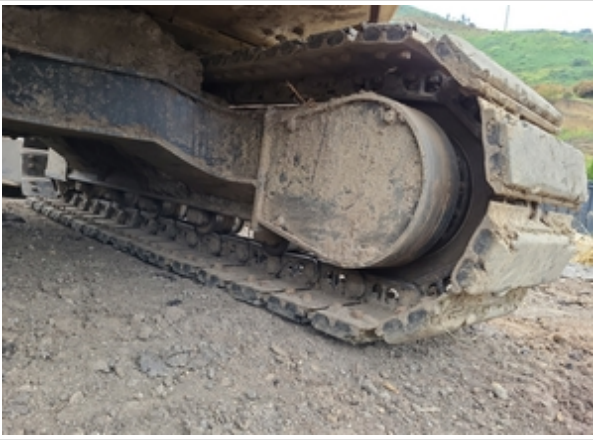
Overall Chassis	3 - Normal Wear & Tear	
Overall Chassis Comments	Main frame and implements in great condition.

Undercarriage Overall Condition	3 - Normal Wear & Tear	
Undercarriage Overall Photos

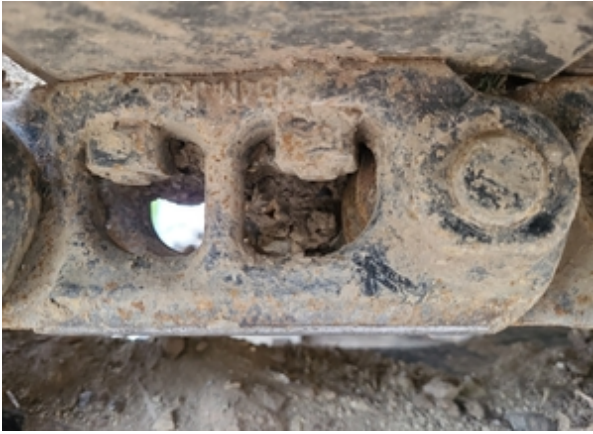
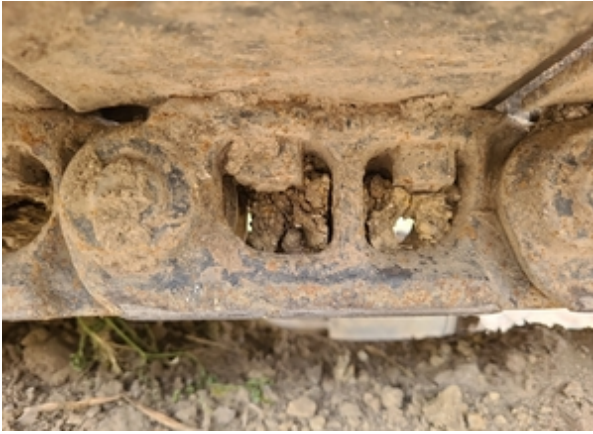
Pin & Bushings	3 - Normal Wear & Tear
Pin & Bushings Photos

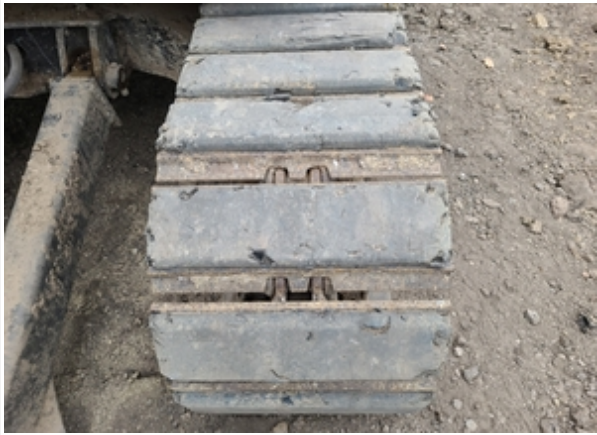
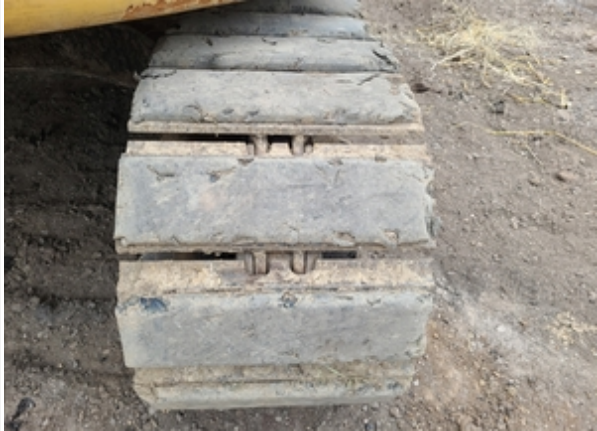
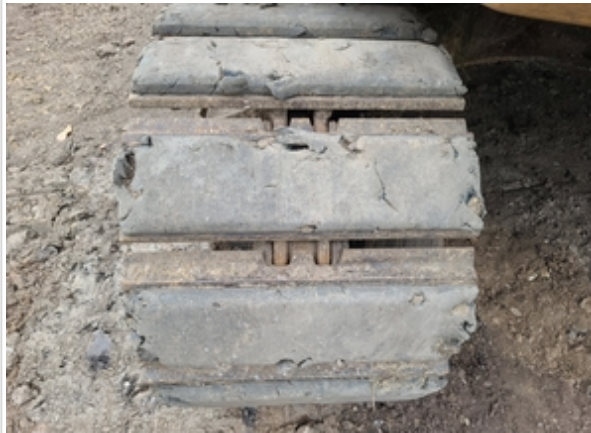
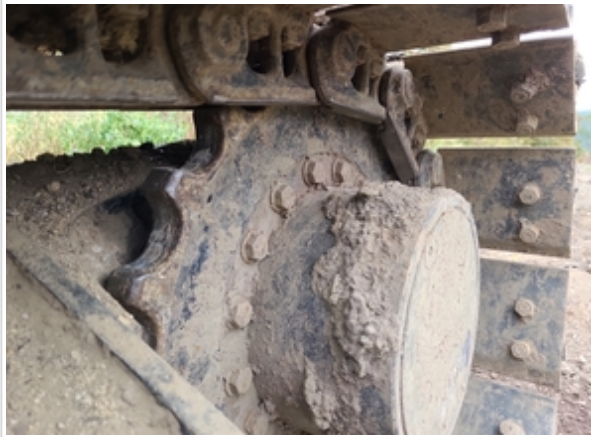
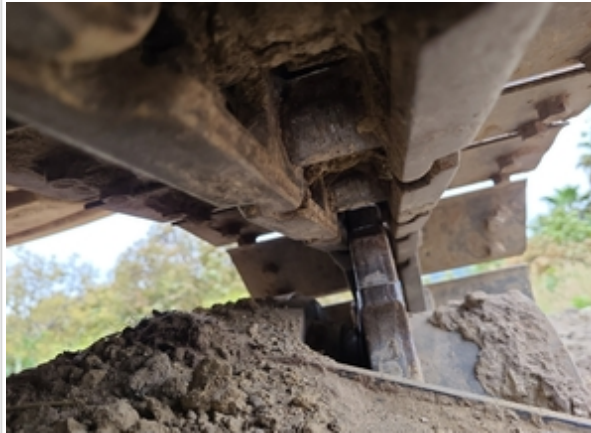
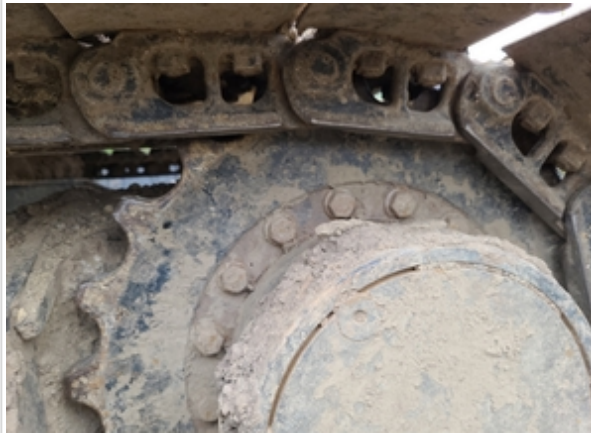
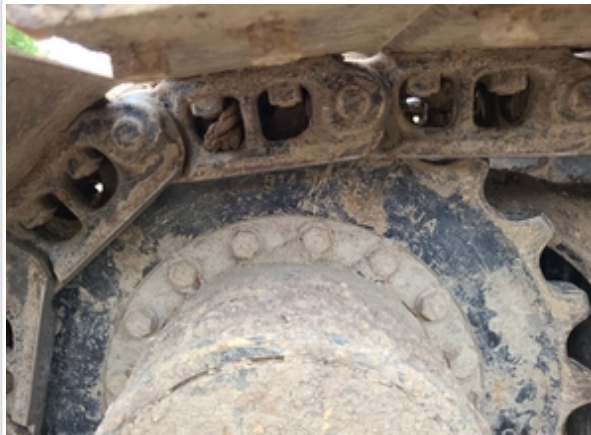
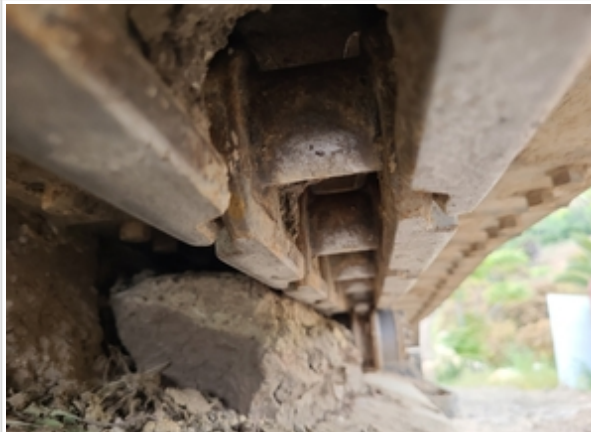
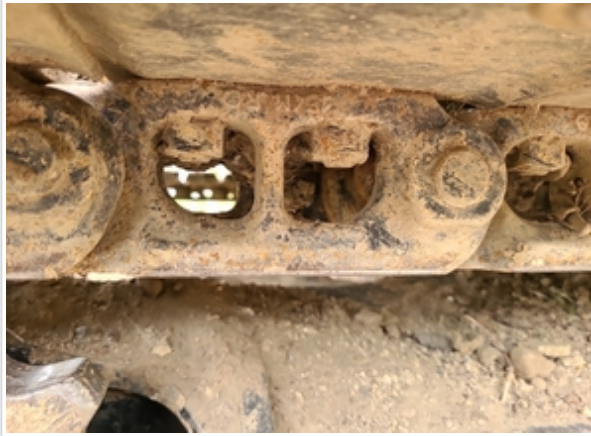
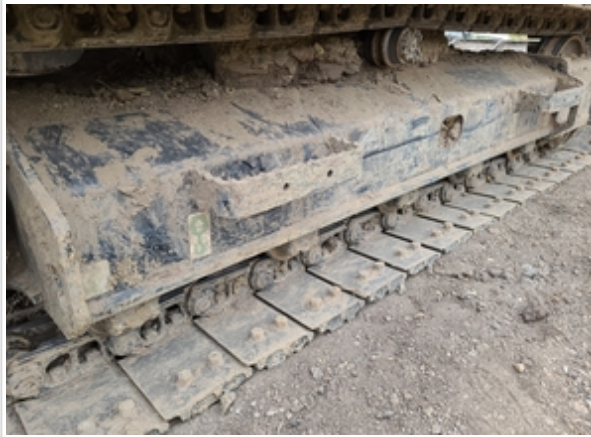
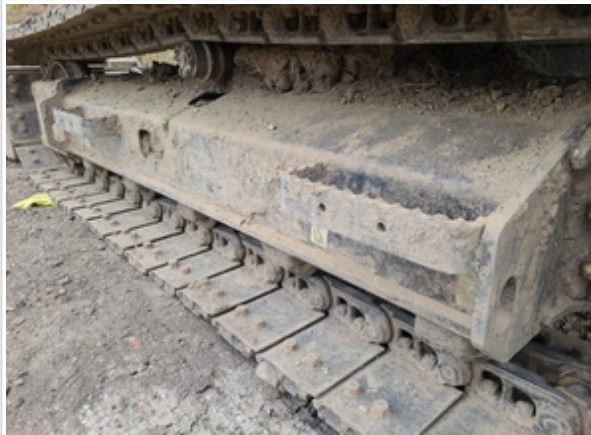
Tracks	3 - Normal Wear & Tear
Comments	Bolt-on Rubber Track Pads have normal wear and tear but still have plenty of life left

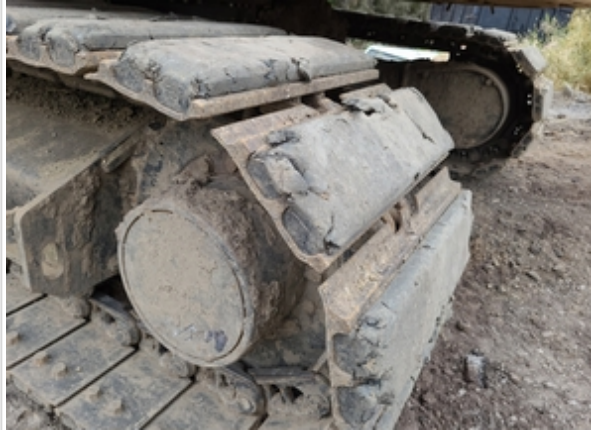
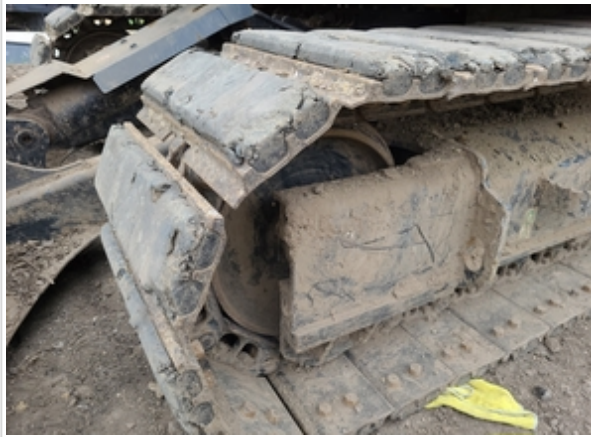
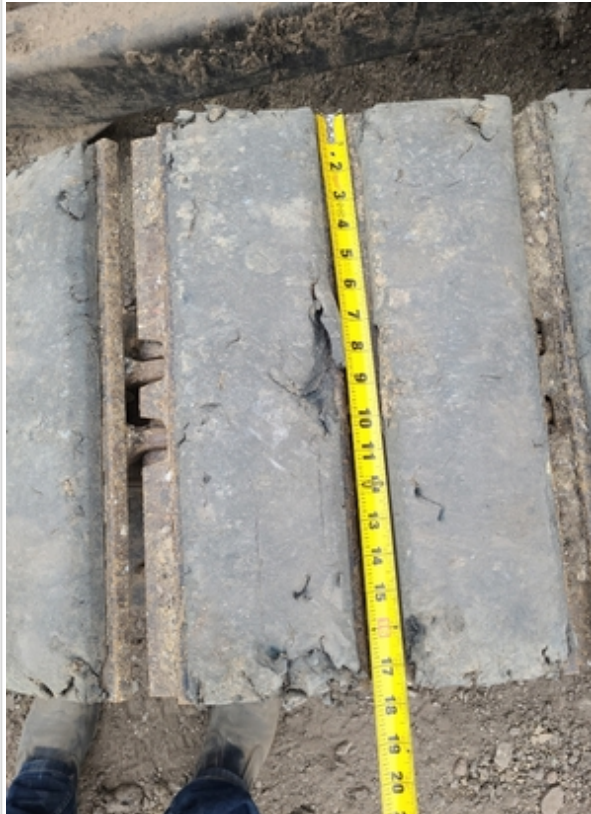
Left Side: Link Bushings / Drive Sprocket / Shoe Condition	3 - Normal Wear & Tear
Left Side: Upper & Lower Roller / Front Idler Condition	3 - Normal Wear & Tear
Comments	Steel Tracks at 90% and/or above
Track Condition: Left Front	90%
Track Condition: Left Rear	90%
Undercarriage Left Side Photo Instructions	Take photos of the undercarriage of this piece of equipment. Must have shots to capture: <ul style="list-style-type: none"> - Roller Frame (left) - Track Tensioner (left) - Track Pads (left) - Grouser Height (left) - Track Links (left) - Track Bushings (left) - Carrier Rollers (left) - Track Rollers (left) - Idler (left) - Sprocket (left)

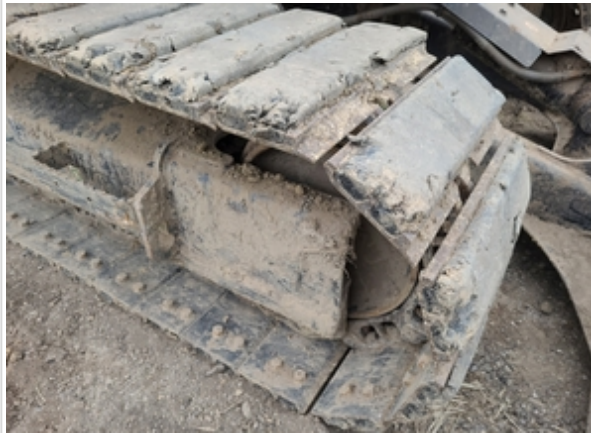
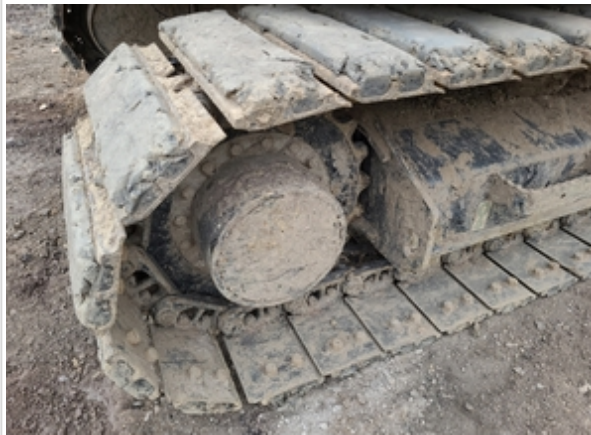
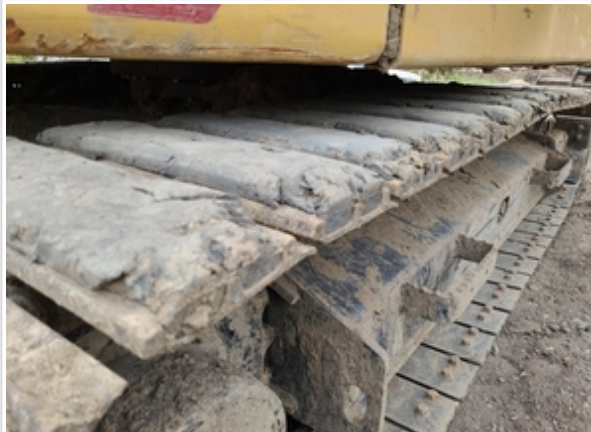
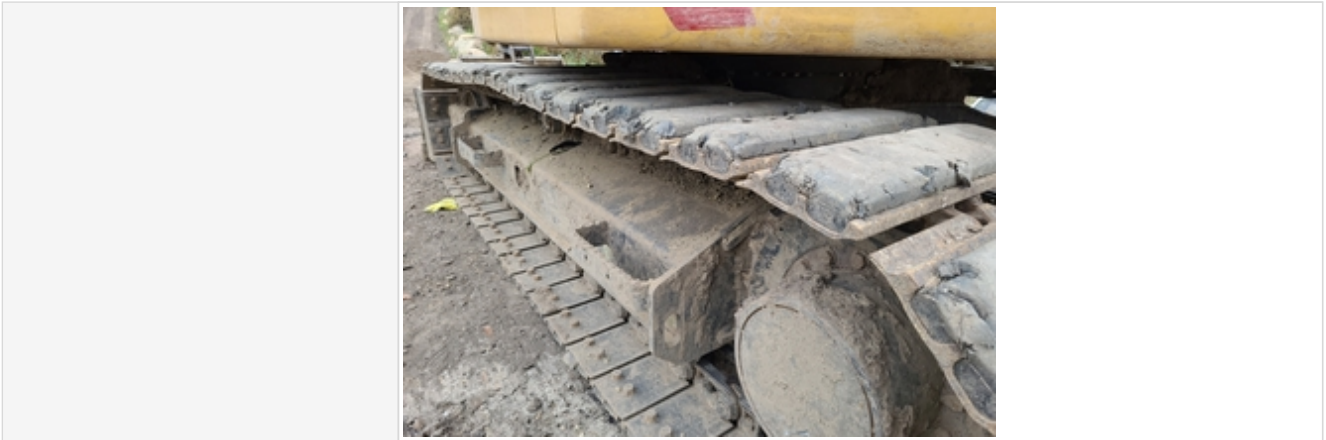
Right Side: Link Bushings / Drive Sprocket / Shoe Condition	3 - Normal Wear & Tear	
Comments	Steel Tracks at 90% and/or above	
Right Side: Upper & Lower Roller / Front Idler Condition	3 - Normal Wear & Tear	
Track Condition: Right Front	90%	
Track Condition: Right Rear	90%	
Undercarriage Right Side Photo Instructions	Take photos of the undercarriage of this piece of equipment. Must have shots to capture: <ul style="list-style-type: none"> - Roller Frame (right) - Track Tensioner (right) - Track Pads (right) - Grouser Height (right) - Track Links (right) - Track Bushings (right) - Carrier Rollers (right) - Track Rollers (right) - Idler (right) - Sprocket (right) 	
Undercarriage Right Side Photos

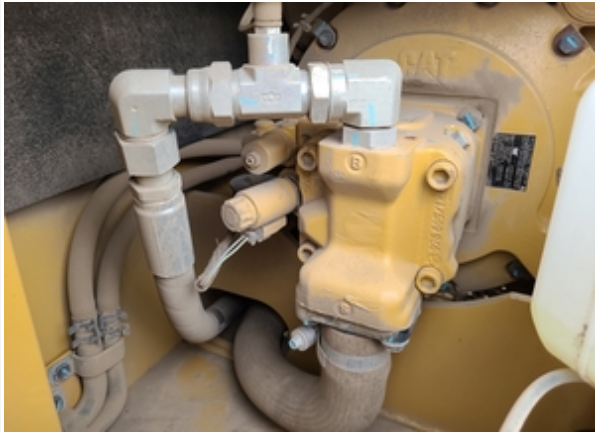
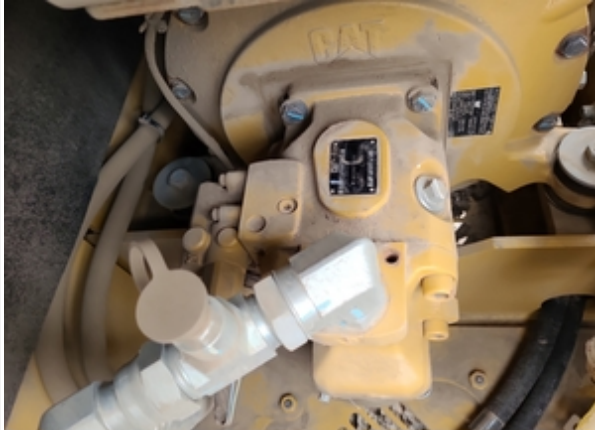
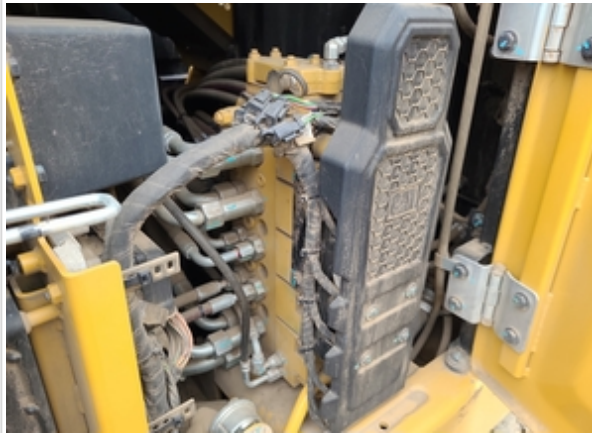
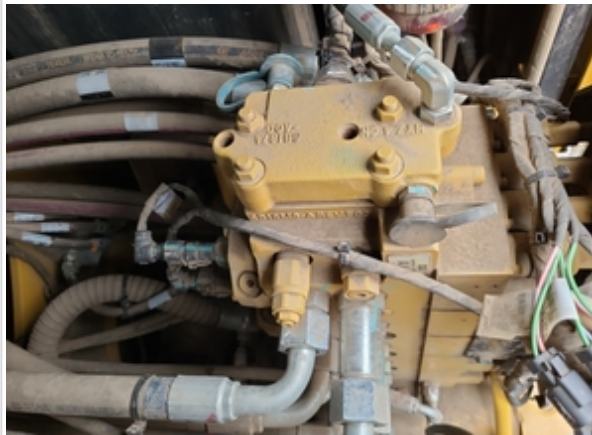
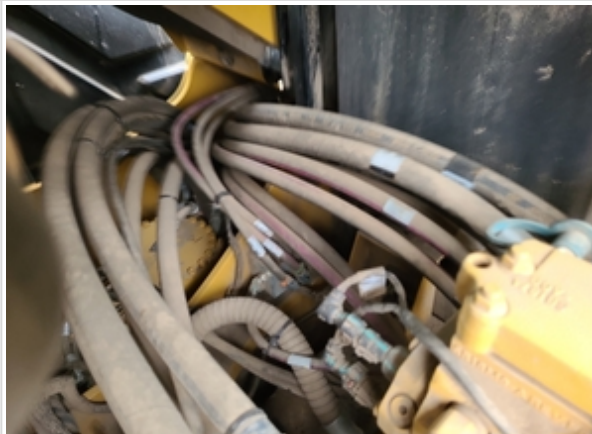
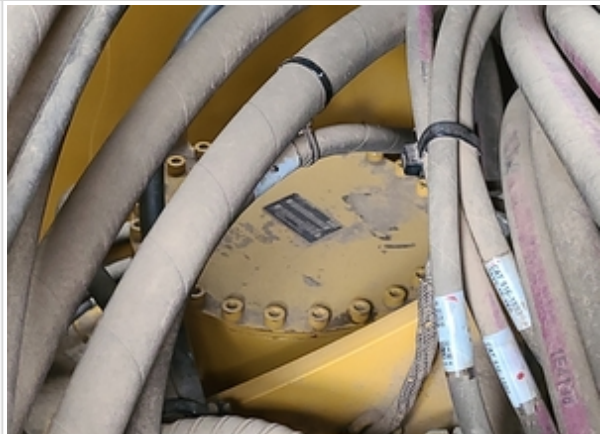
Swing Motor/Drive Unit	
Wet or Damp Hydraulic Lines / Fittings	No	
Appearance of Hydraulic Lines / Fittings	3 - Normal Wear & Tear	
Hydraulic Lines / Fittings Condition	Hydraulic lines & fittings are clean and in good condition	
Unusual Noises (Hydraulic Pump)	No	
Hydraulic Pump Notes	No unusual noises heard during operation

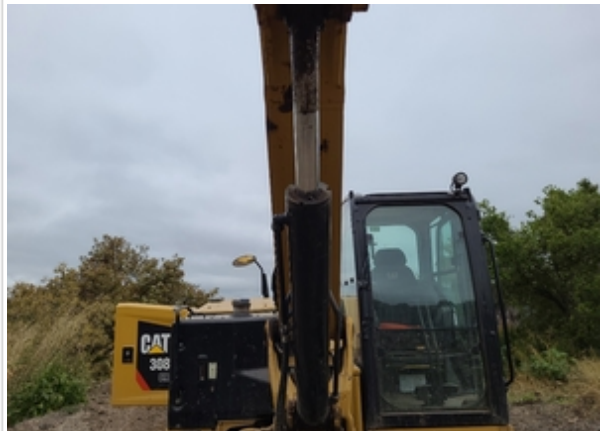
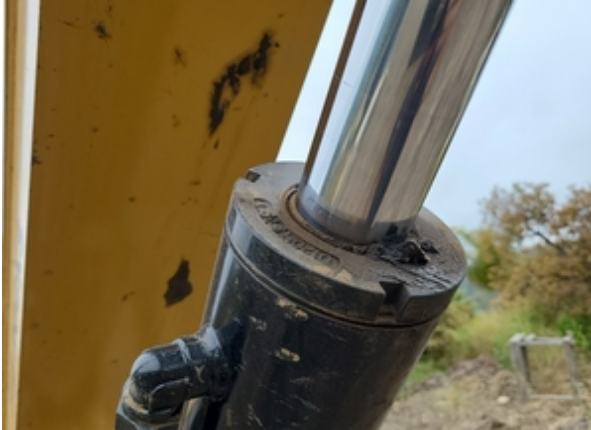
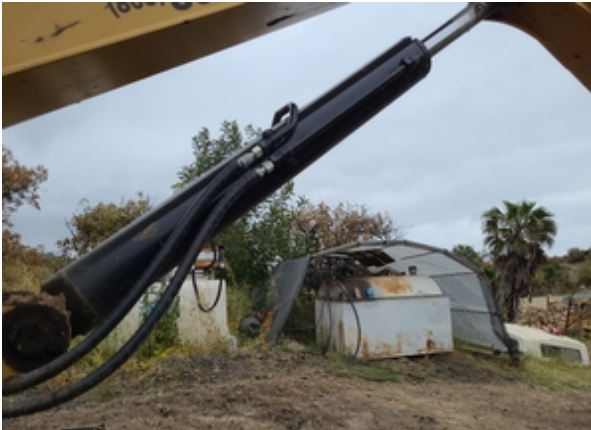
Boom Cylinder	Check the boom cylinder. Note any wear, pitting, discoloration, etc. Take photos.	
Boom Cylinder: Mounting Pin	4	
Boom Cylinder: Oil Leaks	No	
Boom Cylinder Photos

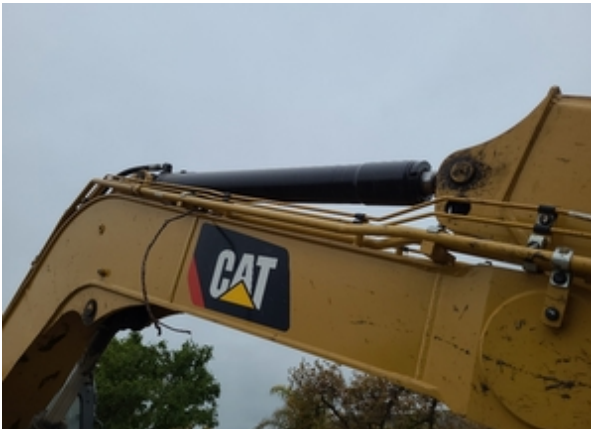
Stick Cylinder	Check the stick cylinder. Note any wear, pitting, discoloration, etc. Take photos.	
Stick Cylinder: Mounting Pin	3	
Stick Cylinder: Oil Leaks	No	
Stick Cylinder Photos

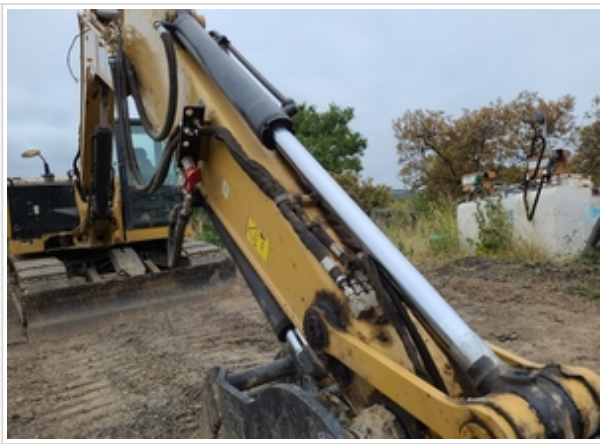
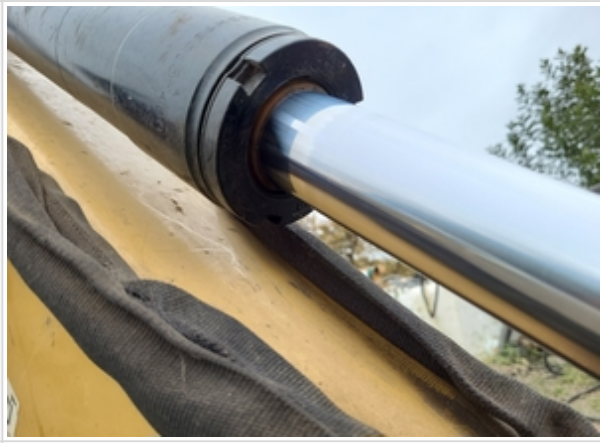
<p>Score Marks</p>

Bucket Cylinder	Check the bucket cylinder. Note any wear, pitting, discoloration, etc. Take photos.
Bucket Cylinder: Mounting Pin	3
Bucket Cylinder: Oil Leaks	No
Comments	Minor Score marks observed on chrome rod
Bucket Cylinder Photos

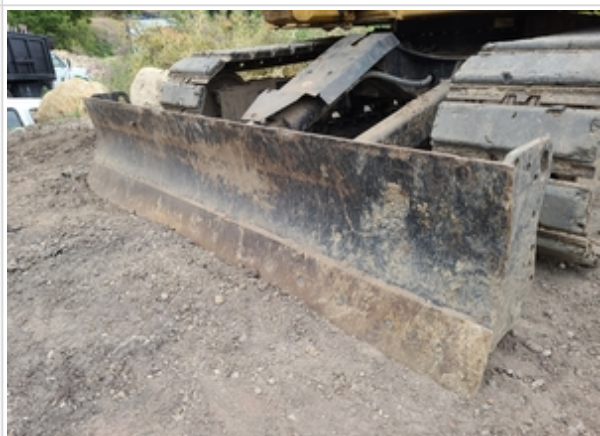
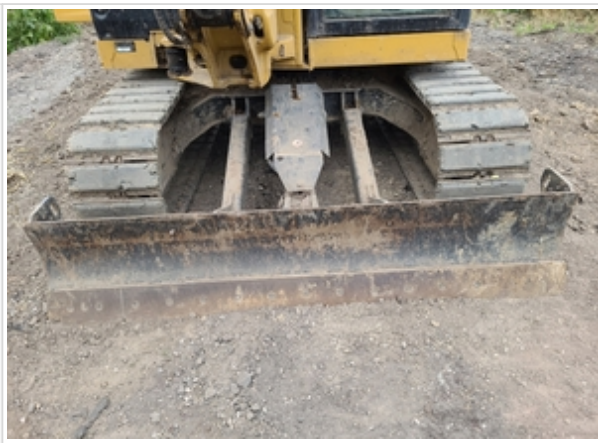
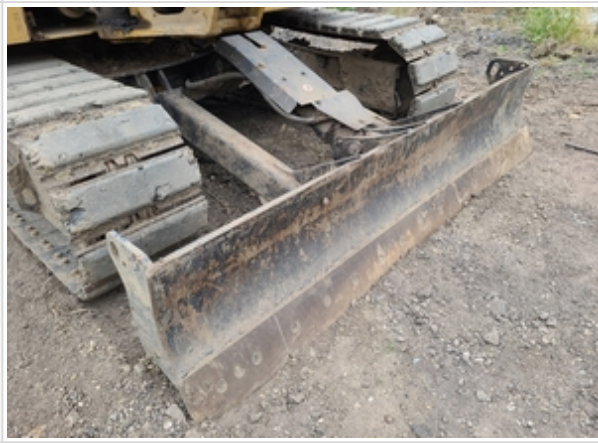
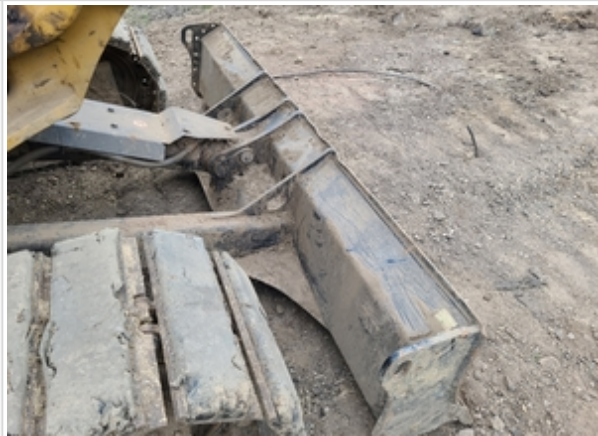
Blade	Check the blade. Note any wear, pitting, discoloration, etc. Take photos.	
Blade	3	
Comments	90" Wide	
Blade Photos

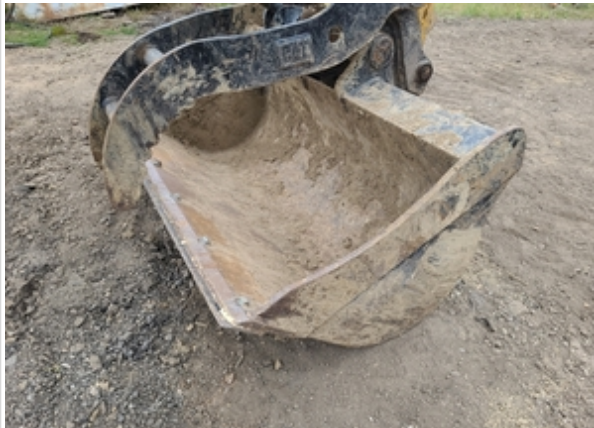
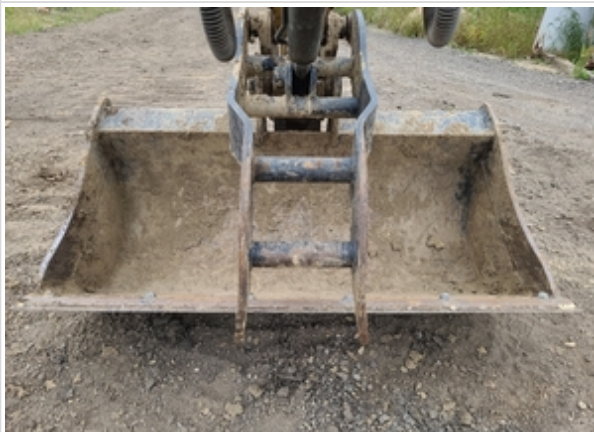
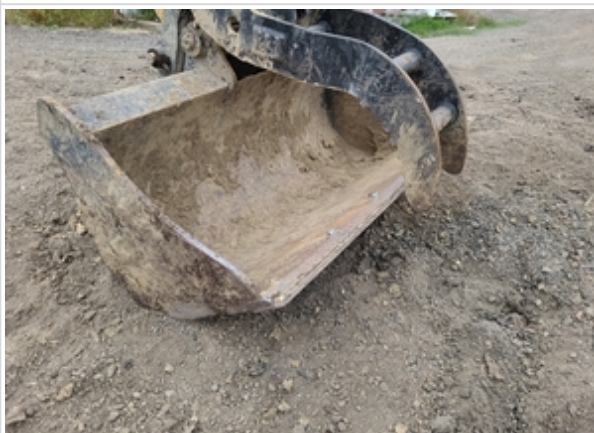
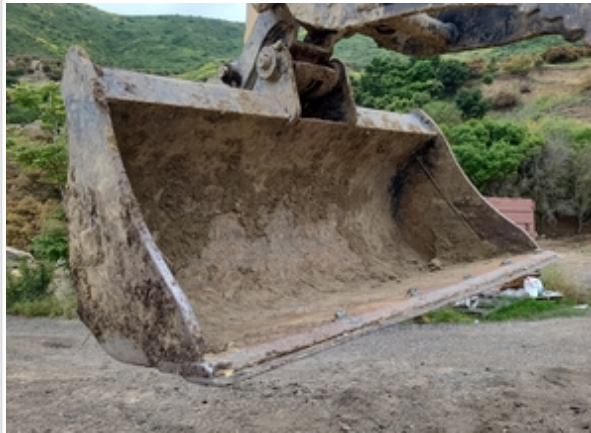
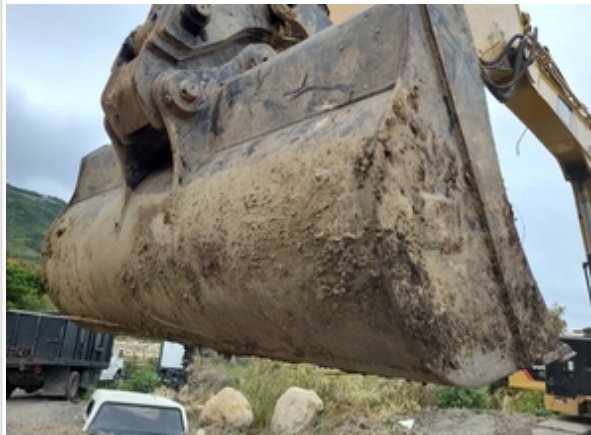
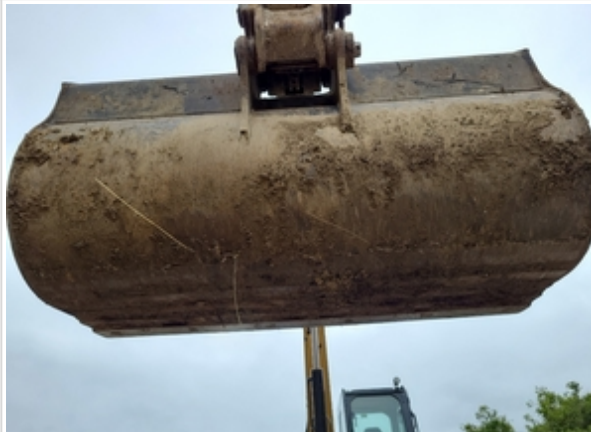
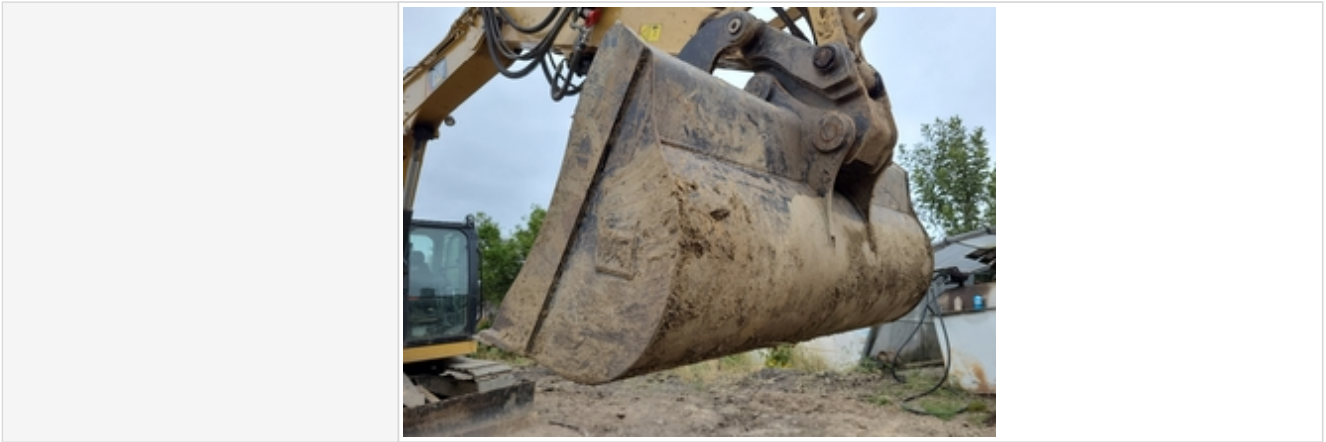
<p>Bucket Photos</p>

Bucket Condition	3 - Normal Wear & Tear
Comments	Normal wear and tear

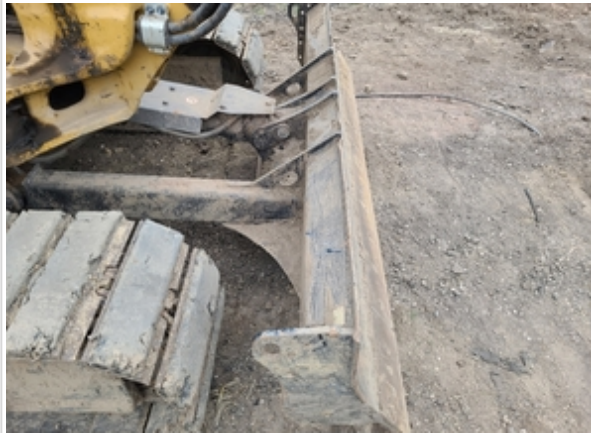
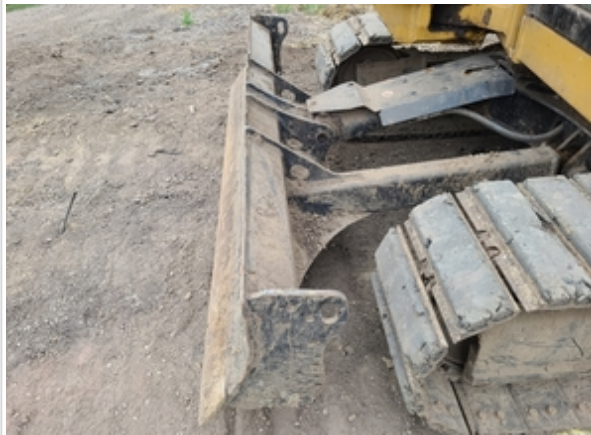
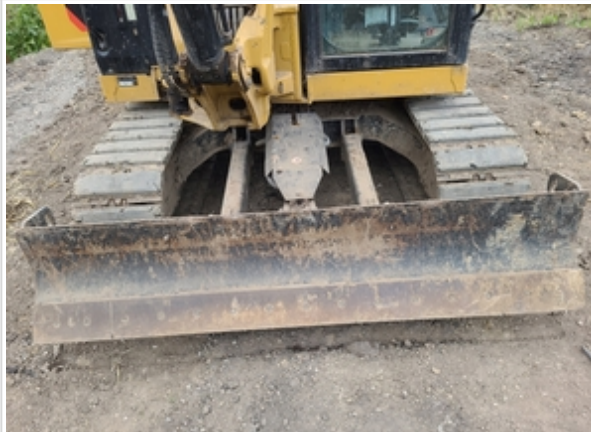
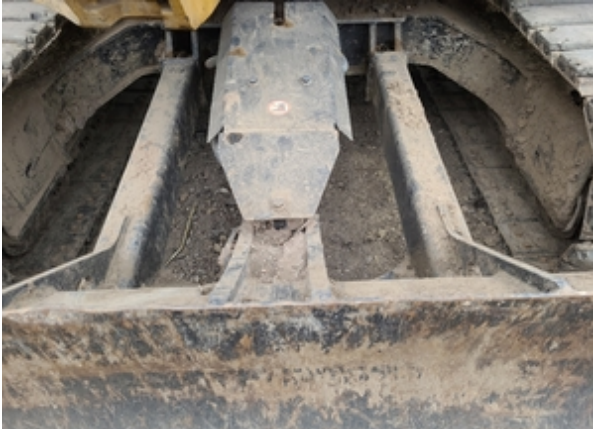
Blade Condition	3 - Normal Wear & Tear
Blade Photos

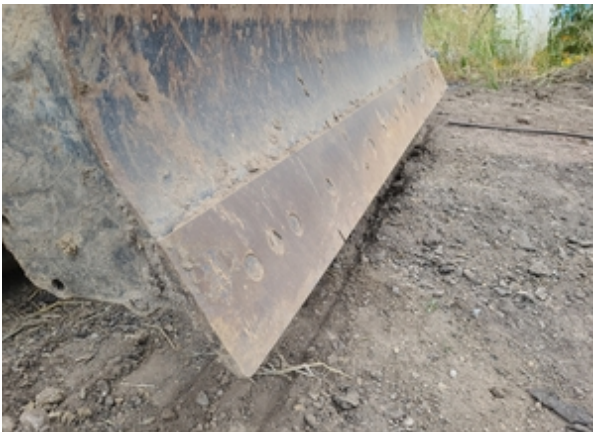
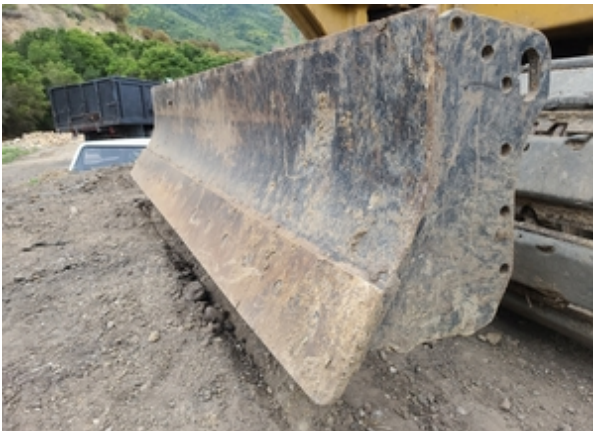
Blade Edge	3 - Normal Wear & Tear	
Blade Edge Photos
