B&B Stock Number	1
Year	2023
Make	John Deere
Model	700L XLT
Serial Number	1T0700LXHPF445537
Hour Meter Reading	25 Hrs.
Previous Application (e.g., earth moving, mining, demolition, etc)	Landscape/Rock Removal

Inspection Report (Bulldozer)

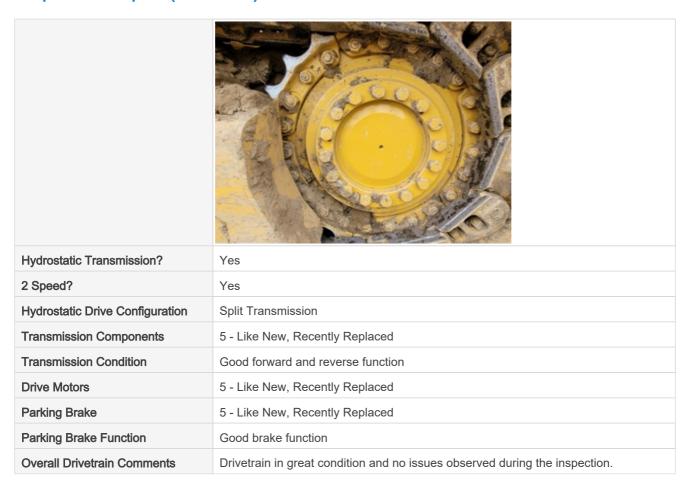
ondereamage compensate		
Sprocket Teeth	4 - Very Light or Minimal Wear	
Track Bushings	4 - Very Light or Minimal Wear	
Track Frames	5 - Like New, Recently Replaced	
Pivot Shafts	5 - Like New, Recently Replaced	
Equalizer Bar & Joints	5 - Like New, Recently Replaced	
Front Idler	4 - Very Light or Minimal Wear	
Track Tensioner	5 - Like New, Recently Replaced	
Track links	5 - Like New, Recently Replaced	
Bottom Rollers	4 - Very Light or Minimal Wear	
Carrier Rollers	4 - Very Light or Minimal Wear	
Overall Undercarriage	5 - Like New, Recently Replaced	
Overall Undercarriage Comments	Great shape, Normal break-in wear.

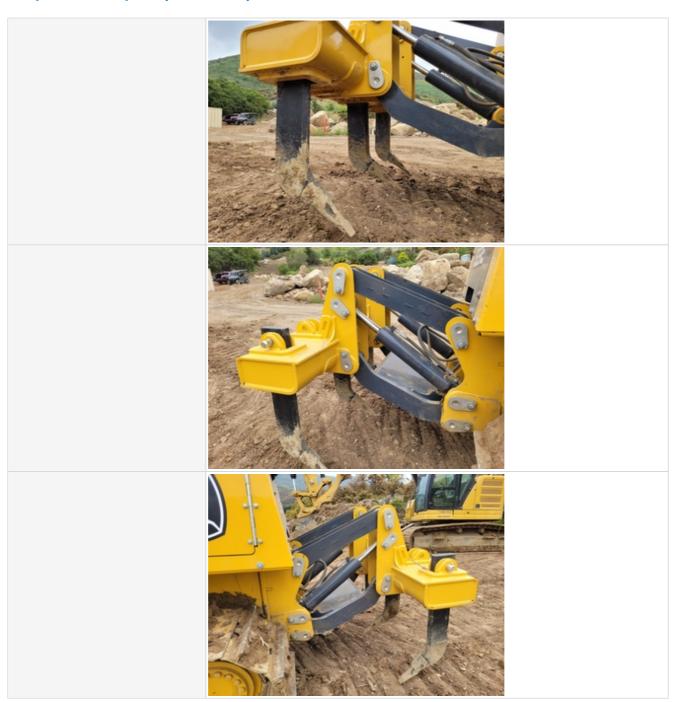
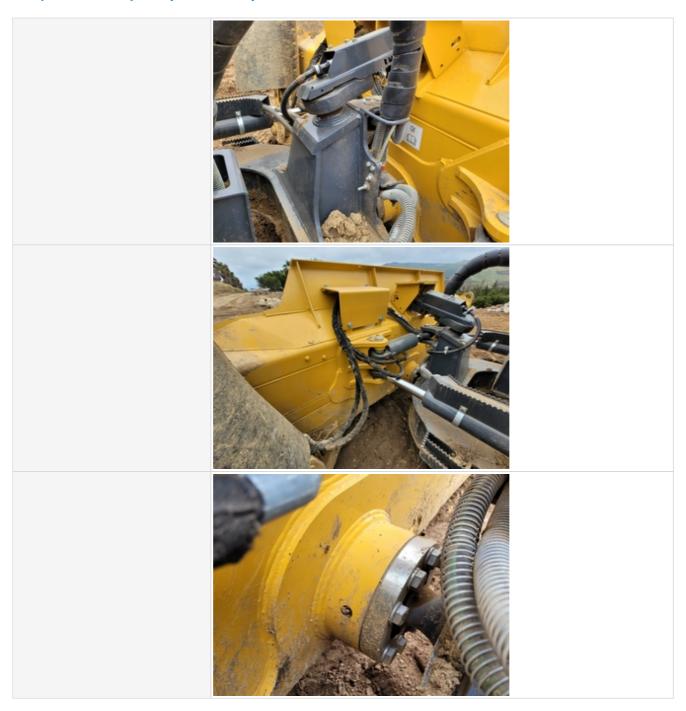
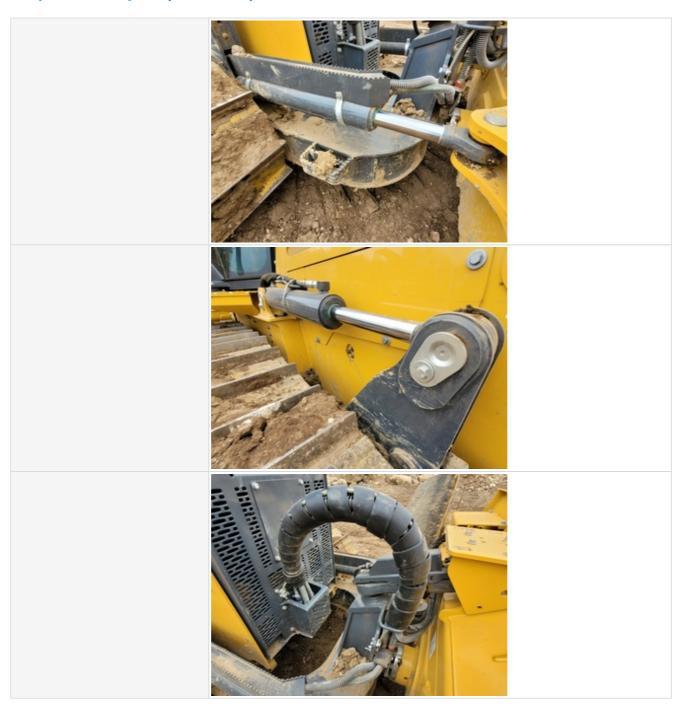
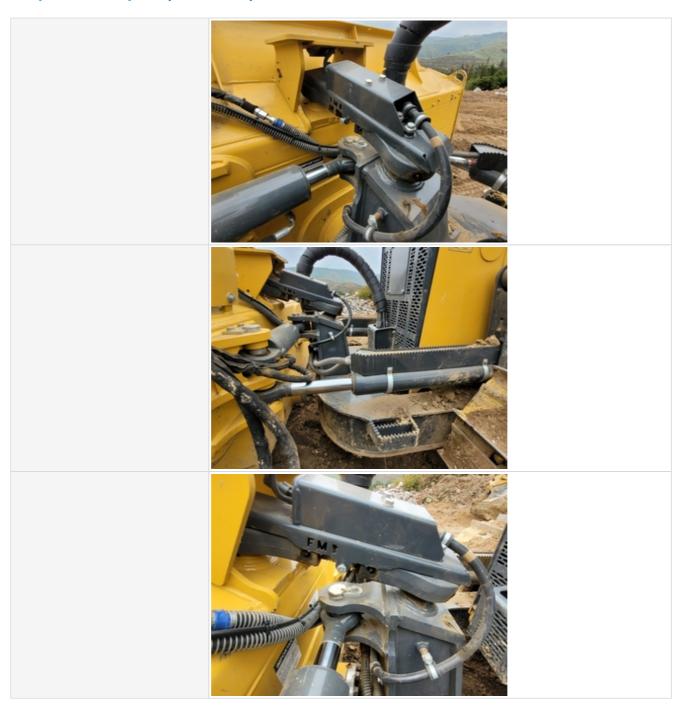
Push Arm / C-Frame Condition	5 - Like New, Recently Replaced
Push Arm Pivot / C-Frame Trunnions Condition	5 - Like New, Recently Replaced
Tilt Linkage Pin & Bushings	5 - Like New, Recently Replaced
Angle Linkage Pin & Bushings	5 - Like New, Recently Replaced
Blade Trunnions / Bushings	5 - Like New, Recently Replaced
Frame Condition	5 - Like New, Recently Replaced
Belly Pans	5 - Like New, Recently Replaced
Overall Chassis	5 - Like New, Recently Replaced
Overall Chassis Comments	Main Frame and Implements in Excellent Condition.

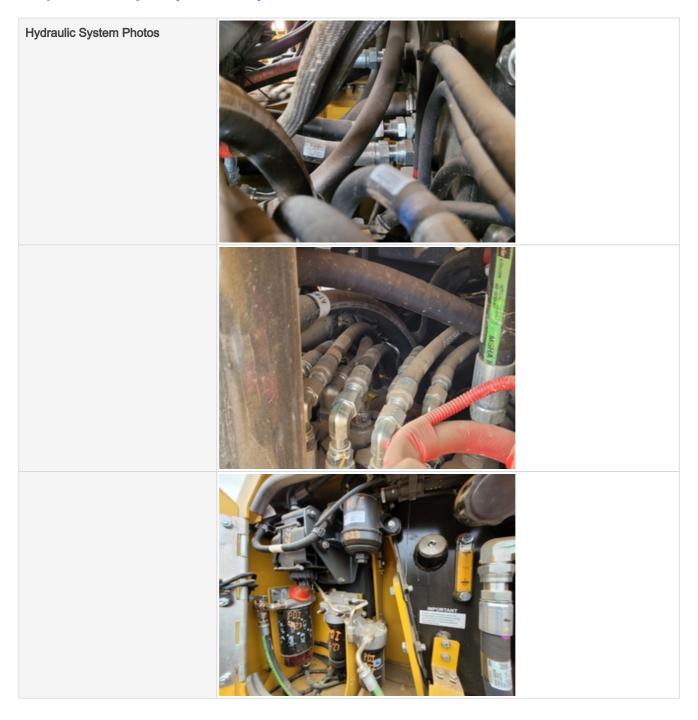
Hydraulics Overall

A CONTRACTOR OF THE PARTY OF TH
Wet or Damp Hydraulic Lines / Fittings	No
Appearance of Hydraulic Lines / Fittings	5 - Like New, Recently Replaced
Hydraulic Lines / Fittings Condition	Hydraulic lines & fittings are clean and in good condition
Hydraulic Pump(s)	5 - Like New, Recently Replaced
Unusual Noises (Hydraulic Pump)	No
Hydraulic Pump Notes	No unusual noises heard during operation
