Inspection Report (Excavator)

B&B Stock Number	1
Year	2020
Make	CAT
Model	325
Serial Number	TEL00737
Hour Meter Reading	720 Hrs.
Previous Application (e.g., earth moving, mining, demolition, etc)	Landscape/Rock Removal

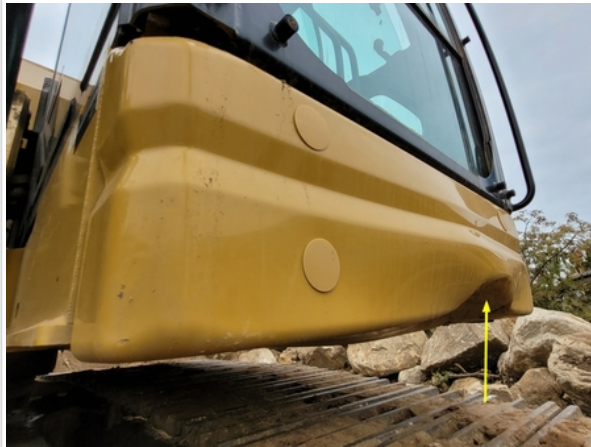
Bottom Panel Dented

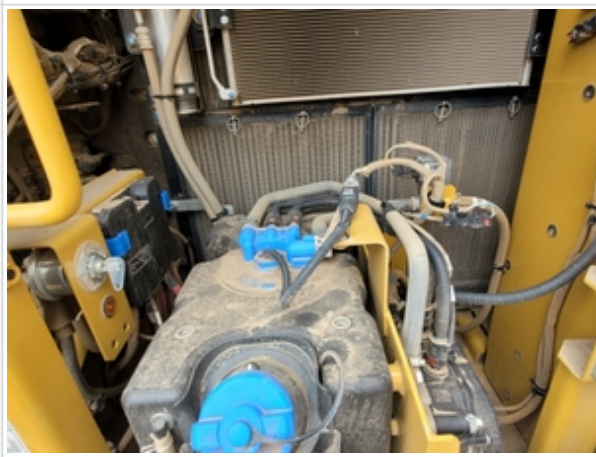
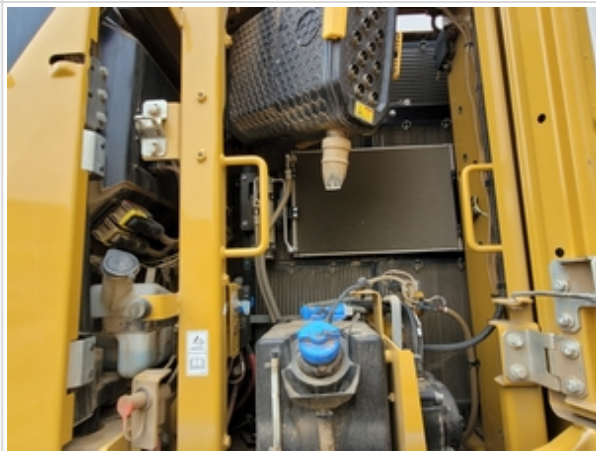
<p>Engine Compartment Photos</p>

Overall Engine Rating	5 - Like New, Recently Replaced
Overall Engine Appearance	Clean & dry, Dusty & dry
Overall Engine Comments	Engine runs well with no operating issues observed.

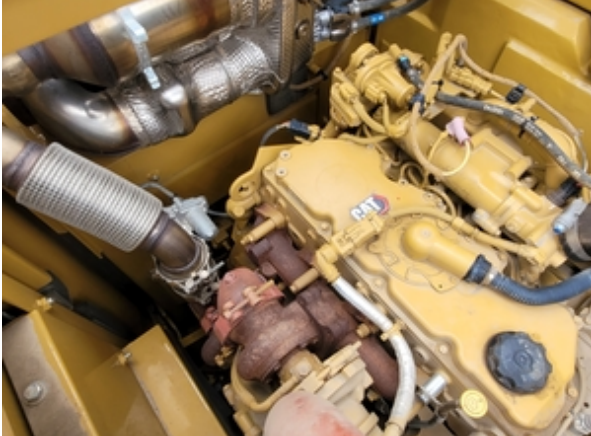
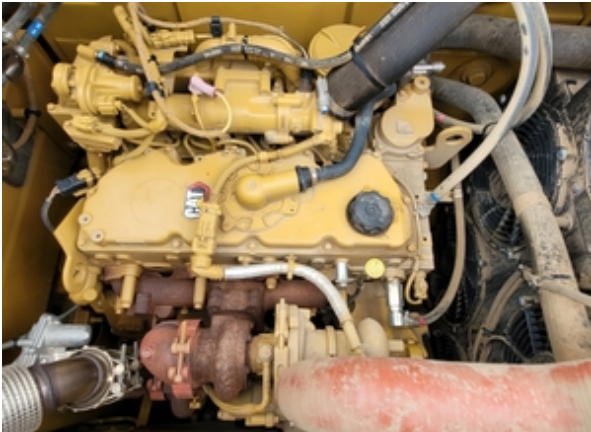
Engine Type (Make, Model, Cylinders, Hp)	CAT - 4.4 - 4CYL. - 174HP
Emissions Tier	Tier 4F
Engine Serial Number	N/A
Engine Fuel Type	Diesel
Blow-by (Visual Observation Check)	No
Unusual Noises (Upon Start-up, Idle, Shutdown)	No
Engine Smoke (Upon Start-up, Idle, Shutdown)	No
Engine Exhaust Color	Clear
Battery	5 - Like New, Recently Replaced
Battery Condition	Like new, recently replaced
Radiator	5 - Like New, Recently Replaced
Radiator Condition	Radiator fins & components appear to be in good working order, no signs of damage or leaks
Belts	4 - Very Light or Minimal Wear
Belt Condition	Belts appear in good condition & alignment with proper tension

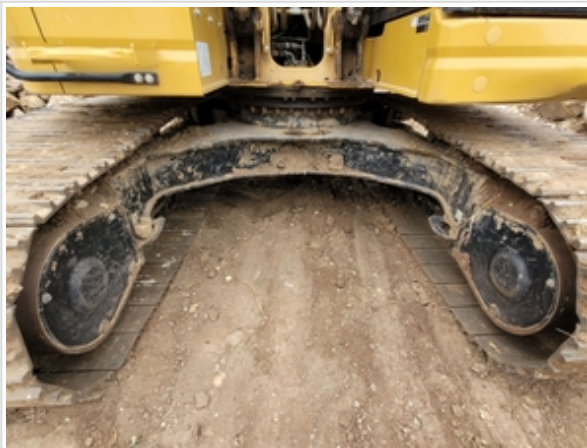
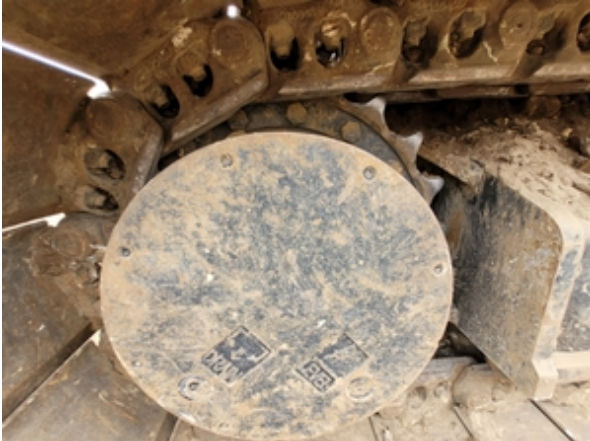
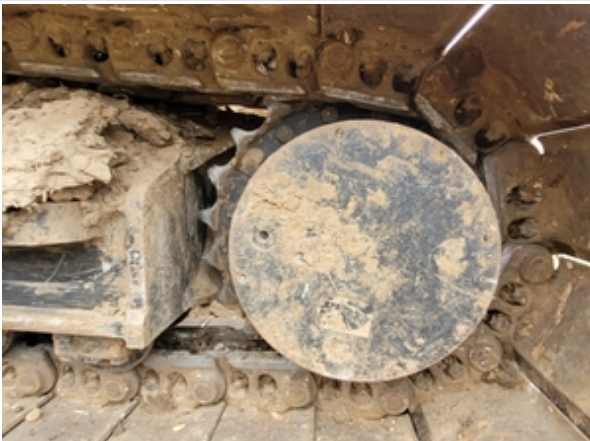
Drivetrain Photos

Hydrostatic Transmission?	Yes	
2 Speed?	Yes	
Hydrostatic Drive Configuration	Split Transmission	
Transmission Components	4 - Very Light or Minimal Wear	
Transmission Condition	Good forward and reverse function	
Drive Motors	4 - Very Light or Minimal Wear	
Parking Brake	5 - Like New, Recently Replaced	
Parking Brake Function	Good brake function	
Overall Drivetrain Comments	Drivetrain working well in all directions and in all speeds.

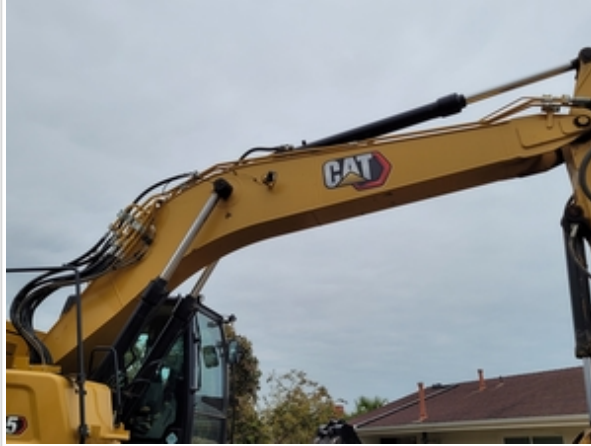
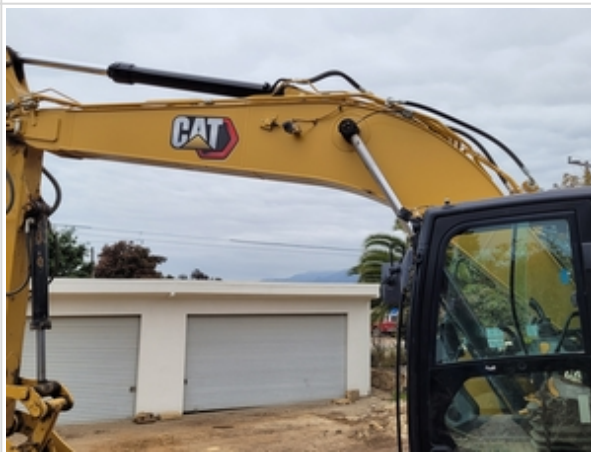
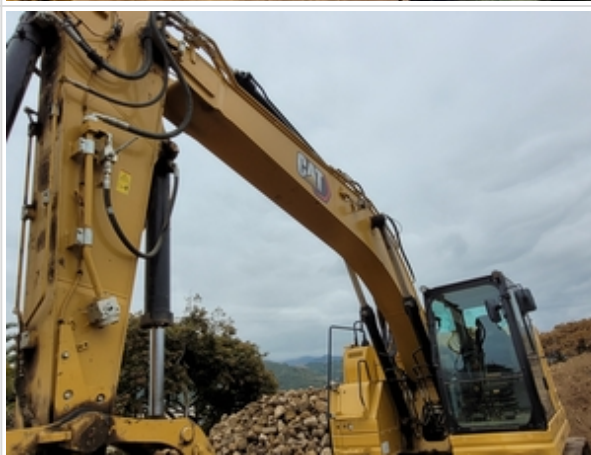
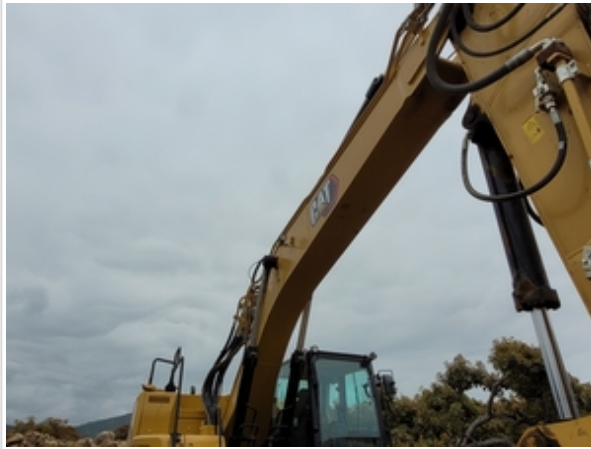
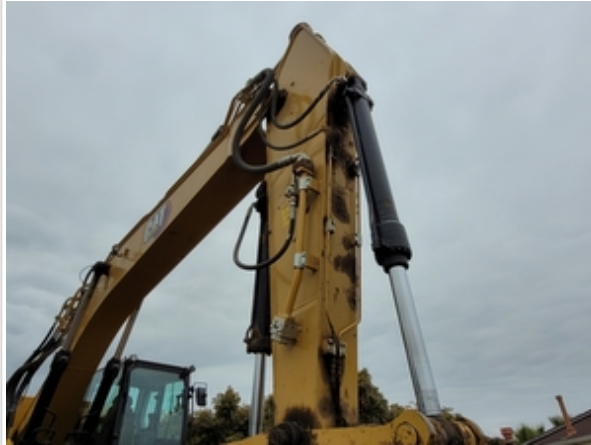
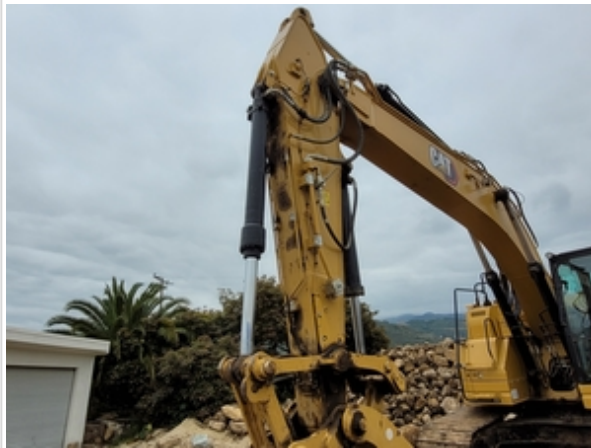
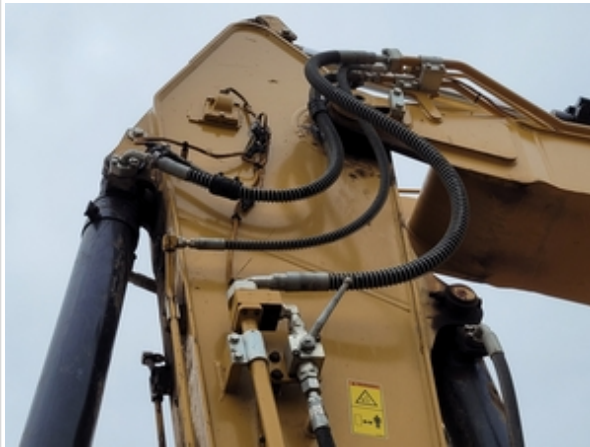
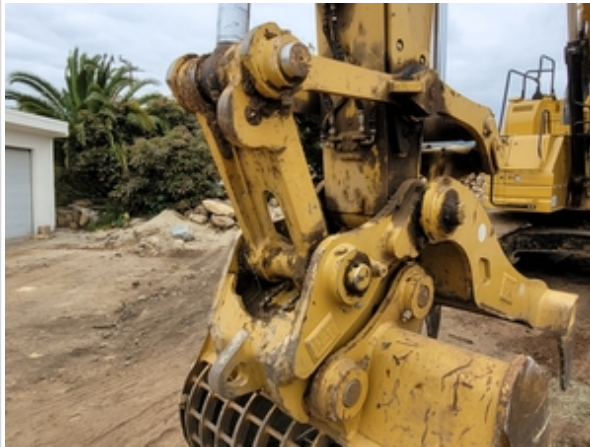
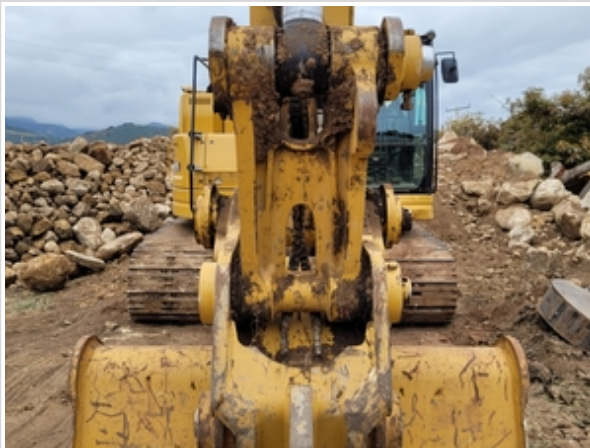
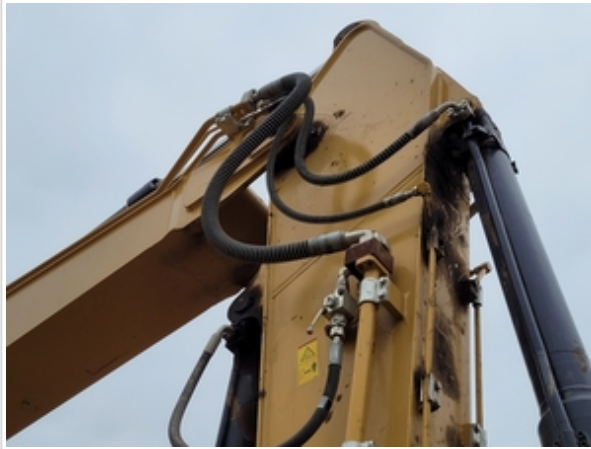
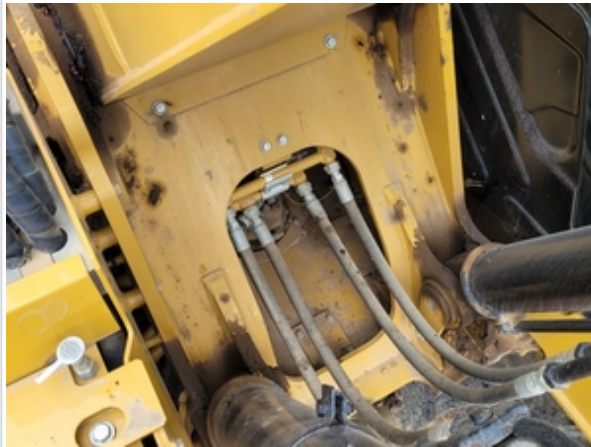
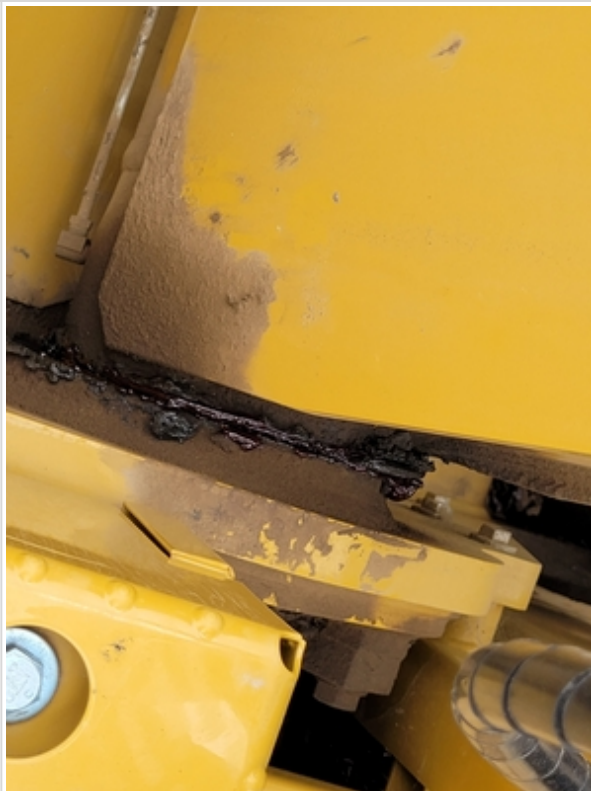
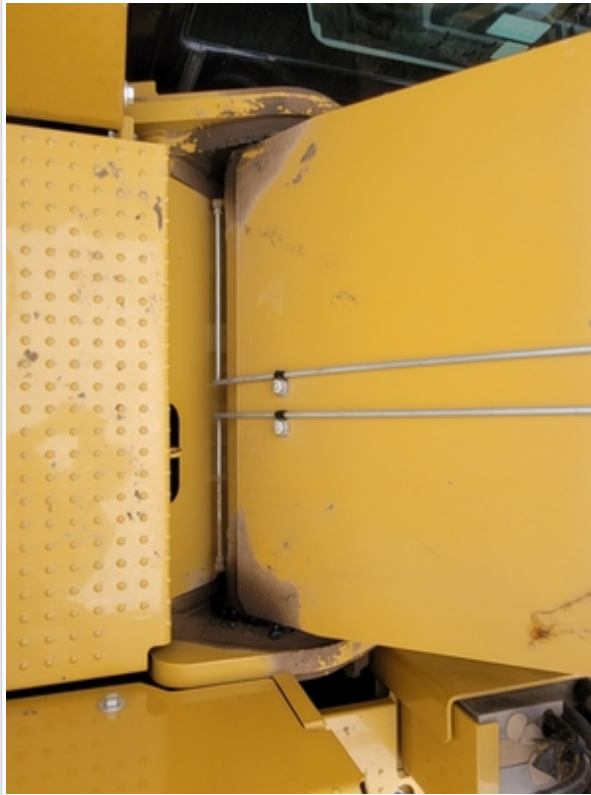
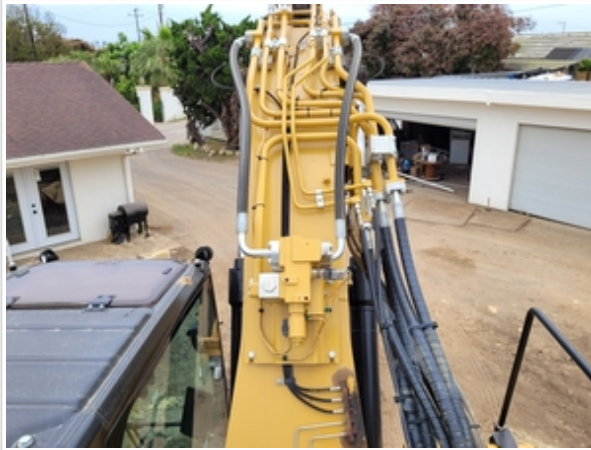
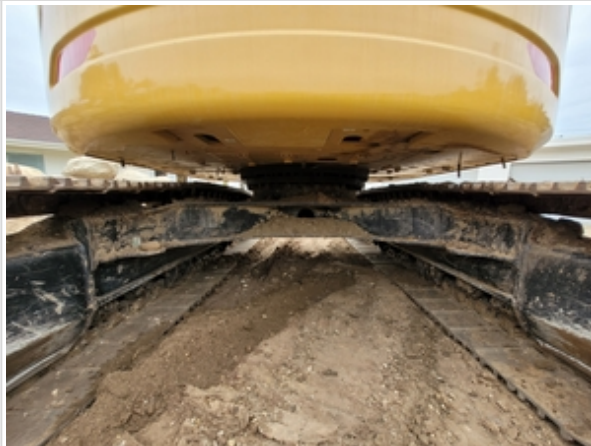
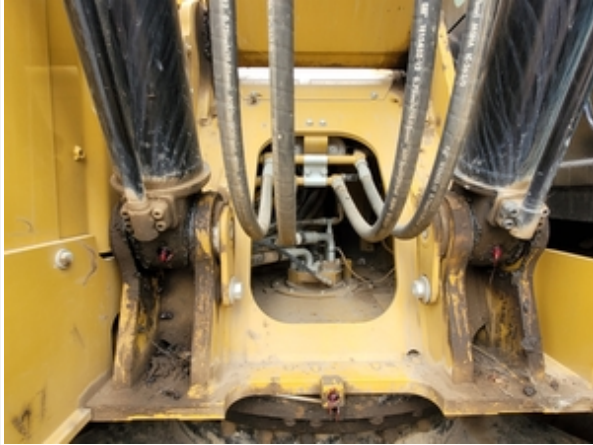
Chassis Photos

Boom Condition	5 - Like New, Recently Replaced
Stick Condition	4 - Very Light or Minimal Wear
Boom Base Pin & Bushings	5 - Like New, Recently Replaced
Boom to Stick Pin & Bushings	4 - Very Light or Minimal Wear
Stick to Bucket Pin & Bushings	4 - Very Light or Minimal Wear
Turntable Bearing	5 - Like New, Recently Replaced
Bottom Covers	4 - Very Light or Minimal Wear
Comments	Some covers dented and most have cosmetic surface damage
Overall Chassis	5 - Like New, Recently Replaced
Overall Chassis Comments	Main Frame and Implements are in solid shape and no issues observed.

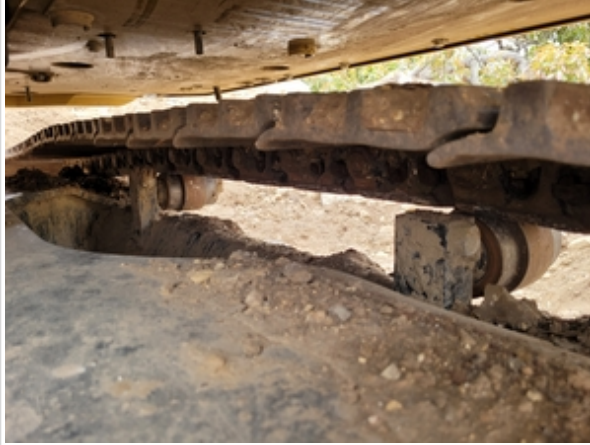
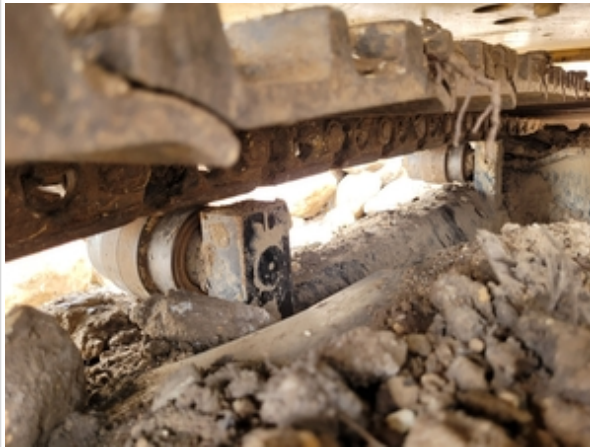
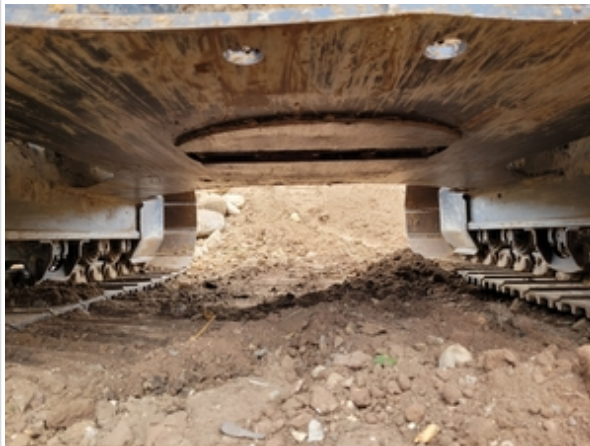
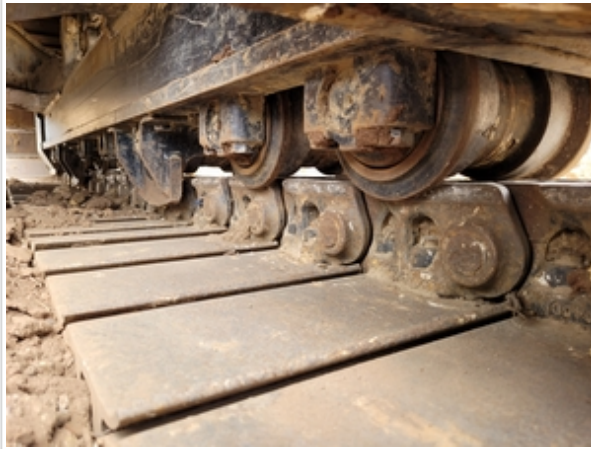
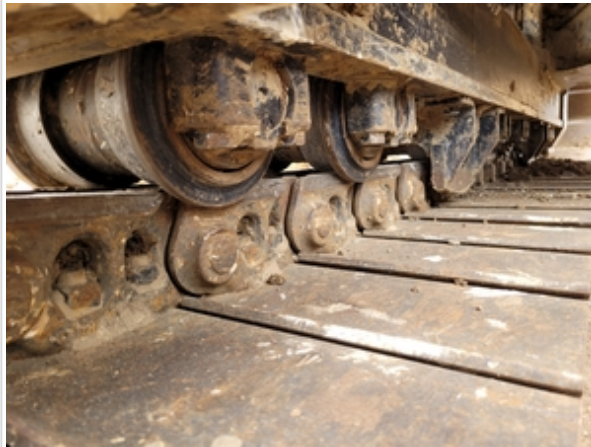
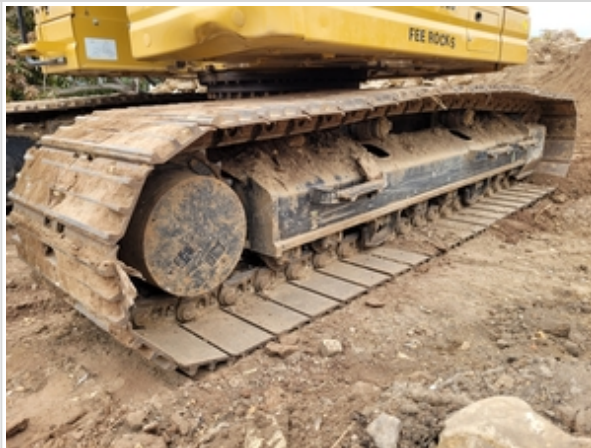
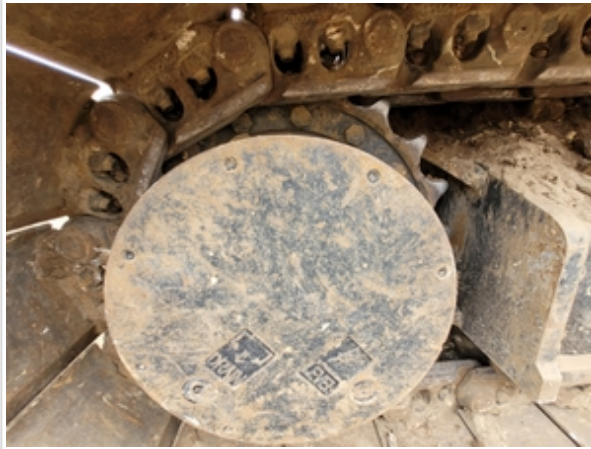
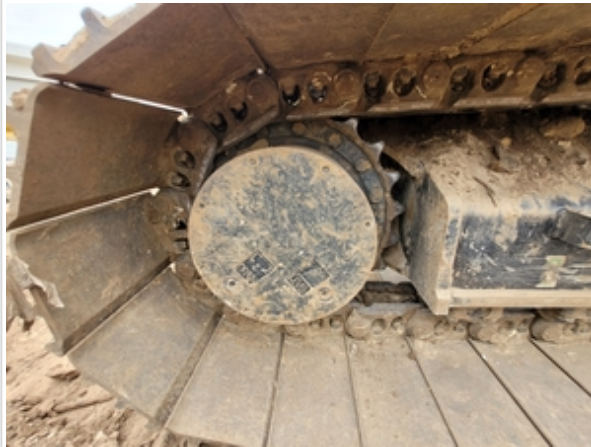
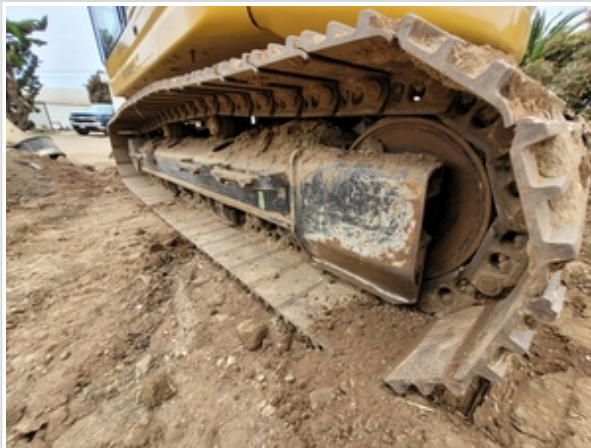
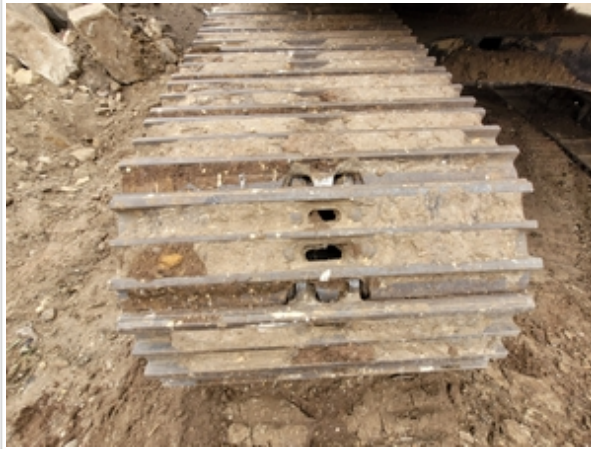
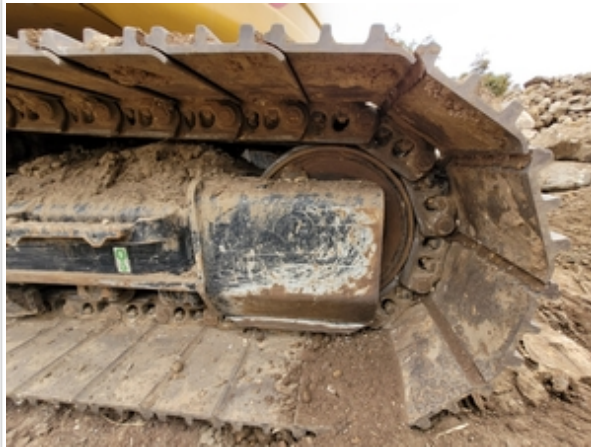
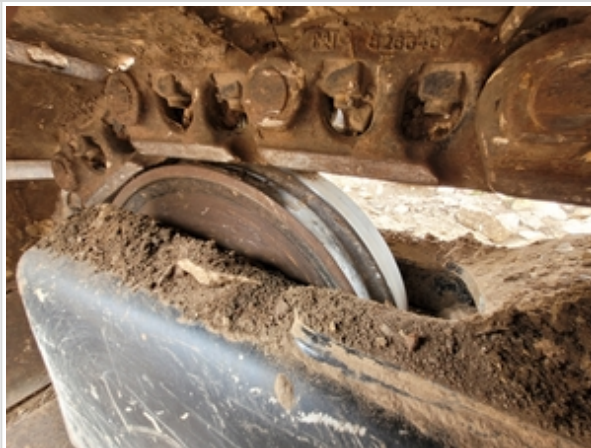
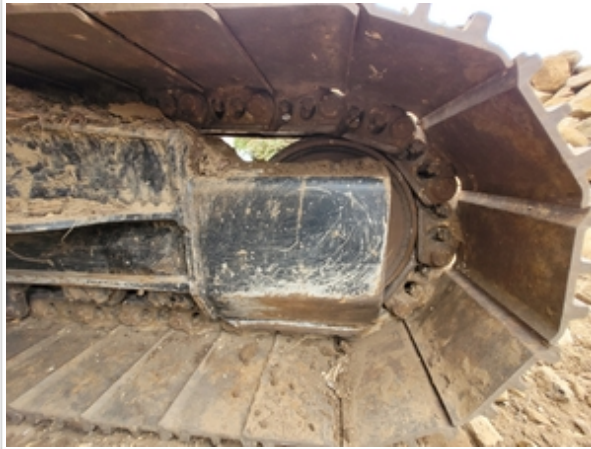
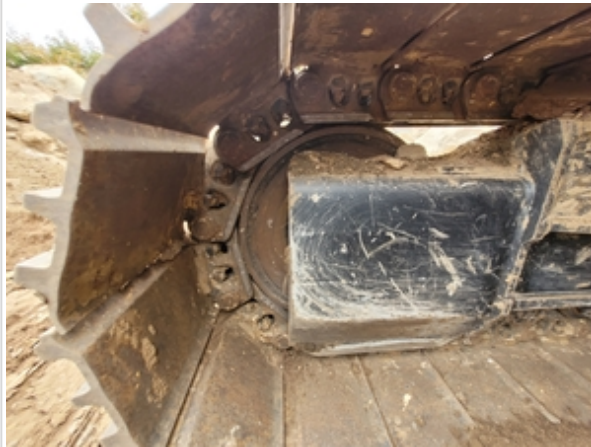
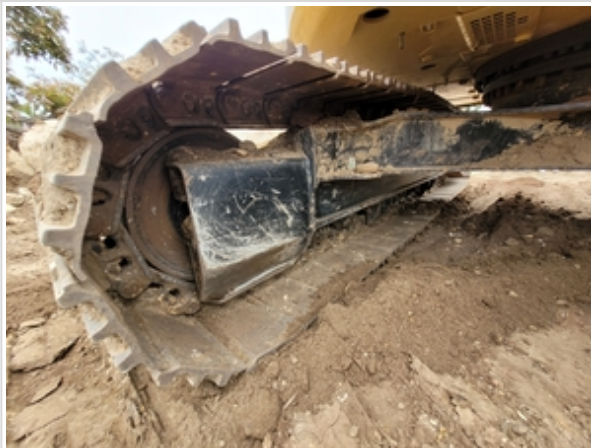
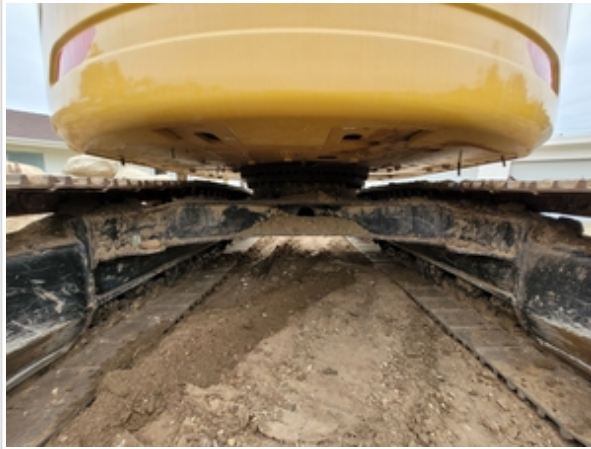
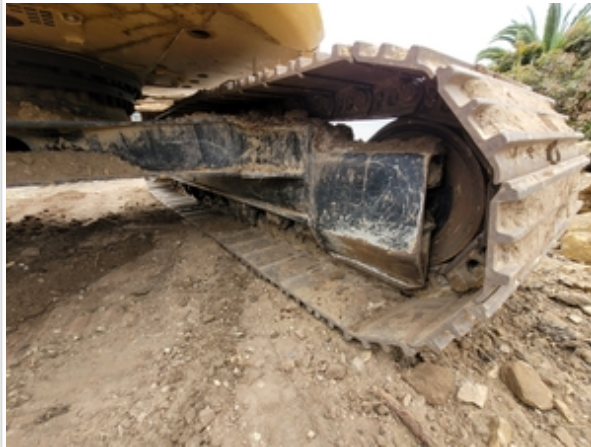
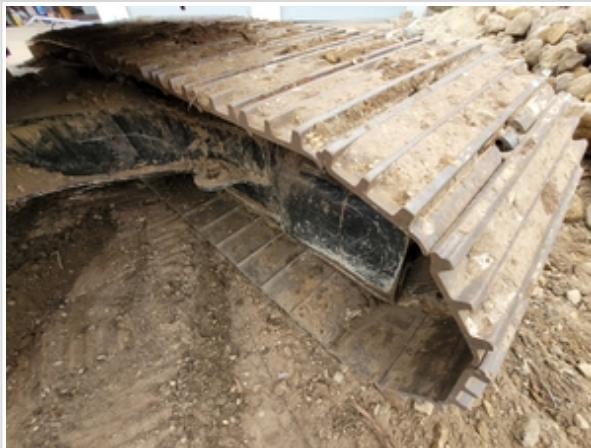
Undercarriage Photos

Sprocket Teeth	3 - Normal Wear & Tear
Track Bushings	3 - Normal Wear & Tear
Track Frames	4 - Very Light or Minimal Wear
Pivot Shafts	0
Equalizer Bar & Joints	0
Front Idler	4 - Very Light or Minimal Wear

Track Tensioner	5 - Like New, Recently Replaced
Track links	4 - Very Light or Minimal Wear
Bottom Rollers	3 - Normal Wear & Tear
Carrier Rollers	3 - Normal Wear & Tear
Overall Undercarriage	4 - Very Light or Minimal Wear
Overall Undercarriage Comments	No issues observed. Normal wear and tear.

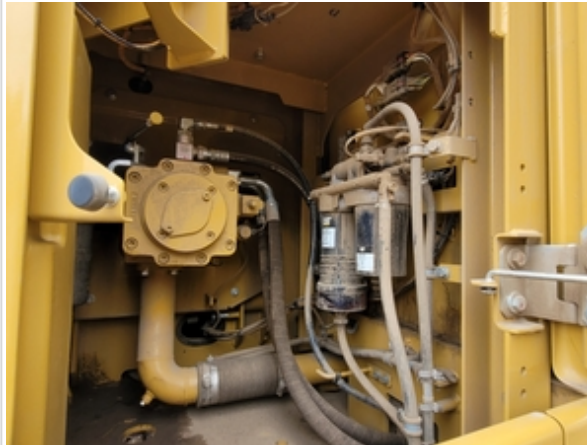
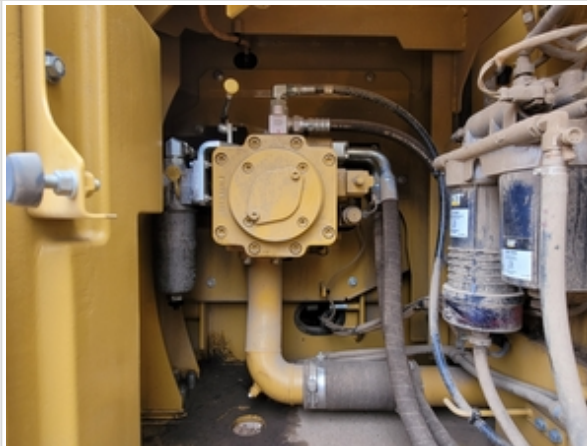
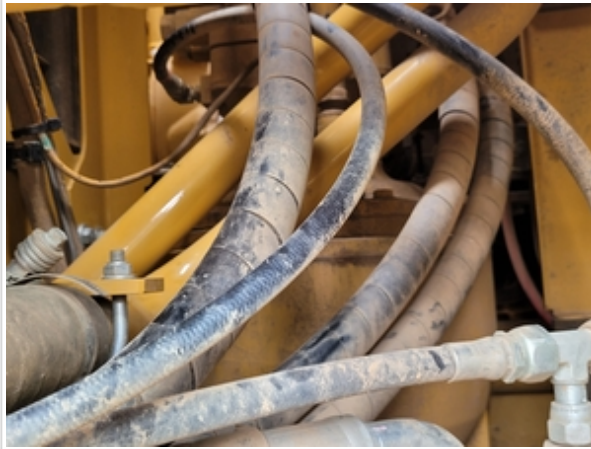
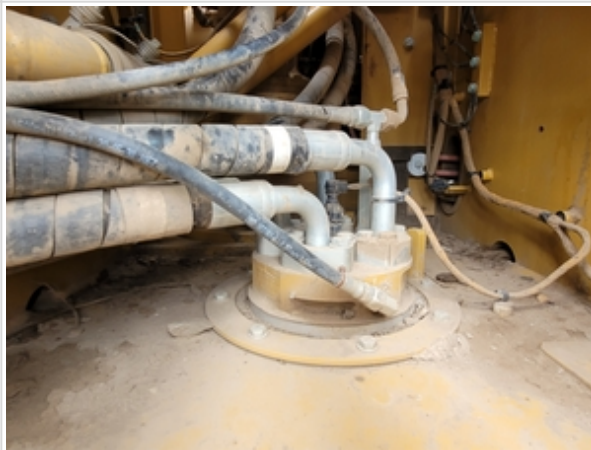
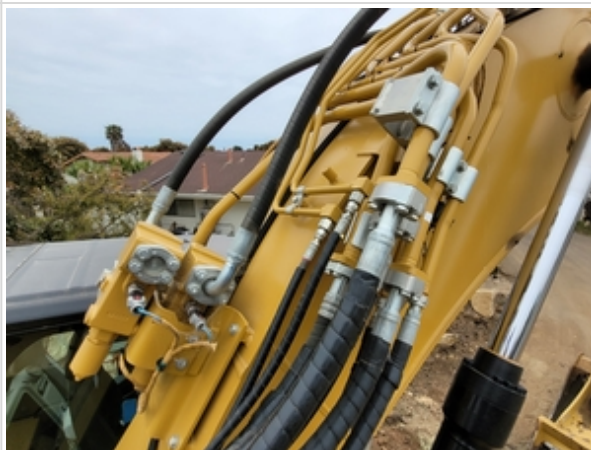
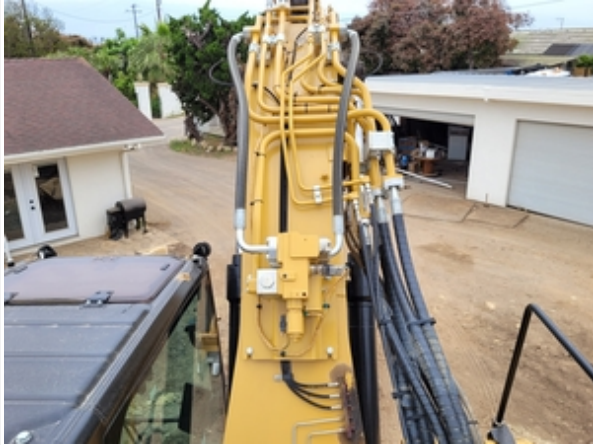
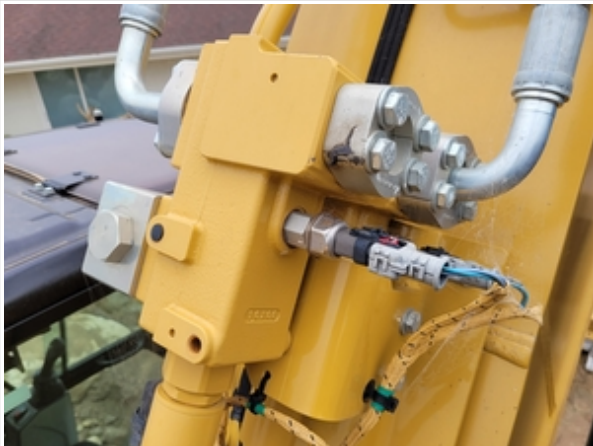
Hydraulic System Photos

Wet or Damp Hydraulic Lines / Fittings	No
Appearance of Hydraulic Lines / Fittings	4 - Very Light or Minimal Wear
Hydraulic Lines / Fittings Condition	Hydraulic lines & fittings are clean and in good condition
Hydraulic Pump(s)	4 - Very Light or Minimal Wear
Unusual Noises (Hydraulic Pump)	No
Hydraulic Pump Notes	No unusual noises heard during operation

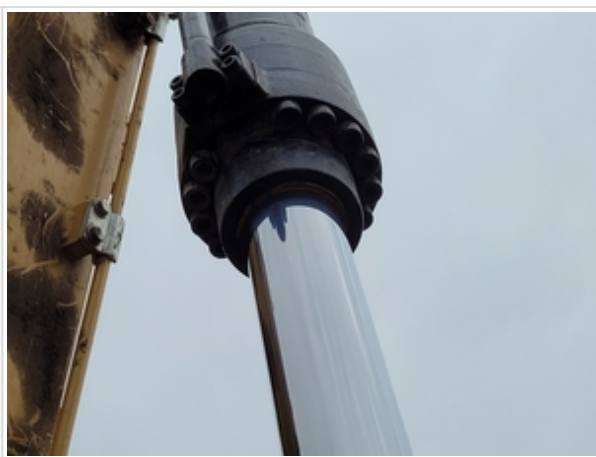
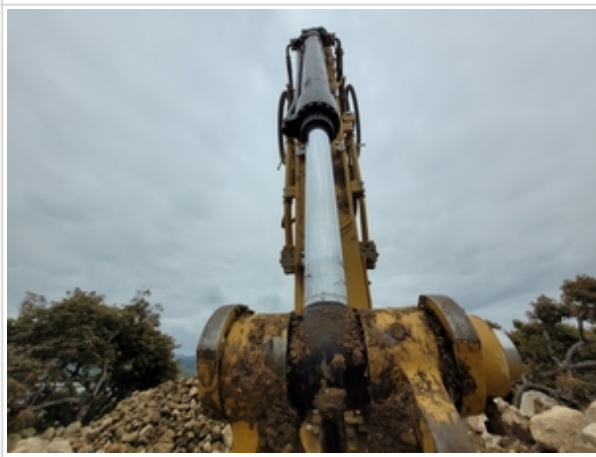
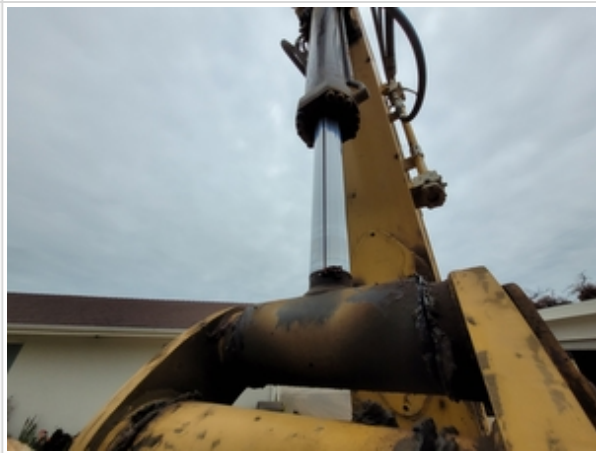
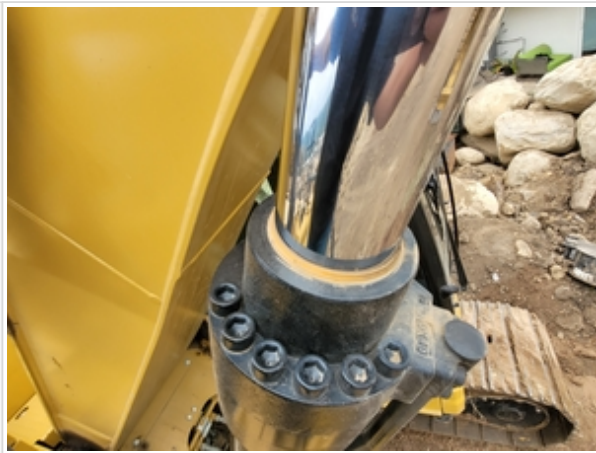
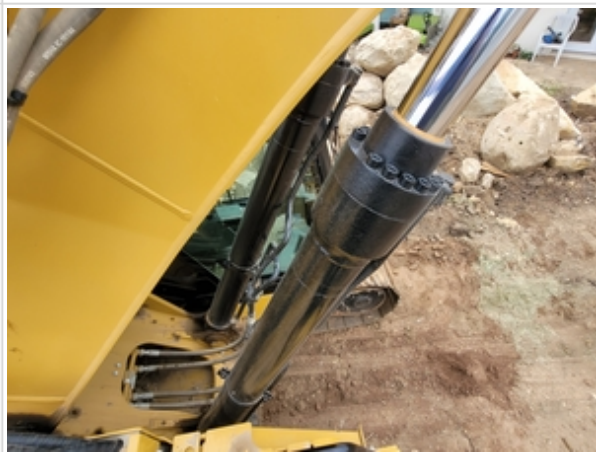
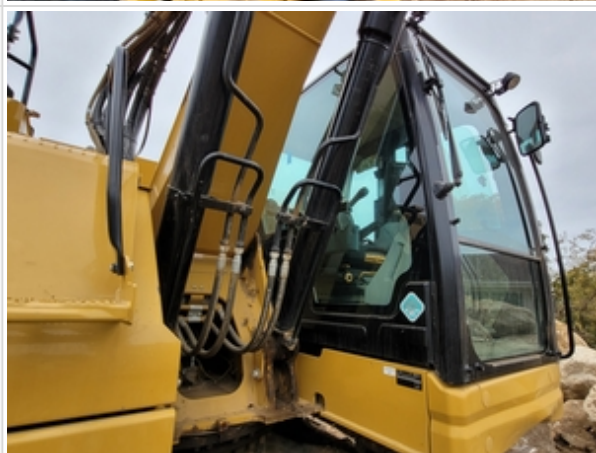
<p>Hydraulic Cylinder Photos</p>

Hydraulic Cylinder(s): Mounting Pins	5 - Like New, Recently Replaced
Cylinder: Oil Leaks	No

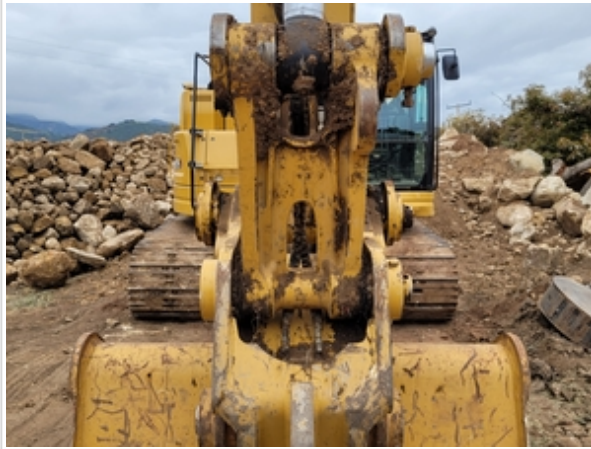
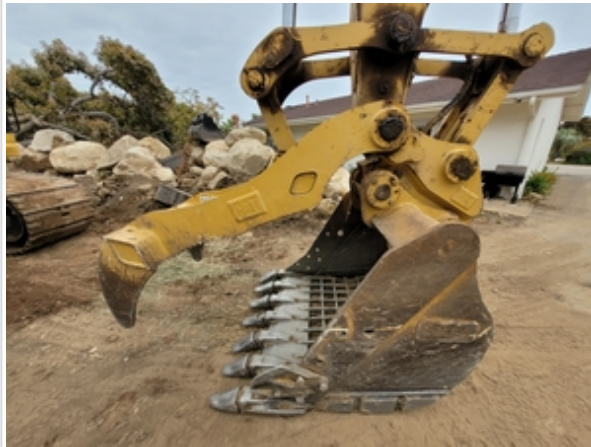
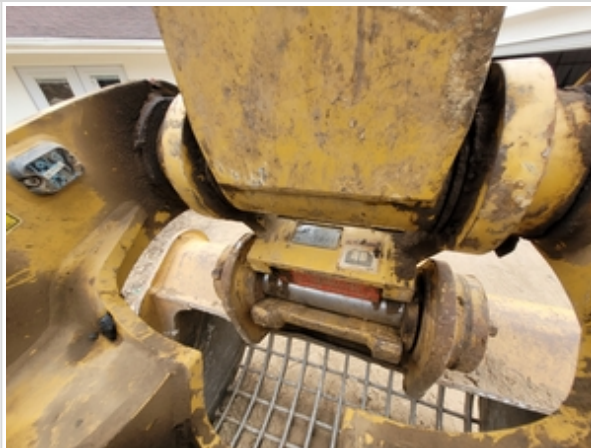
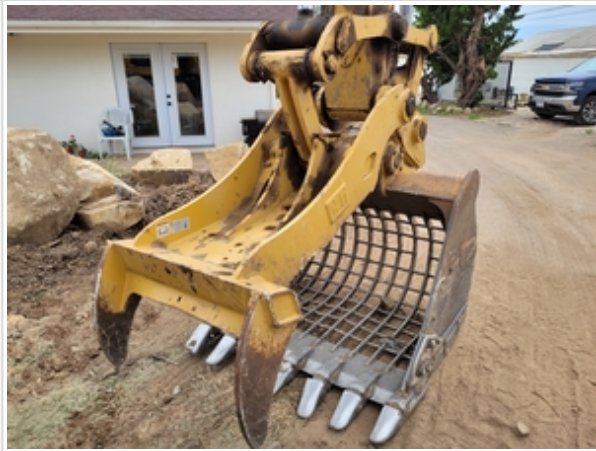
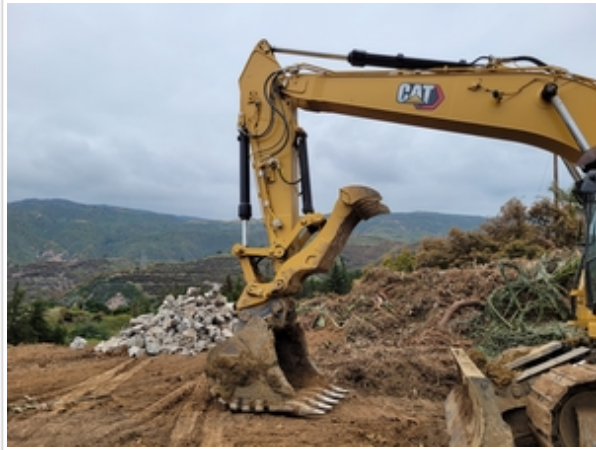
Attachment Photos

Bucket	4 - Very Light or Minimal Wear
Bucket Teeth	0
Blade	0
Blade Edge	0
