## Inspection Report (Wheel Loader)

B&B Stock Number	1 (B&B Stock # N/A in HUBSPOT)
Year	2001
Make	CAT
Model	966G
Serial Number	3SW00976
Hour Meter Reading	11,256 Hrs.
Previous Application (e.g., earth moving, mining, demolition, etc)	Rental Equipment

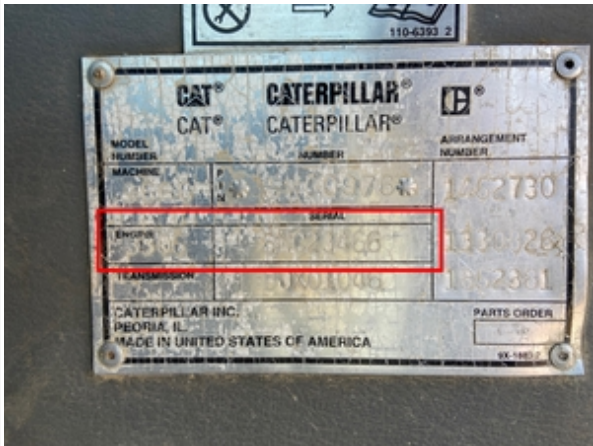
Engine Data Plate

Engine Type (Make, Model, Cylinders, Hp)	CAT - 3306 - 6Cyl. - 250HP
Emissions Tier	Tier 2
Engine Serial Number	6NC23466
Engine Fuel Type	Diesel
Blow-by (Visual Observation Check)	Yes
Comments	Minor Blowby Seen
Unusual Noises (Upon Start-up, Idle, Shutdown)	No
Engine Smoke (Upon Start-up, Idle, Shutdown)	Yes
Engine Smoke Notes	Engine smoke observed upon start up, Other (see comments)
Comments	Black smoke at initial startup and cleared up as it warmed up
Engine Exhaust Color	Heavy black smoke at start up, Clear at operating temperature, Black
Battery	3 - Normal Wear & Tear
Battery Condition	Clean & dry appearance, tight connections, Dusty & dirty appearance
Radiator	3 - Normal Wear & Tear
Radiator Condition	Radiator fins & components appear to be in good working order, no signs of damage or leaks
Belts	3 - Normal Wear & Tear
Belt Condition	Belts appear in good condition & alignment with proper tension
Hoses	3 - Normal Wear & Tear
