Inspection Report (On-Highway Dump Truck)

B&B Stock Number	1 (N/A In HUBSPOT)
Year	2016
Make	Freightliner
Model	M2
Serial Number	3ALACWDU6GDFY3260
Truck Odometer Reading	43,721 Mi.
Current Inspection / State Cert / DOT	N/A
Previous Application (e.g., earth moving, mining, demolition, etc)	Asphalt General Construction

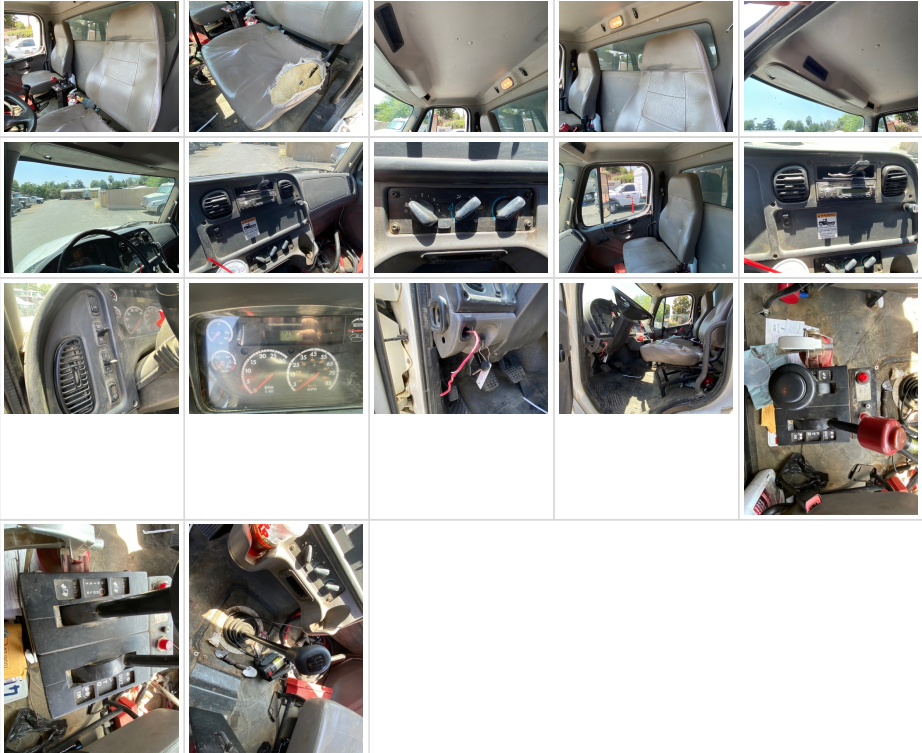
Cab Interior Photos

Odometer Activity	3 - Normal Wear & Tear
Odometer Condition	Odometer is working and in good condition
Controls/Switches/Gauges	3 - Normal Wear & Tear
Controls/Switches/Gauges Condition	All switches/gauges are in good condition and functioning
Brake System Type	Hydraulic
Clutch	0
Horn	3 - Normal Wear & Tear
Horn Condition	Horn is functioning as expected
Reverse Alarm / Backup Camera	3 - Normal Wear & Tear
Reverse Alarm / Backup Camera Condition	Reverse alarm working as expected
Heater & A/C	3 - Normal Wear & Tear
Heat & A/C Condition	Heater and A/C work as expected
Interior Lights	3 - Normal Wear & Tear
Interior Lights Condition	All interior lights are installed and functioning
Seats/Seat Belts	3 - Normal Wear & Tear
Seats/Seat Belt Condition	Seat belt secures properly, Seat(s) has major surface staining or tears, Other (see comments)
Comments	Driver seat upholstery damaged
Cab Interior Overall Rating	3 - Normal Wear & Tear

Comments	Normal wear and tear
