Inspection Report (On-Highway Box Truck)

B&B Stock Number	A5527154
Year	2015
Make	Ford
Model	F 750
Serial Number	3FRNF7FA3FV727536
Truck Odometer Reading	42928.0
Current Inspection / State Cert / DOT	Unable to verify
Previous Application (e.g., earth moving, mining, demolition, etc)	The truck was used in a rental company

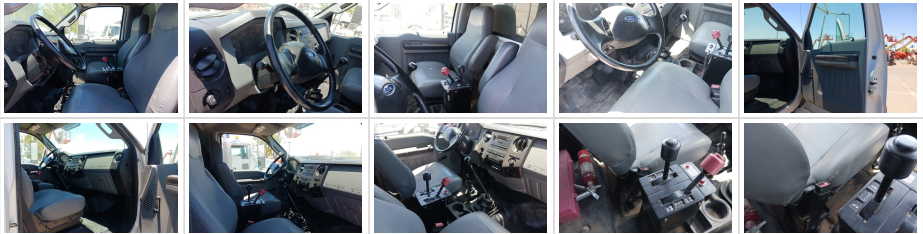
Cab Interior Photos

Controls/Switches/Gauges	3 - Normal Wear & Tear
Controls/Switches/Gauges Condition	All switches/gauges are in good condition and functioning
Brake System Type	Hydraulic
Clutch	3 - Normal Wear & Tear
Clutch Function	Clutch is functioning as expected
Horn	3 - Normal Wear & Tear
Horn Condition	Horn is functioning as expected
Reverse Alarm / Backup Camera	0
Heater & A/C	3 - Normal Wear & Tear
Heat & A/C Condition	Heater and A/C work as expected
Interior Lights	3 - Normal Wear & Tear
Interior Lights Condition	All interior lights are installed and functioning
Seats/Seat Belts	3 - Normal Wear & Tear
Seats/Seat Belt Condition	Seat(s) in good condition, no stains or tears in upholstery, Seat belt secures properly
Cab Interior Overall Rating	3 - Normal Wear & Tear
Comments	The cab is well taken care of and in good condition
