## Inspection Report (On-Highway Service Truck)

| Year | 2013 |
| Make | Ford |
| Model | F-550 |

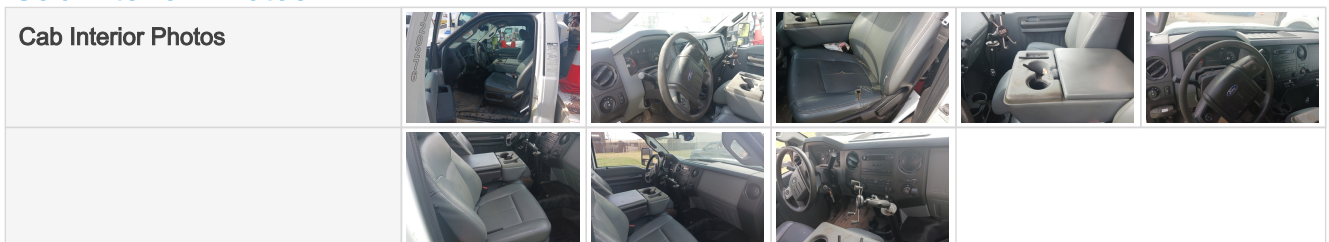
#### Cab Interior Photos

| <b>Cab Interior Overall Rating</b> | 3 - Normal Wear & Tear |
| <b>Comments</b> | The cab is in good condition |
