Inspection Report (Excavator)

B&B Stock Number	A2195138
Year	2018
Make	Komatsu
Model	PC 78us-10
Serial Number	KMTPC258HJA035012
Hour Meter Reading	2328.6
Previous Application (e.g., earth moving, mining, demolition, etc)	Earth moving

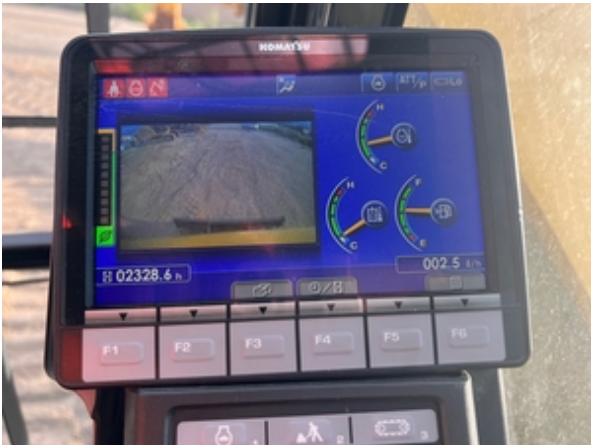
Hour Meter/Odometer

Controls & Switches	3 - Normal Wear & Tear
Controls & Switches Condition	All switches are installed and functional
Hour Meter Activity	3 - Normal Wear & Tear
Hour Meter Condition	Hour meter is functional and in good condition
Other Gauge Activity	3 - Normal Wear & Tear
Other Gauge Condition	All cockpit gauges are functional and in good condition
Heater & A/C	1 - Service Required
Heater & A/C Condition	Other (see comments)
Comments	Rear cab a/c ducting removed
Travel Alarm	3 - Normal Wear & Tear
Travel Alarm Condition	Travel alarm is installed and functioning as expected
Horn	3 - Normal Wear & Tear
Horn Condition	Horn is installed and functioning as expected
Backup Camera	3 - Normal Wear & Tear
Backup Camera Condition	Back up camera is installed and functioning as expected
Control Station Overall Rating	1 - Service Required
Control Station Overall Condition	Minor cosmetic wear to cabin surfaces, floors, panels, and ceiling
