## Inspection Report (Backhoe Loader)

B&B Stock Number	N/a
Year	2016
Make	Cat
Model	420f
Serial Number	C7n30862
Hour Meter Reading	3714.1

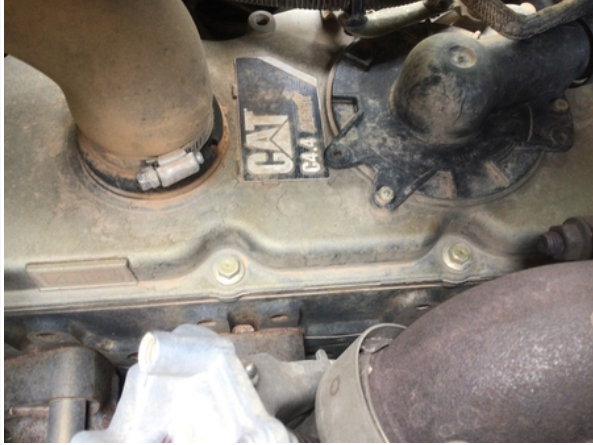
Engine Data Plate

Cooling System Leaks	No
Coolant Appearance	5 - Like New, Recently Replaced
Coolant Appearance Notes	Normal Translucent appearance, no visual signs of contamination
Oil Leaks	No
Oil Appearance	5 - Like New, Recently Replaced
Oil Appearance Notes	Clean oil appearance, no signs of cross contamination
Fuel Leaks	No
Equipped with DPF (Diesel Particulate Filter)	No
Requires DEF (Diesel Exhaust Fluid)	No
Overall Engine Rating	5 - Like New, Recently Replaced
Overall Engine Appearance	Dusty & dry
Overall Engine Comments	Clean, no leaks
