## Inspection Report (Skid Steer)

B&B Stock Number	A6678184
Year	2010
Make	Caterpillar
Model	289C
Serial Number	CAT0289CHJMP01467
Hour Meter Reading	3438.4

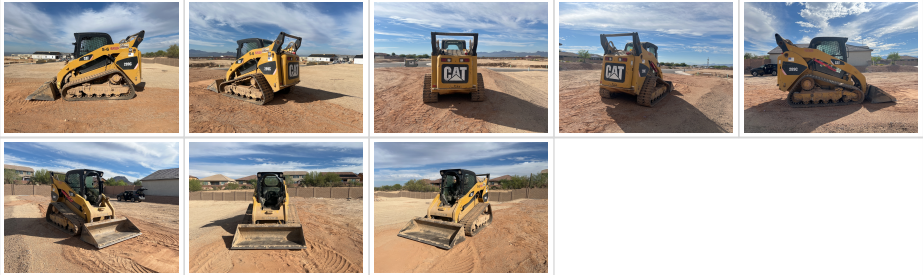
Exterior Walkaround Photos

Steps / Ladders Condition	Steps/ladders are fully intact and appear structurally sound
Handrails	3 - Normal Wear & Tear
Glass	3 - Normal Wear & Tear
Mirrors	0
Exterior Lights	3 - Normal Wear & Tear
Overall Exterior	3 - Normal Wear & Tear
Comments	Normal wear and tear no major issues to report

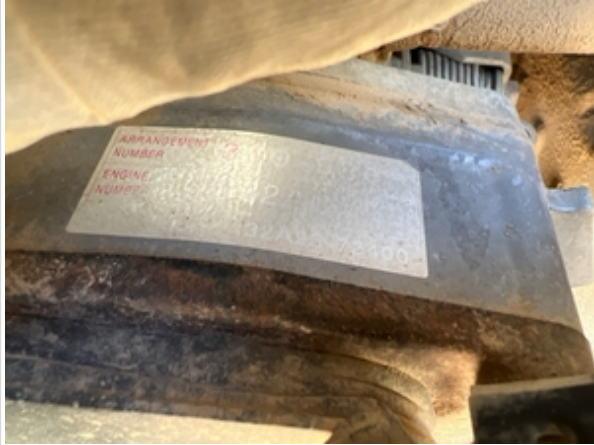
Engine Data Plate

Engine Exhaust Color	Heavy black smoke at start up
Battery	3 - Normal Wear & Tear
Battery Condition	Inaccessible, unable to determine condition
Radiator	3 - Normal Wear & Tear
Radiator Condition	Radiator fins & components appear to be in good working order, no signs of damage or leaks
Belts	3 - Normal Wear & Tear
Hoses	3 - Normal Wear & Tear
Hose Condition	Firm, pliant hoses with no signs of wear or leaks
Water Pump	3 - Normal Wear & Tear
Water Pump Condition	No unusual pump noises heard
Cooling System Leaks	No
Coolant Appearance	3 - Normal Wear & Tear
Coolant Appearance Notes	Normal Translucent appearance, no visual signs of contamination
Oil Leaks	No
Oil Appearance	3 - Normal Wear & Tear
Fuel Leaks	Yes
Fuel Leak Notes	Wet spots & streaking on fuel lines indicate an active leak
Comments	Fuel leak near bottom of engine
Equipped with DPF (Diesel Particulate Filter)	No
Requires DEF (Diesel Exhaust Fluid)	No
Overall Engine Rating	2 - Above Average Wear & Tear

Overall Engine Appearance	Active leaks/pooling observed in & around engine compartment
Overall Engine Comments	Fuel leak near bottom of engine
