## Inspection Report (Vibratory Compactor)

B&B Stock Number	A2691455
Year	2017
Make	Volvo
Model	DD110B
Serial Number	VCED110BT0S285209
Hour Meter Reading	672 Hrs.
Previous Application (e.g., earth moving, mining, demolition, etc)	Equipment Rental

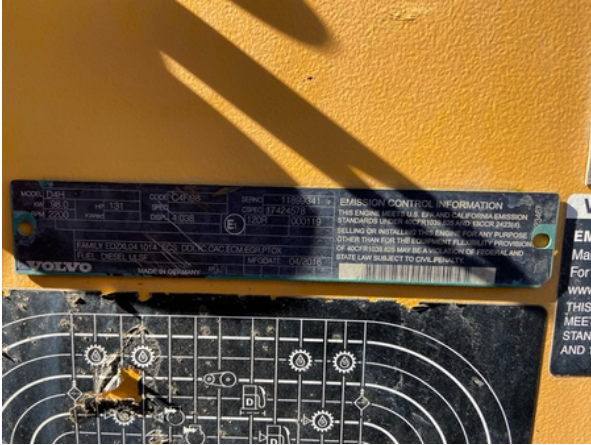
<b>Engine Data Plate</b>

<b>Engine Type (Make, Model, Cylinders, Hp)</b>	Volvo - D4H - 6Cyl - 131Hp
<b>Emissions Tier</b>	Tier 4i
<b>Engine Serial Number</b>	11899341
<b>Engine Fuel Type</b>	Diesel
<b>Blow-by (Visual Observation Check)</b>	No
<b>Unusual Noises (Upon Start-up, Idle, Shutdown)</b>	No
<b>Engine Smoke (Upon Start-up, Idle, Shutdown)</b>	No
<b>Engine Exhaust Color</b>	Clear
<b>Battery</b>	3 - Normal Wear & Tear
<b>Battery Condition</b>	Clean & dry appearance, tight connections, Dusty & dirty appearance
<b>Radiator</b>	3 - Normal Wear & Tear
<b>Radiator Condition</b>	Radiator fins & components appear to be in good working order, no signs of damage or leaks
