### **Inspection Report (Excavator)**

B&B Stock Number	A9837265
Year	2011
Make	John Deere
Model	135D
Serial Number	1FF135DXHBD302793
Hour Meter Reading	6396.9
Previous Application (e.g., earth moving, mining, demolition, etc)	Earth moving

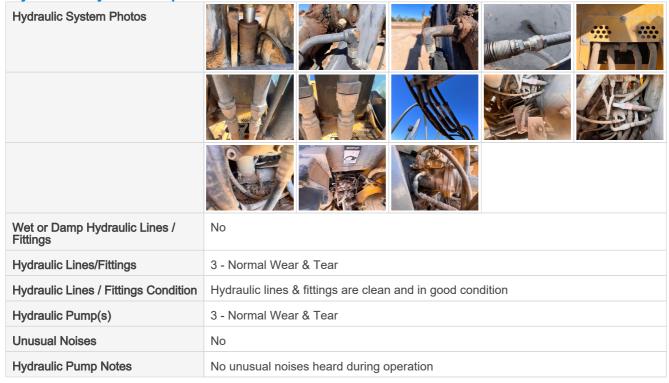
# **Hydraulic System Inspection Points**

Mounting Pins	3 - Normal Wear & Tear
Cylinder Oil Leaks	No
Hydraulic System Overall	3 - Normal Wear & Tear
