## Inspection Report (Telehandler)

B&B Stock Number	A7097685
Year	2013
Make	JCB
Model	509-42
Serial Number	1404811
Hour Meter Reading	2,798 Hrs.
Previous Application (e.g., earth moving, mining, demolition, etc)	General Construction

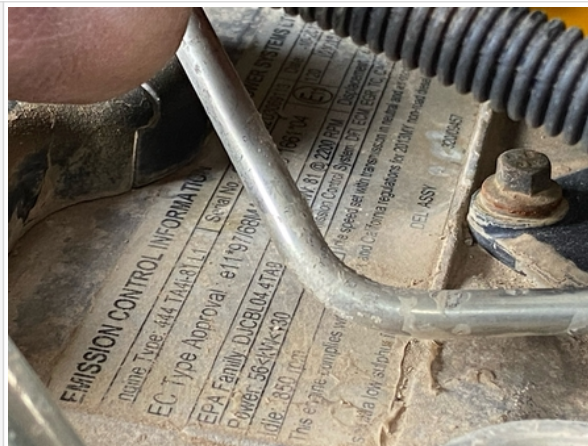
Engine Data Plate

Engine Type (Make, Model, Cylinders, Hp)	JCB - 4.4L - 4Cyl. - 74Hp				
Emissions Tier	Tier 4i				
Engine Serial Number	SH320/40532U3069113				
Engine Fuel Type	Diesel				
Blow-by (Visual Observation Check)	No				
Unusual Noises (Upon Start-up, Idle, Shutdown)	No				
Engine Smoke (Upon Start-up, Idle, Shutdown)	Yes				
Engine Smoke Notes	Continuous engine smoke observed during operation, Other (see comments)				
Comments	Minor smoke observed only occurred when hydraulics were lugging down the engine.				
Engine Exhaust Color	Black puffs observed under throttle				
Battery	3 - Normal Wear & Tear				
Battery Condition	Clean & dry appearance, tight connections				
Radiator	3 - Normal Wear & Tear				
Radiator Condition	Radiator fins & components appear to be in good working order, no signs of damage or leaks
