Inspection Report (On-Highway Service Truck)

| B&B Stock Number | A1838822 |
| Make | Frightliner |
| Model | M2 |

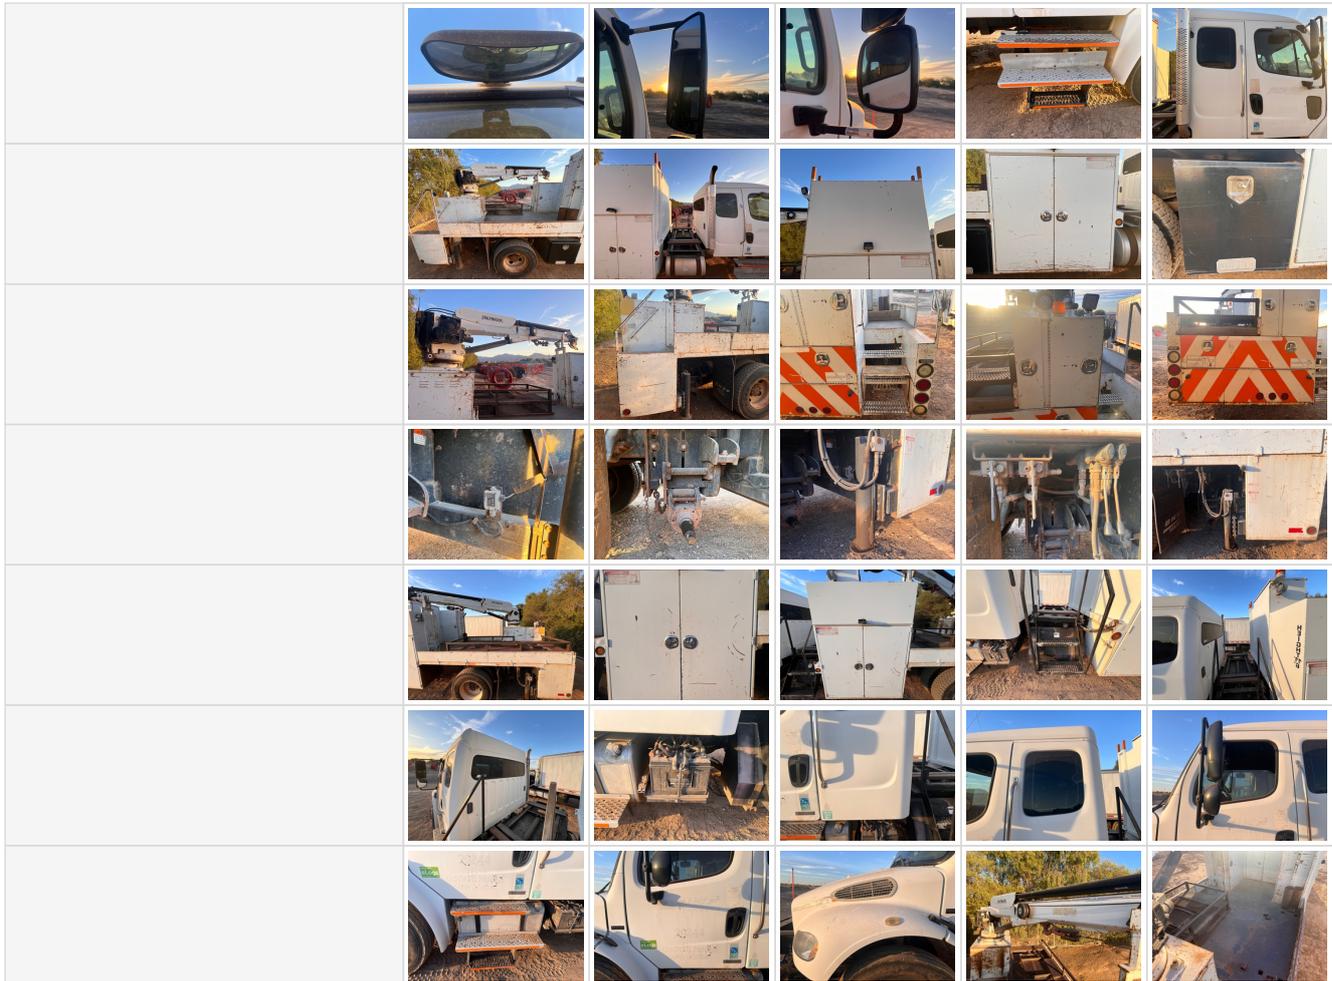
| Inspection Rating Criteria | Rating Scale | Explanation |
|---|--|---|
| Body Panels | 2 - Above Average Wear & Tear | |
| Body Panel Condition | Some panel misalignment observed, Visible chipped paint or dents, Areas of surface rust observed | |
| Comments | Chipped paint/ surface rust | |
| Doors / Canopy Latches | 2 - Above Average Wear & Tear | |
| Doors / Canopy Latches Condition | Intermittent sticking observed on one or more latches/doors, Loose or missing latches, hinges or handles | |

| Comments | Latching mechanism to tool boxes loose and sticking |

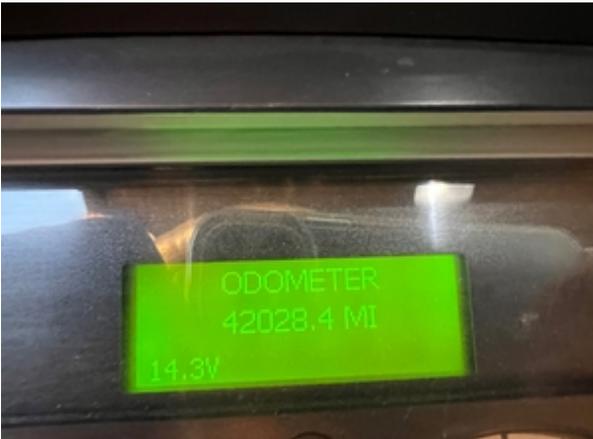
| Odometer Photo | |

| Odometer Activity | 3 - Normal Wear & Tear |
| Odometer | Odometer is working and in good condition |

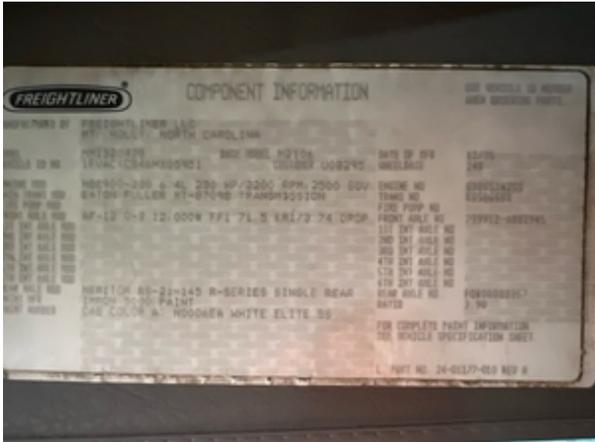
| Engine Data Plate | | | | | |

| Engine Type (Make, Model, Cylinders, Hp) | Mercedes MBE 900-230 6.4L 230Hp | | | | |
