Inspection Report (Boom Lift)

B&B Stock Number	A3279882
Year	2008
Make	Genie
Model	s125
Serial Number	S12508-2447
Hour Meter Reading	5096

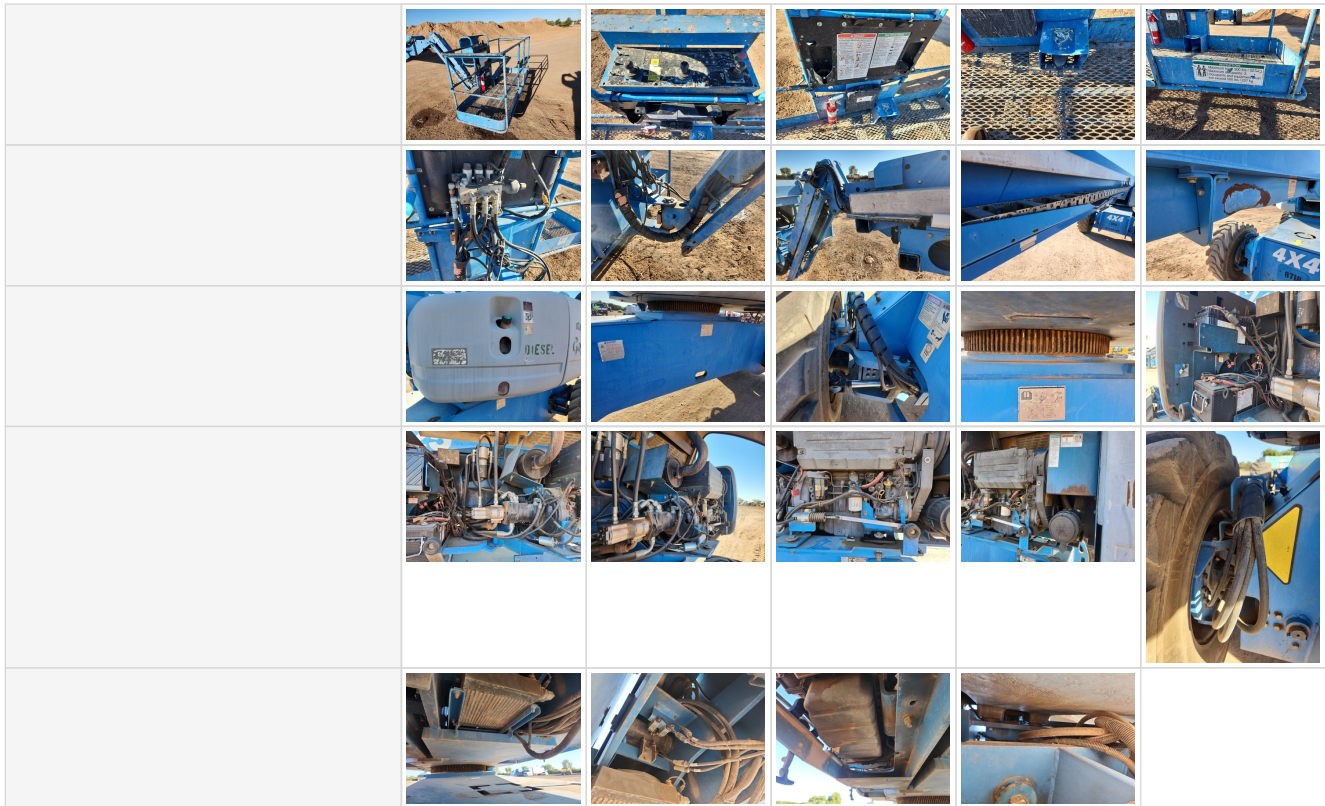
Comments	1 compartment latch broken	
Steps / Ladders	0	
Handrails	3 - Normal Wear & Tear	
Handrails Condition	Handrails are fully intact and appear structurally sound, Other (see comments)	
Comments	paint worn off

Glass	0
Mirrors	0
Exterior Lights	0
Overall Exterior	3 - Normal Wear & Tear
Comments	Structurally solid unit. Has some surface rust and minor dent,
