Inspection Report (Paver)

B&B Stock Number	A4333610
Year	2007
Make	Roadtec
Model	RP195
Serial Number	JTF01003
Hour Meter Reading	est 7700hrs
Previous Application (e.g., earth moving, mining, demolition, etc)	This machine used in asphalt paving

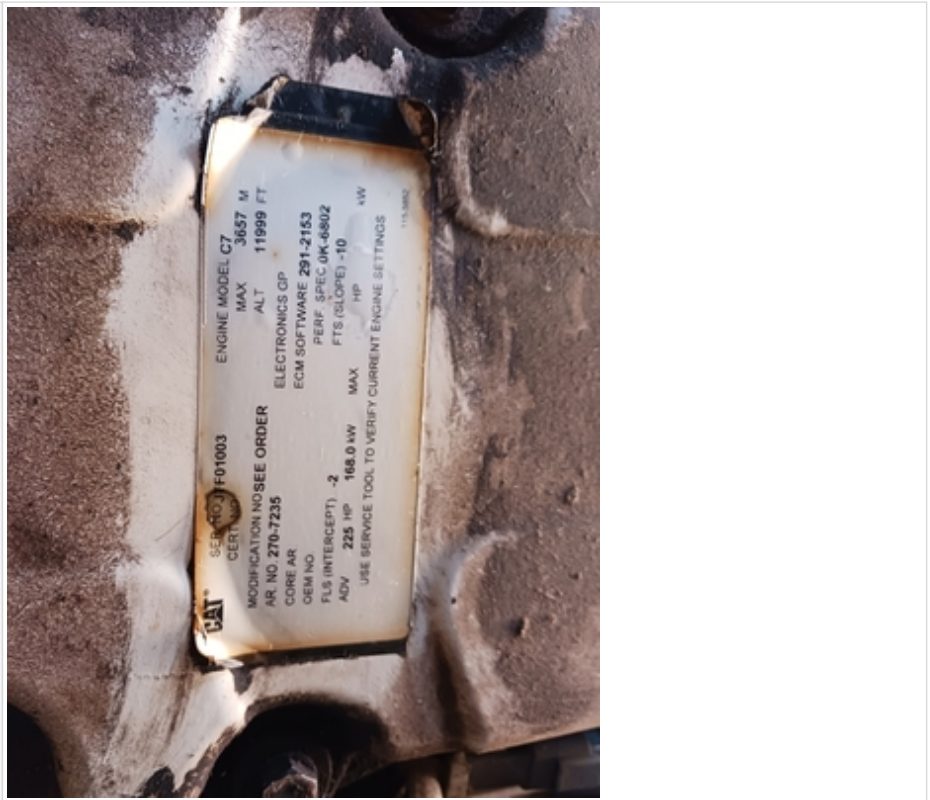
Engine Data Plate

Engine Type (Make, Model, Cylinders, Hp)	Cat, C7, 225Hp,				
Emissions Tier	Undetermined				
Engine Serial Number	JTF01003

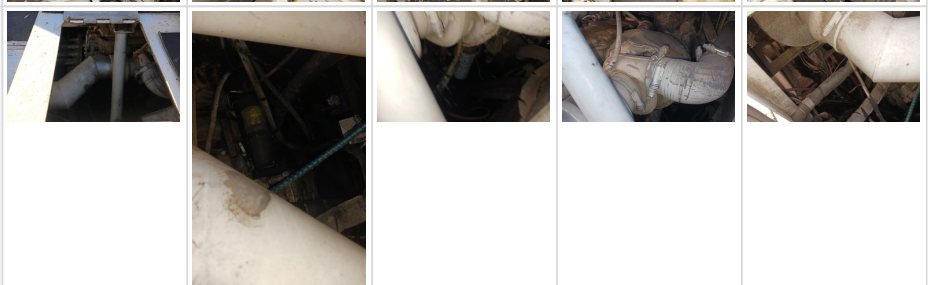
Engine Compartment Photos

Overall Engine Comments	Everything looks to be in good condition, but the engine would not start. The Radiator, belts and hoses appear to be ok but their functionality could not be tested/verified due to the engine not starting. Unusual noises from the engine could not be verified, water pump condition could not be verified, and smoke coming from the engine could not be verified due to the engine not starting.
-------------------------	---

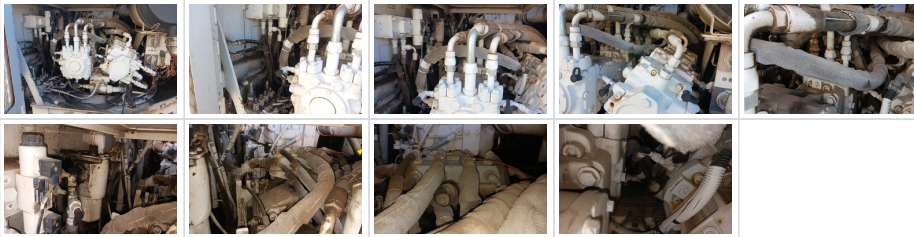
Hydraulic System Photos

Wet or Damp Hydraulic Lines / Fittings	No				
Hydraulic Lines/Fittings	3 - Normal Wear & Tear				
Hydraulic Lines / Fittings Condition	Hydraulic lines & fittings are clean and in good condition				
Hydraulic Pump(s)	3 - Normal Wear & Tear				
Unusual Noises	No				
Hydraulic Pump Notes	Other unusual sounds (see comments)

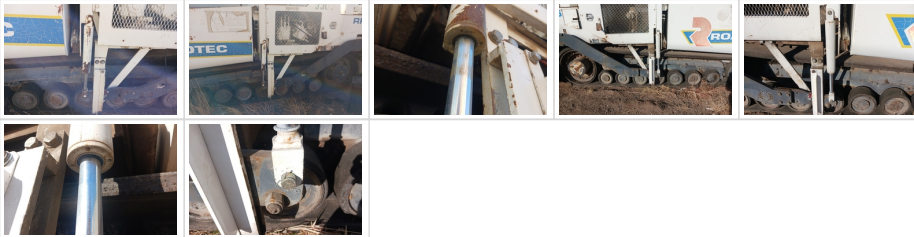
Hydraulic Cylinder Photos

Mounting Pins	3 - Normal Wear & Tear				
Cylinder Oil Leaks	No				
Comments	The hydraulic cylinders appeared to be in good working order, but their functionality could not be verified				
Hydraulic System Overall	3 - Normal Wear & Tear				
Comments	Overall, the hydraulic system appears to be in good order, but its functionality could not be verified due to the engine not starting.
