## Inspection Report (On-Highway Truck Cab + Chassis)

B&B Stock Number	A1733512
Year	2016
Make	International
Model	Prostar
Serial Number	1HSDHSNR7GH380759
Odometer Reading	507151
Current Inspection / State Cert / DOT	unable to determine
Previous Application (e.g., earth moving, mining, demolition, etc)	This machine was used to haul fuel

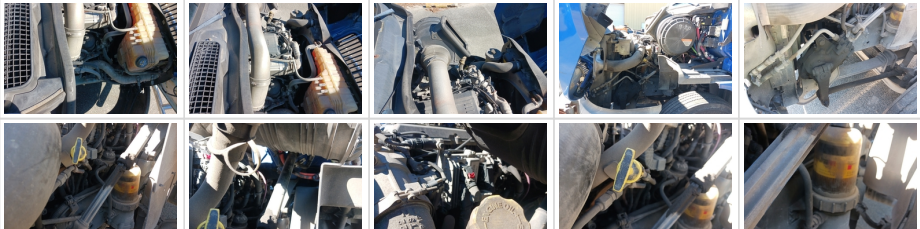
Engine Compartment Photos

Engine Type (Make, Model, Cylinders, Hp)	Navistar, A450MT, 12.4 L
Emissions Tier	Tier 4F
Engine Serial Number	124KM2Y4405804
Engine Fuel Type	Diesel
Blow-by (Visual Observation Check)	N/A
Unusual Noises (Upon Start-up, Idle, Shutdown)	No
Engine Smoke (Upon Start-up, Idle, Shutdown)	No
Engine Exhaust Color	Clear
Battery	3 - Normal Wear & Tear
Battery Condition	Dusty & dirty appearance
Radiator	3 - Normal Wear & Tear
Radiator Condition	Radiator fins & components appear to be in good working order, no signs of damage or leaks
Belts	2 - Above Average Wear & Tear
Belt Condition	Cracks, missing grooves, or separating layers on one or more belts
Hoses	3 - Normal Wear & Tear
Hose Condition	Firm, pliant hoses with no signs of wear or leaks
Water Pump	3 - Normal Wear & Tear
Water Pump Condition	No unusual pump noises heard
Cooling System Leaks	No
Coolant Appearance	3 - Normal Wear & Tear

Coolant Appearance Notes	Normal Translucent appearance, no visual signs of contamination
Oil Leaks	No
Oil Appearance	3 - Normal Wear & Tear
Oil Appearance Notes	Appropriate oil level, Very dark, black & burnt oil appearance
Fuel Leaks	No

Equipped with DPF (Diesel Particulate Filter)	Yes
DPF Condition	3 - Normal Wear & Tear
DPF Condition Notes	Filter housing is intact with no signs of damage or malfunction, DPF indicator is not illuminated
Requires DEF (Diesel Exhaust Fluid)	Yes
DEF Tank	3 - Normal Wear & Tear
DEF Tank Condition	Area around DEF tank cap is clean, fluid is clear & appears free of contaminants
Overall Engine Rating	3 - Normal Wear & Tear
Overall Engine Appearance	Dusty & dry
Overall Engine Comments	The engine is in good operating condition with a normal amount of wear and tear displayed throughout the engine.
