Inspection Report (On-Highway Truck Cab + Chassis)

B&B Stock Number	A2184637
Year	2011
Make	Freightliner
Model	Cascadia
Serial Number	1FUJGBDVXBLAY3287
Odometer Reading	521854
Current Inspection / State Cert / DOT	unable to determine
Previous Application (e.g., earth moving, mining, demolition, etc)	This machine was previously used to haul fuel

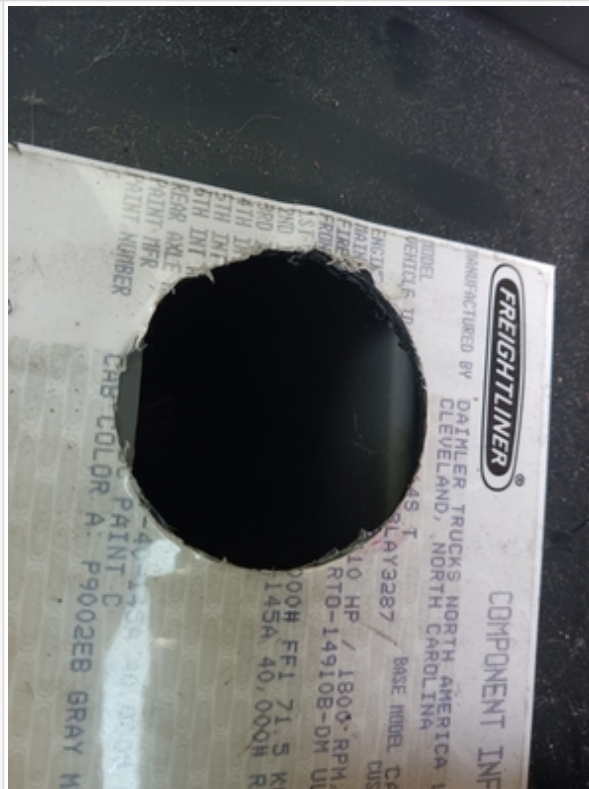
Engine Data Plate

Engine Type (Make, Model, Cylinders, Hp)	Detroit Diesel, DD15, 455Hp
Emissions Tier	Tier 4F
Engine Serial Number	Unable to verify
Engine Fuel Type	Diesel
Blow-by (Visual Observation Check)	N/A
Unusual Noises (Upon Start-up, Idle, Shutdown)	No
Engine Smoke (Upon Start-up, Idle, Shutdown)	No
Engine Exhaust Color	Clear
Battery	3 - Normal Wear & Tear
Battery Condition	Clean & dry appearance, tight connections
Radiator	3 - Normal Wear & Tear
Radiator Condition	Radiator fins & components appear to be in good working order, no signs of damage or leaks
Belts	3 - Normal Wear & Tear
Belt Condition	Belts appear in good condition & alignment with proper tension
Hoses	3 - Normal Wear & Tear
Hose Condition	Firm, pliant hoses with no signs of wear or leaks
Water Pump	3 - Normal Wear & Tear
Water Pump Condition	No unusual pump noises heard

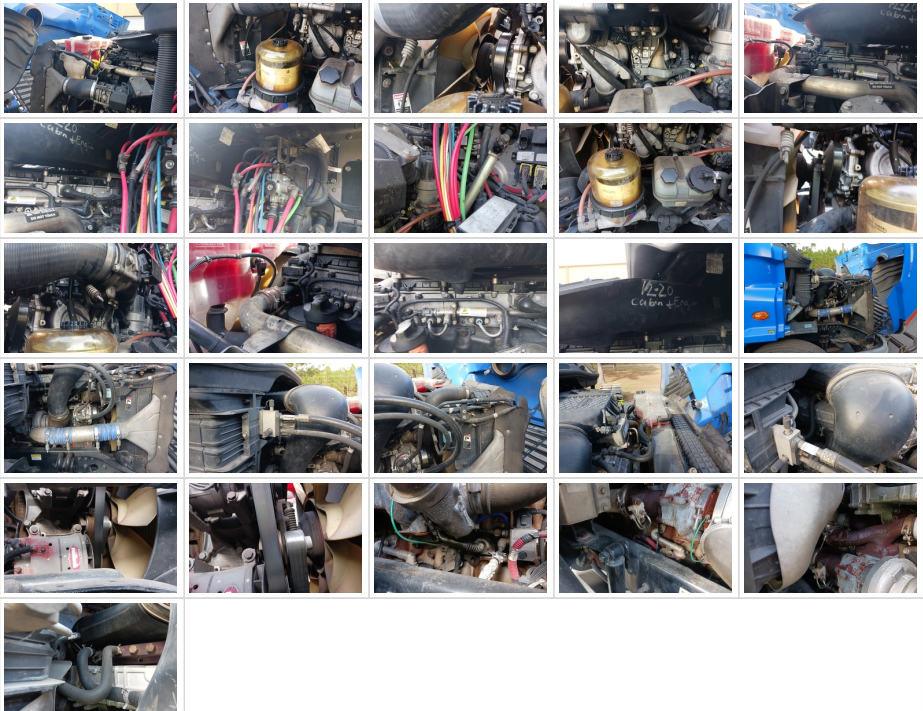
Engine Compartment Photos

Cooling System Leaks	No
Coolant Appearance	3 - Normal Wear & Tear
Coolant Appearance Notes	Normal Translucent appearance, no visual signs of contamination
Oil Leaks	No
Oil Appearance	3 - Normal Wear & Tear
Oil Appearance Notes	Appropriate oil level, Thick, opaque oil appearance
Fuel Leaks	No
Equipped with DPF (Diesel Particulate Filter)	Yes
DPF Condition	3 - Normal Wear & Tear
DPF Condition Notes	Filter housing is intact with no signs of damage or malfunction, DPF indicator is not illuminated
Requires DEF (Diesel Exhaust Fluid)	Yes
DEF Tank	3 - Normal Wear & Tear
DEF Tank Condition	Area around DEF tank cap is clean, fluid is clear & appears free of contaminants
Overall Engine Rating	3 - Normal Wear & Tear
Overall Engine Appearance	Dusty & dry
Overall Engine Comments	The engine is fully functional and in good working condition.
