Inspection Report (Scraper)

B&B Stock Number	A1426606
Year	1980
Make	CAT
Model	623B
Serial Number	46P1583
Hour Meter Reading	15,236 Hrs. (Exact hours may vary)
Previous Application (e.g., earth moving, mining, demolition, etc)	General Construction

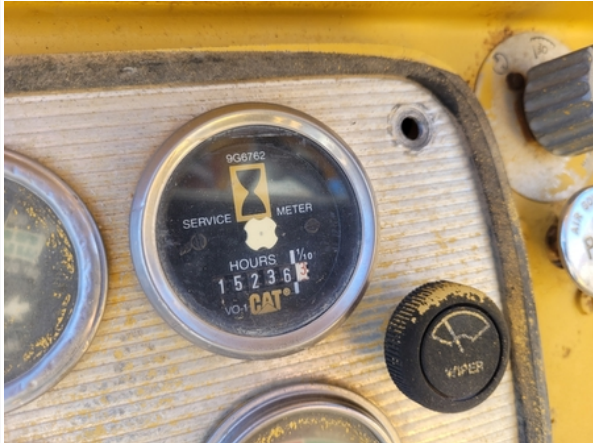
GIVE ALL NUMBERS IN ALL COMMUNICATIONS			MODEL NUMBER	SERIAL NUMBER	ARRANGEMENT NUMBER	VEHICLE	46P1583		ENGINE	70V10142		TRANS. MISSION	405				AV1721 2
GIVE ALL NUMBERS IN ALL COMMUNICATIONS																			
MODEL NUMBER	SERIAL NUMBER	ARRANGEMENT NUMBER																	
VEHICLE	46P1583																		
ENGINE	70V10142																		
TRANS. MISSION	405																		
		AV1721 2																	
Hour Meter/Odometer
