Inspection Report (Vibratory Compactor)

B&B Stock Number	A3094393
Year	2013
Make	Volvo
Model	SD75B
Serial Number	VCESD75BC0S241140
Hour Meter Reading	1709.7hrs
Previous Application (e.g., earth moving, mining, demolition, etc)	This machine was used in civil construction

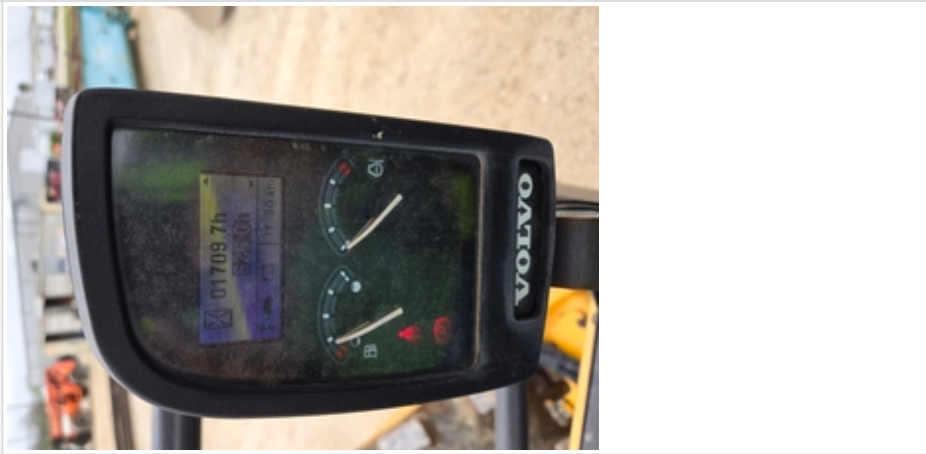
<p>01709.7h 52,300 117,000 BT</p>
Control Station Type	Open Cab (OROPS)
Option List	Unable to Confirm
Seat	2 - Above Average Wear & Tear

Seat Condition	Seat(s) in good condition, no stains or tears in upholstery, Seat adjustment controls have limited range of motion, Seat belt shows limited functionality or does not secure properly
Cabin Lights	0
Safety Lock Out / Stop	3 - Normal Wear & Tear
Safety Lock Out / Stop Condition	Safety lock out device is present, in good condition, and functional
Controls & Switches	3 - Normal Wear & Tear
Controls & Switches Condition	All switches are installed and functional
Hour Meter Activity	3 - Normal Wear & Tear
Hour Meter Condition	Hour meter is functional and in good condition
Other Gauge Activity	3 - Normal Wear & Tear
Other Gauge Condition	All cockpit gauges are functional and in good condition
Heater & A/C	0
Travel Alarm	0
Horn	0
Backup Camera	0
Control Station Overall Rating	3 - Normal Wear & Tear
Control Station Overall Condition	Minor cosmetic wear to cabin surfaces, floors, panels, and ceiling
Comments	The seatbelt does not secure properly.

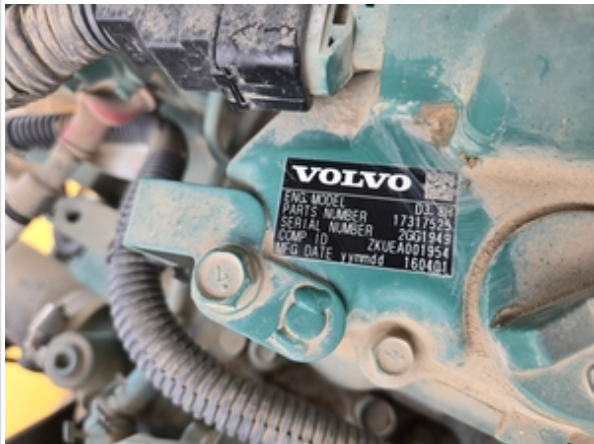
Engine Data Plate

Engine Type (Make, Model, Cylinders, Hp)	Volvo, D3.8, 4 Cylinder, 74Hp
Emissions Tier	Tier 4F
Engine Serial Number	2GG1949
Engine Fuel Type	Diesel
Blow-by (Visual Observation Check)	Yes
Comments	The blow by check was good
Unusual Noises (Upon Start-up, Idle, Shutdown)	No
Engine Smoke (Upon Start-up, Idle, Shutdown)	No
Engine Exhaust Color	Clear
Battery	3 - Normal Wear & Tear
Battery Condition	Dusty & dirty appearance
Radiator	3 - Normal Wear & Tear
Radiator Condition	Radiator fins & components appear to be in good working order, no signs of damage or leaks
Belts	3 - Normal Wear & Tear
Belt Condition	Belts appear in good condition & alignment with proper tension
Hoses	3 - Normal Wear & Tear
Hose Condition	Firm, pliant hoses with no signs of wear or leaks
Water Pump	3 - Normal Wear & Tear
Water Pump Condition	No unusual pump noises heard

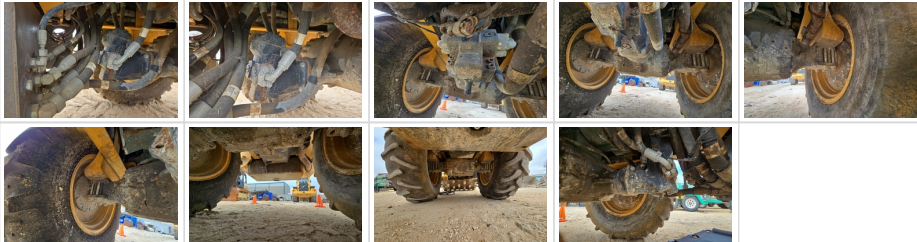
Drivetrain Photos

Hydrostatic Transmission?	N/A
Drive Type	2WD
Transmission Components	3 - Normal Wear & Tear
Transmission Condition	Good forward and reverse function
Parking Brake	3 - Normal Wear & Tear
Parking Brake Function	Good brake function
Overall Drivetrain Rating	3 - Normal Wear & Tear
Overall Drivetrain Comments	The drivetrain is in good working order.

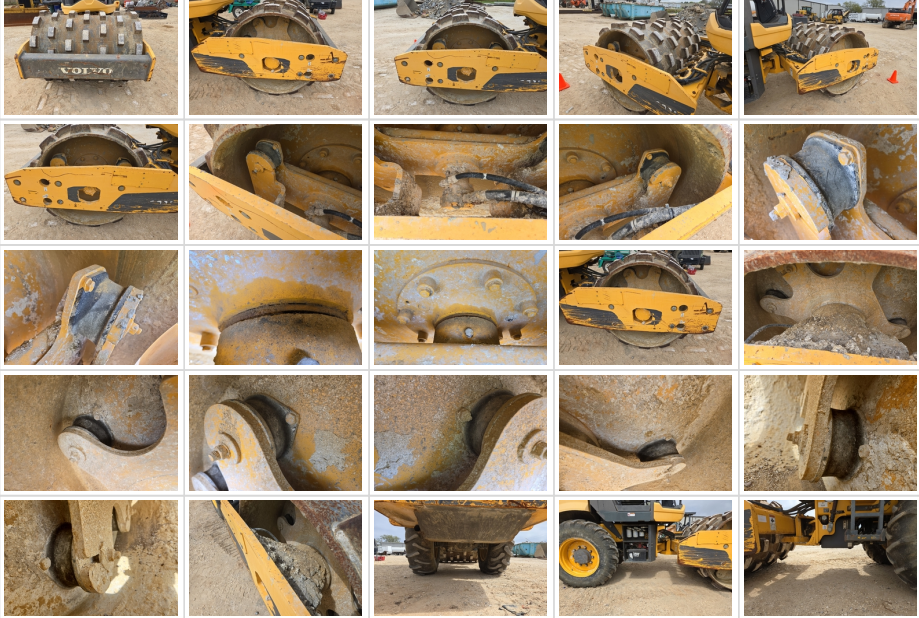
Chassis Photos

Frame	3 - Normal Wear & Tear
Stance	3 - Normal Wear & Tear
Drum(s) Condition	3 - Normal Wear & Tear
Vibratory Rubber Mounts (Front & Rear)	3 - Normal Wear & Tear
Drum Scraper	3 - Normal Wear & Tear
Padfoot Feet Condition	3 - Normal Wear & Tear
Padfoot Fitment	3 - Normal Wear & Tear
Padfoot Hardware	3 - Normal Wear & Tear

Overall Chassis	3 - Normal Wear & Tear
Overall Chassis Comments	The chassis is in good condition.
