## Inspection Report (Telehandler)

B&B Stock Number	A8106911
Year	2005
Make	Caterpillar
Model	TH330B
Serial Number	CATTH330ESLB00889
Serial Plate Photo

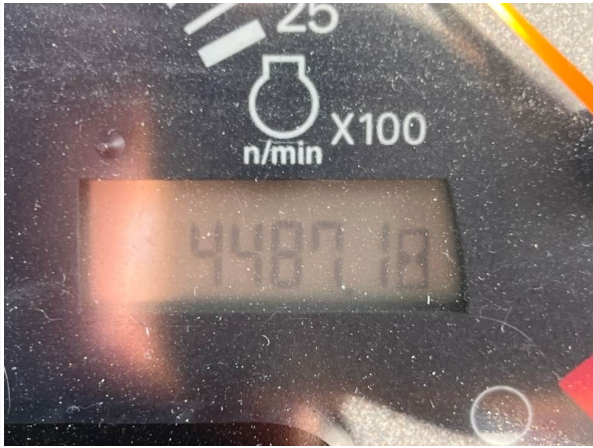
Hour Meter Reading	4487.18
Hour Meter Photo

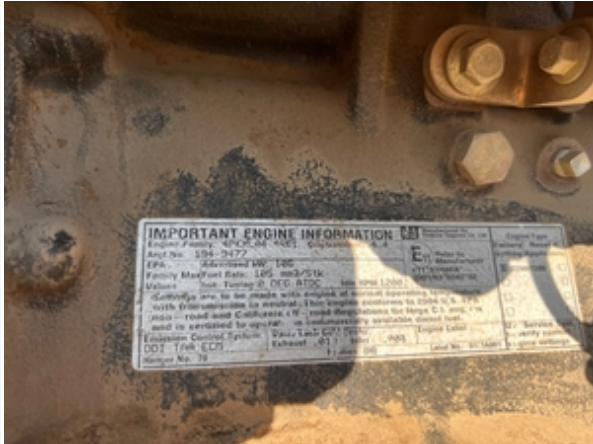
Engine Data Plate

Engine Smoke (Upon Start-up, Idle, Shutdown)	Yes
Engine Smoke Notes	Engine smoke observed upon start up
Engine Exhaust Color	White
Battery	2 - Above Average Wear & Tear
Battery Condition	Dusty & dirty appearance
Radiator	3 - Normal Wear & Tear
Belts	3 - Normal Wear & Tear
Hoses	2 - Above Average Wear & Tear
Hose Condition	Cracking, stiff, or charred hoses
Water Pump	3 - Normal Wear & Tear
Water Pump Condition	No unusual pump noises heard
Cooling System Leaks	No
Coolant Appearance	3 - Normal Wear & Tear
Coolant Appearance Notes	Normal Translucent appearance, no visual signs of contamination
Oil Leaks	No
Oil Appearance	3 - Normal Wear & Tear
Fuel Leaks	No
Equipped with DPF (Diesel Particulate Filter)	No
Requires DEF (Diesel Exhaust Fluid)	No
Overall Engine Rating	2 - Above Average Wear & Tear
Overall Engine Appearance	Areas of dried seepage seen on engine hoses & components, Active leaks/pooling observed in & around engine compartment

Overall Engine Comments	Above average wear and tear dried seepage noticed throughout engine compartment Could not the source of the seepage or what type of fluid it may be

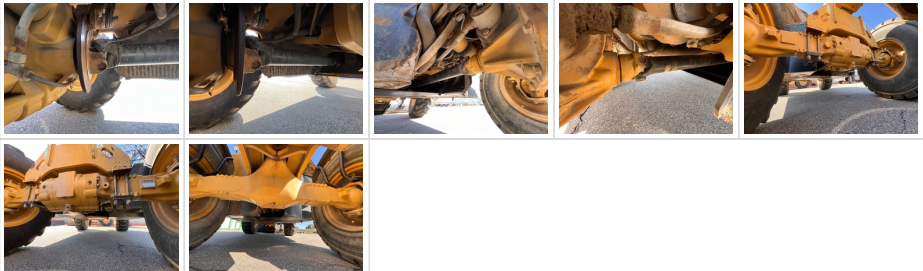
Drivetrain Photos

Hydrostatic Transmission?	Yes
Speeds	Variable Speed
Drive Type	AWD
Transmission Components	3 - Normal Wear & Tear
Transmission Condition	Good forward and reverse function
Drive Motors	0
Parking Brake	3 - Normal Wear & Tear
Overall Drivetrain Rating	3 - Normal Wear & Tear
Overall Drivetrain Comments	Normal wear and tear no major issues to report
Front Axle	3 - Normal Wear & Tear
Rear Axle	3 - Normal Wear & Tear
