Inspection Report (Excavator)

B&B Stock Number	A2758803
Year	2016
Make	Hyundai
Model	220LC-9A
Serial Number	HHKHZ610HF0000331
Serial Plate Photo

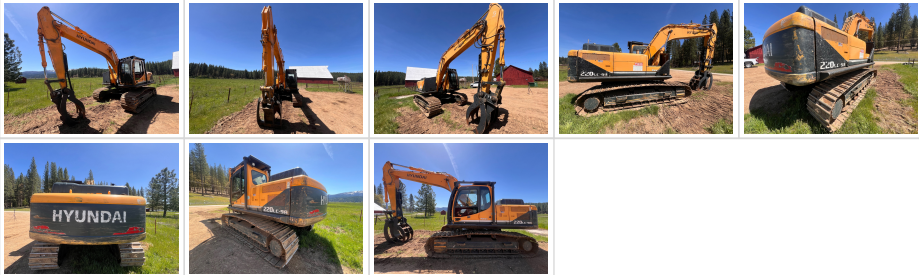
Exterior Walkaround Photos

Mirrors	0
Exterior Lights	3 - Normal Wear & Tear
Exterior Lights Condition	No visible damage, lighting system is operational
Overall Exterior	2 - Above Average Wear & Tear
Comments	Above average wear and tear to exterior of machine due to bent panels and chipped paint

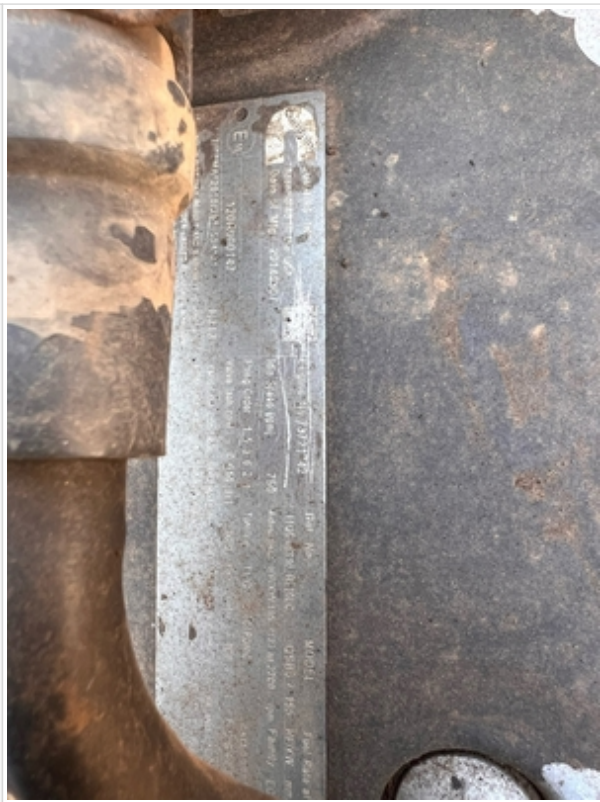
<p>Engine Data Plate</p>

Overall Engine Comments	Above average wear and tear to the engine compartment due to the dried seepage throughout engine compartment, as well as areas of fluid pooling at the base of the engine compartment
