## Inspection Report (Bulldozer)

B&B Stock Number	A8501217
Year	2006
Make	Caterpillar
Model	D5G XL
Serial Number	CAT00D5GCWGB03429
Serial Plate Photo

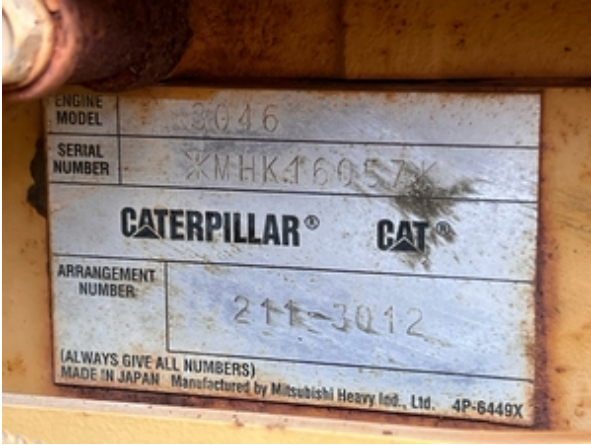
Engine Data Plate

Engine Type (Make, Model, Cylinders, Hp)	Mitsubishi, 3046
Emissions Tier	Undetermined
Engine Serial Number	211-3012
Engine Fuel Type	Diesel
Blow-by (Visual Observation Check)	No
Unusual Noises (Upon Start-up, Idle, Shutdown)	No
Engine Smoke (Upon Start-up, Idle, Shutdown)	No
Engine Exhaust Color	Clear
Battery	3 - Normal Wear & Tear
Battery Condition	Dusty & dirty appearance
Radiator	3 - Normal Wear & Tear
Radiator Condition	Radiator fins & components appear to be in good working order, no signs of damage or leaks
