# 1999 CHEVROLET C7500 / 0

Job #: 71495 / VIN: 1GBM7H1C2XJ105054

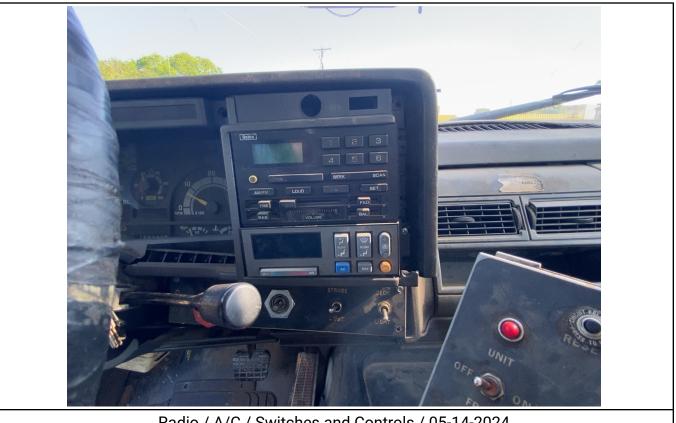
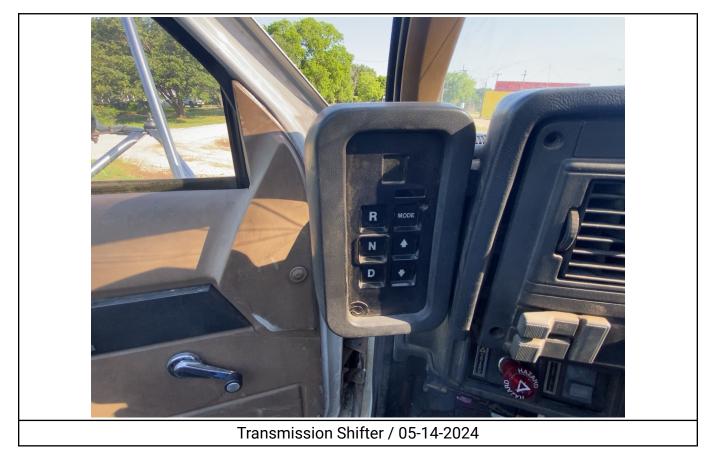
Radio / A/C / Switches and Controls / 05-14-2024

| Year1999MakeChevroletModelC7500Date of Inspection05/14/2024Location of Inspection5112 E University Dr , Denton, TX,<br>76208, USAVIN1GBM7H1C2XJ105054GVWR33,000Odometer146,300Engine Hours25,099EMS Warning LightsNo Active WarningsCab InteriorSee NotesDriver's SeatNo Damages ObservedPassenger's SeatNo Damages ObservedFloorboardNo Damages ObservedFloorboardNo Damages ObservedRadioYesA/CYesSwitches and ControlsSee NotesPower MirrorsNoHeated MirrorsNoSteering WheelSee NotesMirrorsNo Damages ObservedStepsSee NotesMirrorsNo Damages ObservedEngine CompartmentNo Damages ObservedEngine CompartmentNo Damages ObservedEngine CompartmentObstructedObstructedObstructed | Specifications | |
|---|---|---|
| Heated MirrorsNoSteering WheelSee NotesMirrorsNo Damages ObservedStepsSee NotesHandrailsNo Damages ObservedExhaust PipeSee NotesEngine CompartmentNo Damages ObservedEngine Serial PlateObstructed | Switches and Controls | See Notes |

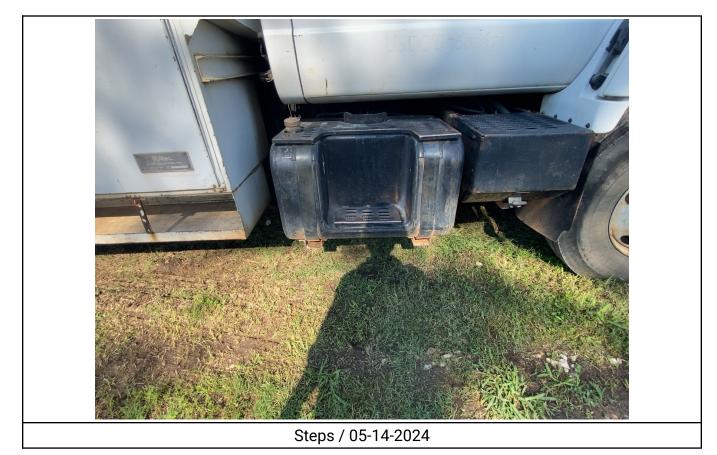
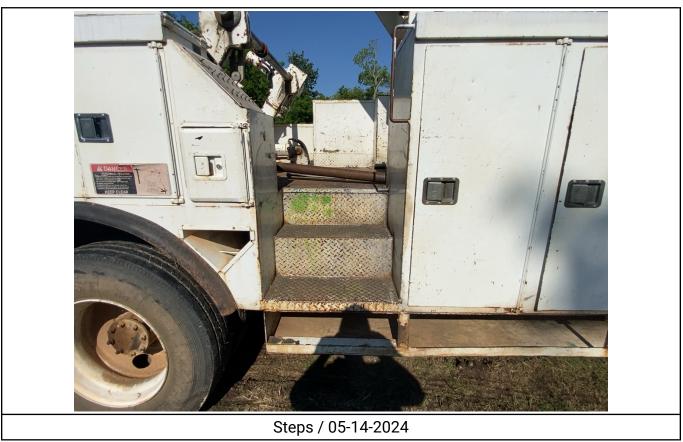
Steps / 05-14-2024

| Year1999MakeChevroletModelC7500Date of Inspection05/14/2024Location of Inspection5112 E University Dr , Denton, TX,<br>76208, USAVIN1GBM7H1C2XJ105054GVWR33,000Odometer146,300Engine Hours25,099EMS Warning LightsNo Active WarningsCab InteriorSee NotesDriver's SeatNo Damages ObservedPassenger's SeatNo Damages ObservedFloorboardNo Damages ObservedFloorboardNo Damages ObservedRadioYesA/CYesSwitches and ControlsSee NotesPower MirrorsNoHeated MirrorsNoSteering WheelSee NotesMirrorsNo Damages ObservedStepsSee NotesMirrorsNo Damages ObservedEngine CompartmentNo Damages ObservedEngine CompartmentNo Damages ObservedEngine CompartmentObstructedObstructedObstructed | Specifications | |
|---|---|---|
| Exhaust PipeSee NotesEngine CompartmentNo Damages ObservedEngine Serial PlateObstructed | Steps | See Notes |
