Inspection Report (Skid Steer/Track Loader)

B&B Stock Number	A5067887
Year	2018
Make	Caterpillar
Model	249D
Serial Number	CAT0249DEGWR02723
Serial Plate Photo

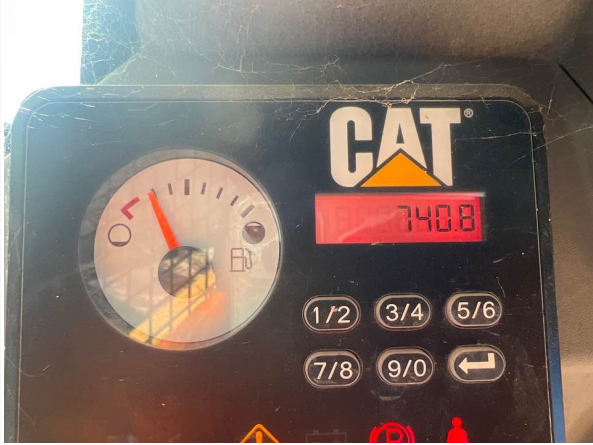
Hour Meter Reading	740.8
Hour Meter Photo

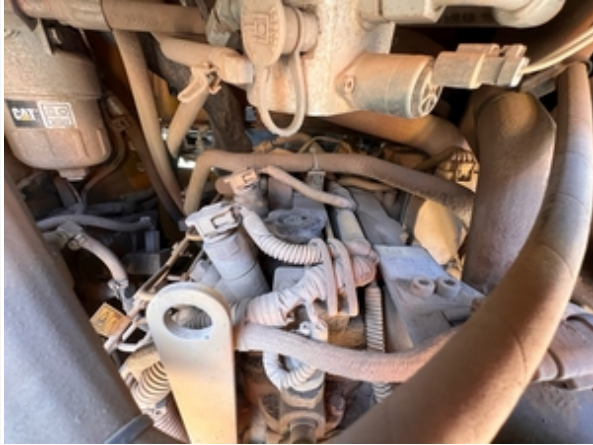
Engine Data Plate

Unusual Noises (Upon Start-up, Idle, Shutdown)	No
Engine Smoke (Upon Start-up, Idle, Shutdown)	No
Engine Exhaust Color	Clear
Battery	3 - Normal Wear & Tear
Radiator	3 - Normal Wear & Tear
Belts	3 - Normal Wear & Tear
Hoses	3 - Normal Wear & Tear
Water Pump	3 - Normal Wear & Tear
Cooling System Leaks	No
Coolant Appearance	3 - Normal Wear & Tear
Oil Leaks	No
Oil Appearance	3 - Normal Wear & Tear
Fuel Leaks	No
Equipped with DPF (Diesel Particulate Filter)	No
Requires DEF (Diesel Exhaust Fluid)	No
Overall Engine Rating	3 - Normal Wear & Tear
Overall Engine Appearance	Areas of dried seepage seen on engine hoses & components, Very dirty
Overall Engine Comments	Normal wear and tear no major issues to report
