General Into	
B&B Stock Number	A6753886
Year	2013
Make	Caterpillar
Model	140M2
Serial Number	M9D01452
Serial Plate Photo	CATERPILAR BRASIL LTDA The distribution was the second process of
Hour Meter Reading	8942
Hour Meter Photo	5
Previous Application (e.g., earth moving, mining, demolition, etc)	Marana,Az

Inspection Report (Motor Grader)

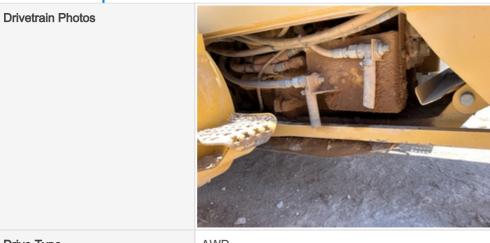
Drivetrain Inspection Points

Drive Type	AWD
Transmission Components	3 - Normal Wear & Tear
Parking Brake	3 - Normal Wear & Tear
Overall Drivetrain Rating	3 - Normal Wear & Tear
Overall Drivetrain Comments	Good
Rear Tandems (Chain Drives) Condition	3 - Normal Wear & Tear
Rear Drive Axle	3 - Normal Wear & Tear
